## Preliminary bat roost assessment

Site Location	Ruffits, Headley Road, Grayshott, GU266DL
Document reference	CE4480
Date of Site visit	26 <sup>th</sup> February 2024
Report by	[REDACTED]

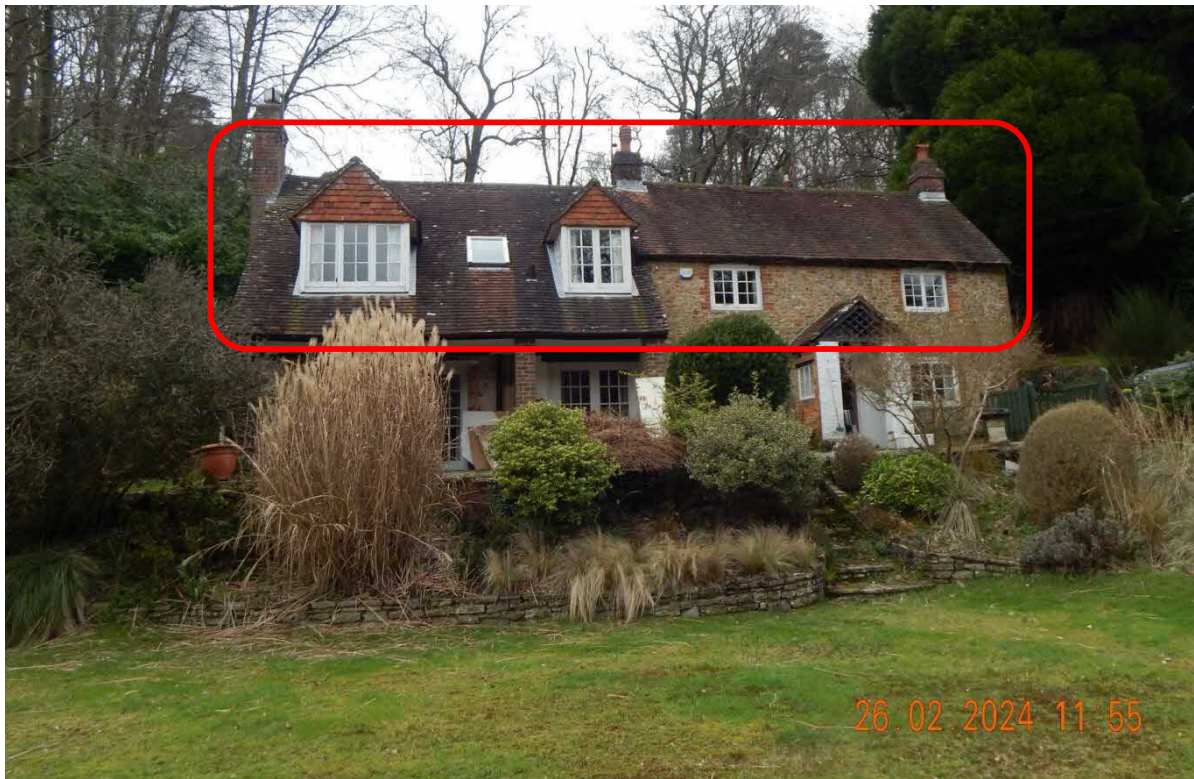
Image 2 – B1 – South facing elevation of the structure which has demonstrated a moderate level of gaps of accessible proportions to offer value to bats

**6.4** B1 – The main dwelling has evidenced roosting features of moderate value within the roof coverings, vertical hanging tiles, eaves and stoneworks which look to offer access and availability to both void & crevice dwelling bats and could not be fully ruled out during the Preliminary Roost Assessment without causing disturbance to materials which in effect may cause disturbance to possible bat roosts within.

In line with best practice survey guidelines, a structure that has demonstrated moderate value must have a further two emergence surveys to rule out or confirm activity from bats. These survey should be carried out within the recommended survey season from May to September with at least one of these visits during the optimal time of May to August.

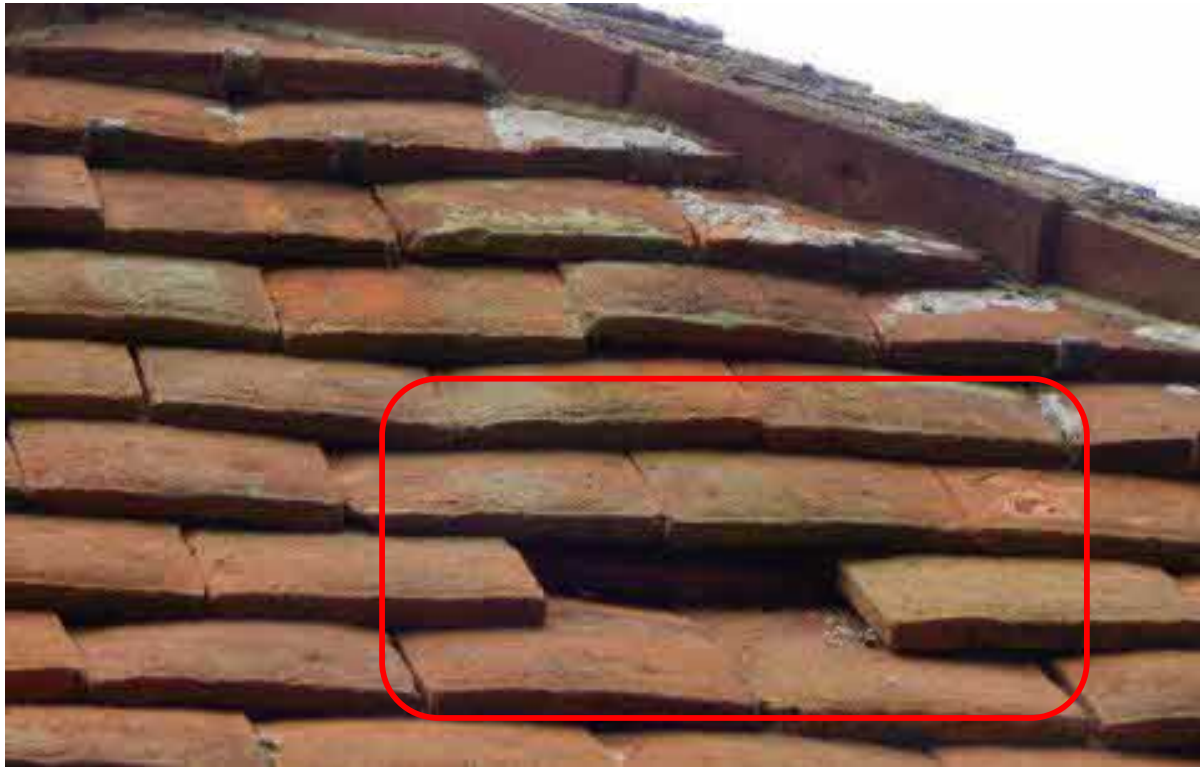
Image 4 – B1 – Gaps observed within the South facing vertical hanging tiles

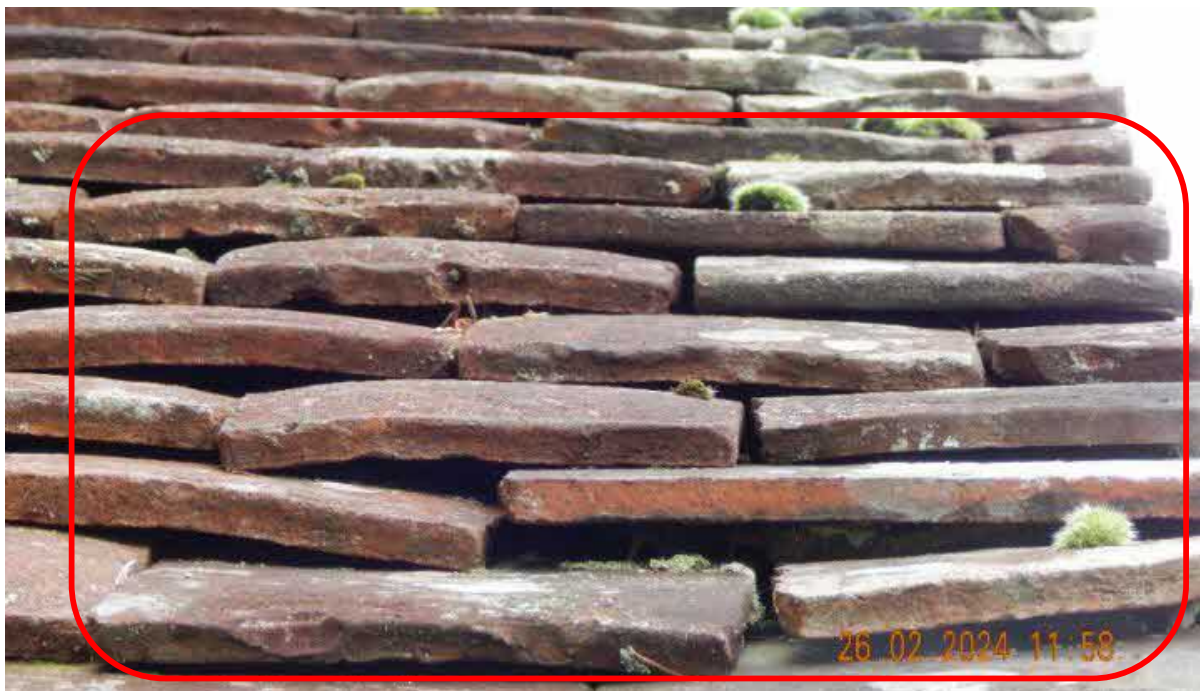
Image 5 – B1 – Further features of value to bats across the lower front roof coverings with likely roosting habitats within

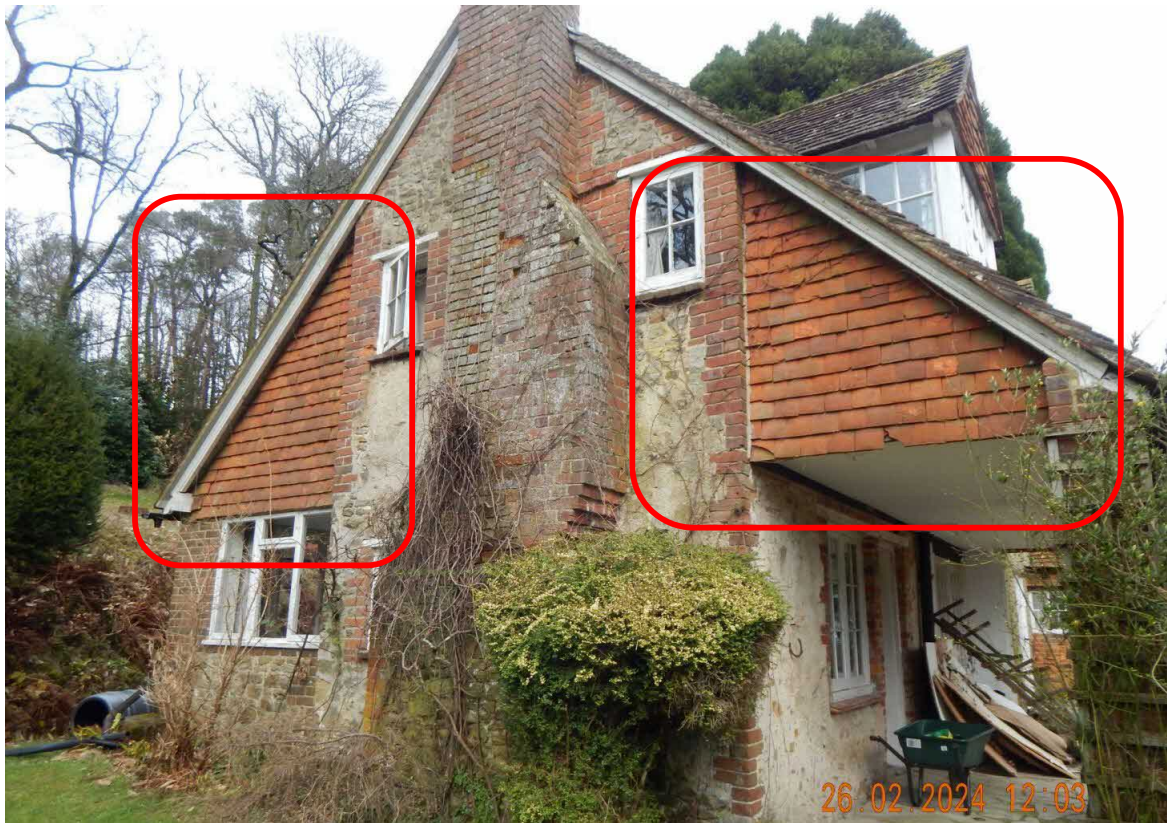
Image 6 – B1 – West facing elevation of the property where the proposed development works will take place. Further features of value to bats were observed within the vertical hanging tiles

Image 7 – B1 – As above image

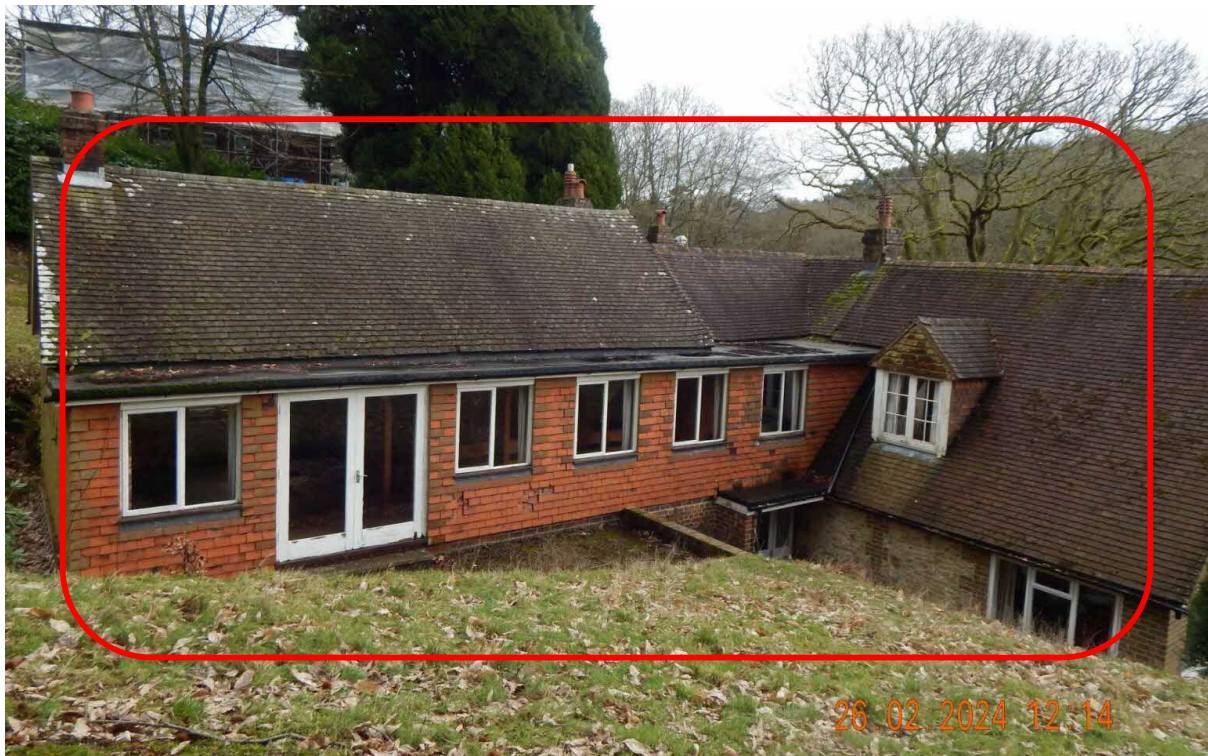
Image 8 – B1 – North & West facing elevation of the property offering further gaps of value to bats within the roof and vertical tile coverings

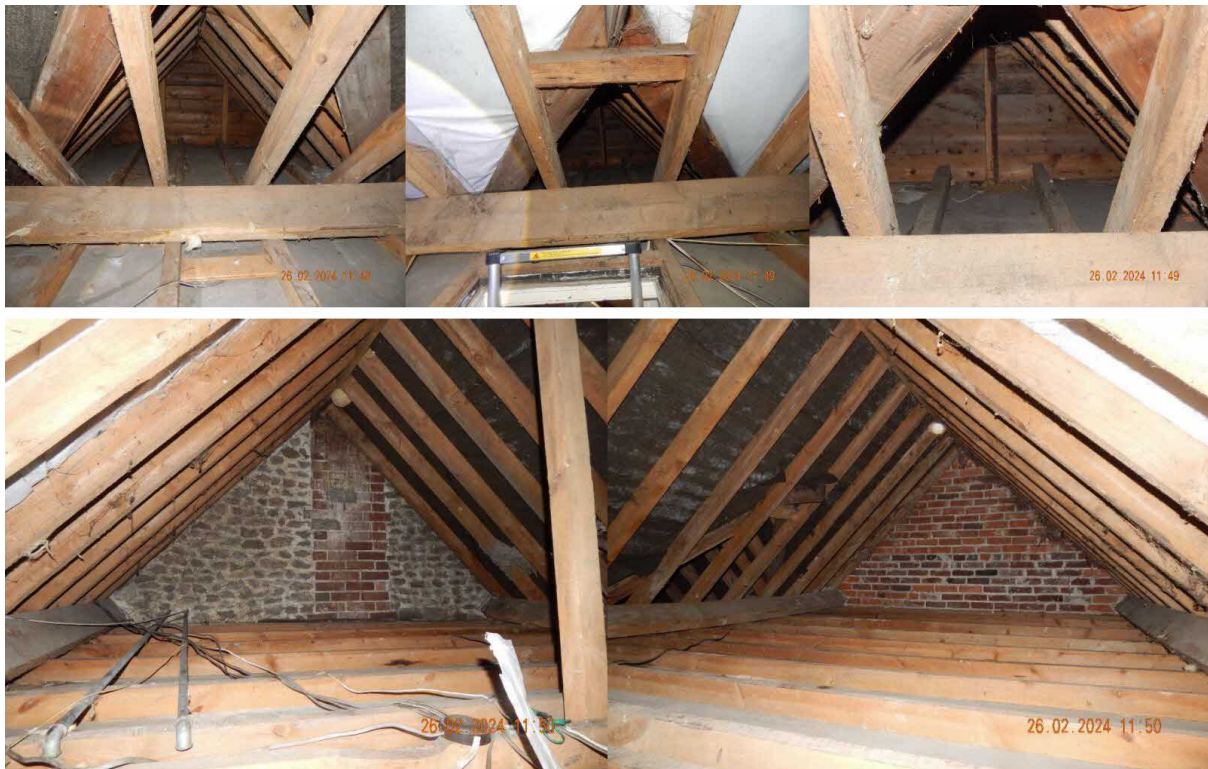
Internal	Features of value to bats	Notes
Membrane coverings	Yes	<p>B1 – Both felt and PVC membrane coverings were observed within the main roof void spaces of the property.</p> <p>Such coverings may offer further roosting habitats between the coverings and roof tiles where external gaps likely provide access.</p> <p>B2 – No features of value to bats noted.</p> <p>B3 – No features of value to bats noted.</p> <p>B4 – No features of value to bats noted.</p>

Image 9 – B1 – Internal view from within the main upper roof coverings of the property

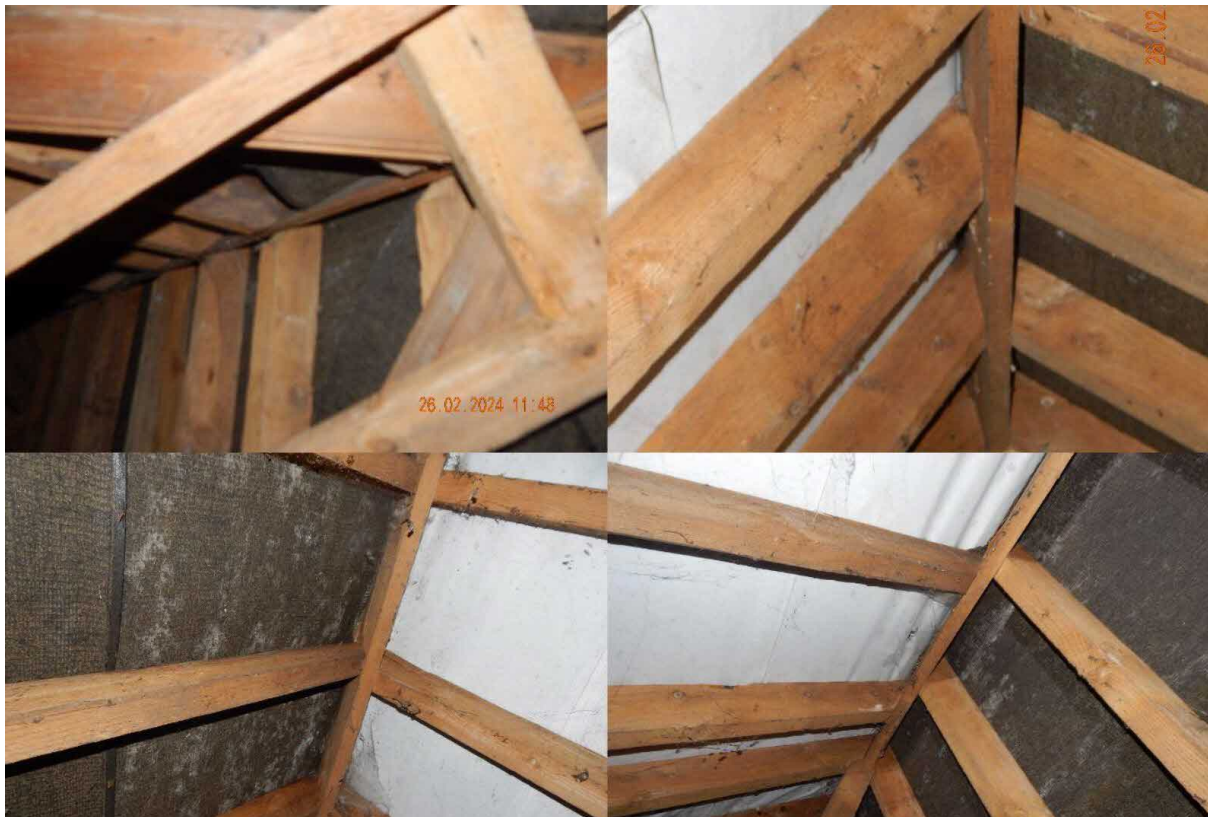
Image 10 – B1 – Evidence of felt/PVC membrane coverings below the tiled roof coverings

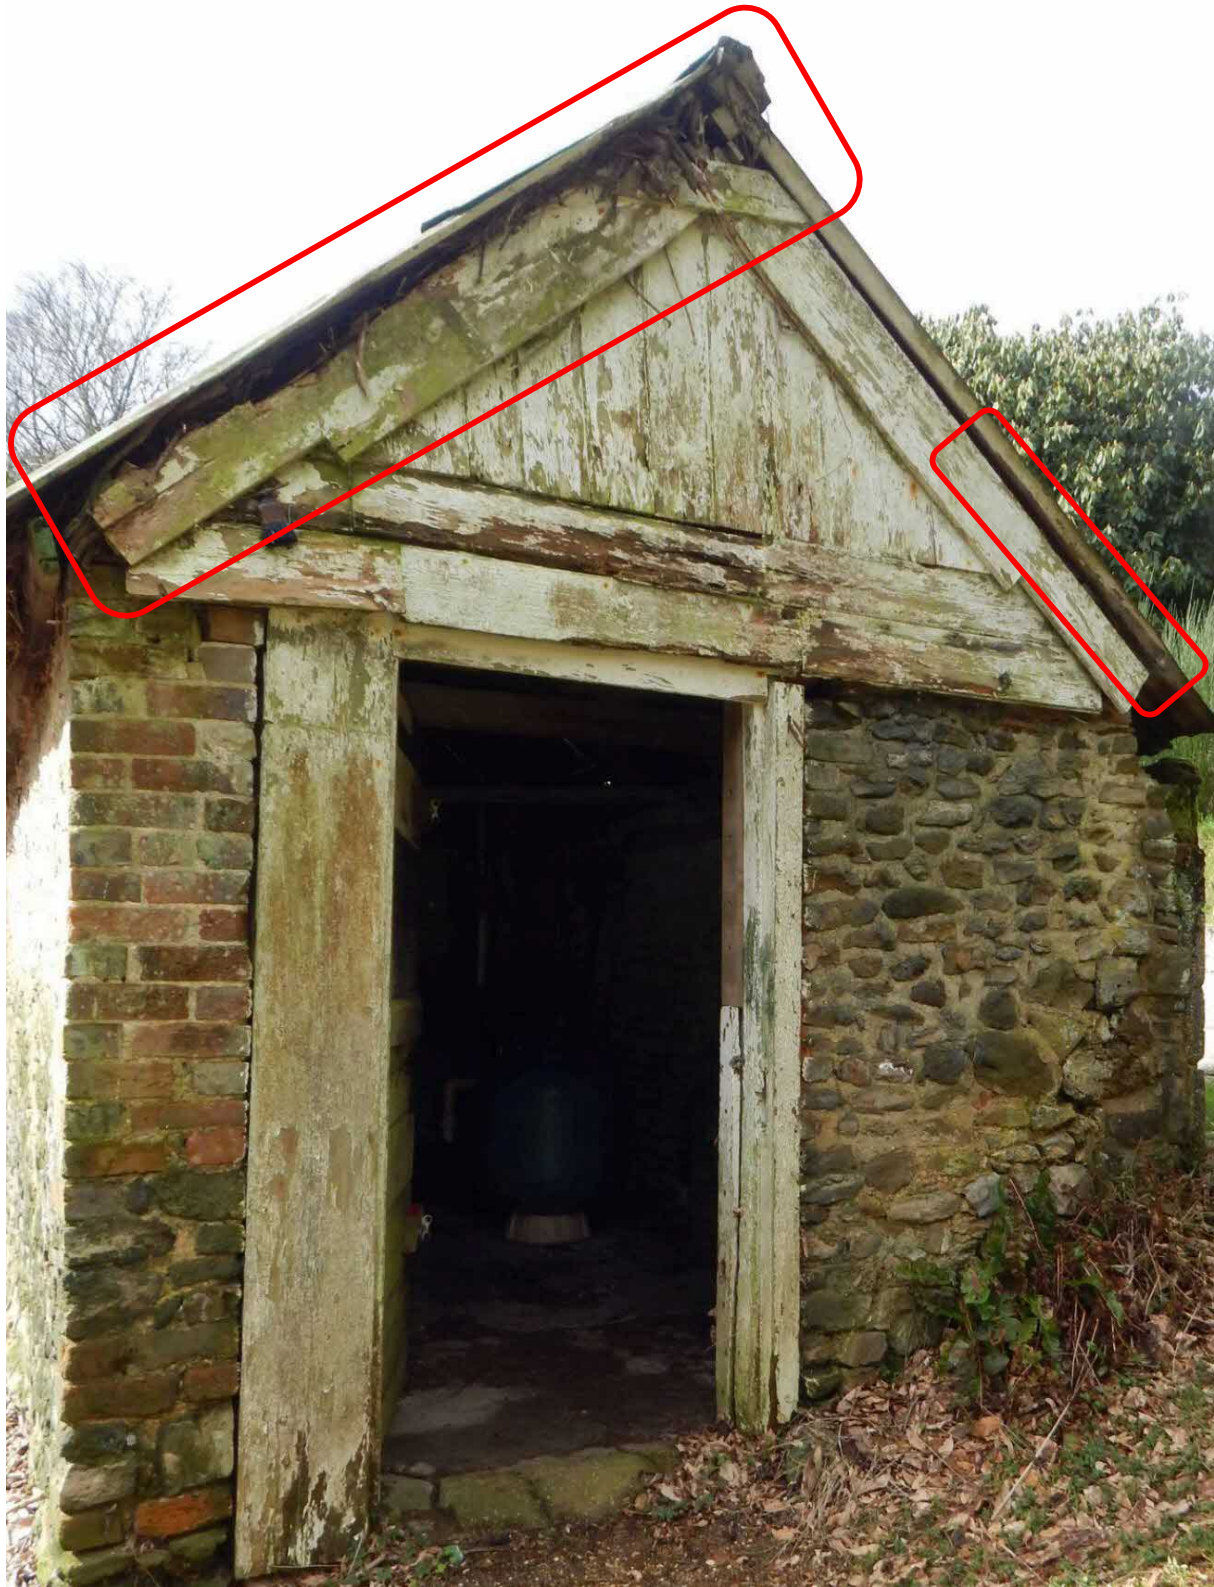
Image 12 – B2 – Front elevation of the structure offering further gaps between the roof coverings and timber fabrics below

**6.5** B2 – The stone outbuilding has evidenced roosting features of moderate value within the stoneworks which look to offer access and availability to

In line with best practice survey guidelines, a structure that has demonstrated moderate value must have a further two emergence surveys to rule out or confirm activity from bats. These survey should be carried out within the recommended survey season from May to September with at least one of these visits during the optimal time of May to August.

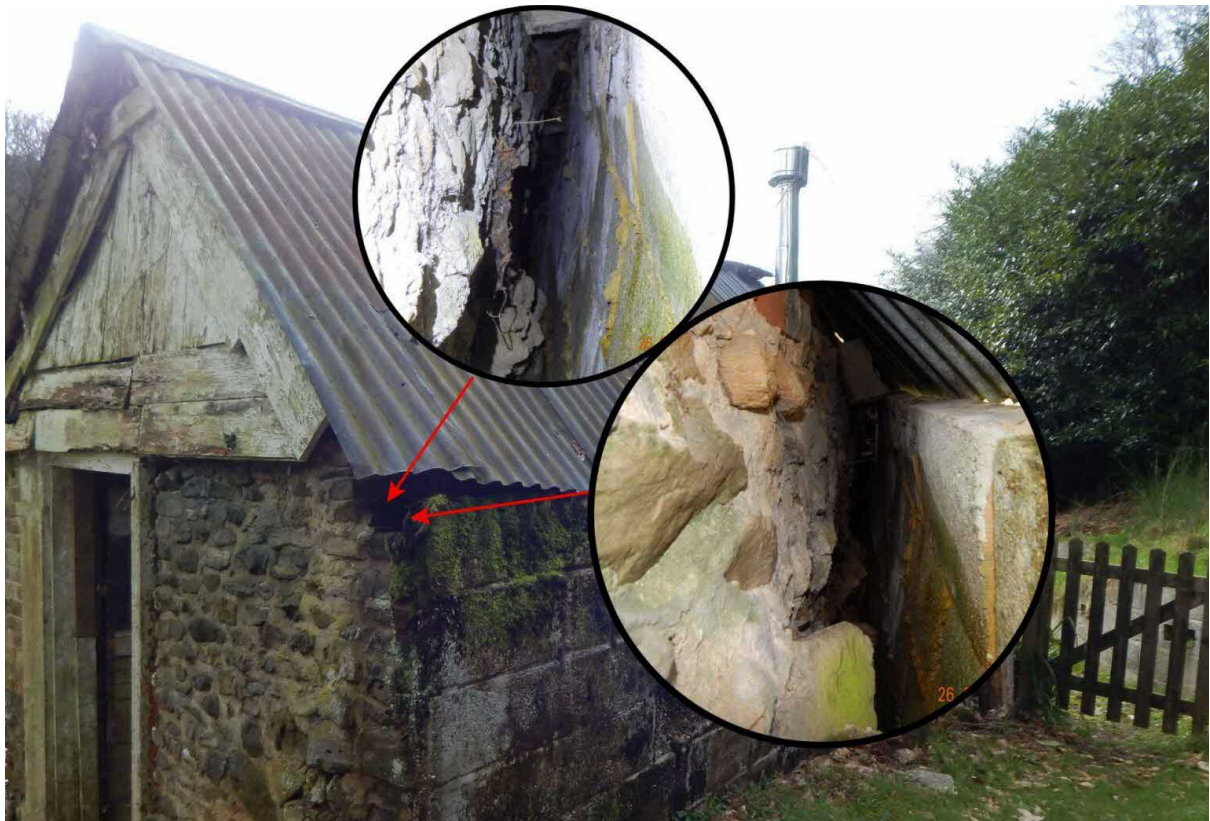
Image 13 – B2 – North elevation offering enclosed crevice spaces of value to bats

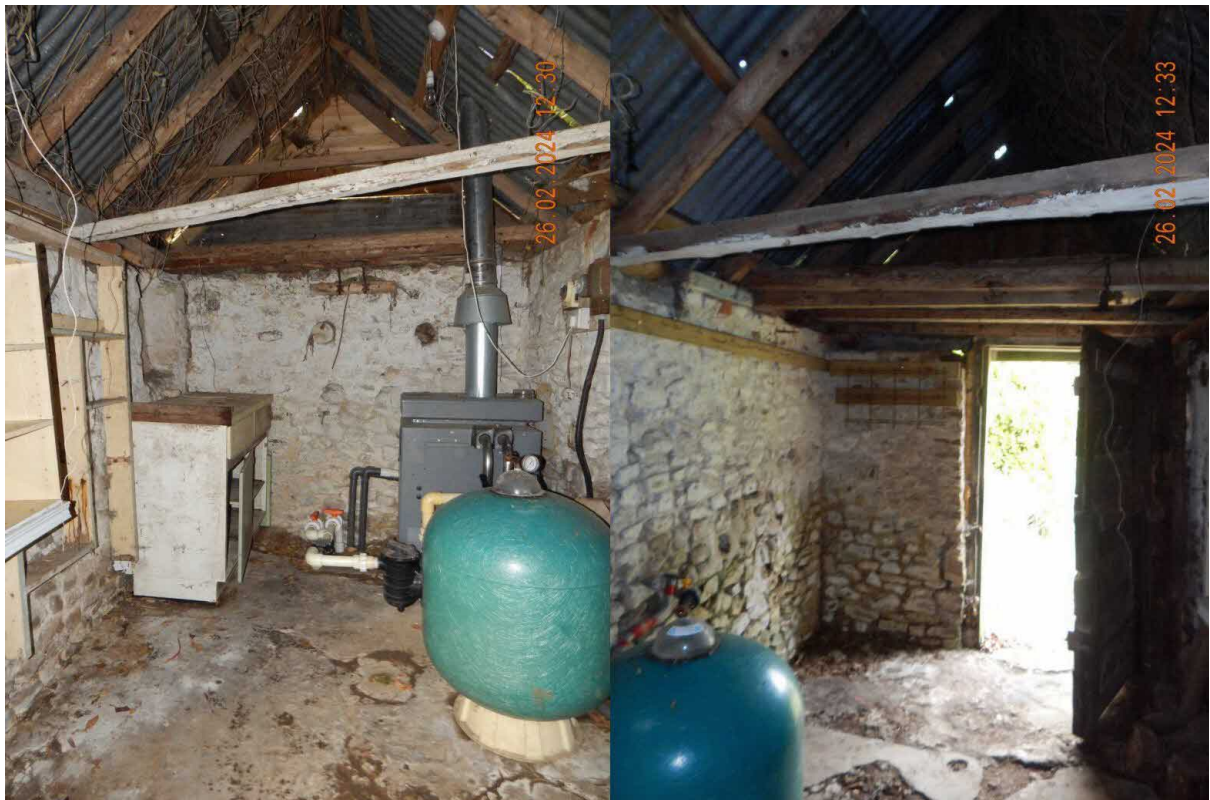
Daylight/gaps internally	Yes	B2 – Gaps offering protruding daylight within the roof sheeting.
Internal fabrics	Yes	B2 – Several gaps within the inner stoneworks were observed of adequate proportions to offer likely roosting habitats commonly used by creative dwelling species.
Evidence from bats	No	<p>B1 – No evidence from bats observed during the site visit. However, we are unable to rule out or confirm evidence/activity within the enclosed habitats beyond the eaves, between roof coverings or vertical hanging tiles where evidence such as droppings wouldn't always be visible.</p> <p>B2 – No evidence from bats observed during the site visit. However, we are unable to rule out or confirm evidence/activity within the enclosed habitats within the stoneworks both externally and internally where evidence such as droppings wouldn't always be visible.</p> <p>B3 - No evidence from bats observed during the site visit.</p> <p>B4 - No evidence from bats observed during the site visit.</p>

Image 14 – B2 – Internal view from within the structure

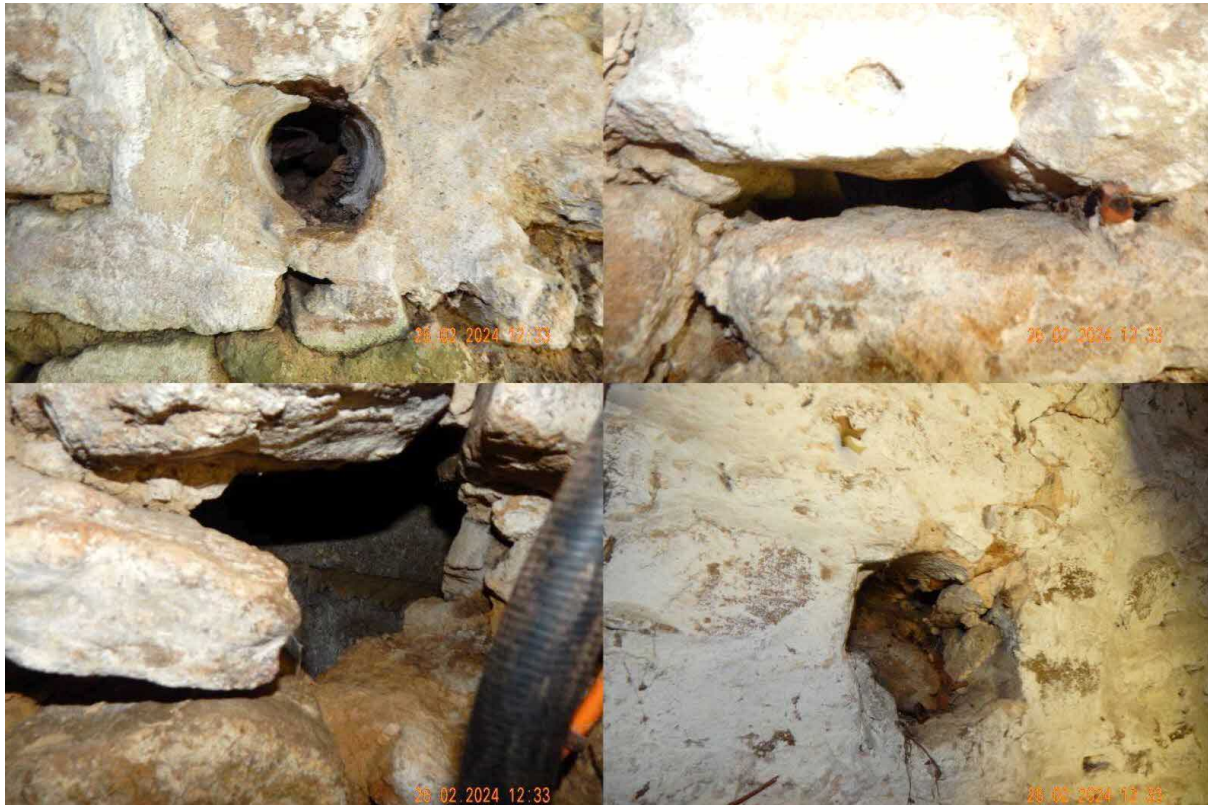
Image 15 – B2 – Accessible crevice habitats within the stoneworks internally

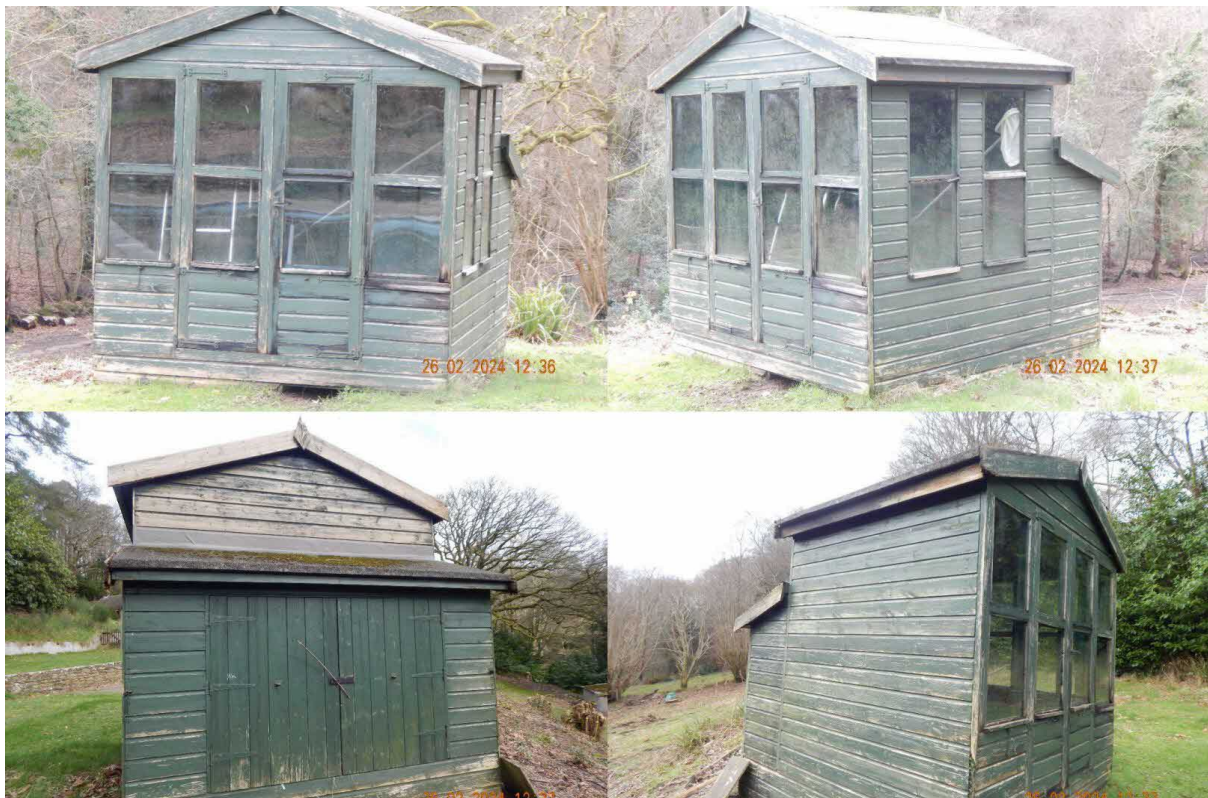
Image 16 – B3 – Timber fabricated structure

**6.6** B3 & B4 have demonstrated no features of value to bats or evidence from bats. No further survey requirements identified.

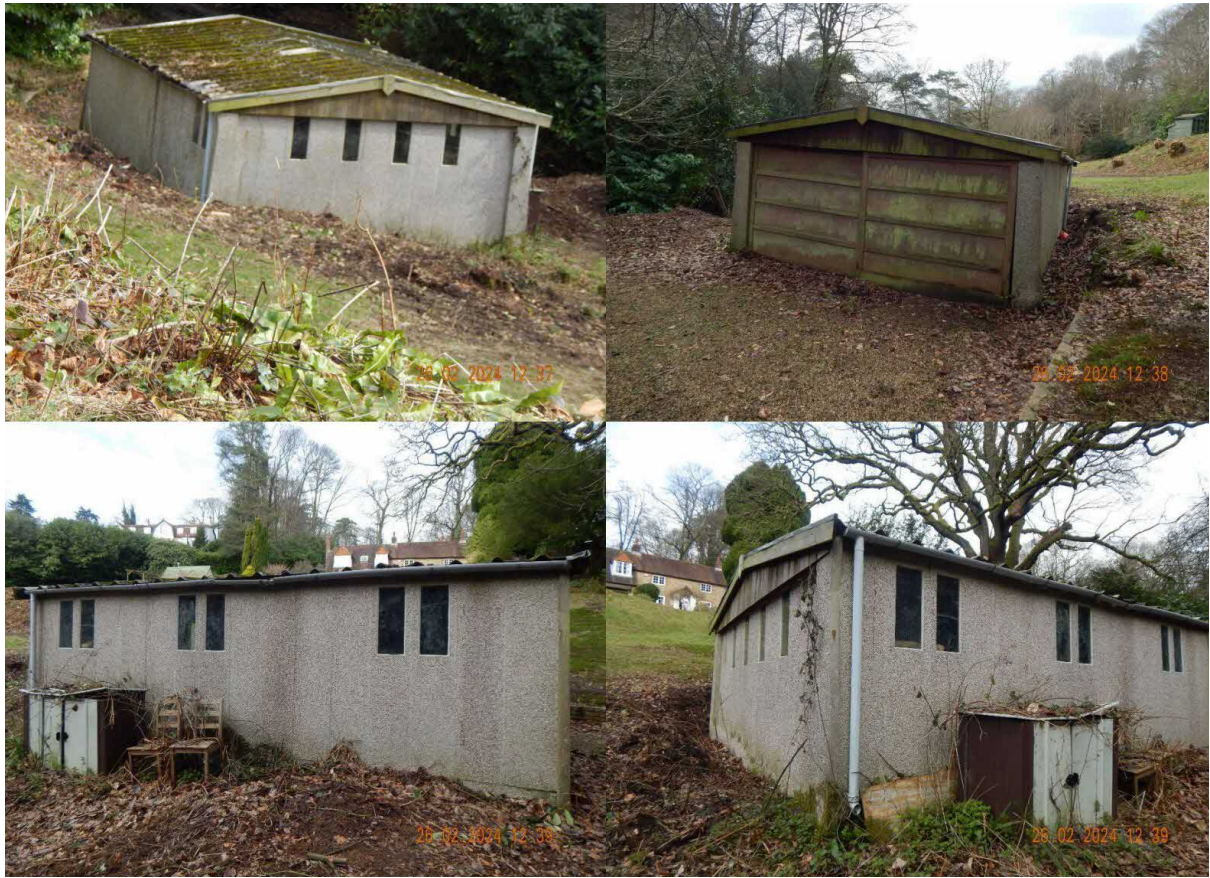
Image 17 – B4 – Fabricated garage structure

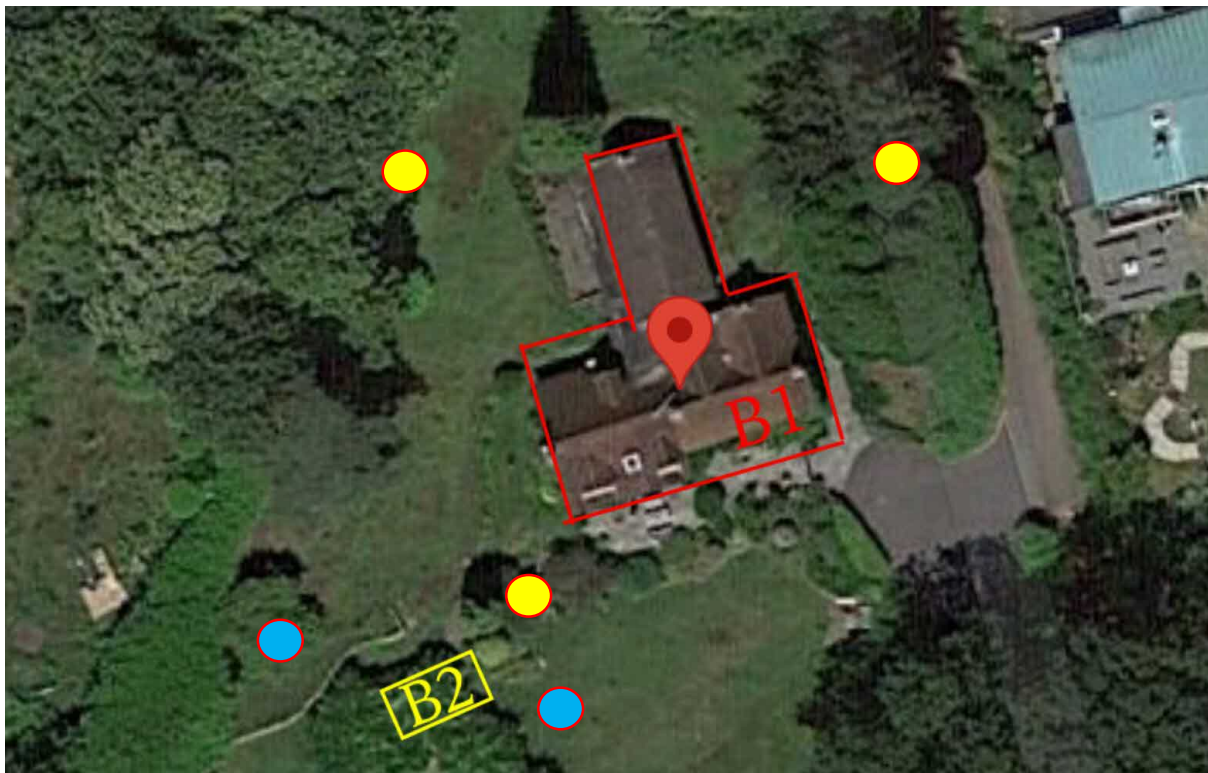
#### Appendix 4: Emergence Survey Location Points

Below site view to show suitable surveyor location points during each emergence survey to maintain visibility of the property.

In line with best practice survey guidelines, a total of three surveyors will be required to visually cover all elevations of B1 & two Surveyors to cover all elevations of B2 during each emergence survey.
