GFW03 W03

Project: Whitfield Farmhouse, Hungerford Lane, Shurlock Row, RG10 0NY Drawing: GFW03 W03

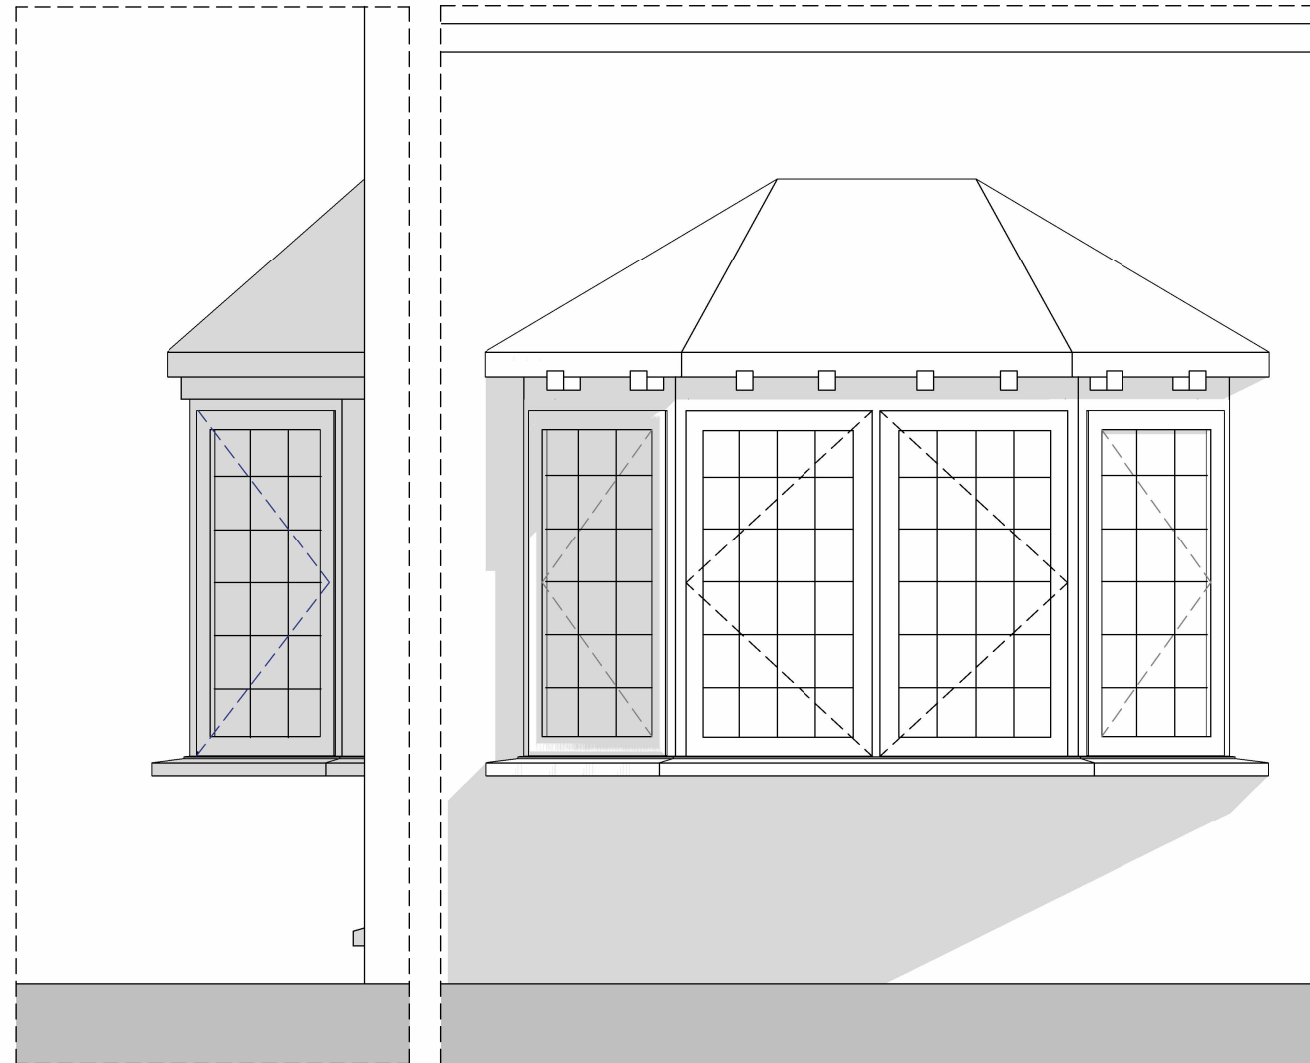
side & front elevation - 1:20

current condition:

estimated late C20 casement oriel window
painted shut, unable to easily open

proposed replacement unit:

3 light oriel window unit to be replaced
with like for like timber unit

replacement unit to contain leadwork to
match existing

slimline double glazing to remove the need
for any further secondary glazing
