FFW03 W07

Project: Whitfield Farmhouse, Hungerford Lane, Shurlock Row, RG10 0NY Drawing: FFW03 W07

Chartered Practice
	Collaborating with: Linda Behan	Date: Mar 24	
Job: 997	Drawing: 10-06	Revision:	Drawn By: JB Checked By: EM

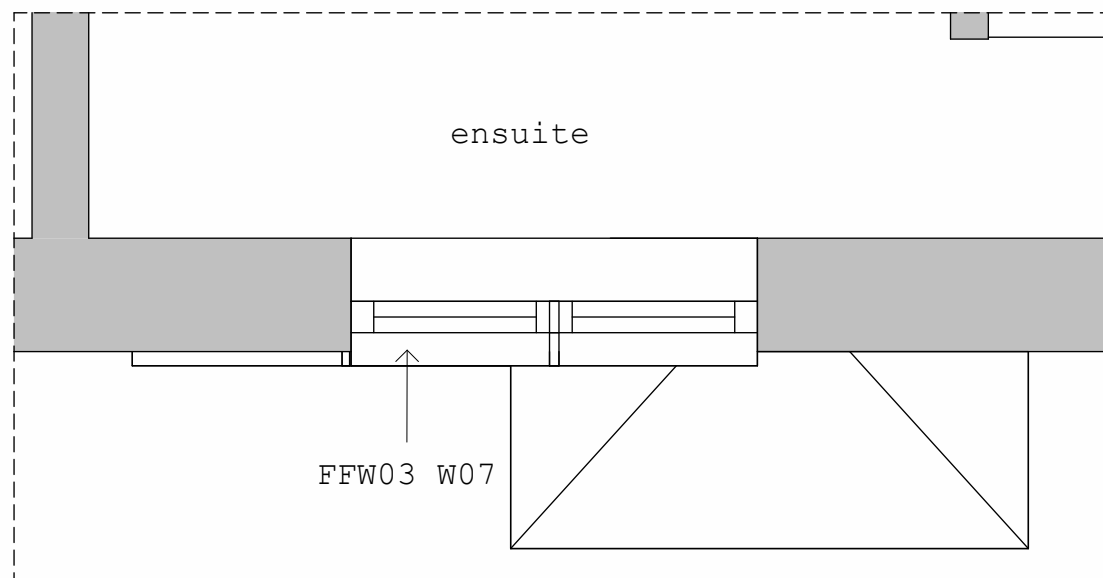
first floor plan - 1:50

current condition:

estimated late C20 casement window

painted shut, unable to open

adjacent shutters in good condition, to be lightly sanded and repainted

timber window frames showing signs of rot & ironmongery worn

expanding foam has previously been used to stop draughts, secondary glazing has also been fitted

proposed replacement unit:

2 light 1 window unit to be replaced with like for like timber unit

replacement unit to contain leadwork to match existing

slimline double glazing to remove the need for any further secondary glazing
