FFW02 W06

Project: Whitfield Farmhouse, Hungerford Lane, Shurlock Row, RG10 0NY Drawing: FFW02 W06

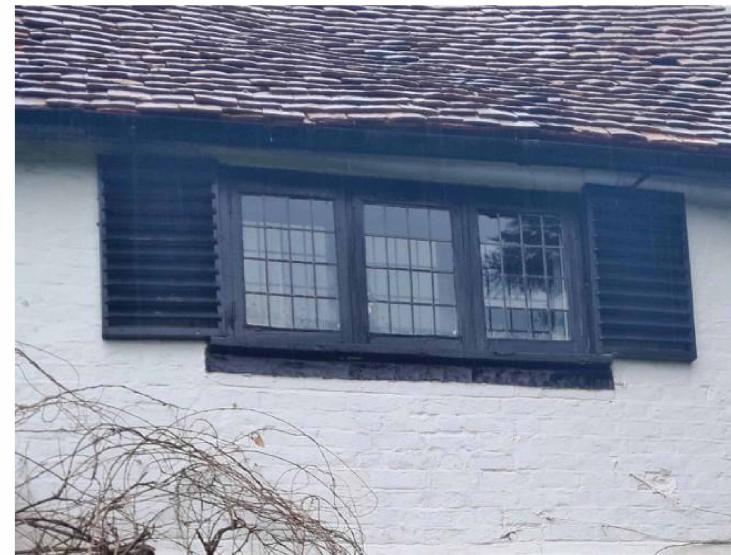
external view

estimated late C20 casement window
 painted shut, unable to easily open
 adjacent shutters in good condition, to be lightly sanded and repainted
 timber window frames showing signs of rot & ironmongery worn
 expanding foam has previously been used to stop draughts, secondary glazing has also been fitted

3 light 1 window unit to be replaced with like for like timber unit
 replacement unit to contain leadwork to match existing
 slimline double glazing to remove the need for any further secondary glazing
