Sherfield Manor, Sherfield English

Bat Activity Survey Report Mr M. Croll

October 2022

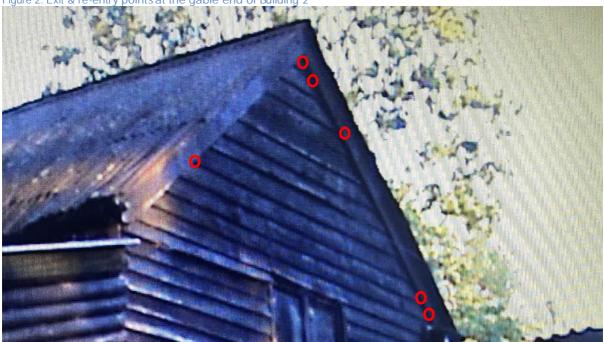
Figure 2. Exit & re-entry points at the gable end of Building 2

Survey date	Bat species recorded emerging	Number recorded	Egress/ingress point
20/07/20	Soprano pipistrelle <i>Pipistrellus pygmaeu</i> s	4	Various points of the gable end of Building 2
22/07/20	Soprano pipistrelle	2	Various points of the gable end of the Building 2
10/08/20	Soprano pipistrelle	1	The gable end of the Building 2
16/06/22	Soprano pipistrelle	3	The gable end of the Buildin 2
28/06/22	Soprano pipistrelle	2	The gable end of the Buildin 2

See Fig 2 below for the exit/entry points from the five surveys (3 in 2020 and 2 in 2022).

The presence of bats roosting in Building 2 was confirmed during each of the five activity surveys.

The emergence of Soprano pipistrelles confirms that Building 2 houses an active bat roost. The roost is characterised as a summer, day roost.

The proposed development works will require the destruction of the roost.

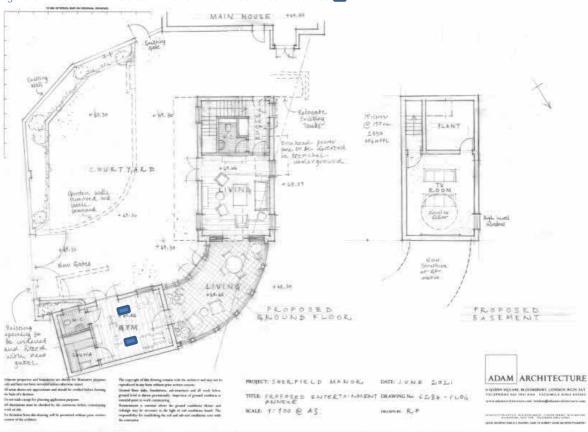
Figure 3 – Location of Habitat Enhancement Measures – Bat Tiles

These will include the installation of 2 bat access tiles to the new roof cladding and the use of Type 1 F roofing felt in the structure, see Figure 3 below.

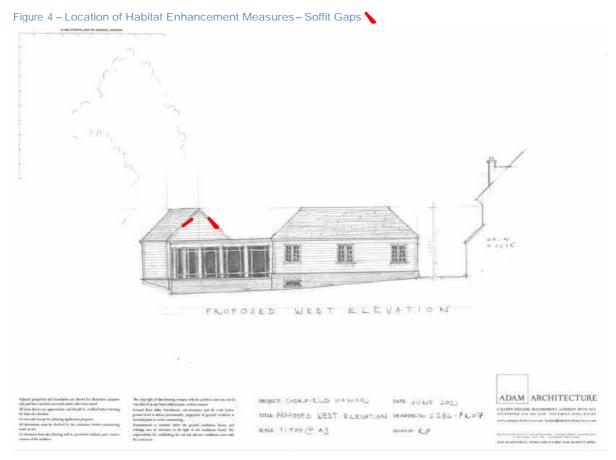
Two gaps in the soffit on the western gable end will be created. Each will measure 1cm high by 4cm wide, see Figure 4 below.
