14a Chapel Road, Hanham, Bristol Proposed Commercial Development Phase One Coal Mining Risk Assessment

Report Reference: ESP.8893.4078

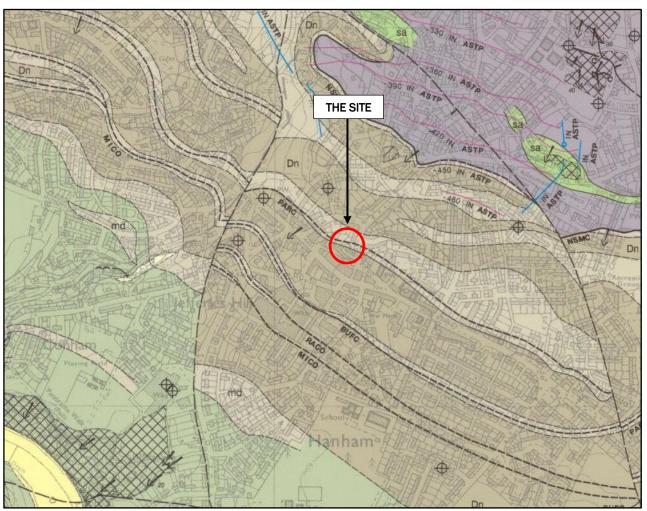
Insert 2 - Extract from BGS Geological Map Sheet ST67SW, original 1:10,000 scale.

The bedrock is indicated to be the Downend Formation, comprised of sandstone with mudstone and conglomerate, seat earths and coal seams. The Parrot Coal seam is indicated to crop out conjecturally trending northwest to southeast through the approximate centre of the north portion of the site, where the seam is shown to trend west to east beneath the site. The proven position of the New Smiths Coal seam is shown crop out some 285m northeast. The conjectural outcrop of the Buff Coal is shown approximately 140m southwest. Based on recorded seam depths in the Ashton Top Coal seam extending north of the site (see Insert 2), the bedrock in the area is indicated to dip at around 20° to the southwest. This ties in with dip angles and directions shown on the geological map to the southwest of the site.

Given this, the Buff Coal seam to the southwest would not be anticipated beneath the site; however, the Parrot Coal seam is shown to conjecturally crop out on site and the New Smiths Coal seam to the north/northeast (below the Parrot Coal seam in succession), could be present beneath the site.

The published 1:10,000 scale geological map for the area of the site (Sheet ST67SW, 2003 editions) indicates the site to be underlain by bedrock of the Middle Coal Measures Formation, comprising mainly mudstones, with sandstones, seat earths and coal seams.

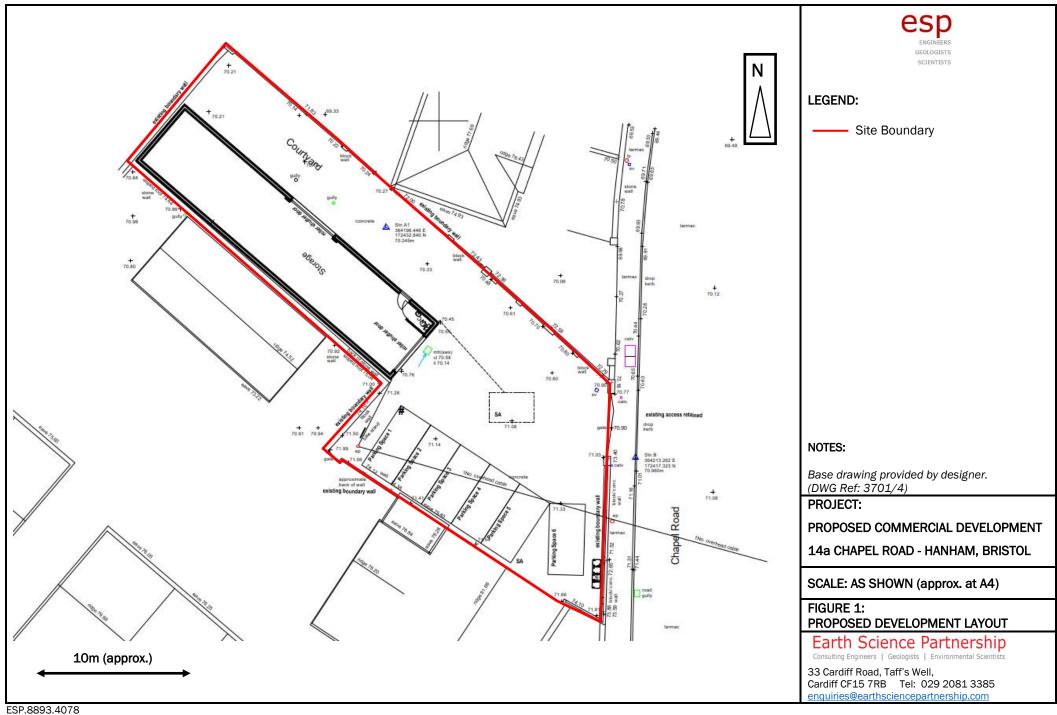
Figure 1 - Proposed Development Layout

The proposed development comprises a storage unit within the west/northwest of the site, with remainder of the site to be hardstanding with areas of vehicle parking. The proposed layout is presented as Figure 1.

A topographic survey has been provided by the Client (see Figure 1) and indicates a ground level of around 71m AOD in the southeast, lowering to around 70.2 in the northwest.

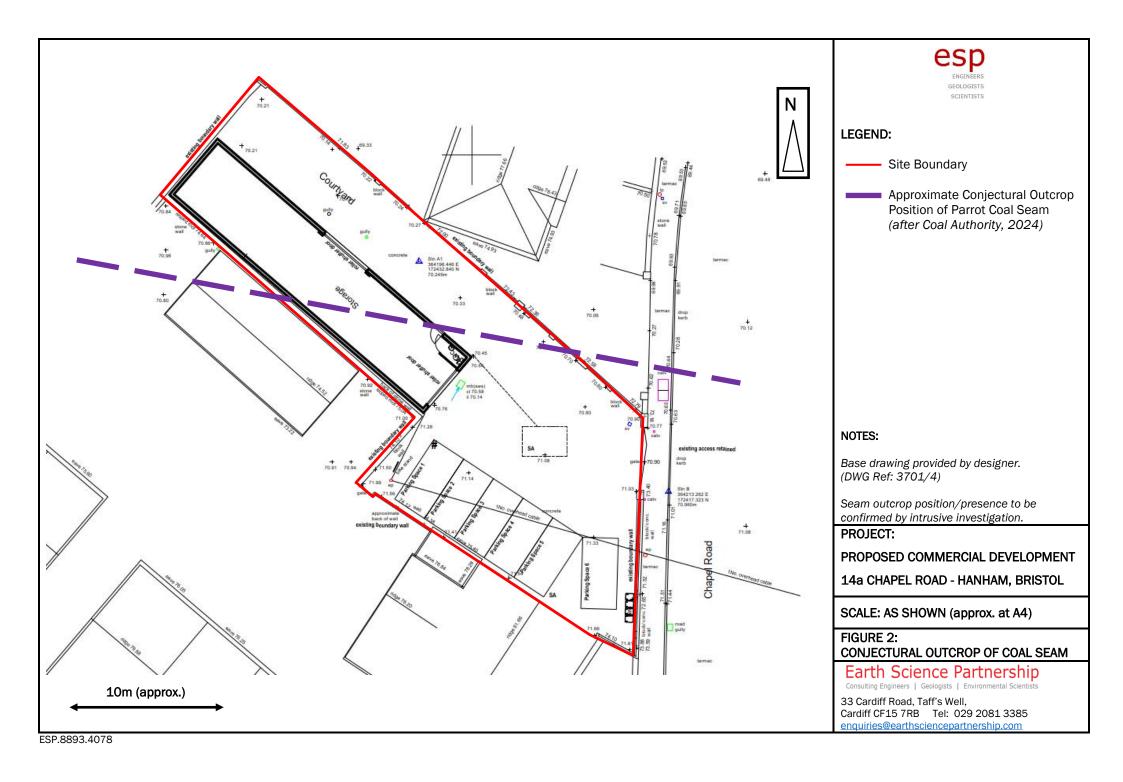
Figure 2 - Conceptual Outcrop of Coal Seam

The site lies above the Coal Measures bedrock (Downend Member) with the Parrot coal seam shown to crop out conjecturally (west-east) across the approximate centre of the site. The strata dips to the southwest, with evidence from the geological mapping and Coal Authority showing an approximate dip angle of 20°, therefore this coal seam would be expected to underlie the south margins of the site, as shown on Figure 3.

Based on the Conceptual Model presented as Figure 3, if the Parrot seam is located at 26m beneath the site, then the outcrop location would be approximately 77m northeast of the site.
