This structural assessment is based on observations made from ground level internally and externally. Site visit made on 6 September 2023.

PROJECT	TENDER	CONSTRUCTION
Evergreen Barn

Structural Assessment

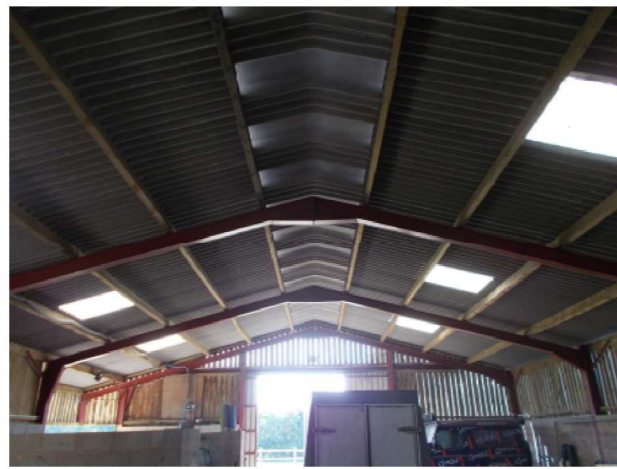
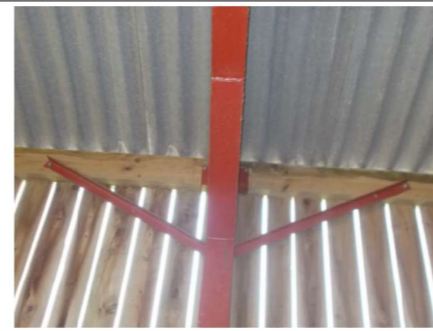
Purlins - Significantly under-sized by current standards, will deflect heavily under code defined snow loading. Will need to be replaced during conversion works, use 178x102x19 UB

Frame - Significantly under-sized by current standards, particularly the rafter sections. Frame likely to deflect heavily under both lateral wind loading and vertical snow loading. Deflections unacceptable once sensitive finishes introduced due to conversion to domestic use.

Typical - Longitudinal stability currently provided by lightweight steel bracing. Inadequate for conversion; detail elevations in such a way as to provide frame stiffness.

General - Where column bases are visible they appear to be lightly corroded, delamination not yet evident. Expose bases and protect steelwork.

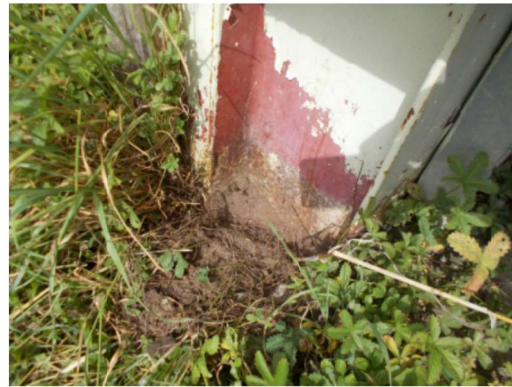
100 brick 60 cavity 100 block cavity wall construction at low level with timber framing/cladding over. Walls appear to be free from movement and cracking suggesting foundations are performing satisfactorily. If re-using walls, head will need restraint
