**56A FOREST WAY, WARFIELD PARK
BAT SURVEY REPORT**

Prepared for Warfield Homes Ltd.

Hankinson Duckett Associates

February 2024

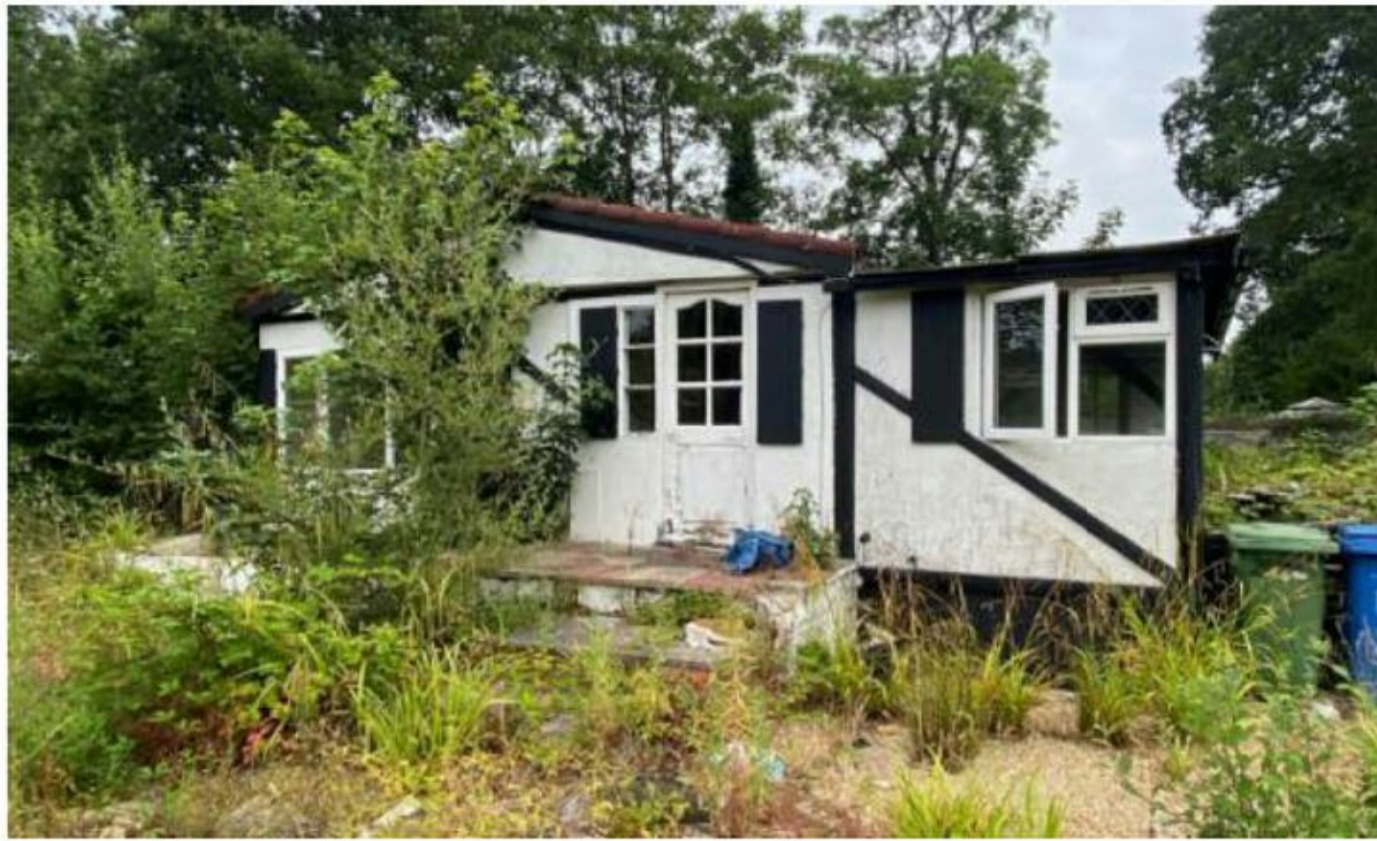
Building	Description	Findings	Bat roost potential
B1 (Photos 1 to 5)	Disused prefabricated park home on brick footings. The park home is constructed of wood panels with rendered sections and a pitched tiled roof.	External: Bat access opportunities into the building include multiple gaps under roof and ridge tiles, and a large hole in the south-eastern corner of the pitched roof which provides a potential access route into an internal roof void. Internal: No loft hatches were present in the building interior however it is believed that a loft void of at least 30cm high is present. No evidence of roosting bats was recorded.	Moderate

Photo 1 : Southern elevation of B1

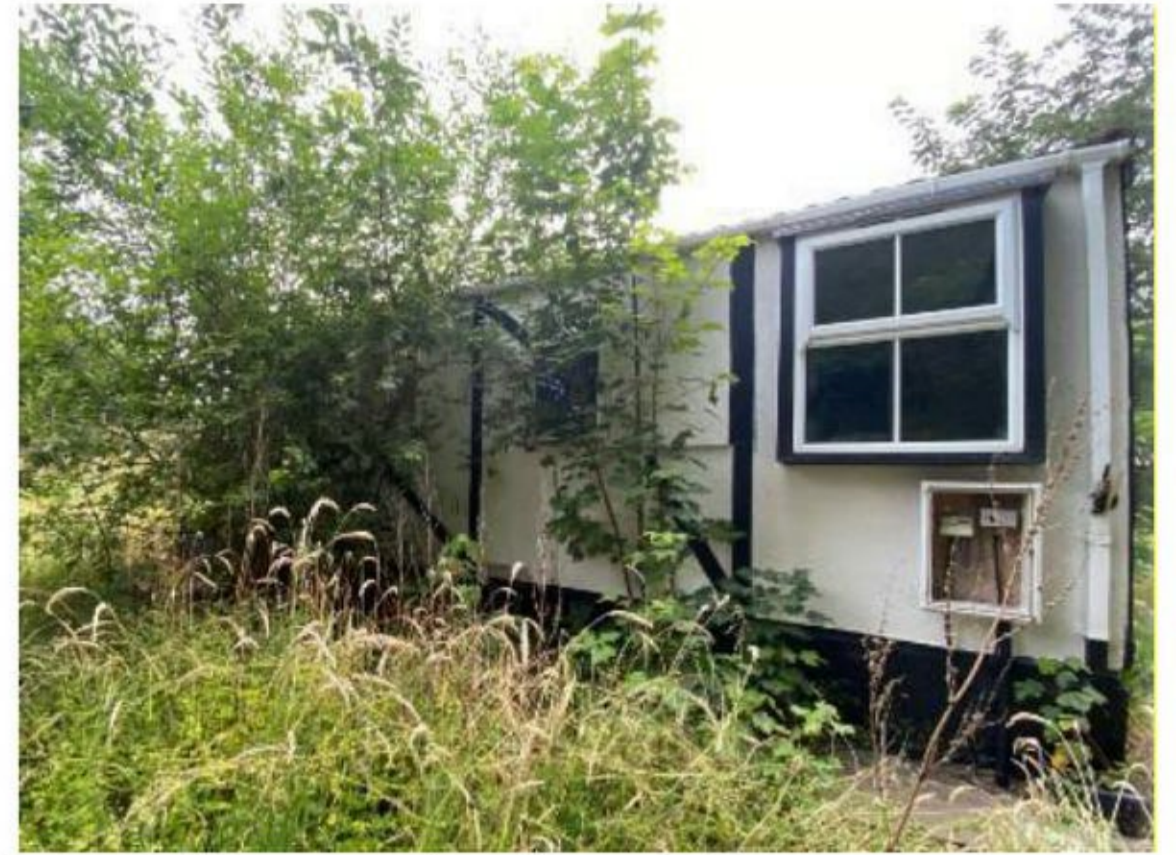
Photo 2: Western elevation of B1

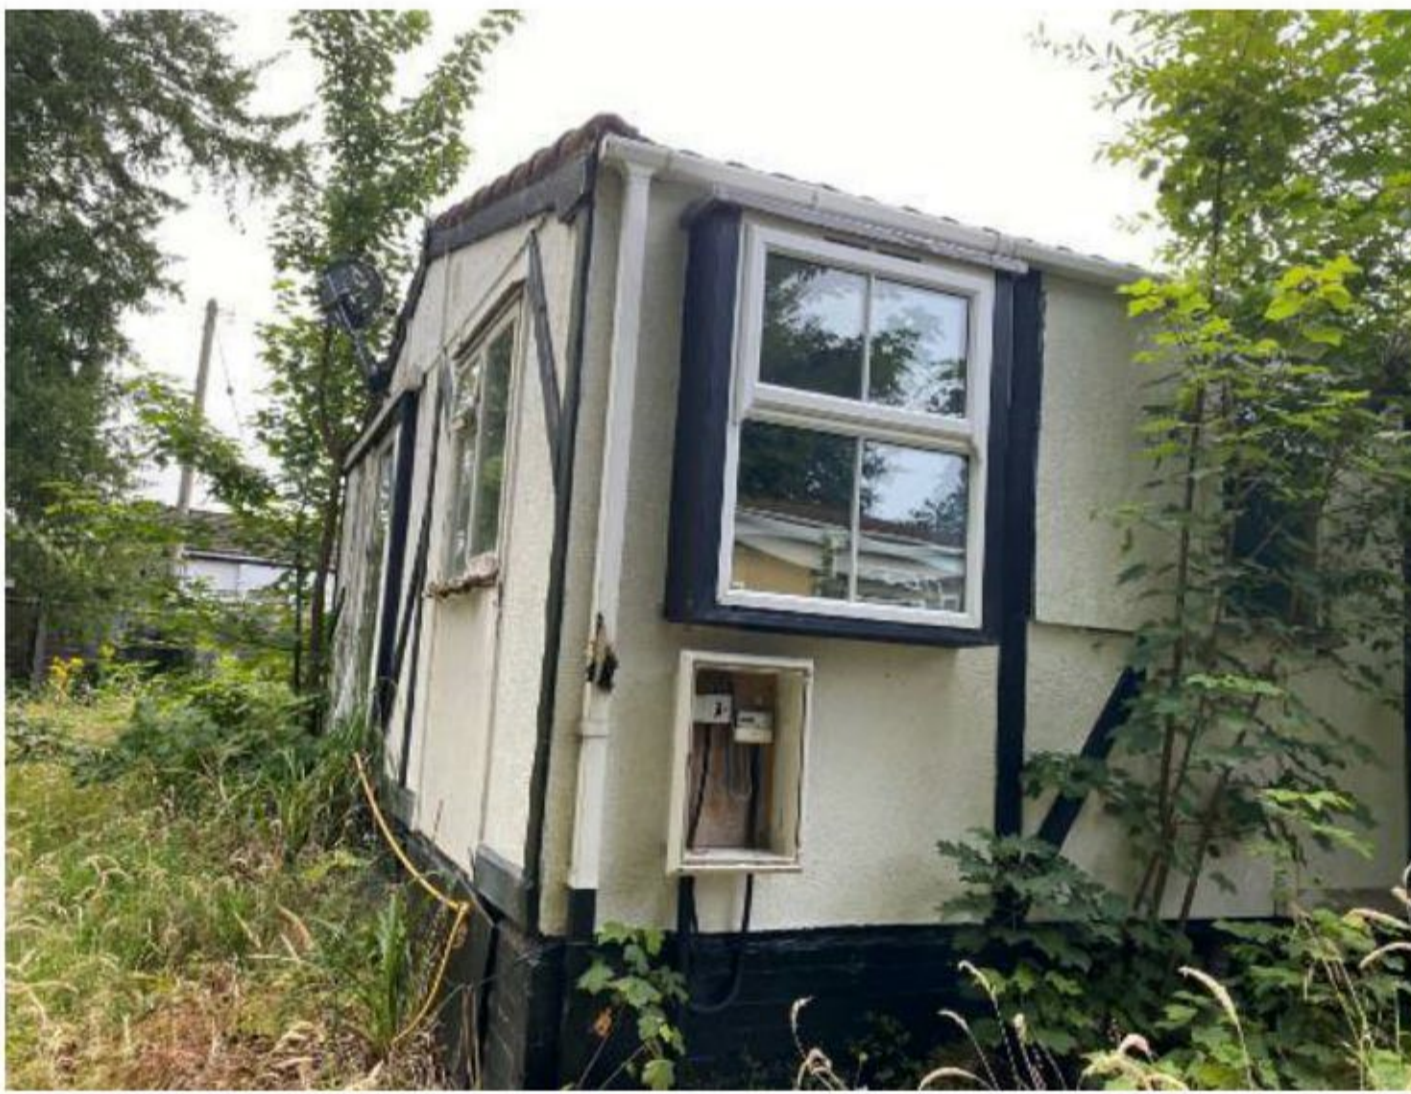
Photo 3: North-western elevation of B1

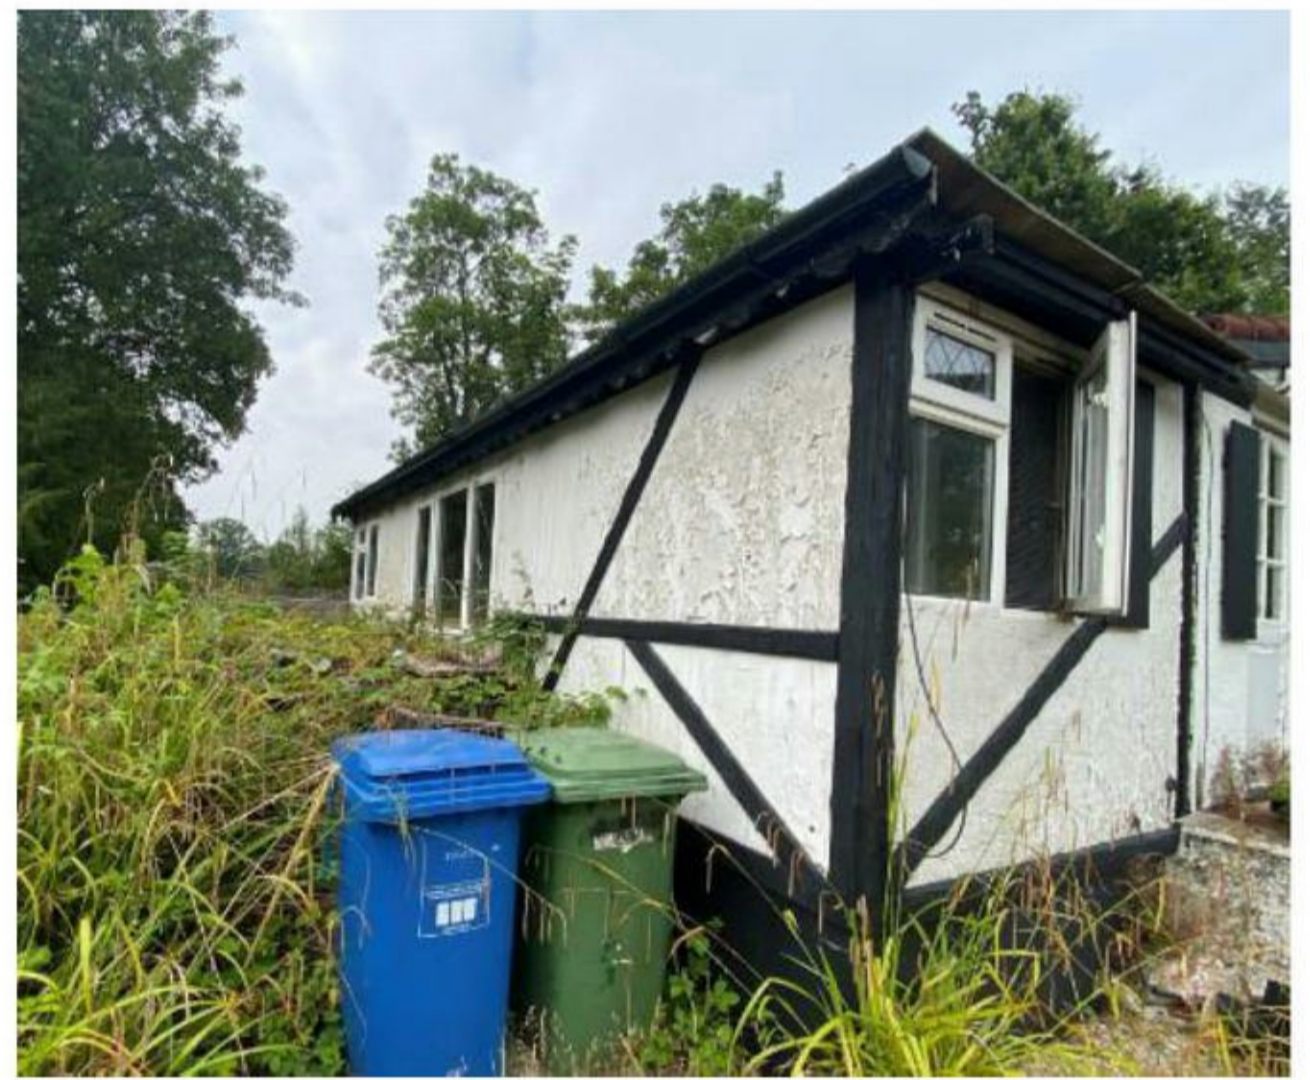
Photo 4: South-western elevation of B1

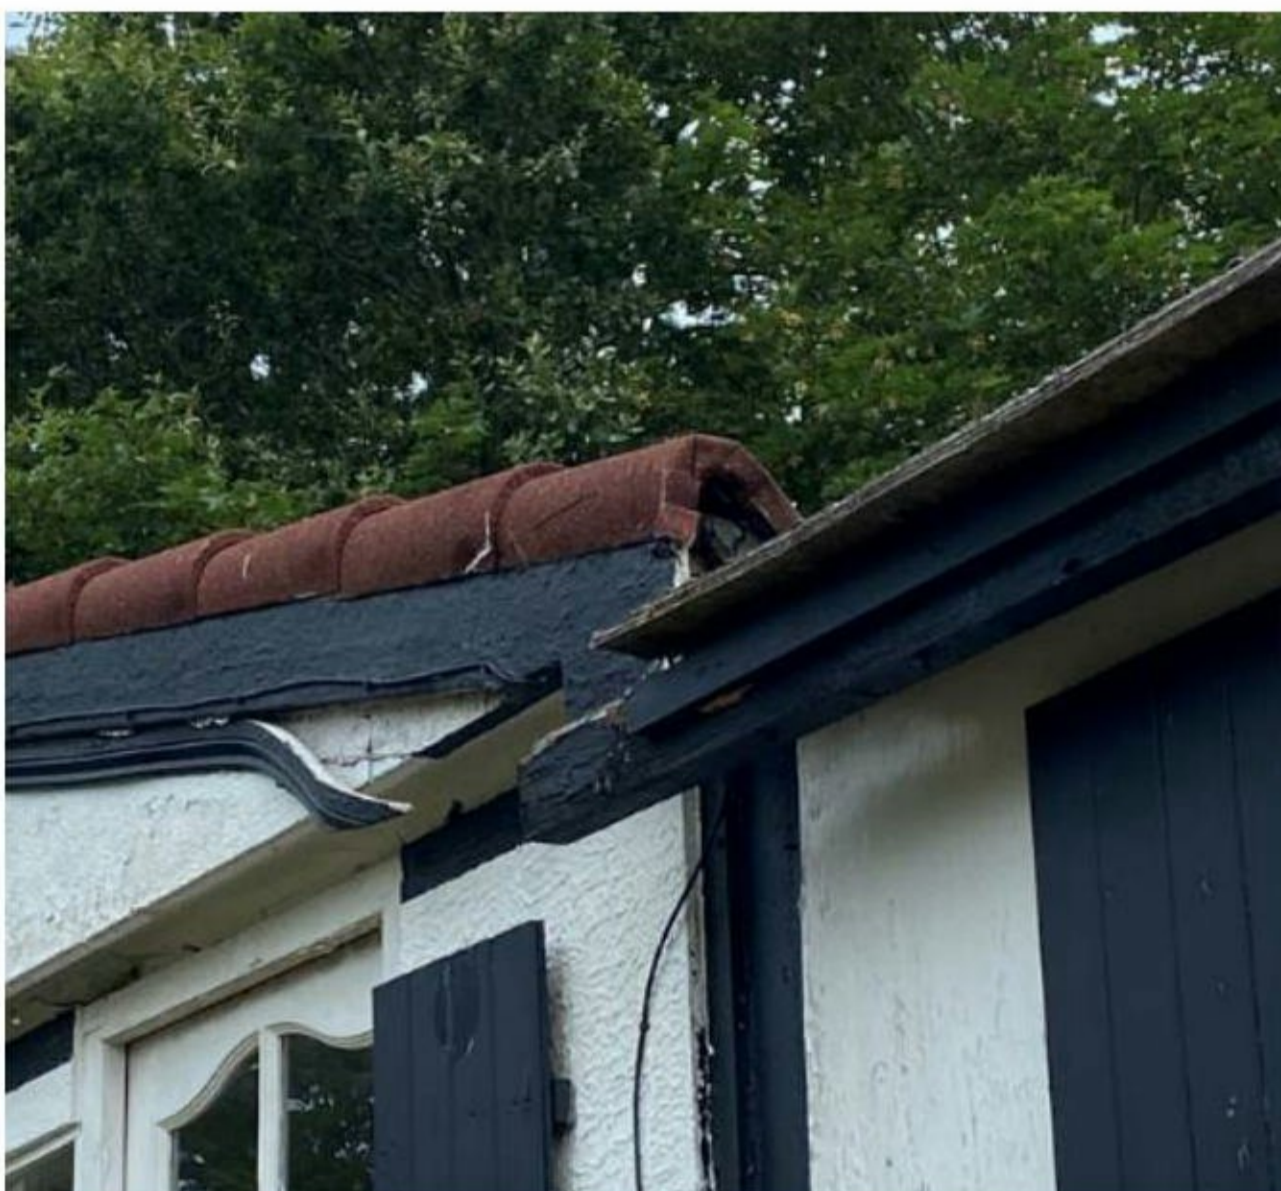
Photo 5: Close up of potential bat access point on the south-eastern corner of the pitched roof.

- 5.2.2 Bats may occupy roost sites on a seasonal or temporary basis, and old roost sites may be abandoned and new roosts occupied within relatively short periods of time. In view of this, it is recommended that a single emergence survey of B1 is carried out immediately in advance of works to the building commencing. This would ensure that up-to-date information is available to confirm the continued absence of roosting bats and avoid the need for supervised works assuming no bats are encountered (see below).

- 5.2.3 Unless a future survey is carried out to confirm the continued absence of roosting bats as detailed above, all demolition/stripping works involving the removal of features with the potential to conceal roosting bats should be overseen by a licensed bat worker under an Ecological Watching Brief. Potential features at the site may include: lifted tiles on north-eastern elevation and a large hole in the corner of the pitched roof on the south-eastern elevation. Suitable features should be inspected prior to works progressing and a cautious approach to removal should be employed, with features removed by hand, where appropriate.
