Phase 1 bat and nesting bird survey report

Site: 24 Woolbrook Park,

Sidmouth,

Reference Number: DCE1672

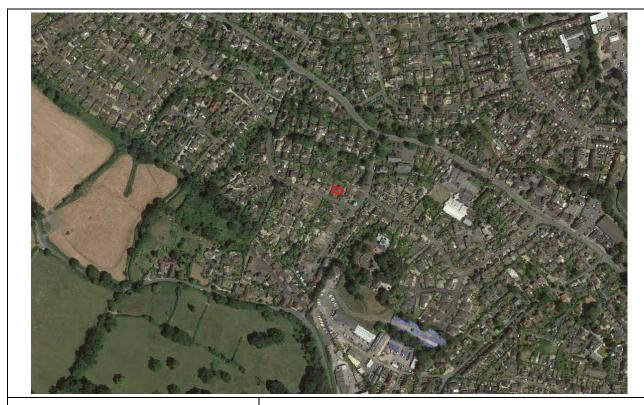
Approximate site location

In the wider landscape the site is located in an environment that is generally unfavourable for bats. The urban development of Sidmouth surrounds the site, with further buildings and a network of urban roads extending over 1km to the north and east and 250m to the south and west. These features present a significant barrier for most bat species, with foraging and commuting opportunities mostly restricted to residential gardens and individual trees. Beyond these barriers, however, the wider landscape has a mix of agricultural fields, open grounds and woodland, particularly to the west. These are likely to provide good opportunities for many bat species, but access to them is difficult due to the widespread presence of artificial lighting. Overall, the site has poor connectivity to this wider landscape and any local populations are likely to be limited to small numbers of common species.

Wider landscape view of 24 Woolbrook Park (Google Earth Pro).

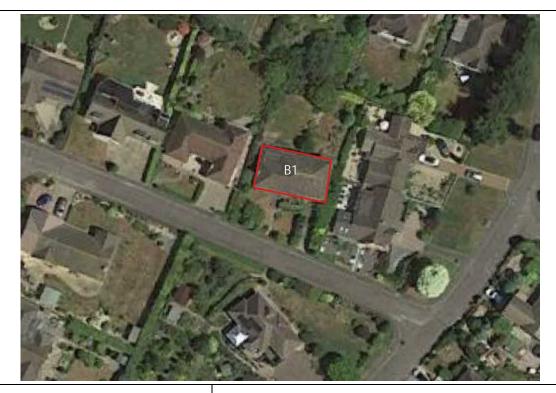
Approximate outline of existing building.

Site layout of 24 Woolbrook Park (Google Earth Pro).

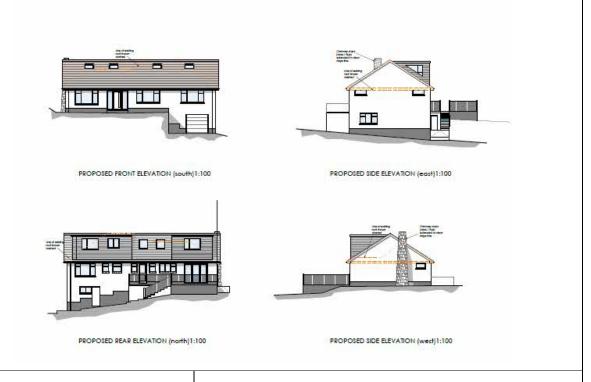
Proposed development at 24 Woolbrook Park, Sidmouth

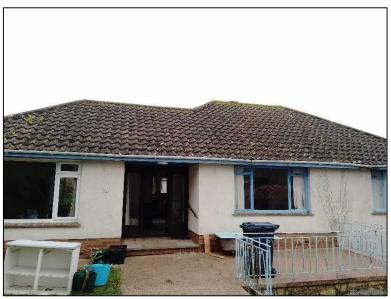
Photograph 1– View of the south aspect of the building.

The building is an irregularly shaped brick and breezeblock residence with a hipped roof.

The irregularly shaped roof has concrete interlocking tiles. These are in very good condition; one small gap was noted beneath just one roof tile.

Concrete ridge tiles are present and in good condition. No gaps were noted beneath the ridges.

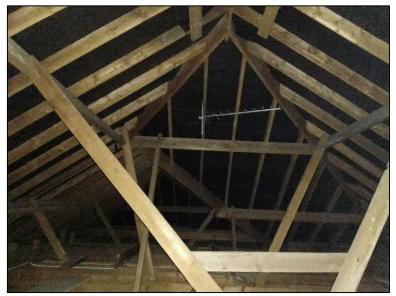
Photograph 2- Example view of the void interior.

The building has a single, irregularly shaped void space that was fully accessible.

The void has a traditional structure with a ridge beam and purlin supports. Additional diagonal supports are also present but do not create a cluttered flight space.

The ridge beam and hips are clean with a light cobwebbing. No signs of use by bats were noted along the ridge or at the hip joints.

No insulation is present in the void. Many mouse droppings were noted throughout the void.

Small areas of light were noted along the eaves on the north side. This is likely to coincide with the hole noted in the soffit. However, a full search of the void found no bat droppings on the floor or beams. It is considered likely the identified access point has been created by mice and the void inhabited by them. No signs of use by bats was recorded.
