RESULTS OF FURTHER BAT SURVEY WORK

**BOSAHAN, ROSCARRACK ROAD, MAEN VALLEY,
GOLDENBANK, FALMOUTH, CORNWALL**

August 2023

Report No: 22-284/JD/Bosahan, Maen Valley, Goldenbank_FB

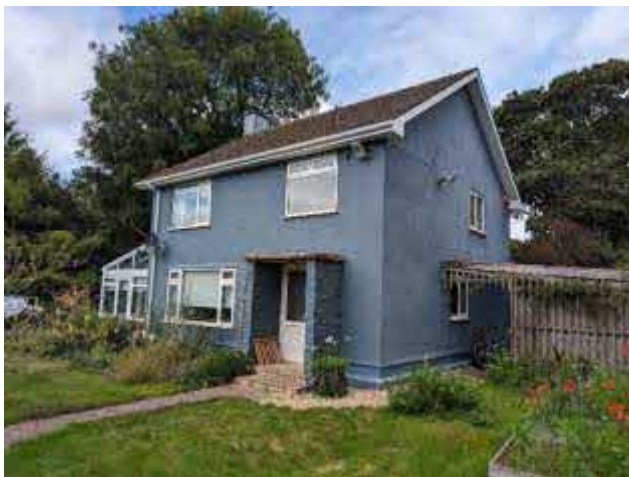
The building subject to this survey is a rectangular two storey rendered blockwork house with gable ends, a lean-to conservatory built onto the south western end of the building, a timber clad lean-to extension built onto the north western side of the building and an open sided carport attached to the south eastern end of the building. The main part of the building has a pitched roof with overhang eaves, roofed with interlocking concrete tiles and has a chimney built into the south western end of the building, see Photos 1 and 2.

Photo 1. Showing the house from the south east

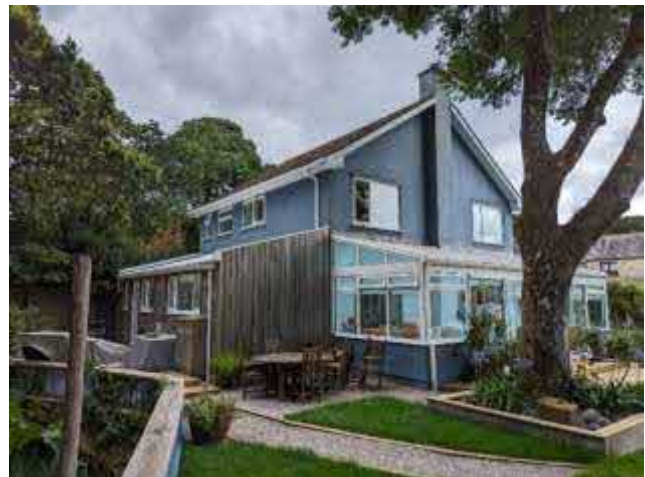
Photo 2. Showing the house from north west

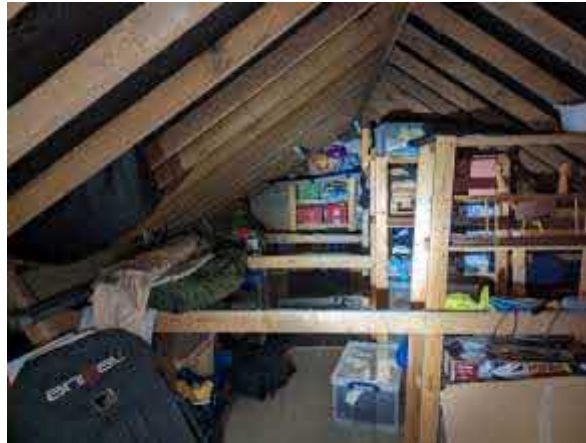
There is a single large, well-used and well organised roof void over the house containing racks and shelving units with stored items on them. The roof void is a single open room, open from the boarded floor to the underside of the roof, which is lined with bitumen based roofing felt and there are a number of horizontal timber tie bars. The floor is carpeted and the roof void is accessed via a loft hatch with a built in pull down ladder, see Photo 3. Both the conservatory and timber lean too have glazed or clear plastic sheeting covered roofs.

Photo 3. Showing the roof void over the house

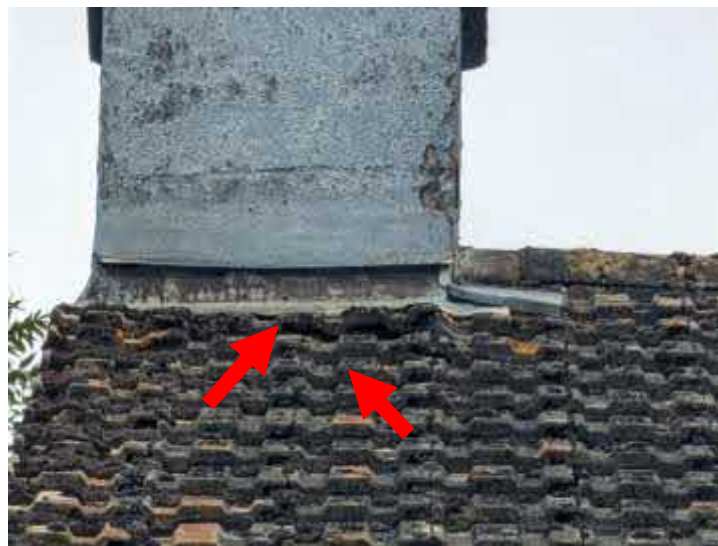
Externally the building appears to be well sealed, with well-sealed fascia boards and soffits, ridge and roof tiles, with the exception of a small number of gaps between a number of roof tiles and the leadwork around the chimney giving potential access for bats to the batten gap, see Photo 4.

Photo 4. Showing the gaps between a number of roof tiles and the leadwork around the chimney

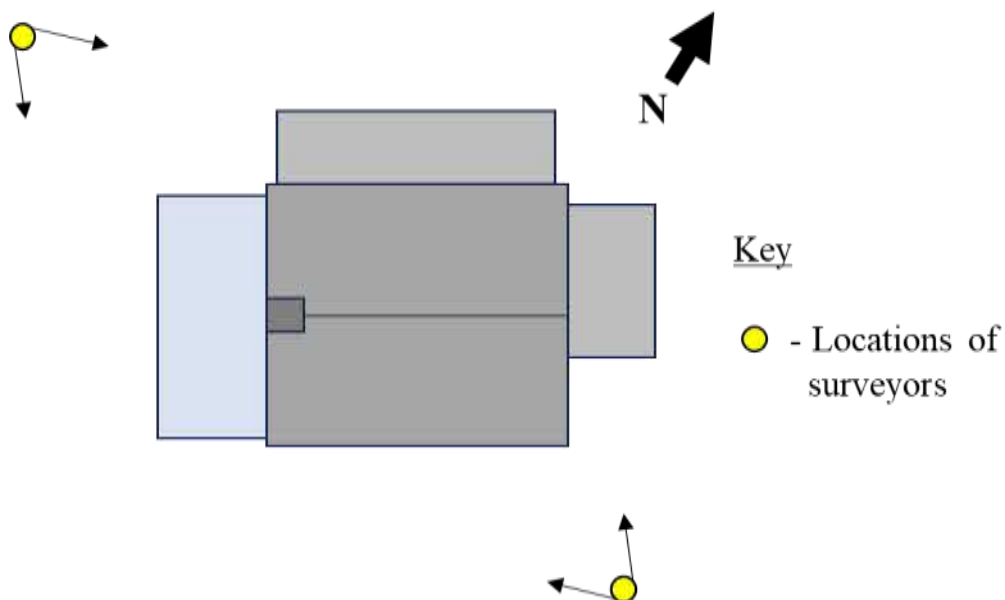
On 22nd August 2023, Simon Barnard and Debra Barnard were positioned on opposite corners of the building so that all aspects could be watched, see Figure 2. for the locations of the surveyors.

Figure 2. The locations of the surveyors during the emergence survey
