BAT, BARN OWL AND NESTING BIRD SURVEY

**BOSAHAN, ROSCARRACK ROAD, MAEN VALLEY,
GOLDENBANK. FALMOUTH, CORNWALL**

July 2023

Wheal Grey Ecology Ltd

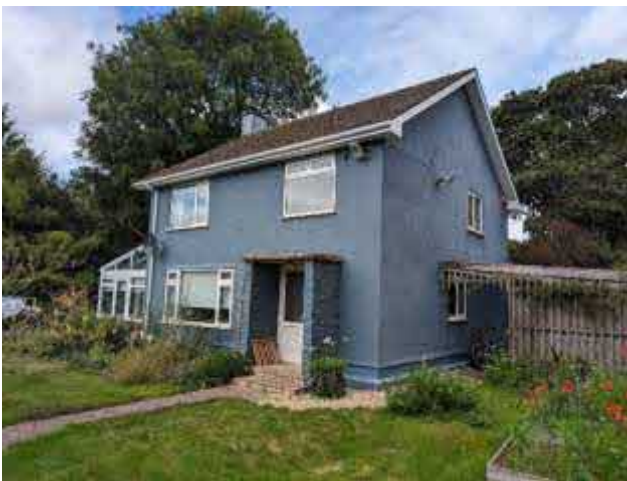
The building subject to this survey is a rectangular two storey rendered blockwork house with gable ends, a lean-to conservatory built onto the south western end of the building, a timber clad lean-to extension built onto the north western side of the building and an open sided carport attached to the south eastern end of the building. The main part of the building has a pitched roof with overhang eaves, roofed with interlocking concrete tiles and has a chimney built into the south western end of the building, see photos 1 and 2.

Photo 1. Showing the house from the south east

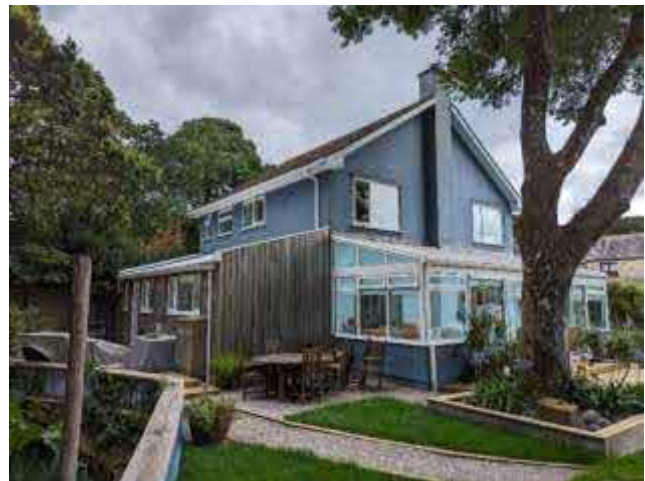
Photo 2. Showing the house from north west

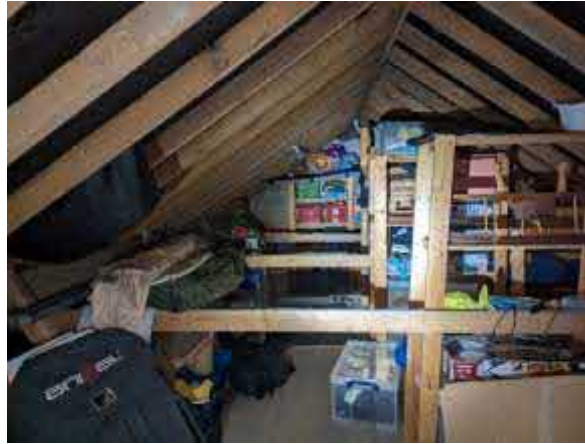
There is a single large, well-used and well organised roof void over the house containing racks and shelving units with stored items on them. The roof void is a single open room, open from the boarded floor to the underside of the roof, which is lined with bitumen based roofing felt and there are a number of horizontal timber tie bars. The floor is carpeted and the roof void is accessed via a loft hatch with a built in pull down ladder, see photo 3. Both the conservatory and timber lean too have glazed or clear plastic sheeting covered roofs.

Photo 3. Showing the roof void over the house

No evidence of the use of the building by roosting bats was found, with no bat droppings being found within the roof void. However, there are a small number of gaps between the tiles and leadwork close to the chimney which have potential to be used by cavity roosting species of bat and could not be inspected.

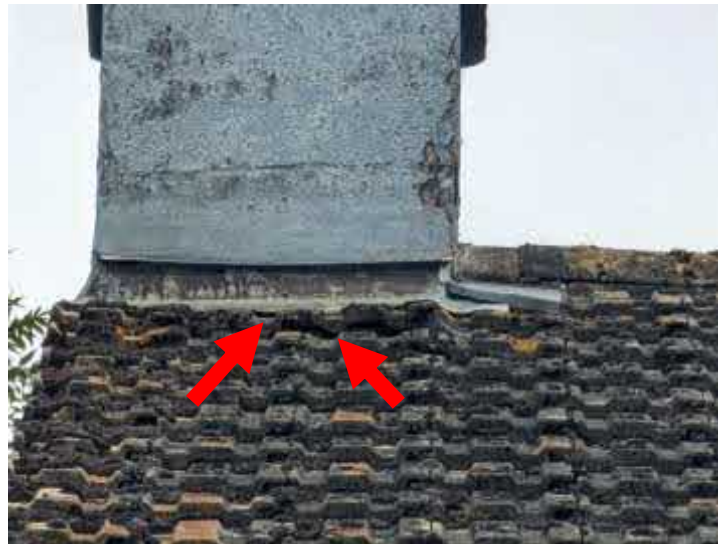
Externally the building appears to be well sealed, with well-sealed fascia boards and soffits, ridge and roof tiles, with the exception of a small number of gaps between a number of roof tiles and the leadwork around the chimney giving potential access for bats to the batten gap, see photo 4.

Photo 4. Showing the gaps between a number of roof tiles and the leadwork around the chimney

There cavities identified above could not be accessed or inspected.

As there are a small number of features on the building with the potential to be used by cavity roosting species which could not be fully inspected and given the value of the surrounding habitats to bats, further bat survey work should be undertaken.

The further survey work should take the form of a single emergence survey, using two surveyors, with a second survey being needed if bats are seen to emerge during the 1st. This further survey work can only be undertaken during the active bat survey season, May to September, with at least one of the surveys being undertaken during the peak survey period before the end of August. The surveys should be undertaken at least four weeks apart.

If bats are found to be currently using the building a Bat Mitigation Licence is likely to need to be obtained before the works can commence lawfully.
