Bat Assessment Report

Woodside

**Fyning Lane
Rogate
Petersfield
GU31 5DJ**

**23-112
August 2023**

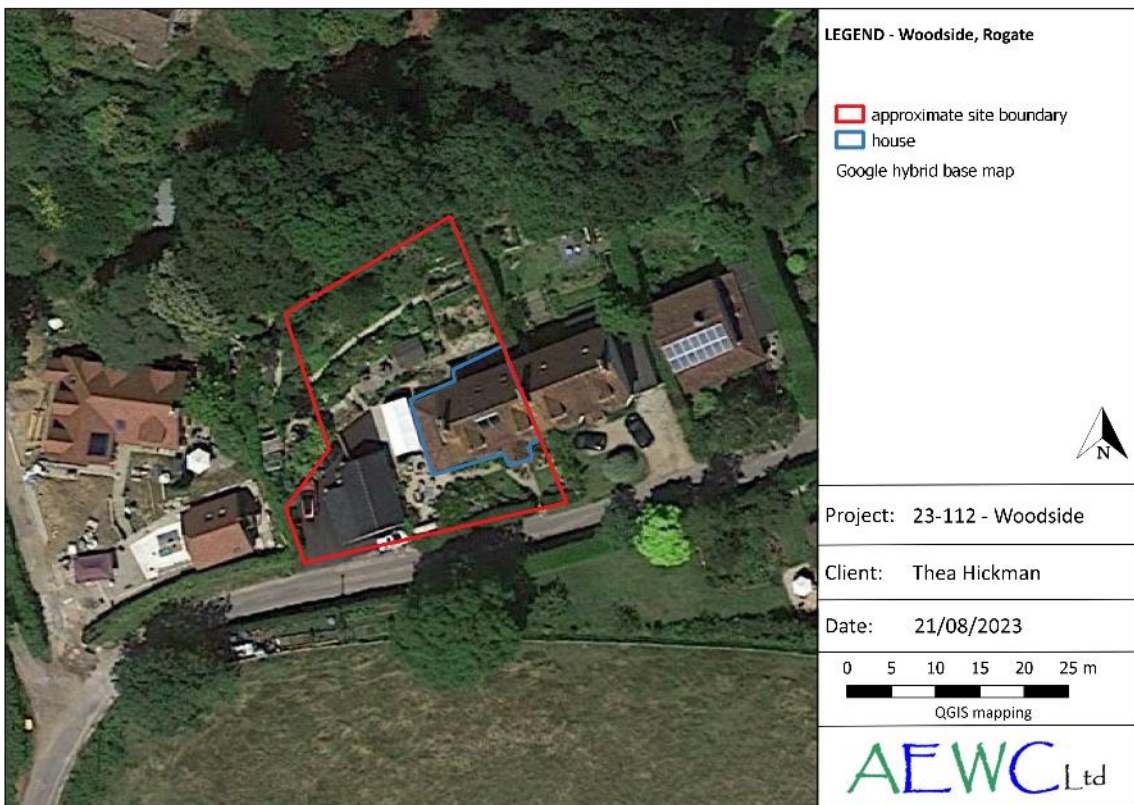
FIGURE 2: SHOWING THE BUILDING SUBJECT TO SURVEY.

1.7 The site consists of a semi-detached property with separate garage situated within an amenity garden.

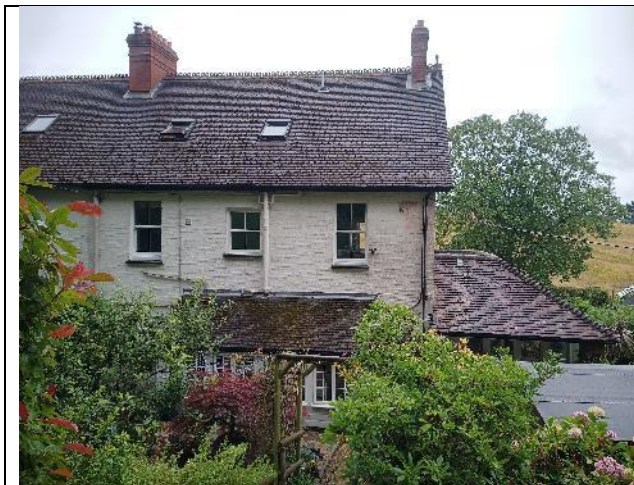
Photograph 1: *Northern elevation*

- 4.1 The site contains a semi-detached two-storey dwelling with gabled roof supporting flat clay tiles. A single-storey hipped, and flat roof extension is present on the western elevation and a mono-pitch lean-to extension on the northern elevation.

- 4.2 The roof tiles were noted to be tight fitting and heavily mossed, particularly on the lean-to extension which is heavily shaded by the terraced garden and house. Soffit boxes were well fitted and tightly sealed. A very low number of slightly lifted tiles were present on the western extension, however a torch light survey found that gaps sufficient to allow access by bats into the batten space were not present.

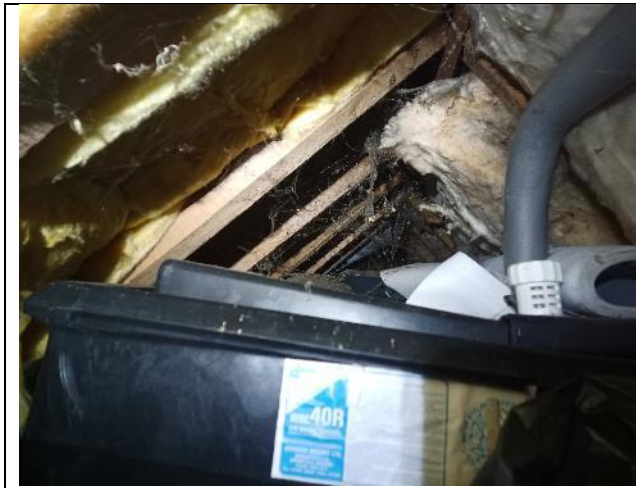
Photograph 3: *Roof void in the apex of the main house*

- 4.3 The roof void of the main house is in use for living space with dormers present on the southern roof pitch. Small roof voids are present within the apex of the void in addition to at the eaves. The eaves voids were not accessible for survey due to a lack of access panels. The void in the apex was found to contain the water tanks with fibreglass insulation filling the majority of the rest of the space within this void. Heavy cobwebbing was noted present at the ridge.

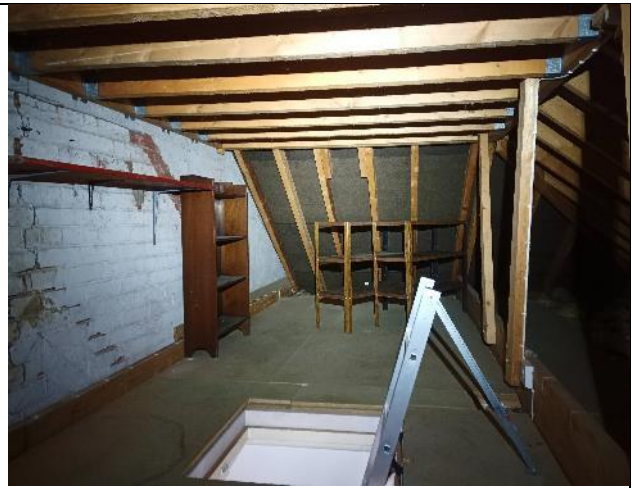
Photograph 4: *Storage loft above the single storey extension*

- 4.4 A storage loft is present above the single storey extension, the roof felt was noted to be in good condition with no splits or gaps noted. No natural light ingress was noted within the roof void. Some cobwebbing was present at the hips.
