# GROUND CONTAMINATION INVESTIGATION AND ASSESSMENT

## PHASE 1 - DESK STUDY

for the proposed  
**Residential and Commercial Developments**  
at  
**Exchange Street,  
Driffield  
YO25 6UH**

**Report on:** Tier 1 Preliminary Risk Assessment -  
Desk Study

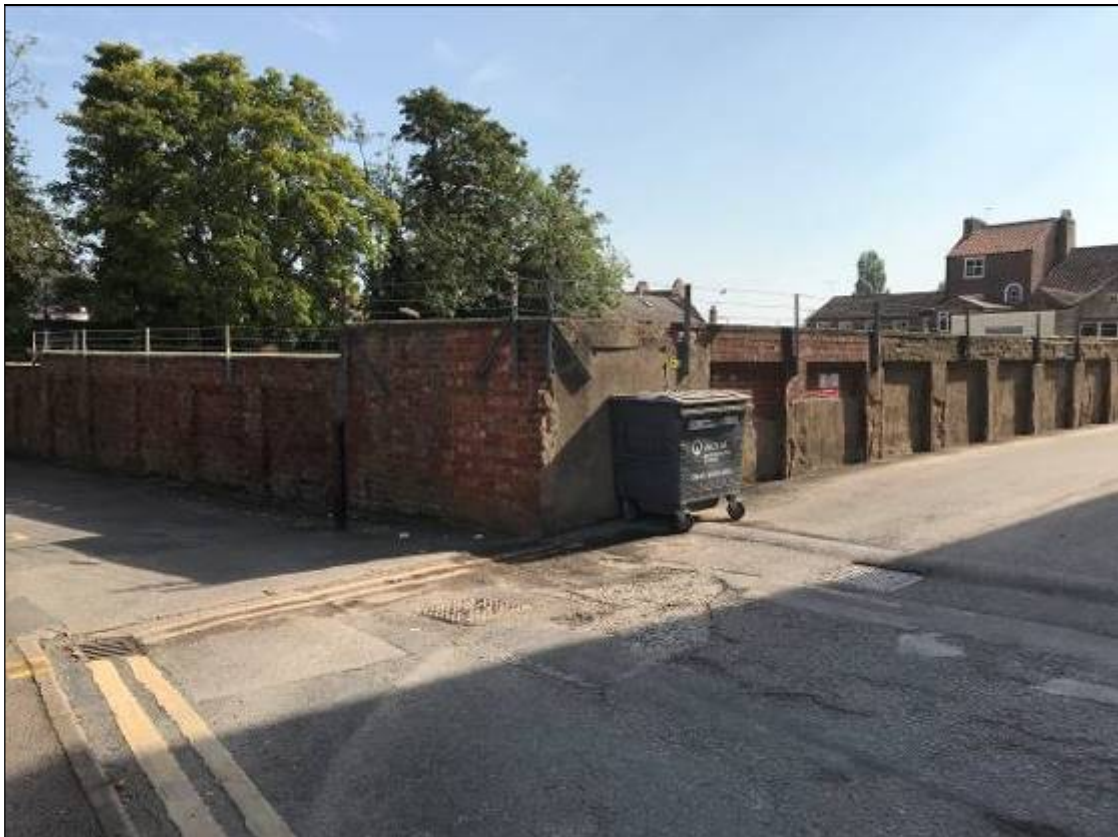
The southwest half of the site is a 35 m square plot that is supported on three sides with a 1.7 m high red brick retaining wall.

**Fig 4 – view to east from Cranwell Road showing raised level and retaining wall**

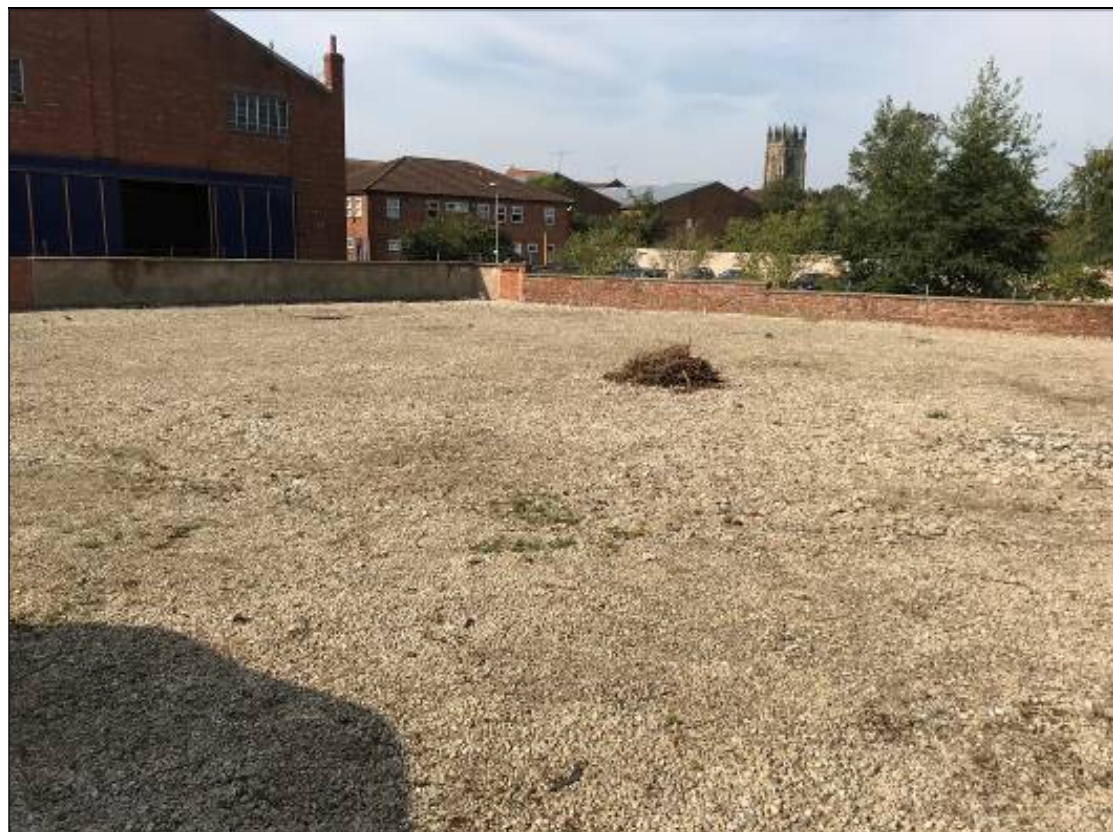
The plot itself is covered with clean coarse gravel.

**Fig 5 – view to west across southwest side showing gravel surface**

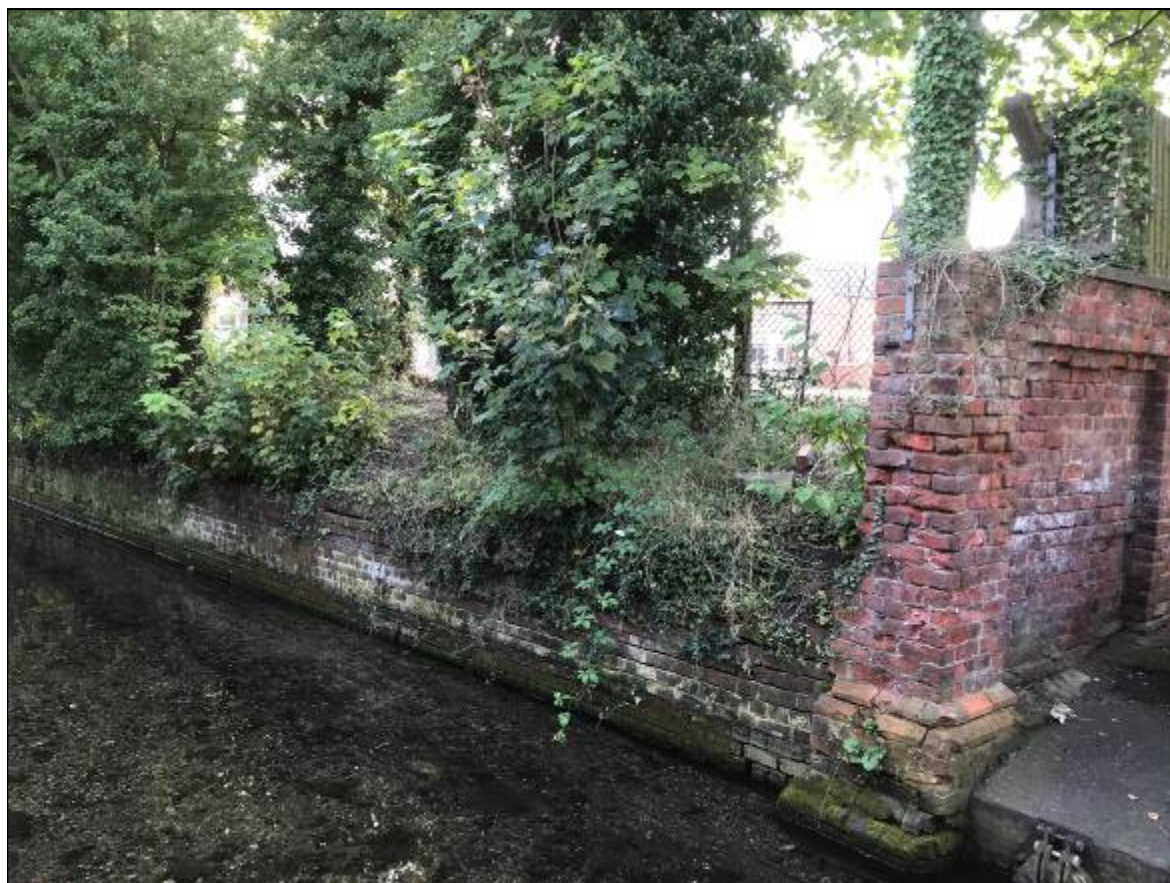
The other side faces onto the Beck on the east side, with a lower wall and sloping ground rising to the site level that supports tree cover.

**Fig 6 – view to south of retaining wall and trees alongside the Beck**

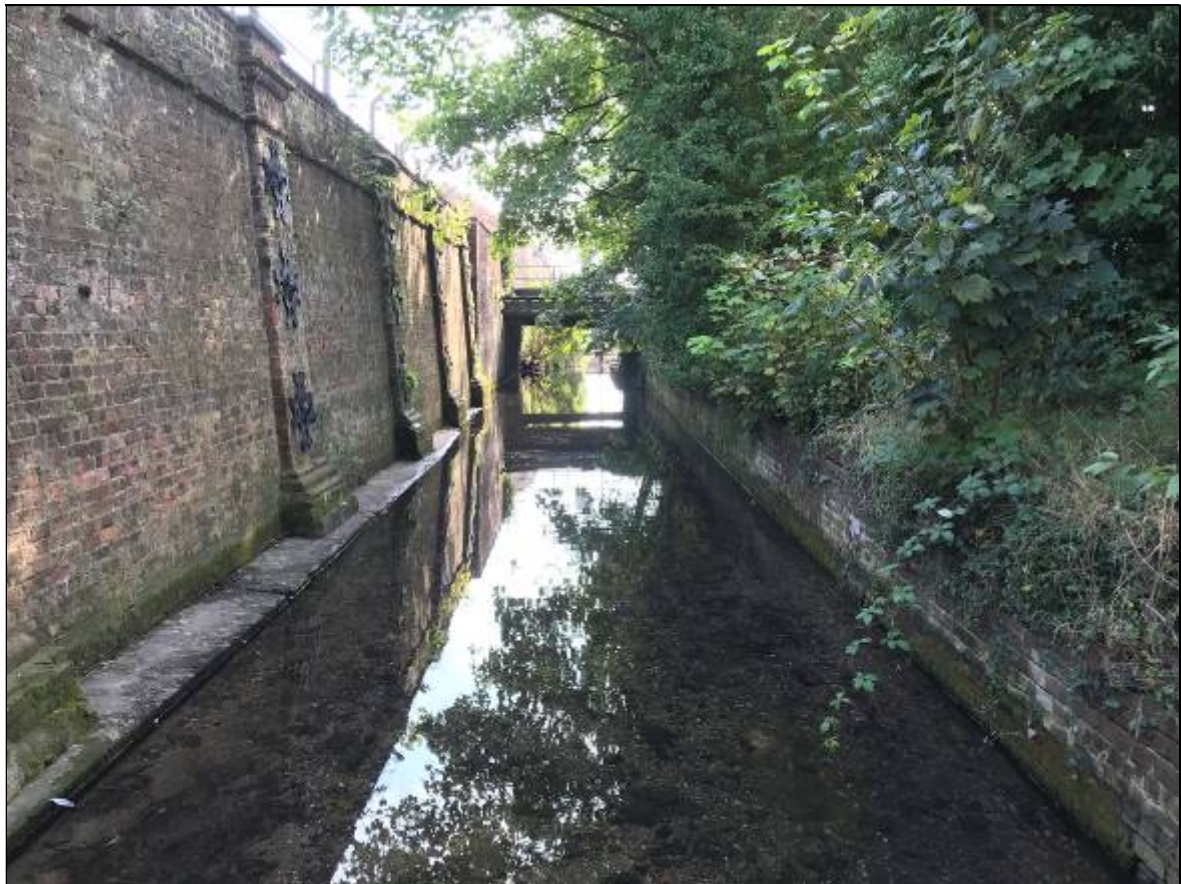
The ground on the northeast side is raised up above the level of the Beck and is supported by a red-brick retaining wall reinforced with ground anchors.

The wall is in good condition, with no seeps or discolouration.

**Fig 7 – view south along Beck showing retaining wall of the northeast side**

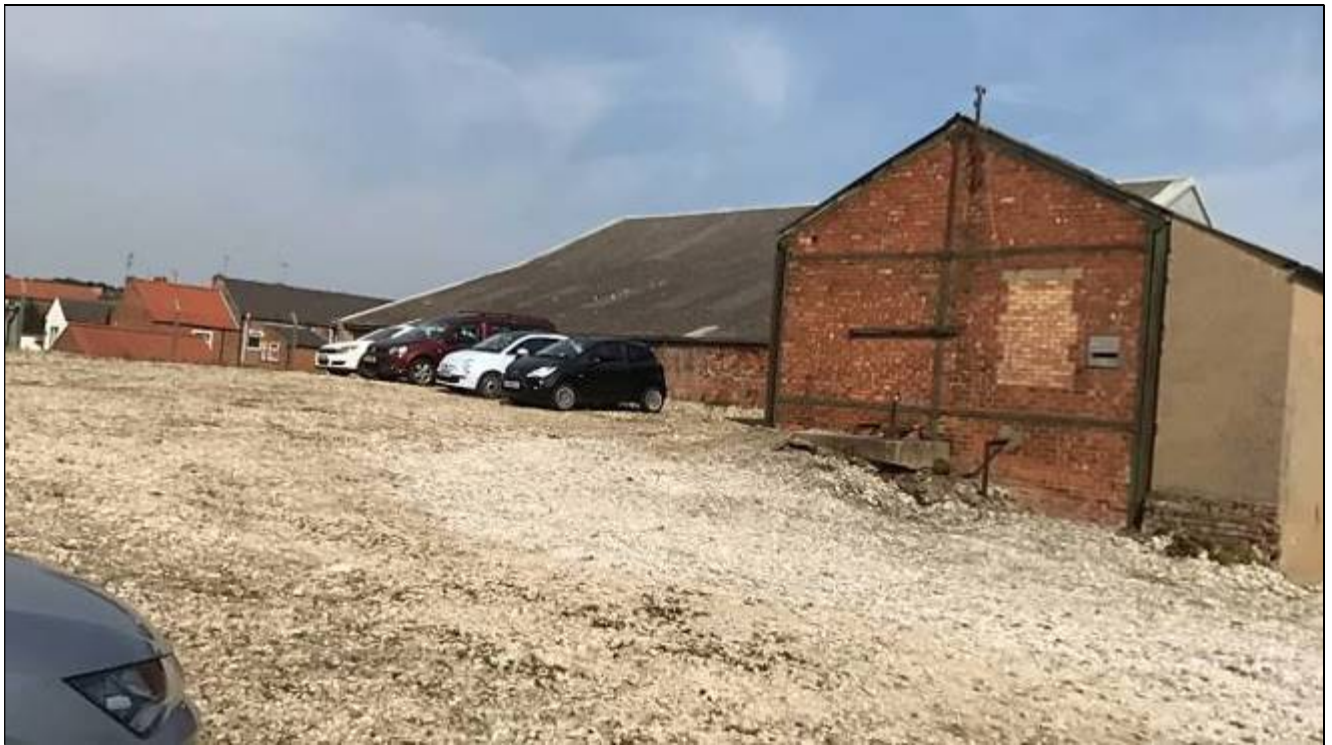
At the north side the ground level has been raised to almost 2 m above the neighbouring car park.

Fig 9 – view to north of central part showing rise in site level

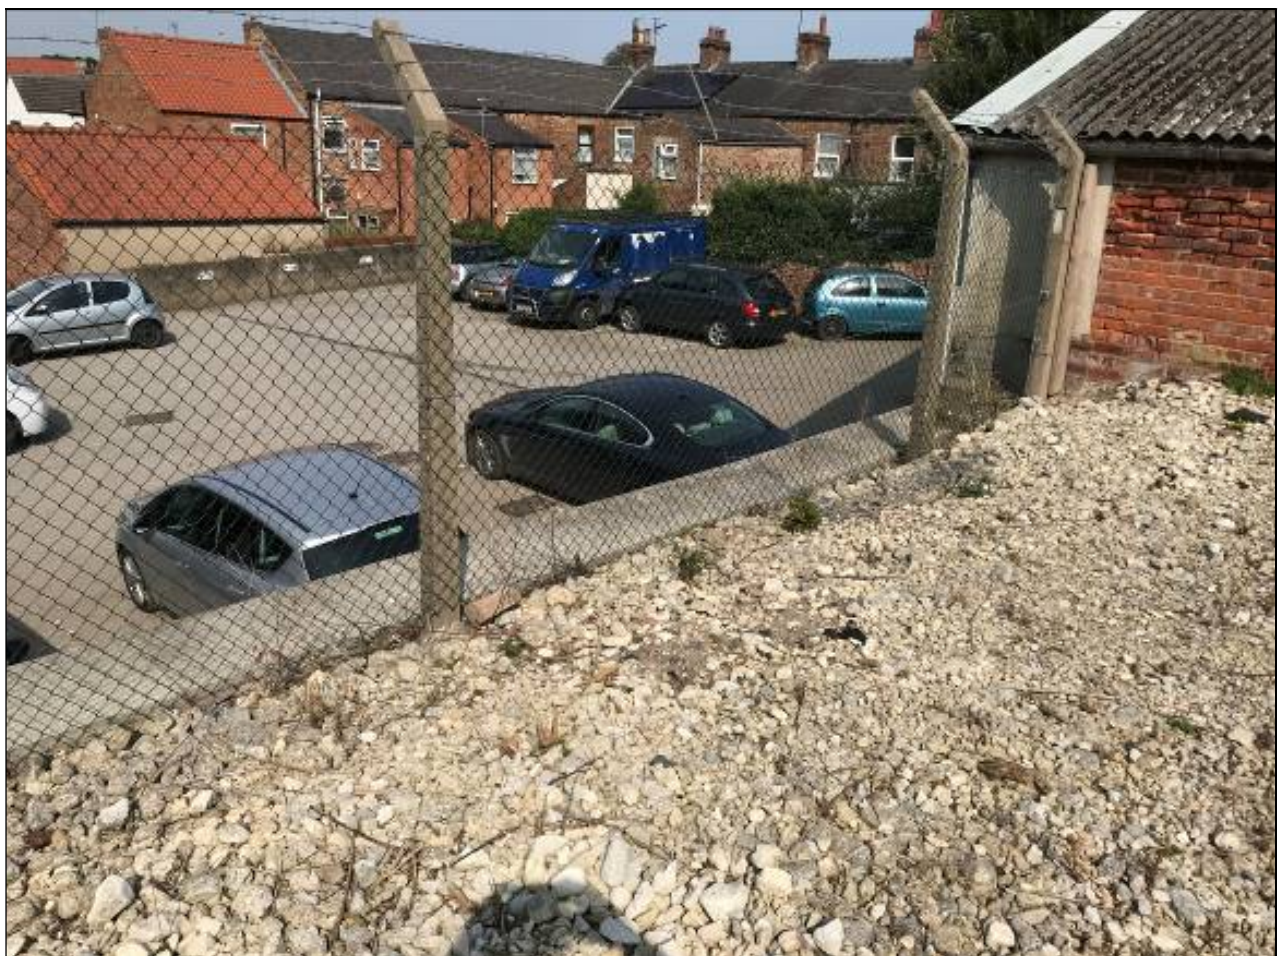
Fig 10 – view to northwest showing drop in level to neighbouring site

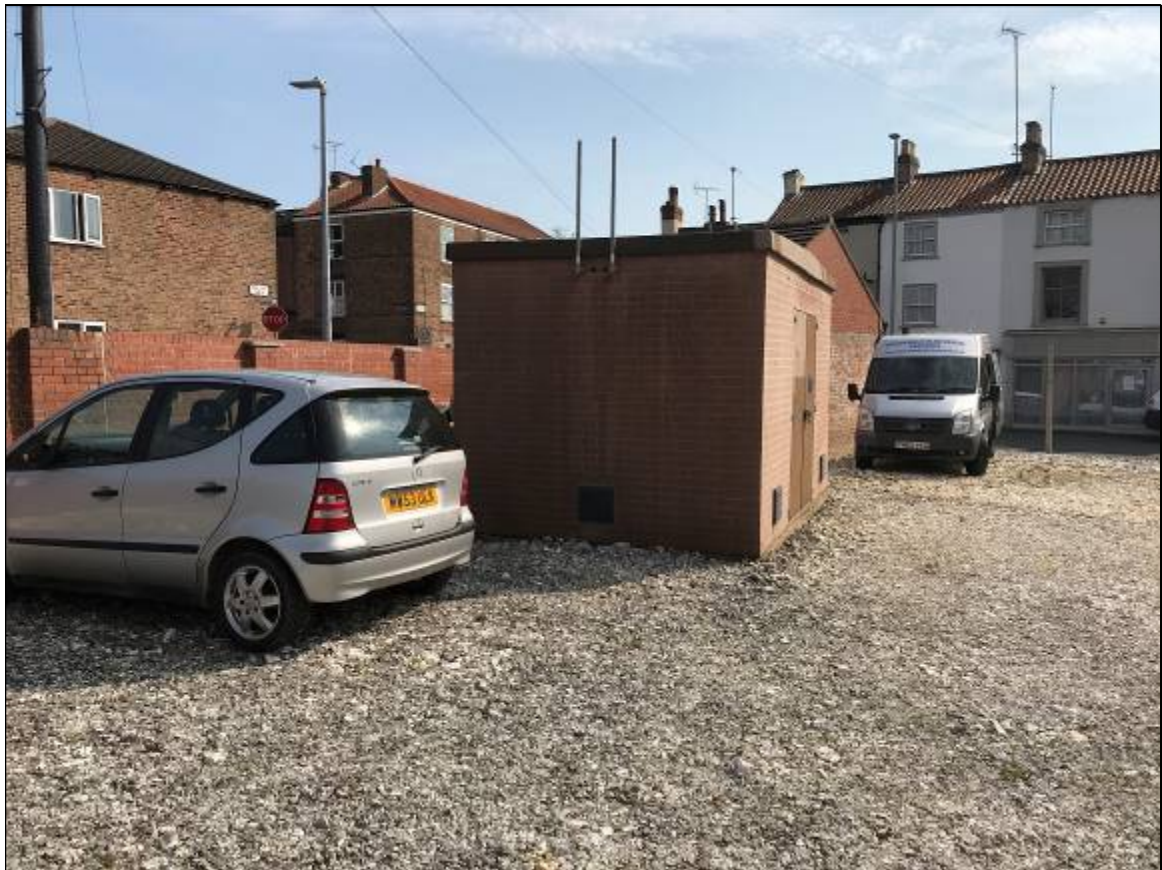
- the modern one housing the gas governor for the natural gas supply that is still routed via the site; and
- the older one housing the former gas governor that is slowly being dismantled for spares.

Fig 11 – new gas governor building

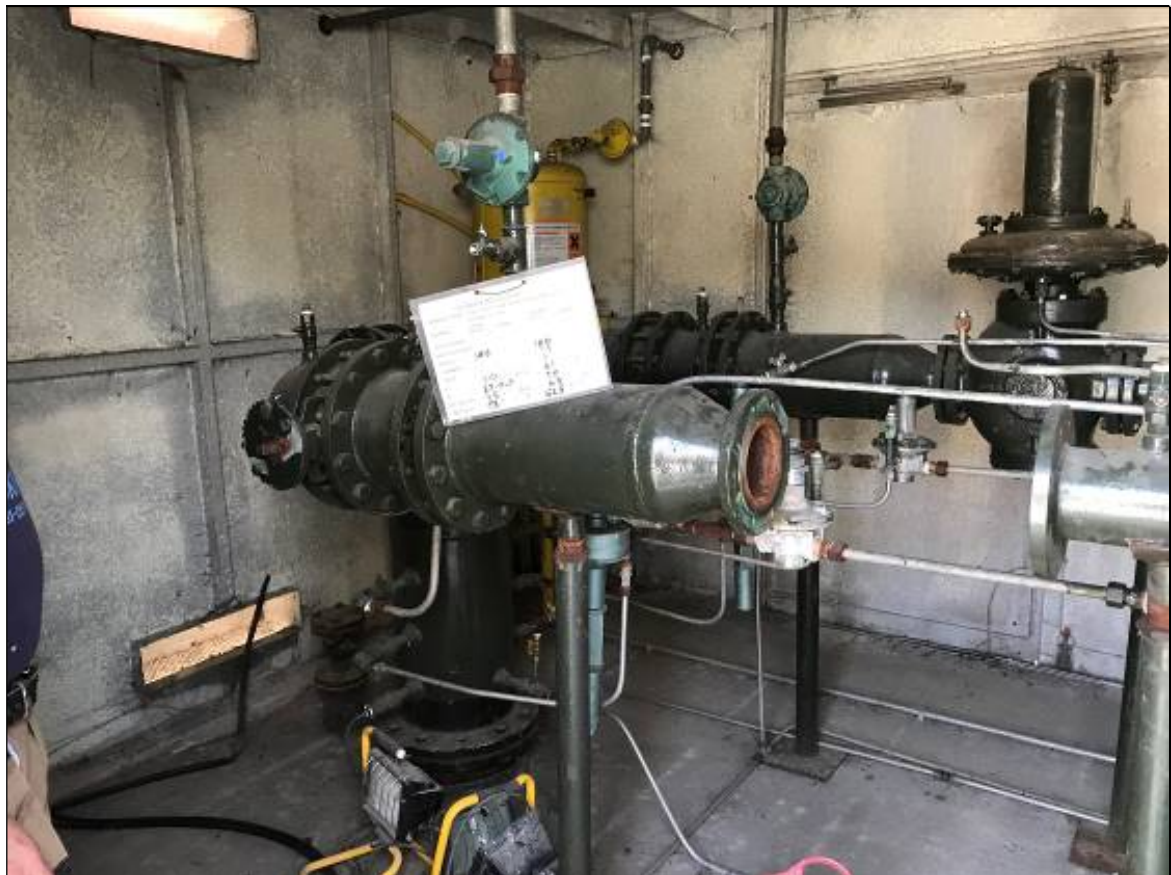
Fig 12 – interior of old gas governor building

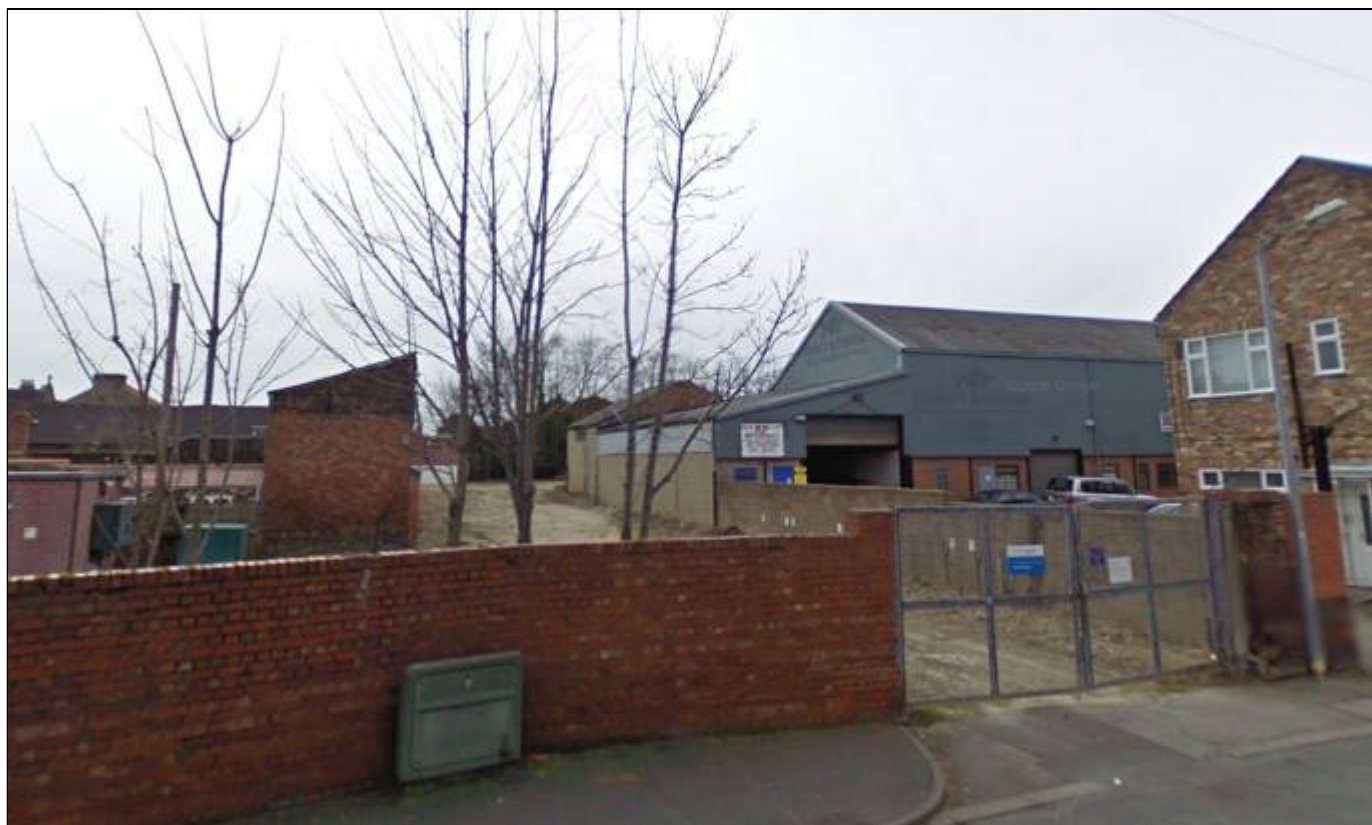
The level of the site slopes down towards entrance on the south side.

Fig 14 – view to west from the east entrance showing rise in site level from road

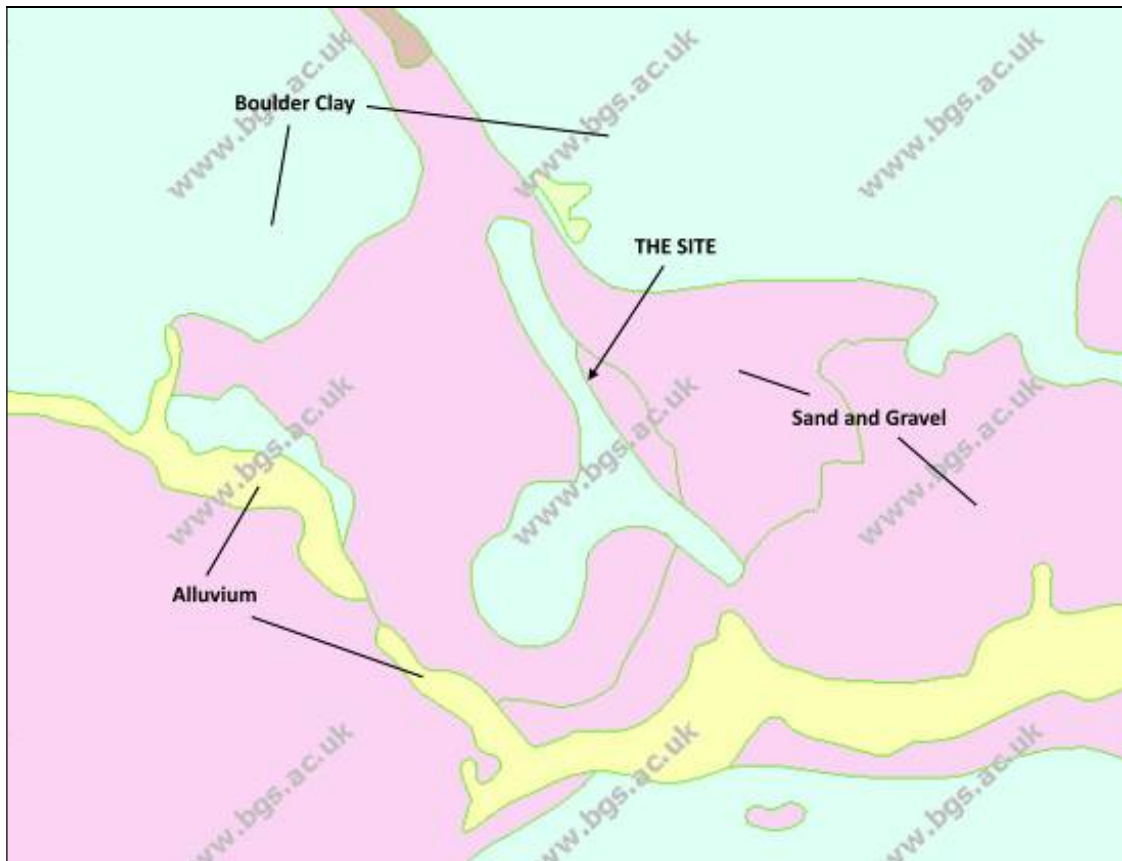
The geological map shows the geology at the site to comprise of the Cretaceous Chalk, overlain by Quaternary Glacial Till clay and Sand and Gravel, all with a fall to the southeast towards the River Hull.

Fig 15 – regional geology
