Preliminary Roost Assessment

Morinda, The Green, Horns Drove, Rownhams, Southampton, Hampshire, SO16 8AJ

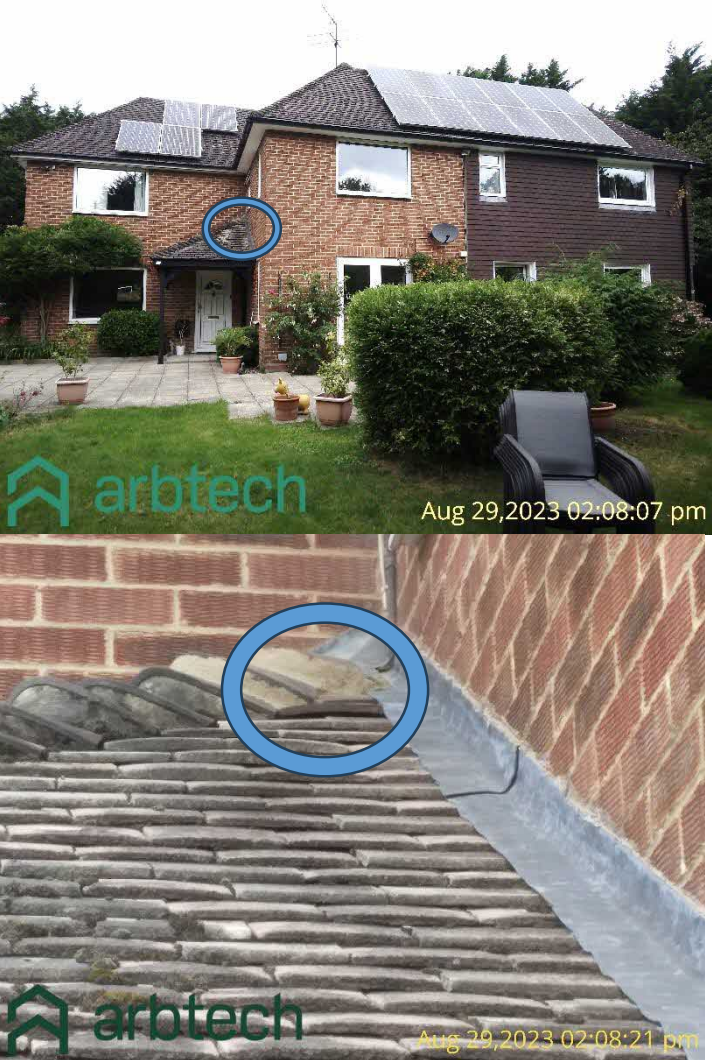
<p>B1 – eastern elevation</p>	<p>These photographs are of the eastern elevation of B1, which has hanging tiles on the upper section of the wall Unlike the southern elevation, there are some roost features within the hanging tiles, with gaps identified to the south of the window seen (circled in blue) as well as lifting on the corner tiles where they do not sit flushed on each other (circled in red)</p> <p>These features are suitable for supporting crevice-dwelling bat species.</p> <p>No droppings were seen on the tiles under these features. No droppings were found at the base of the wall, however, the plant growth at the base of the walls would make finding evidence more restrictive.</p>	 
-------------------------------	--	--

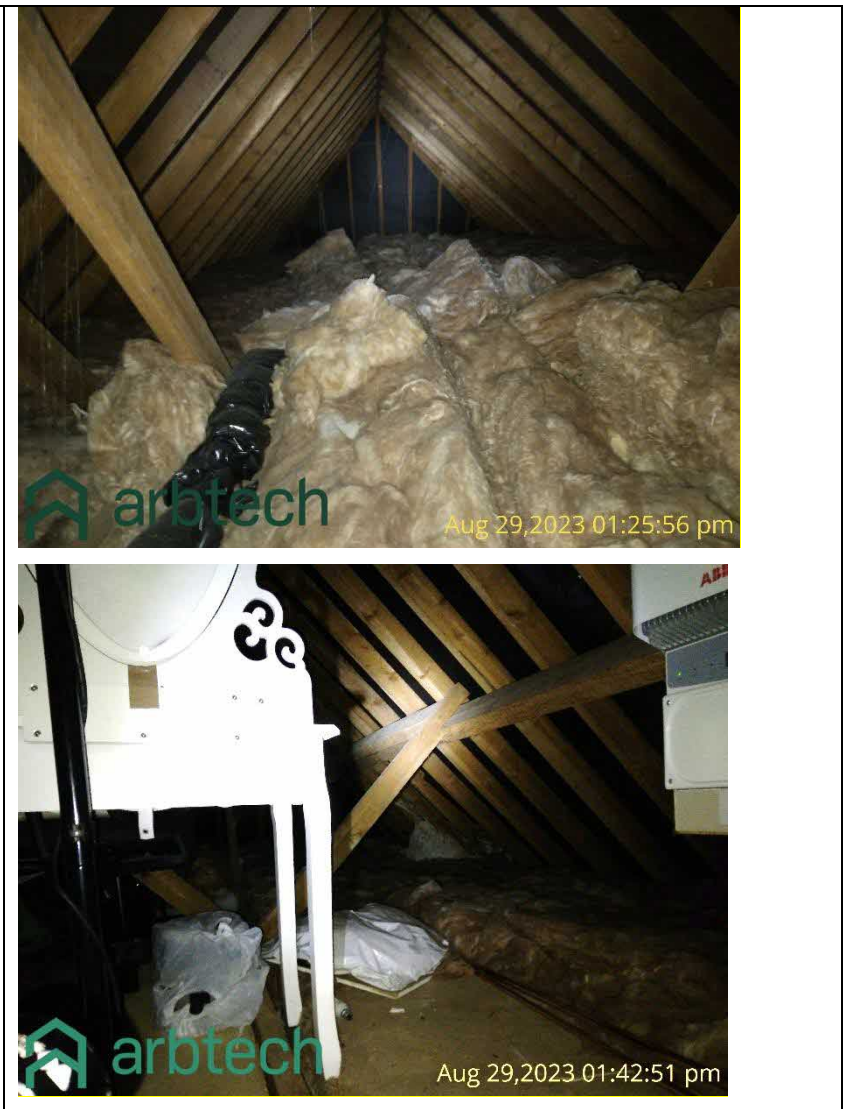
<p>B1 – interior</p>	<p>These photographs show the interior of B1, which is a cornered loft following the roof outline.</p> <p>The top photograph is of the northeastern area of the loft, while the bottom photograph is of the southwest area, close to the access hatch, where items are stored.</p> <p>The loft has exposed rafters and ridge lines, with supporting diagonal struts. The lining is a non-breathable membrane, and is in good condition, except for one small corner in the southern corner, where this has peeled back enough to expose tiles underneath. As the third photograph shows (circled in blue)</p> <p>The insulation is a loose wool roll, which was seen in three different ages of layers, reaching 50cm+ thick in places. The top layer (as these photographs show) appeared to be a recent installation.</p> <p>This loft space measured 2m in height, 10m long at its longest length and 8m at its widest. At the time of the survey internal temperatures measured 25°C and 65% humidity.</p> <p>A search was conducted for any evidence of bat roosting activity, paying attention to key areas, such as under the ridge line, at the wall ends, and around the chimney areas.</p> <p>A search in these key areas under the layers of insulation was also conducted- no evidence was found.</p>

<p>The top photograph shows the northeastern area of the loft, featuring exposed wooden rafters and a thick layer of loose wool insulation. A black pipe runs across the insulation. The bottom photograph shows the southwest area, close to the access hatch, with a white decorative object leaning against a rafter and a white plastic bag on the floor. Both photos include an 'arbtech' watermark and a timestamp of 'Aug 29, 2023 01:25:56 pm' and 'Aug 29, 2023 01:42:51 pm' respectively.</p>

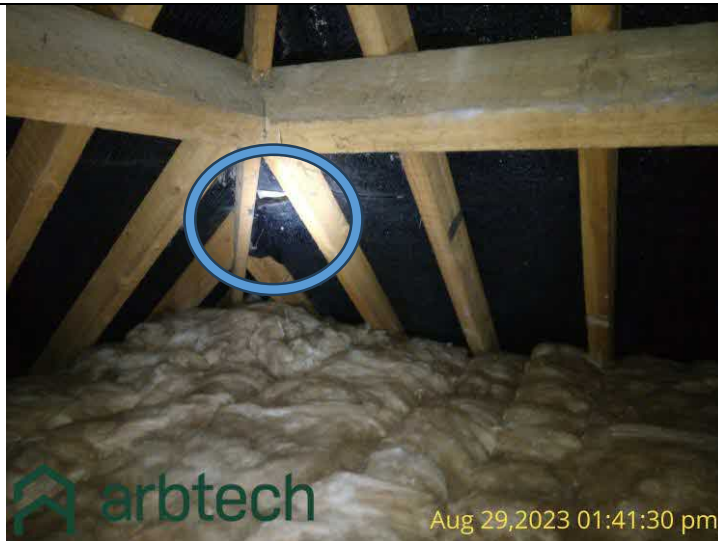
<p>arbtech Aug 29,2023 01:41:30 pm</p>
<p>B1 – suitability assessment</p>	<p>A small number of droppings was seen in the most southern area of the loft in proximity to the lining tear, resting on the area of wood circled opposite, directly under the ridge line. Less than 10 droppings were found in this area, and had the size, shape and crumble texture indicative of bat droppings. A search under the insulation on either side did not yield any further droppings to indicate historic use.</p> <p>Other droppings found in the loft area suggest rodents such as mice.</p> <p>A sample of the droppings was taken for DNA testing and labelled as SI on the survey map in Appendix 3. DNA results confirm the pile of droppings belongs to a common pipistrelle bat.</p> <p>The low volume of droppings only found in one location could suggest these have fallen from a small space in the lining, as this species typically does not roost in open loft areas.</p>

Building	Survey Results Summary	Impact Assessment	Recommendations	Biodiversity Enhancement Opportunities ¹
Roosting bats B1	<p>Building 1 has a confirmed roost, as identified by bat droppings found in the loft which are confirmed to be from a common pipistrelle.</p> <p>There is a low volume of droppings (<10) which is suggestive of a single bat entering the loft or a small number of droppings have come into the loft from a larger accumulation between the roof tiles and roof membrane above.</p> <p>The house has multiple external roost features for supporting this species, such as a gap under a tile on the porch roof, as well as</p>	<p>The proposed development will result in the extensions and alterations to this building, which will be two-storey in height. This could result in destruction of any bat roosts present and could cause disturbance, death or injury to bats.</p>	<p>Three bat emergence and re-entry surveys are required during the active bat season (optimal May to August, suboptimal September) to characterise the roosts present. At least two of the surveys should be completed during the optimal survey period mid-May to August inclusive.</p> <p>Infra-red cameras should be used as an aid. Surveys should be a minimum of two weeks apart.</p> <p>Four surveyors are required to provide full coverage of the building.</p> <p>An EPSL application to Natural England will be required. The EPSL application requires that surveys have been undertaken within the most recent active bat season and planning permission must have been granted and all relevant wildlife-related conditions have been discharged prior to submission.</p> <p>A Material Changes Check will be required within three months of the EPSL submission, if no survey work has been undertaken within that period. If bat droppings were found during the PRA, a sample will need to be sent off for DNA analysis to confirm the bat species present, to inform the EPSL application.</p>	<p>To be confirmed upon completion of the surveys.</p>

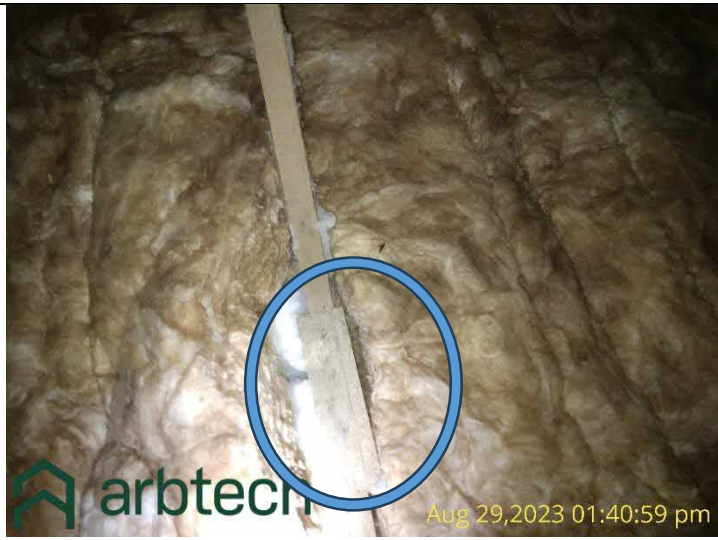
<p>B1 - breeding birds and other incidental observations</p>	<p>No bird nesting behaviour was observed at the time of the survey, no nests were seen under the solar panels which can be a common place for species like pigeons. Roost features identified for bats, were deemed not suitable to also support nesting birds, as tile features on the hanging wall were not lifted enough to allow bird access.</p> <p>Inside the loft of B1, there was a wasp nest observed, but this was inactive and has already been taken care of by professionals. The photograph shows this wasp nest.</p>

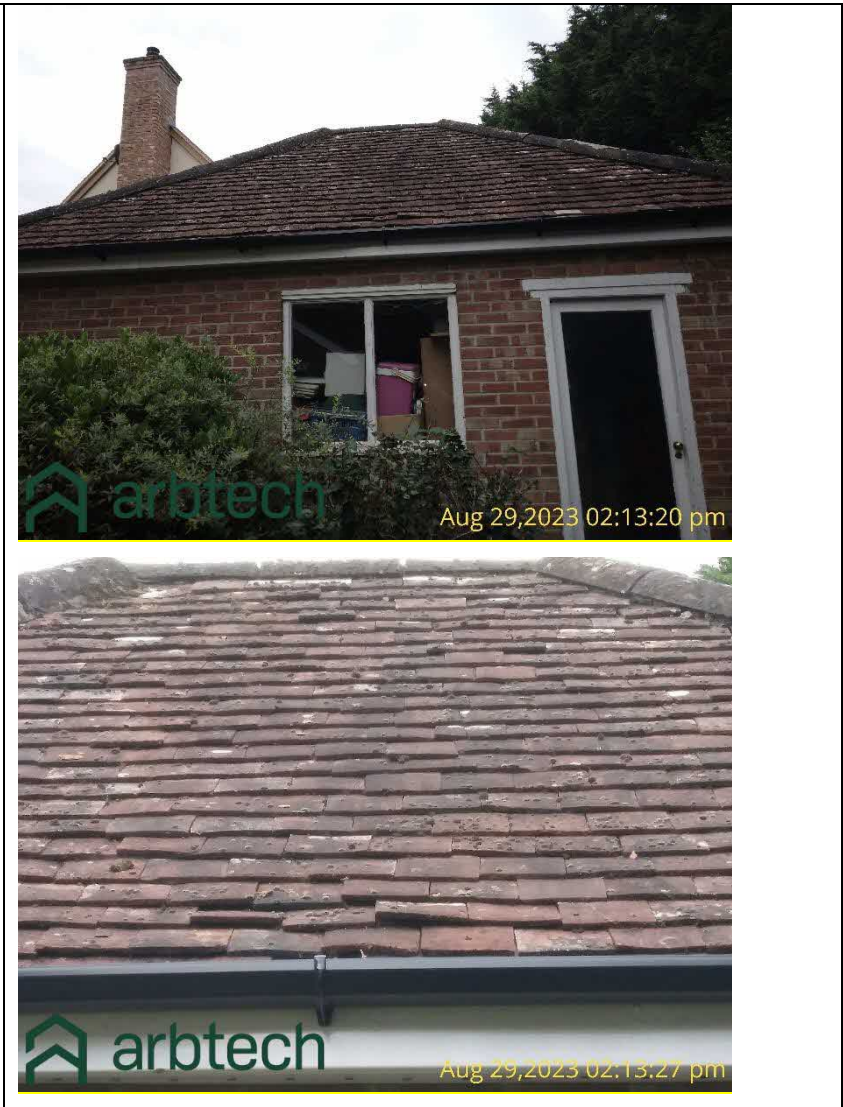
<p>B2- Northern elevation.</p>	<p>These photographs are of the northern elevation of B2. Views of this elevation were limited from the ground, due to the plant growth.</p> <p>Like the east elevation, the roof field tiles are in poor condition with many lifted or slip tiles providing suitable roosting space for supporting bats. The close-up photograph demonstrates this. This elevation had fewer suitable tiles, with a portion of this roof covered in thick moss and lichen growth. This is likely due to a lack of direct sunlight and increased damp, shading and plant material from the adjacent trees at this elevation.</p>	 
--------------------------------	--	--

<p>B2- Southern elevation.</p>	<p>This photograph is of the southern elevation of B2, as with the north and east elevation, there is lifting of tiles across this roof elevation that could support roosting bats.</p> <p>There were no droppings seen on these tiles or around the garage door area.</p> <p>There are no gaps around the garage door that would allow bats to access inside.</p>

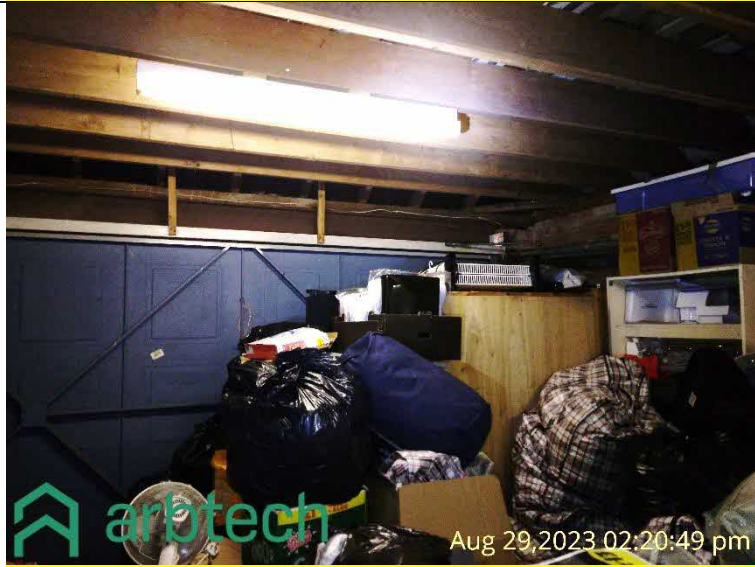
<p>B2- Suitability assessment.</p>	<p>B2 overall has a moderate value for roosting bats. The value is due to the external tiles for crevice-dwelling bats. There are over twenty tiles seen on three of the observable elevations of B2 that could support roosting bats.</p> <p>This building is located directly adjacent to the mature tree line which could be a direct access to a commuting route.</p>

hanging tiles on the eastern half of the building.			
Roosting bats B2	<p>Building 2 has moderate value for roosting bats.</p> <p>There are lifted tiles on all viewable roof elevations that are suitable for supporting roosting crevice-dwelling bats.</p> <p>The close proximity of the building to B1, which has evidence of roosting bats, and the presence of an EPSL for common pipistrelle bats 200m of the site, this greatly increases the likelihood of bats using this building.</p>	<p>The proposed development will result in the alterations to this building to attach an annexe and will include the repairs to the roof space of this building. This could result in damage and destruction of any bat roosts present and could cause disturbance, death or injury to bats.</p>	<p>Two bat emergence and re-entry surveys are required during the active bat season (optimal May to August, suboptimal September) to confirm presence or likely absence of a bat roost in the building. Both of the surveys should be completed during the optimal survey period mid-May to August inclusive.</p> <p>Infra-red cameras should be used as an aid. Surveys should be a minimum of two weeks apart.</p> <p>An additional two surveyors are required to provide full coverage of the building.</p> <p>If bat roosts are confirmed in the building one additional survey may be required to characterise the roost and to inform an EPSL application to Natural England. The EPSL application requires that surveys have been undertaken within the most recent active bat season and planning permission must have been granted and all relevant wildlife-related conditions have been discharged prior to submission.</p>

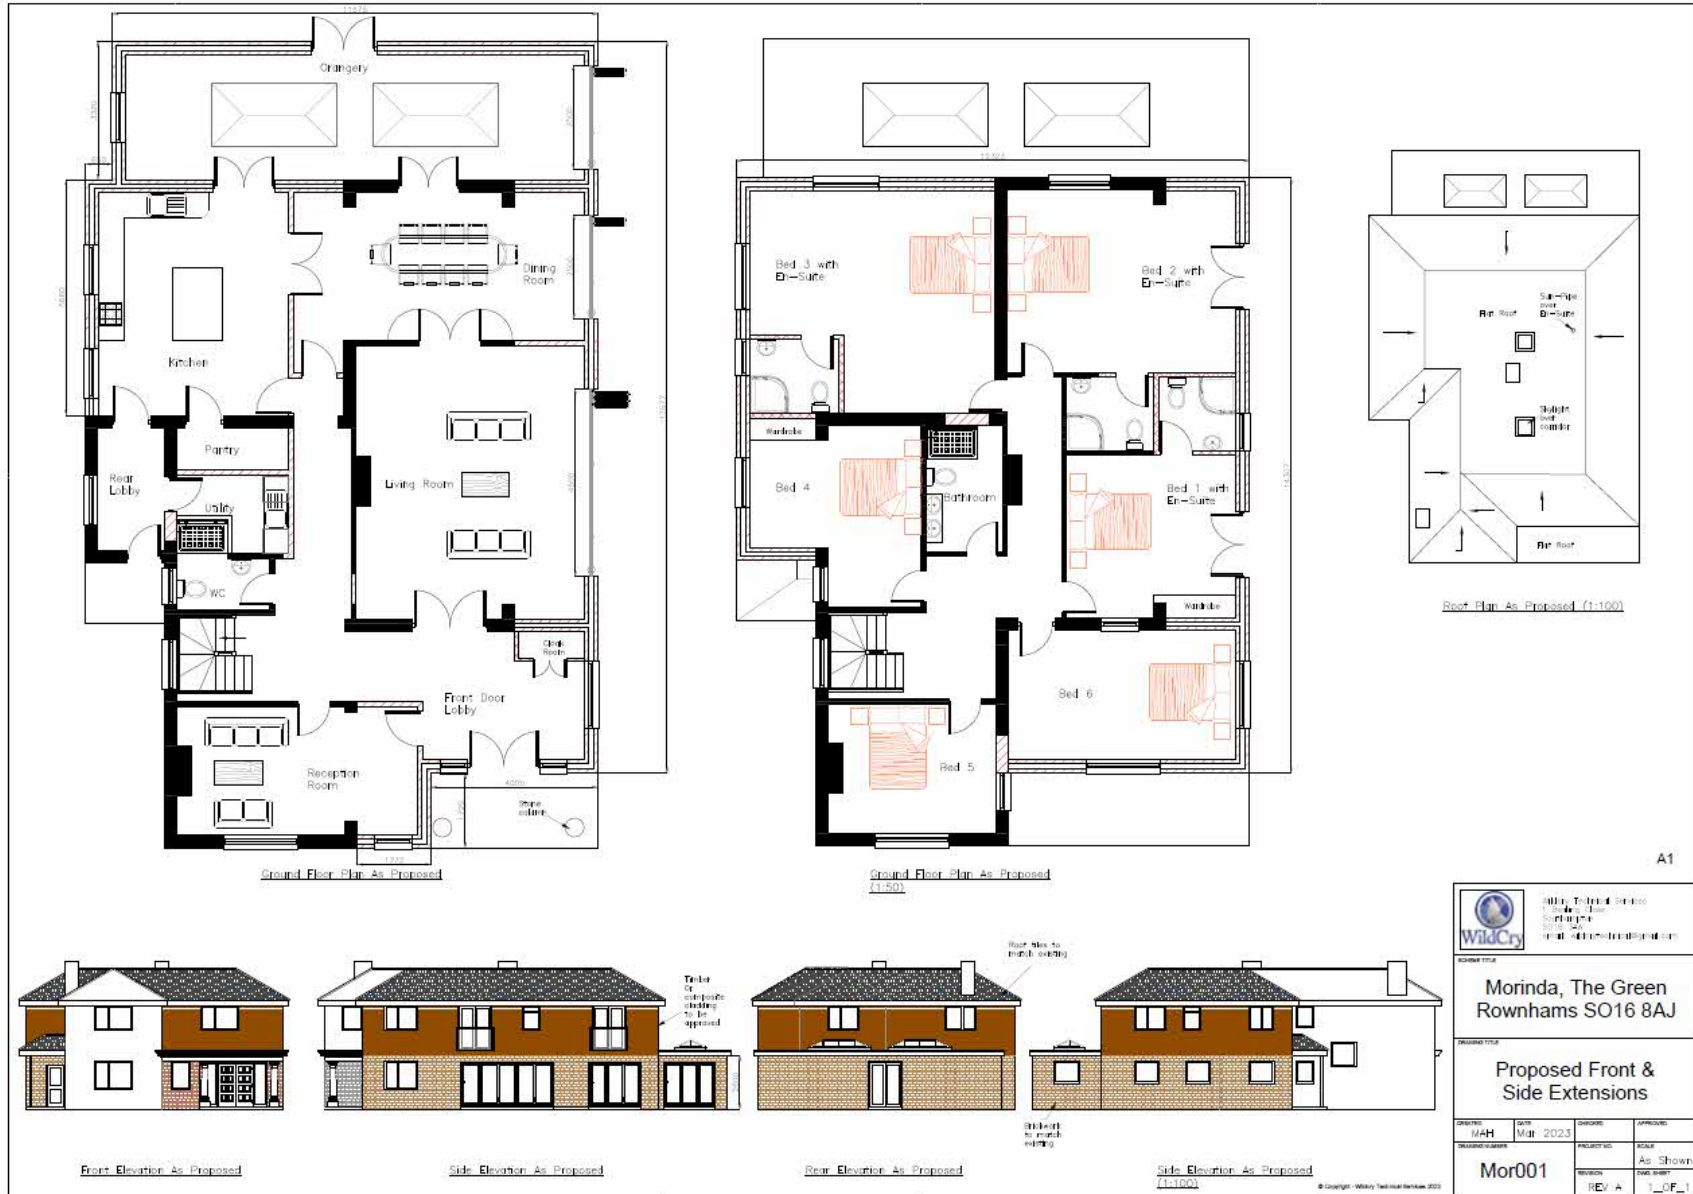
Appendix 1: Proposed Development Plan

Proposed Front & Side Extensions
