**Ecological Survey for dwelling near Catsley
Farm, Kinlet, Shropshire
DY12 3AR
SO 72411 79491**

Survey Objectives

Planning permission was granted to demolish this property following an ecological report in 2020. Since then, only part of it has been demolished. The remainder is now to be demolished. Owing to the time delay a second ecological survey is now necessary to ensure no European Protected Species (primarily bats) will be adversely affected by this development.

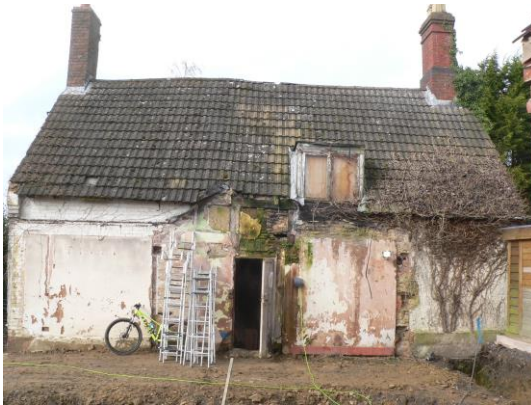
Despite the age of the building, the roof was in a reasonable state of repair. There were no gaps at roof edges, or at eaves level. There was access into the bedroom areas via an open window. No external signs of bats were seen.

Rear view (east facing)

Some vegetation (Ivy) was present on north and east walls, this could attract nesting birds between April and September so is best removed before this period.

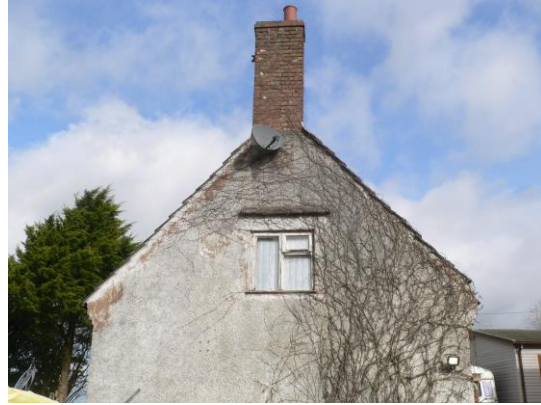
South facing end.

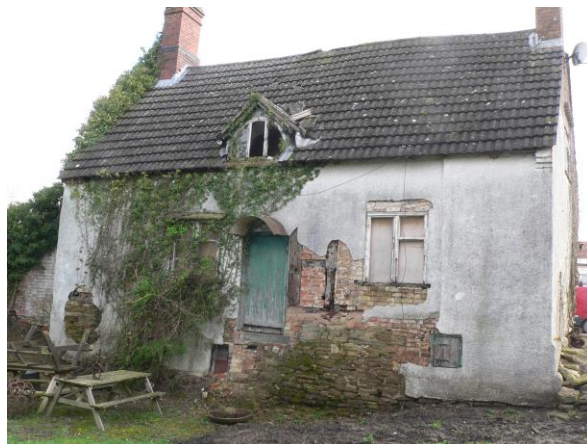
Front view (west facing)

No signs of bat activity or nesting birds was found.

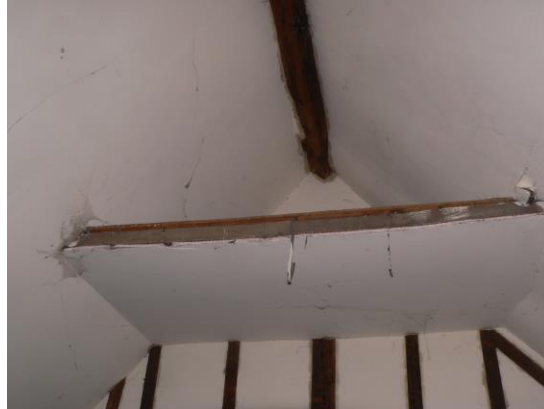
There was no loft area, bedroom ceilings were to the ridge. Access into the bedrooms for bats and birds was however possible via broken windows.

Internal searches were made for hanging bats, bat droppings on floors, tops of beams and tops of stored items. Searches also took place looking for signs of nesting birds. A search through all upstairs rooms did not reveal any sign of bat or bird activity.

Bedroom

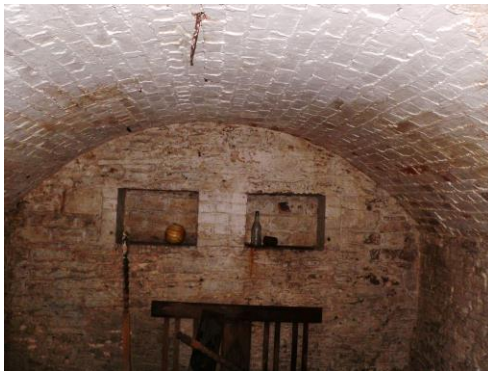
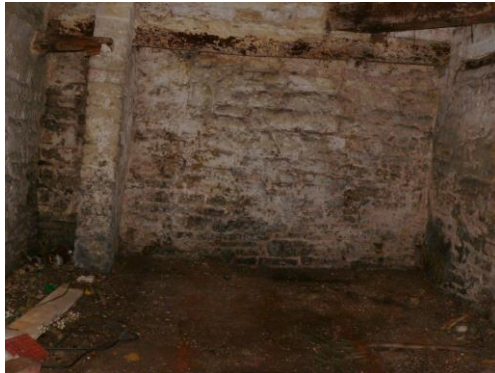
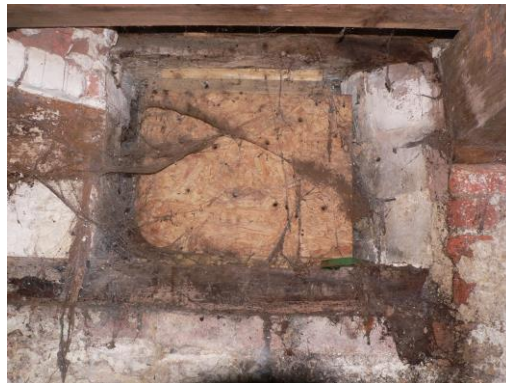
A double room cellar was present, this was also searched for signs of roosting bats, droppings etc. No signs of roosting bats could be found.

Copious amount of cobwebs found on cellar wall.
