18 Dean Street
Crediton
Devon
EX17 3EN

Ref: ORB_3975_BG

Re: Bat and Bird Survey No Impact Letter – 18 Dean Street, Crediton

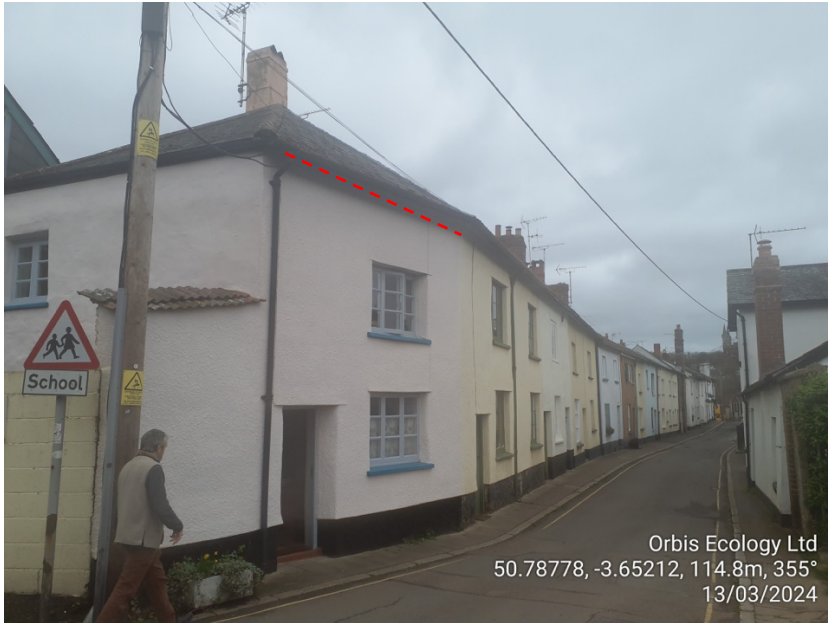
There was evidence of nesting sparrows along the front elevation of the property along the top of the wall plate. Nesting material was noted, but no nesting activity observed. Sparrows were active in the

Area with nesting material observed from within the roof void

Works to the front roof will not commence until after the bird nesting season (1st March – 31st August) unless a competent ecologist has undertaken a nesting bird check within 24 hours of the proposed works and can provide written confirmation that no birds are currently nesting.

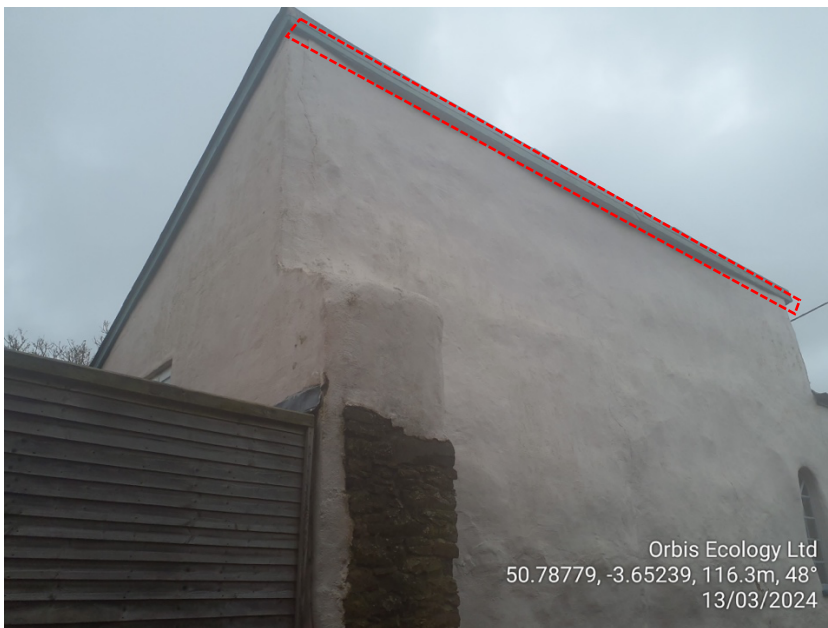
No evidence of bats such as bat droppings or feeding remains were found inside the voids. The roof tiles are in a general good condition, with no obvious areas for roosting on either of the roofs. The open eaves do have suitable features to support roosting bats because the undulating wall plate creates small crevices and cavities that bats could use.

Gaps under fascia board on single pitch rear roof

There will be no removal of fascia boarding or infilling of any wall top gaps. If this becomes necessary, Orbis Ecology must be contacted for advice. If a bat (or signs of bats, such as droppings) is found then works should stop and a licensed bat ecologist should be consulted. Bats should not be handled unless they are injured, in which case using gloves, the bat should be placed in a small breathable container and advice sought from:
