# Bat and Bird Survey of 75 Westgate Road, Chichester

Client CGA Architecture

Reference C1199.001

Date 31 May 2023

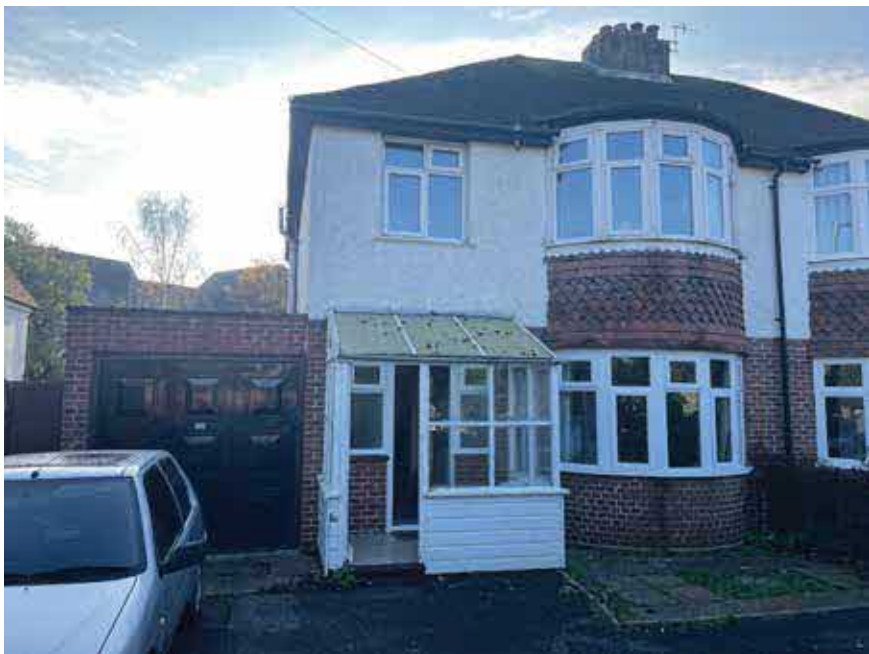
Photograph 1:

Front; north elevation.

A panel of hanging tiles occupies the space between the ground floor and first floor bay windows. The hanging tiles provide significant crevices that provide bats with potential access to the shallow hidden cavity that lies behind the tiles.

Also shown is the front of the garage.

- 3.10. Potential Roosting Features (PRF's) are restricted to the ridge and hip tiles of the main roof where a number are no longer well cemented in place and the panel of hanging tile on the front, northern elevation. The identified crevices have the potential to provide small crevice dwelling bats with access to the inner, hidden recesses beneath / behind the tiles. Refer to photographs 1 & 7.

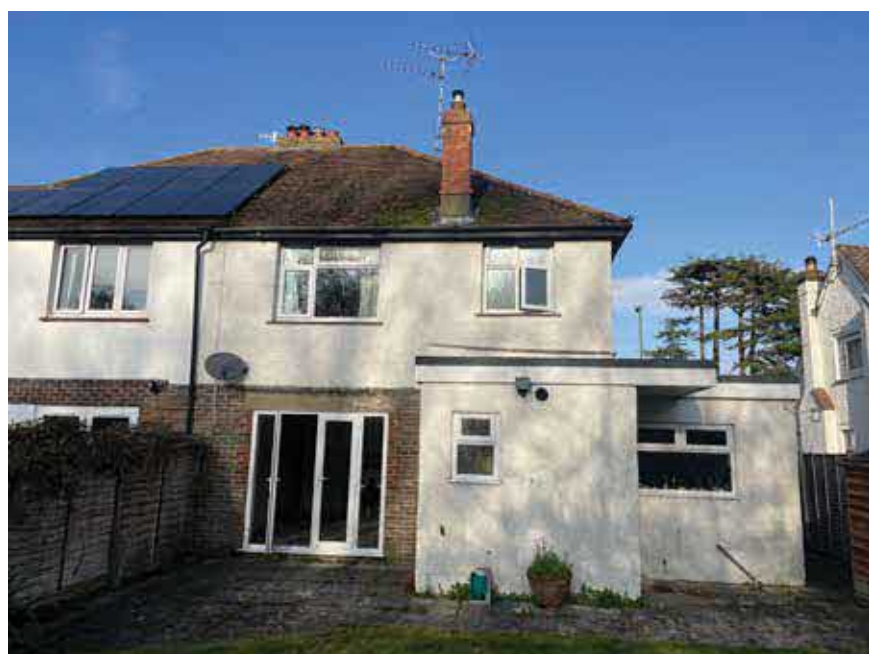
Photograph 2:

Rear; south elevation.  
Shown also is the rear of the fat roofed ground floor extension.

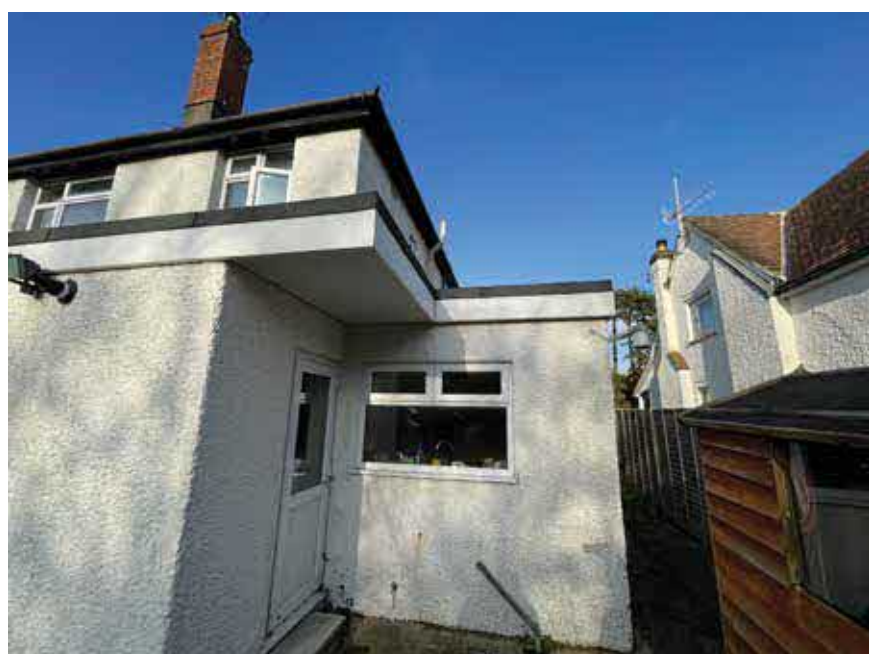
Photograph 3:

Detail; showing the eastern elevation to which the ground floor extension is attached to

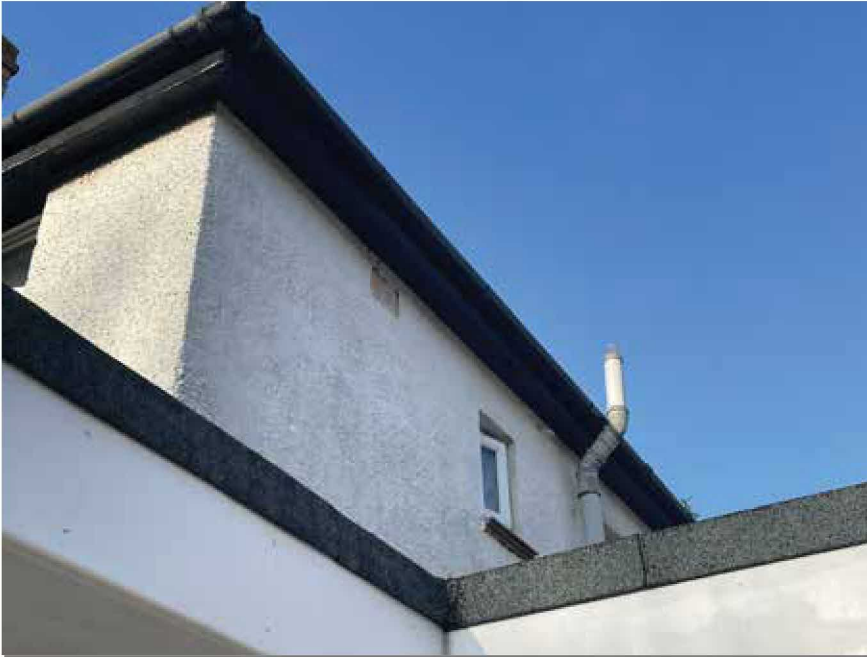
Photograph 4:

The eaves of both the main dwelling and extension remain very well-sealed and in good condition.

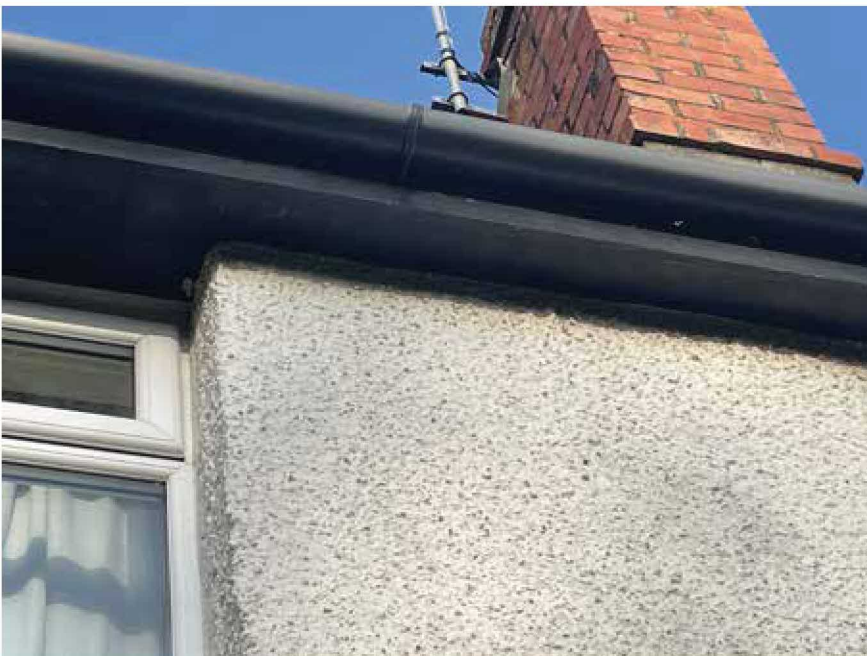
Photograph 6:

Detail; showing the well-sealed eaves on the dwelling.

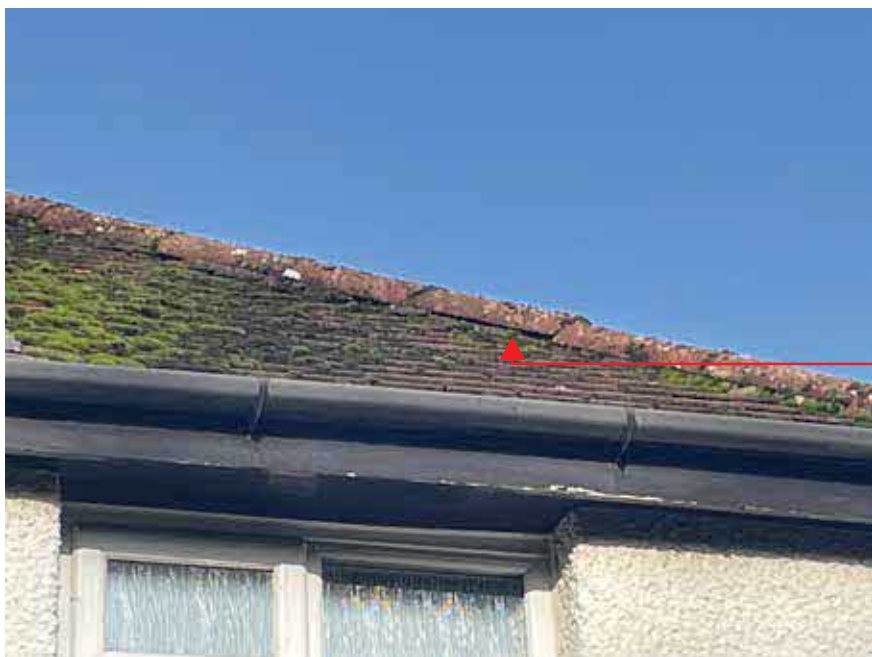
Photograph 7:

A number of the ridge and hip tiles are no longer well cemented in place. This has led to the creation of numerous crevices that provide potential access to the inner recesses of the tiles.

- 4.3. Bats are transient in nature and can occasionally take up sites on an occasional or transient basis. There is a small possibility that bats could be encountered during works; therefore, all works must proceed under a cautionary approach. Tiles and roof panels will be removed in a vertical rather than horizontal sliding motion. Soffits and masonry will be dismantled using a 'soft' approach taking care with cavity walls where present. All site workers will be vigilant at all times and in the very unlikely event that a bat is found then works must stop immediately and advice should be sought from Crossman Associates or Natural England (telephone number 0300 0603900).

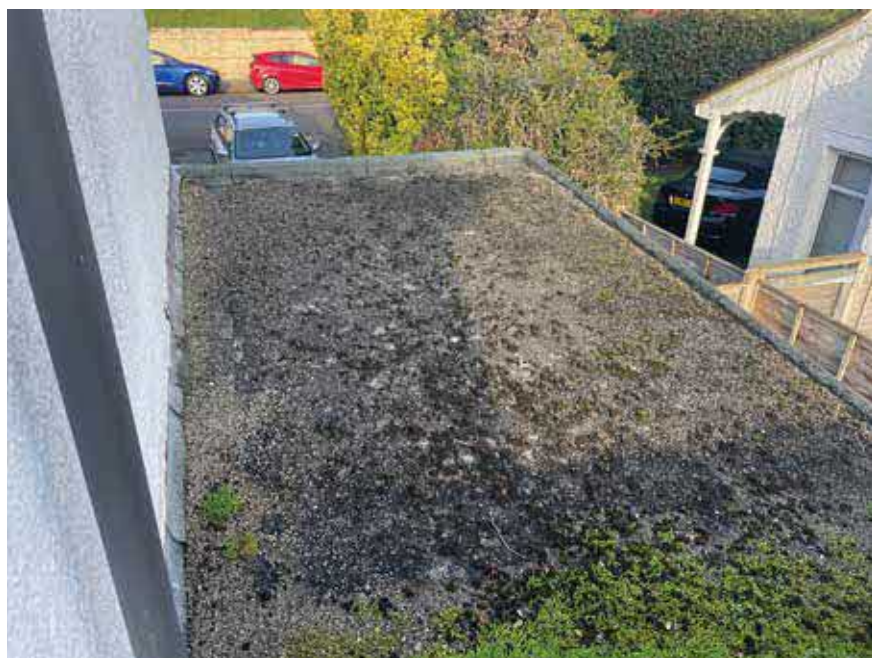
Photograph 8:

The combined garage and extension has a simple fat and well-sealed roof of felt.

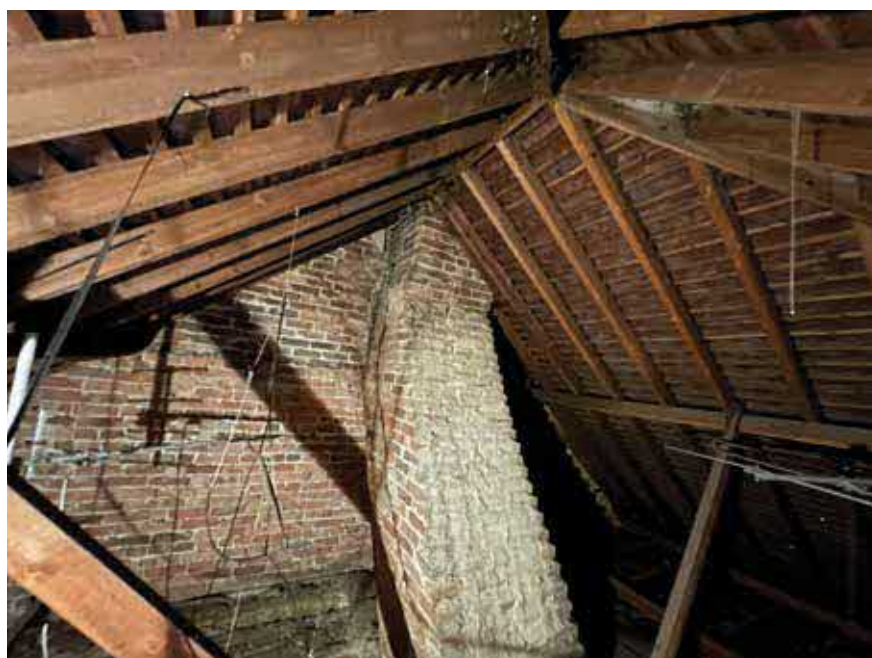
Photograph 9:

The dwelling has a single roof void created from a standard timber cut and pitch roof that lacks any complex joinery. The timbers all remain in good condition. No sarking is present and the underside of the roof tiles are on show. The roof void has a floor to ridge height of approximately 3.5 m. and the simple layout allowed for a full and thorough examination. During the survey no evidence of bat occupation was present and overall, the roof void provides a well sealed area.

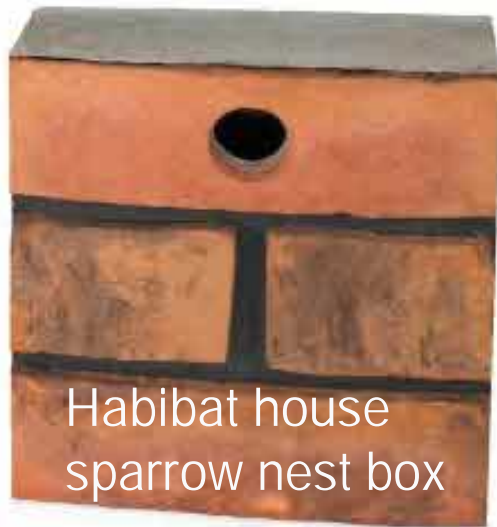
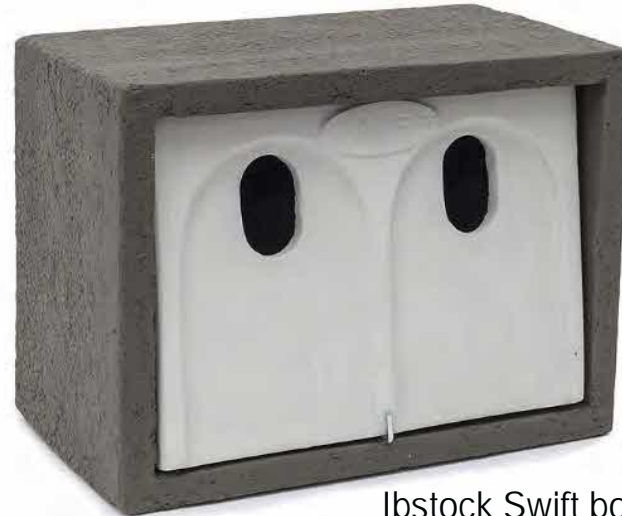
Vivara woodstone sparrow nest box; suitable for both integral fitment or surface mounting

Ibstock Swift boxes are also suitable for house sparrows. Can be customised to suit any exterior finish. Site boxes under eaves, away from windows and direct sunlight.

- 4.10. Integrally fitted models should be used and can be constructed into the outer wall of the extension as it is built. Alternative models are available for surface mounting. Sparrow nest boxes are ideally fitted below eaves or on gable walls, ideally on north or easterly elevations. Suitable models include the Schwegler 1SP, which is suitable for both integral and surface fitment. This model is strong, durable, long lasting and available in brown or stone colour. Other models are available from [www.habibat.co.uk](http://www.habibat.co.uk) and [www.vivara.co.uk](http://www.vivara.co.uk) An information sheet on integral bird nesting boxes is included in Appendix III.

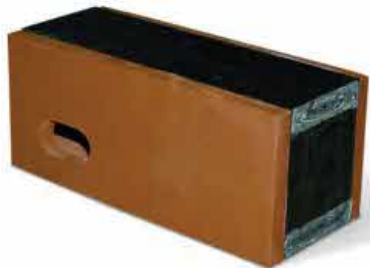
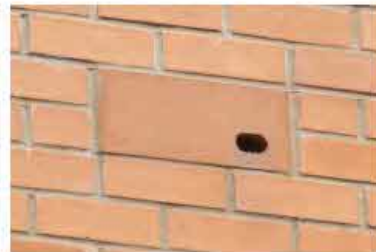
Ibstock Box

Sparrow boxes should be grouped together and be at least 2 m of the ground. The boxes can be also be sited on gable walls. At least 3 per averaged size house.

Swifts boxes should be at least 5 m above the ground with an clear un-obstructed flight path.

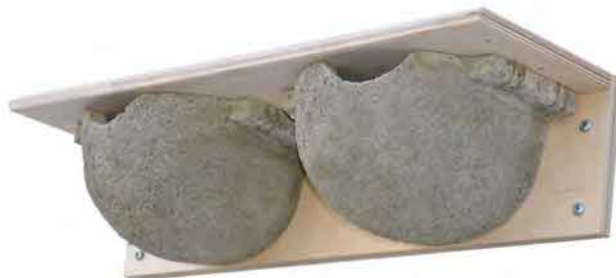
Schwegler model 9b

Schwegler house martin box model 9 b double is a suitable box for house martins and can be used to encourage the uptake of a building by this species. The boxes can be attached to the exterior walls in a sheltered position; ideally beneath the eaves. At least two sets should be placed on an averaged size house.
