**Stables at Flanders Farm,
Thompson's Lane,
Chobham,
Surrey,
GU24 8SU**

Phase 1 Bat survey

MARCH 2024

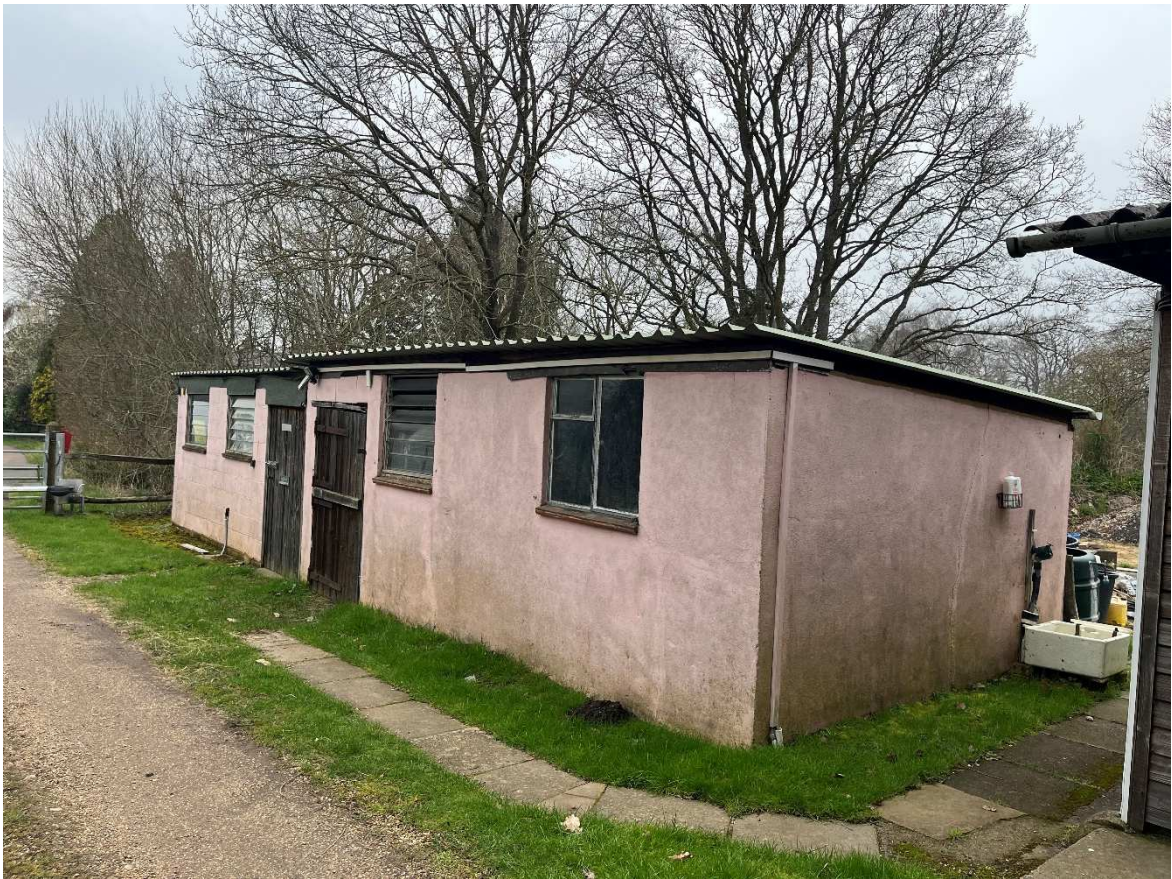
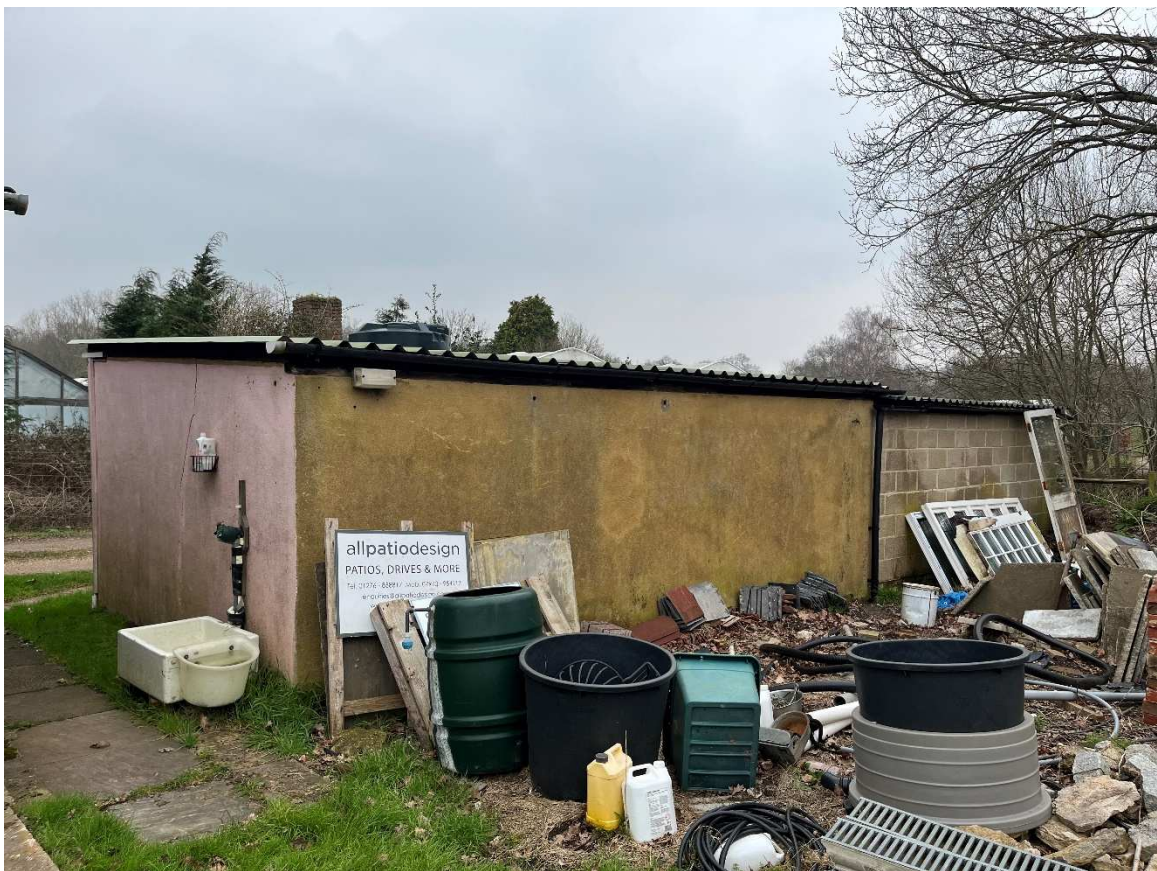
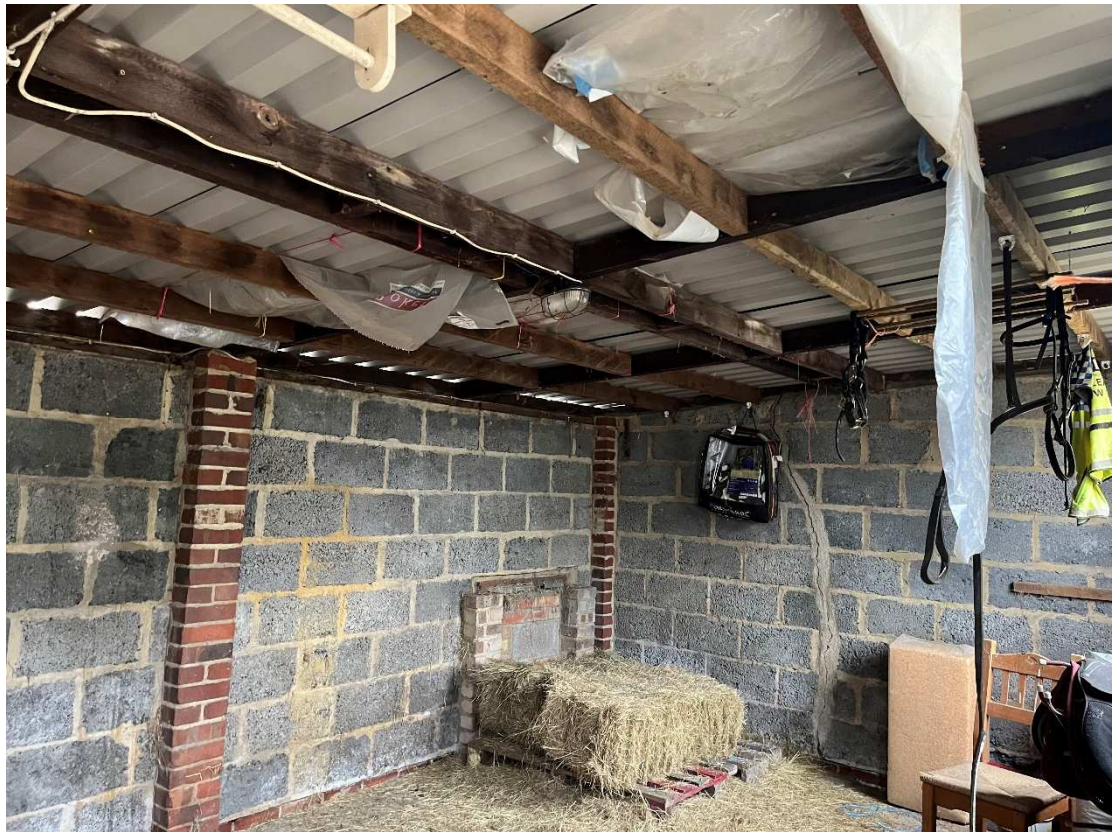
Single storey stable with rendered breezeblock walls and a shallow sloping roof of corrugated metal sheeting (see figures 3-5). There are no enclosed voids within and the roof is unlined with no gaps sufficiently large for crevice roosting bats. The eaves are open with daylight visible beneath the roof sheeting. Therefore the structure has negligible potential for roosting bats.

Figure 3. Building A: Western and southern elevations looking northeast.

Figure 4. Building A: Eastern elevations looking northwest.

Figure 5. North Stable: Interior looking east.

The buildings have negligible potential for crevice roosting bats; therefore, a phase 2 emergence survey is *not* recommended.

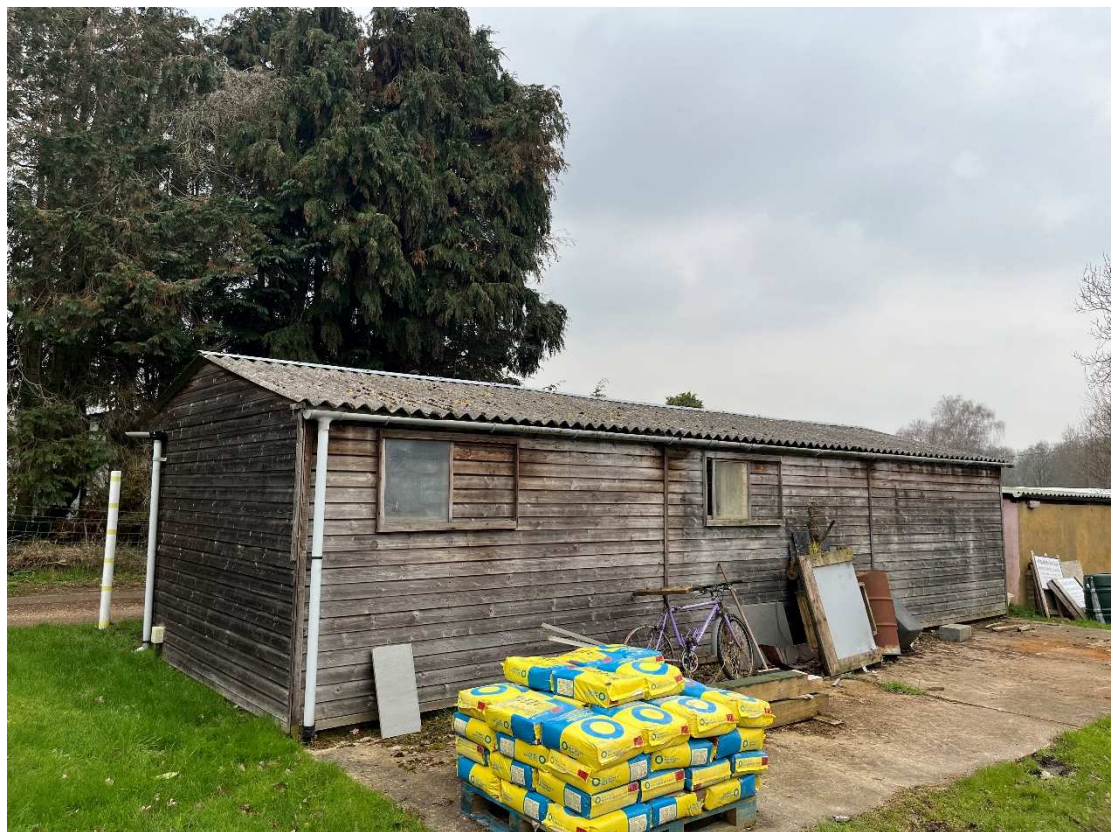
Figure 6. Building B: Eastern and southern elevations looking west.

Building B is immediately south of A and is a prefabricated wooden stable with pitched roof of corrugated sheeting (see figures 6). The space within has no voids and is permanently illuminated via windows on the eastern elevations.

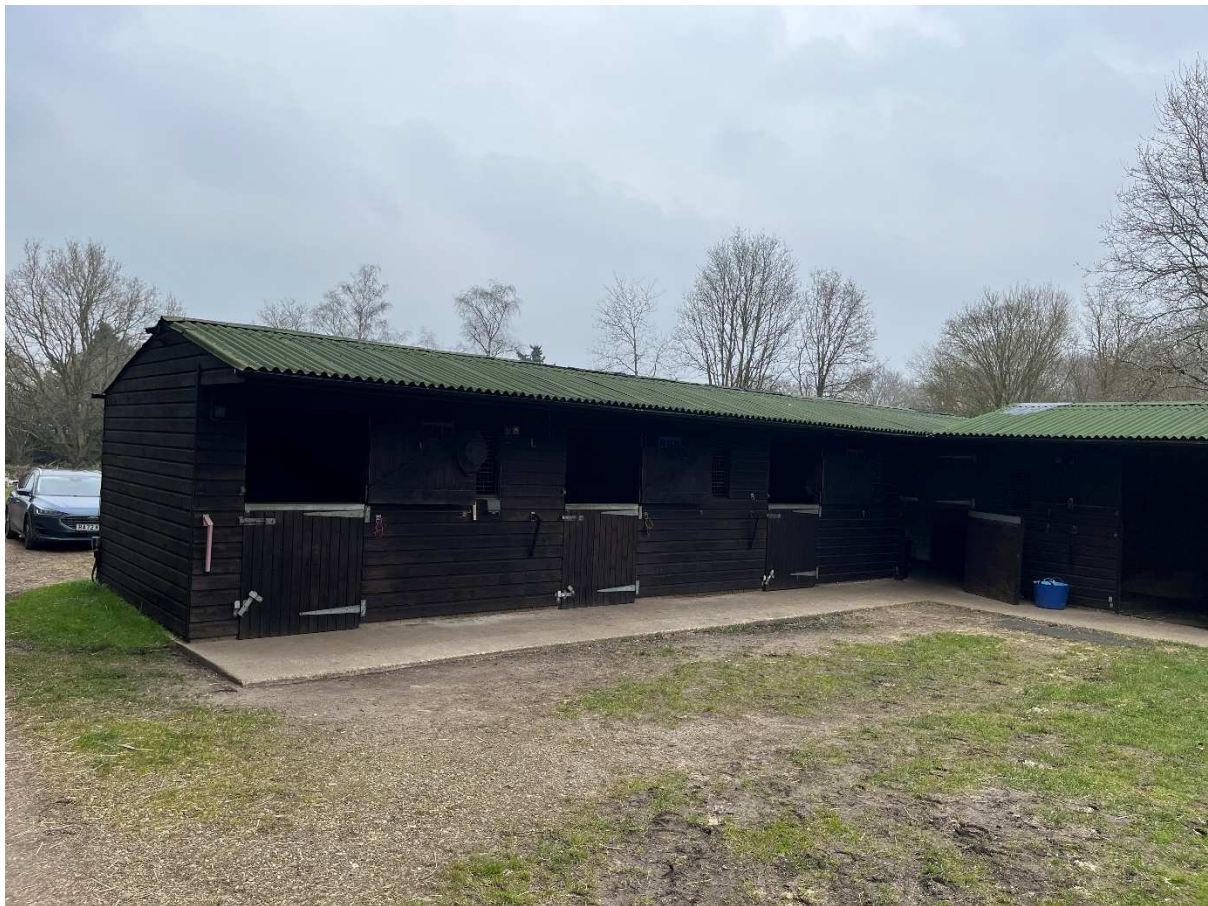
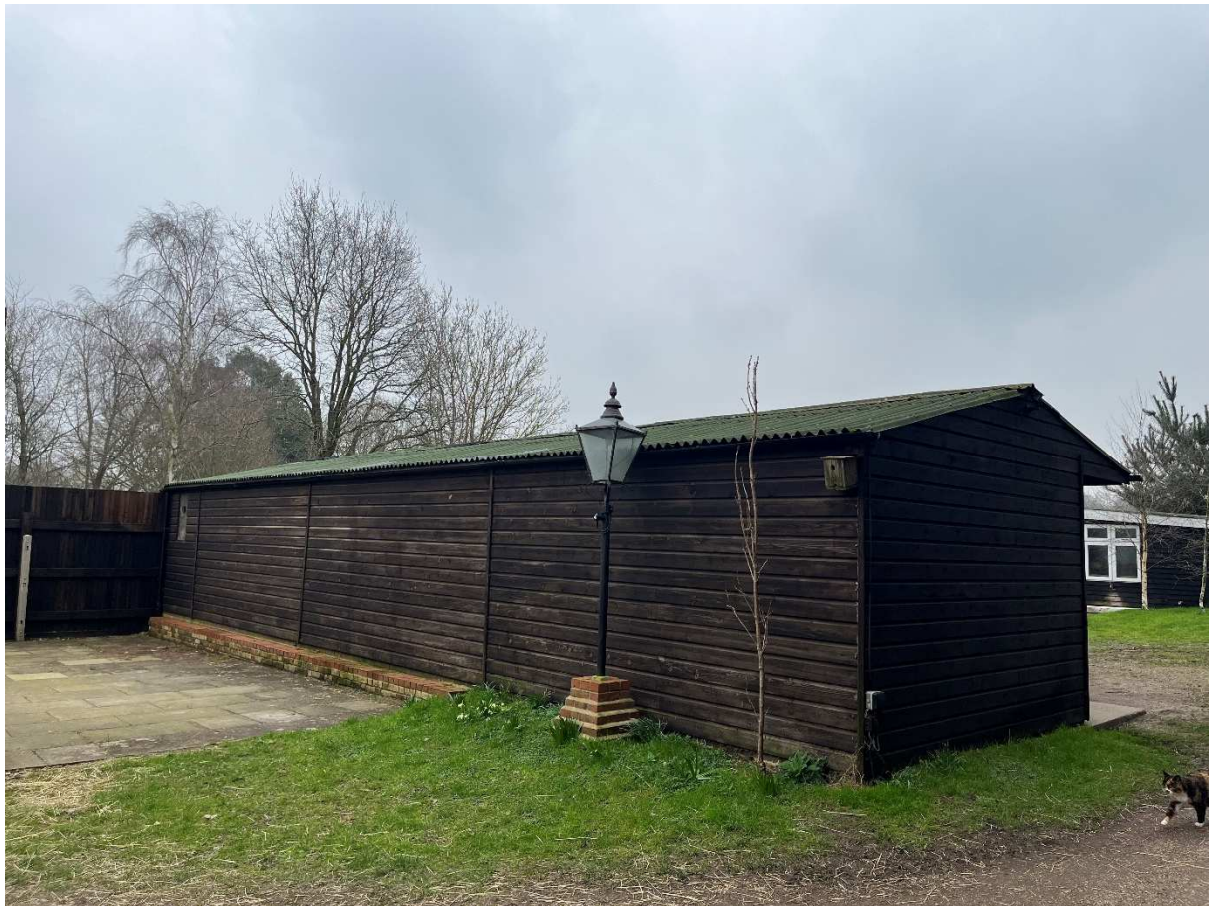
The south stable is a L-shaped prefabricated stable block. It is a wooden building with pitched roof of corrugated metal sheeting on an open wooden frame (see figures 7-8). The space within has no voids and is permanently illuminated via a skylight on the west face of the roof.

Figure 7. Building C: South Stable southern and western elevations looking northeast.

Figure 8. Building C eastern elevations.
