DESK TOP STUDY REPORT

| Site Address: | Valentines, Wellpond Green, Standon, Ware, Herts, SG11 1NJ |
| Project No.: | 18256 |

PRELIMINARY RISK ASSESSMENT – DESKTOP STUDY - PHASE 1 REPORT

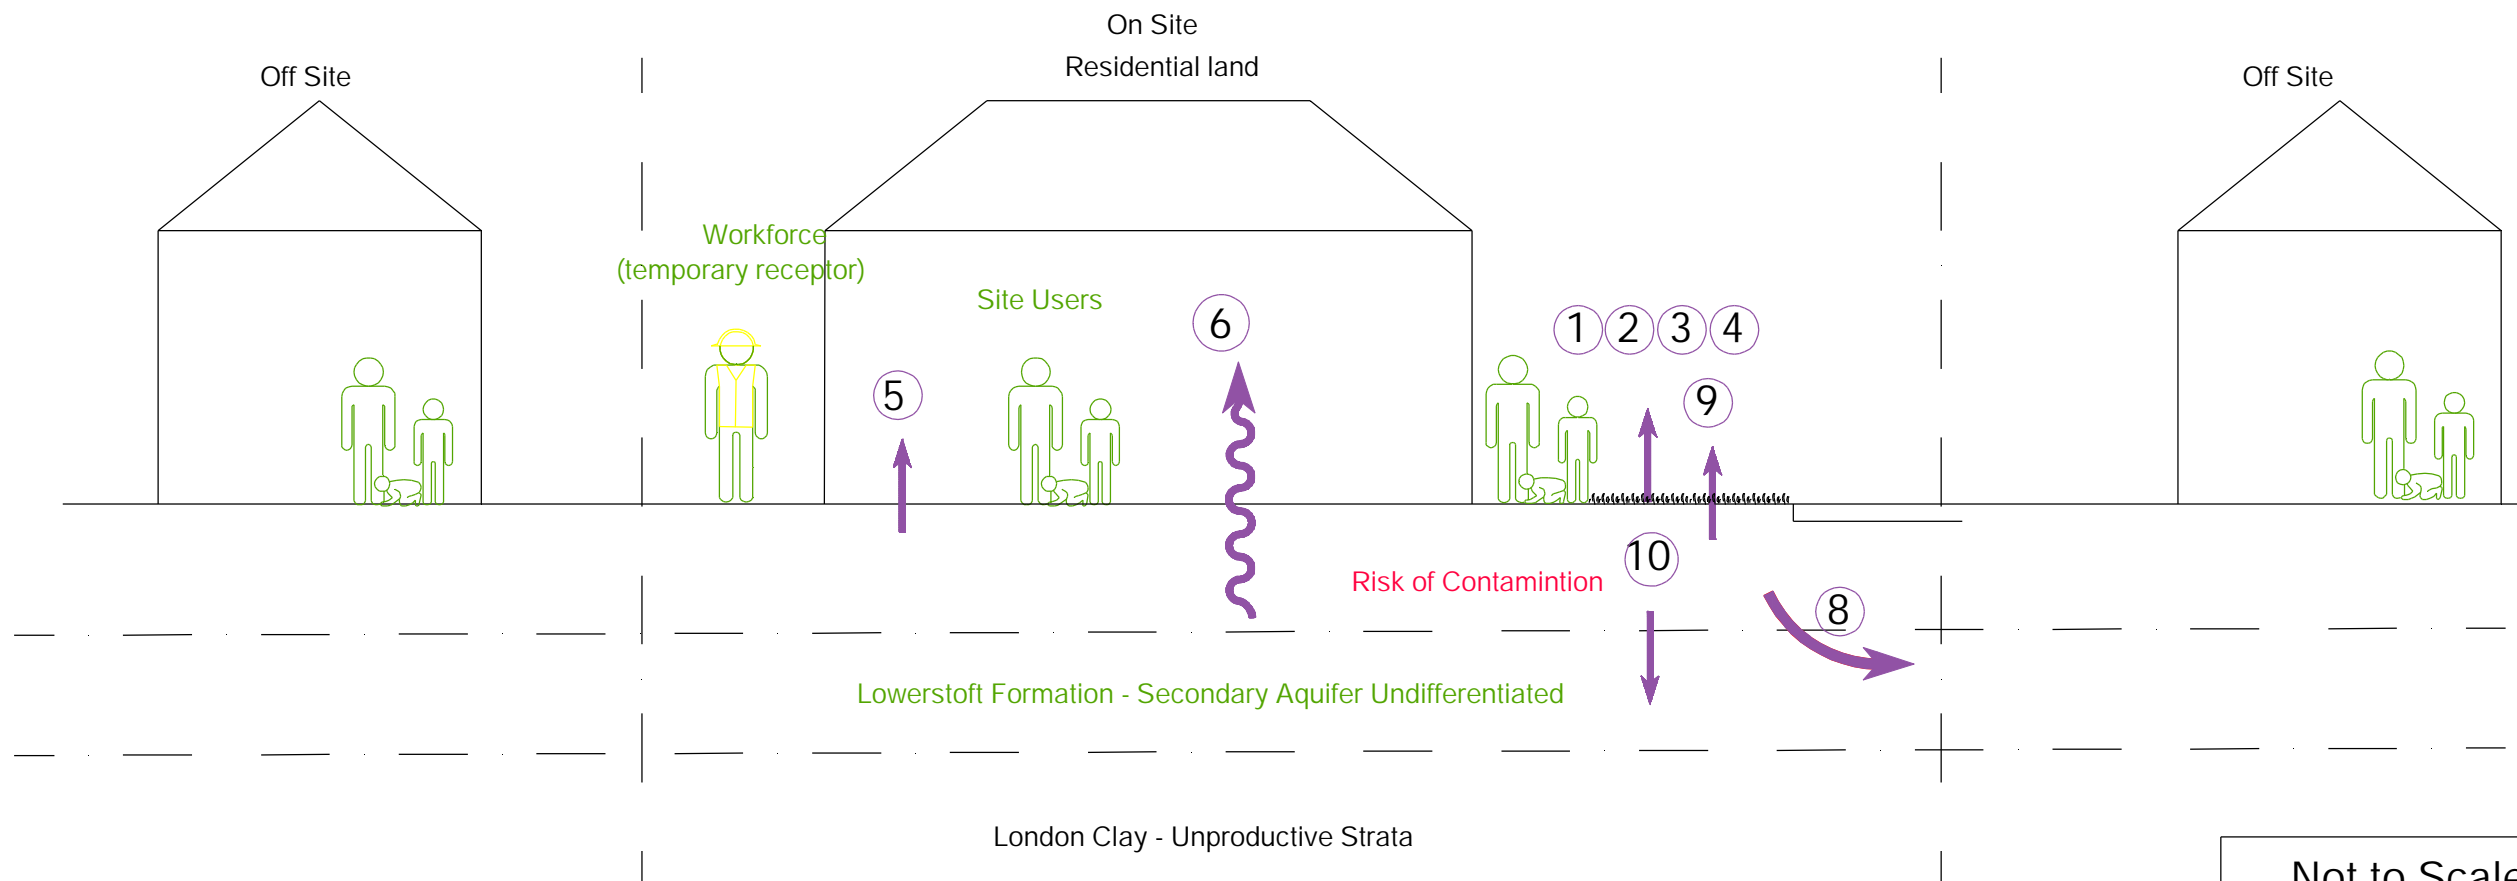
Not to Scale
Sketch No. : DTS / 18741 / 01 / 01

- Purple =Possible pathways
- Green =Possible receptors
- Red =Possible sources
- Grey = Not in place within this site

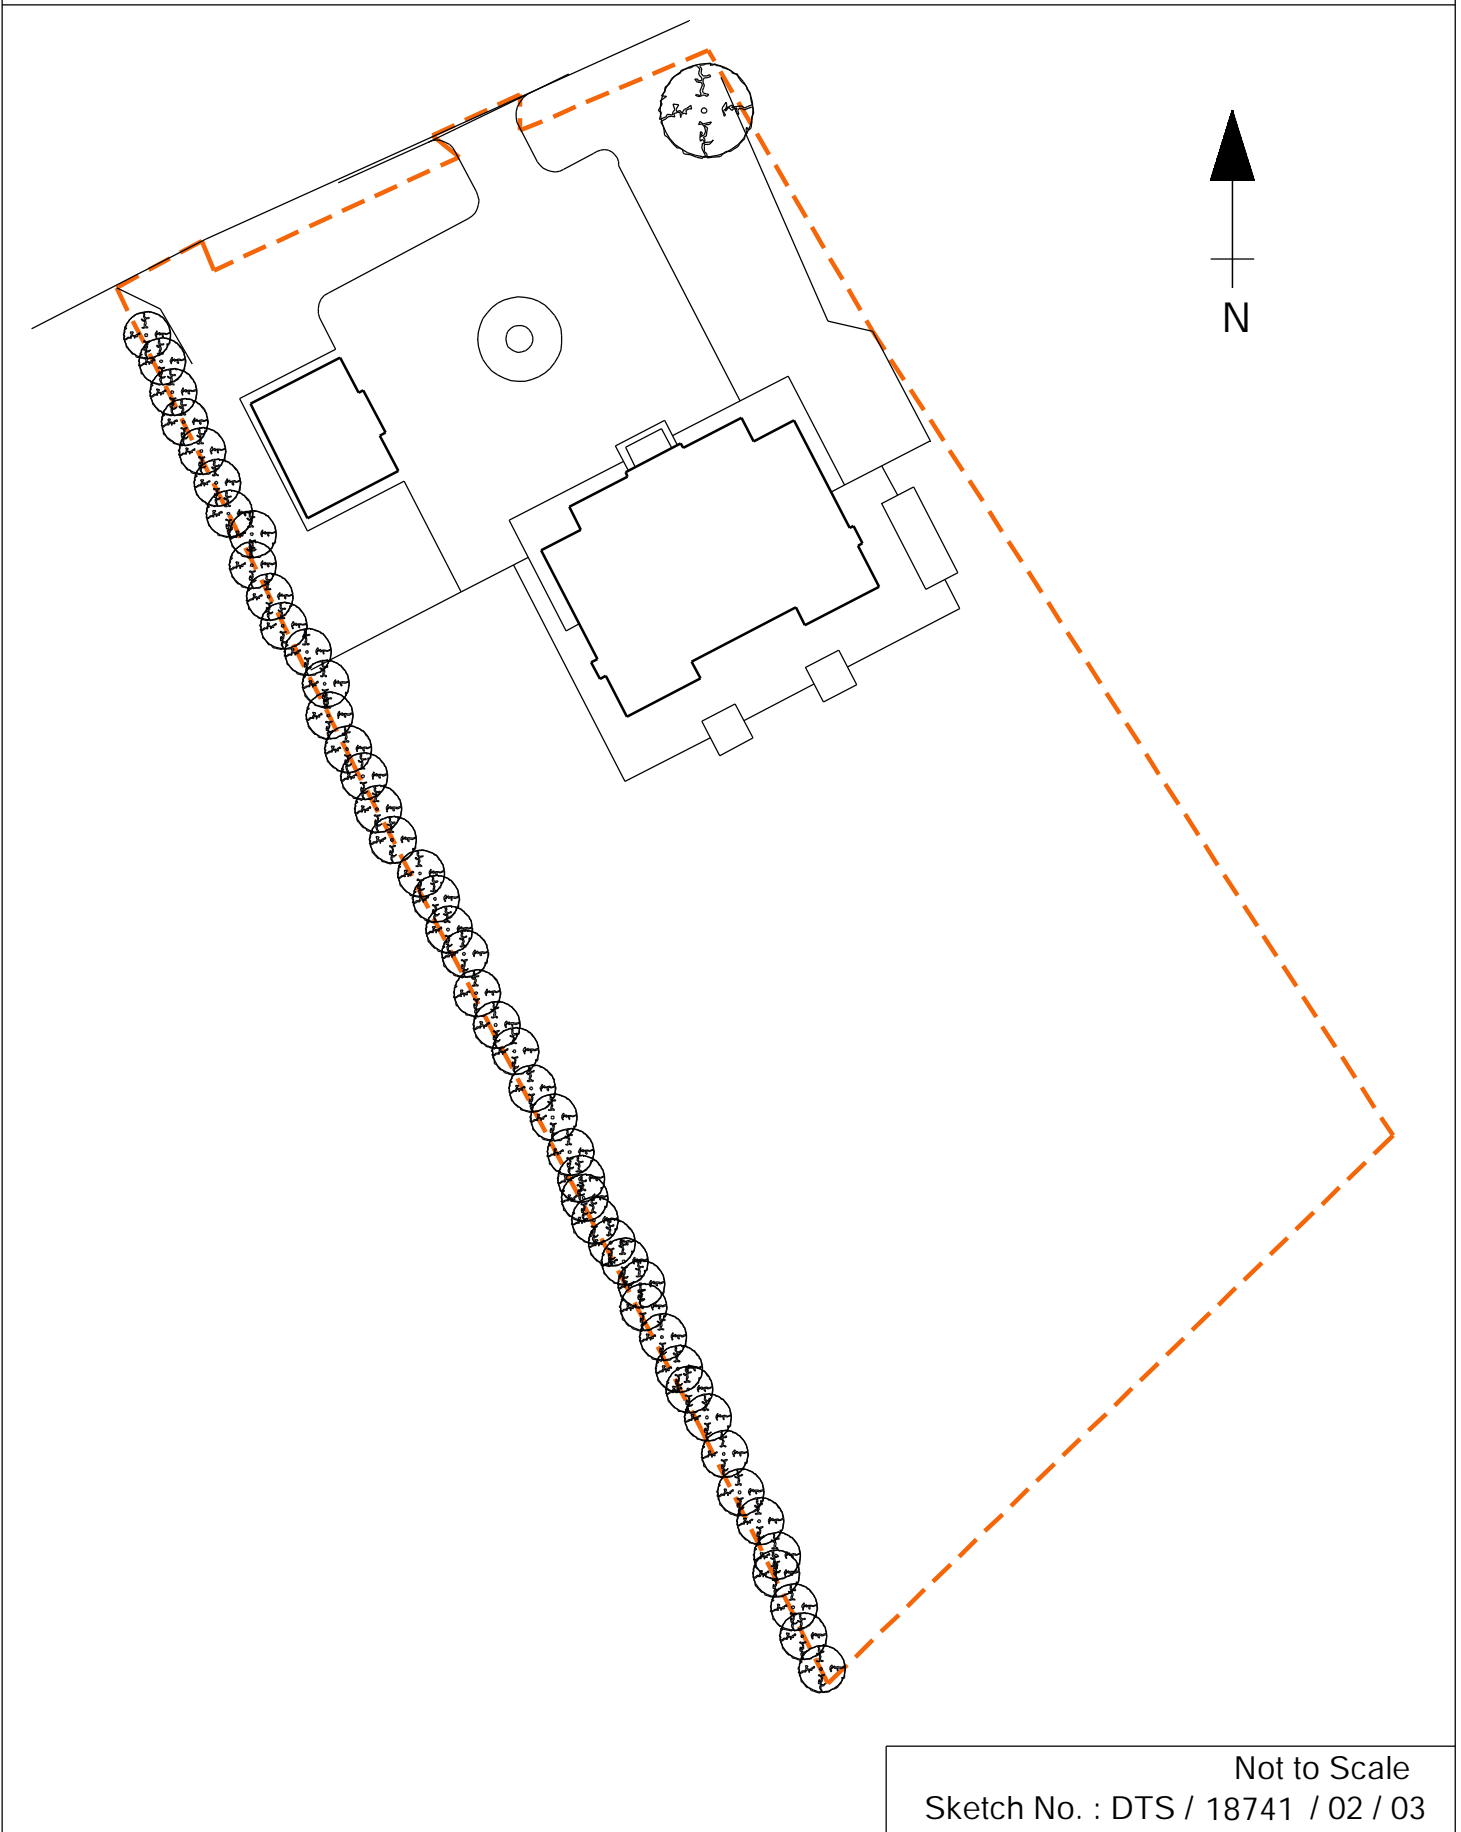
Proposed Site Plan

| Proposed Development | The proposed development forms the demolition of the existing residential house and associated outbuildings and barns and the construction of a large private residential property and associated landscaping, driveway and garage. | | |
