Sawbridgeworth Evangelical Congregational Church, London Rd, Sawbridgeworth, CM21 9EH

Statement of Heritage Significance and Heritage Impact Assessment

SH Ref SECC0323_HIAv1.1 (revised and updated 2024)

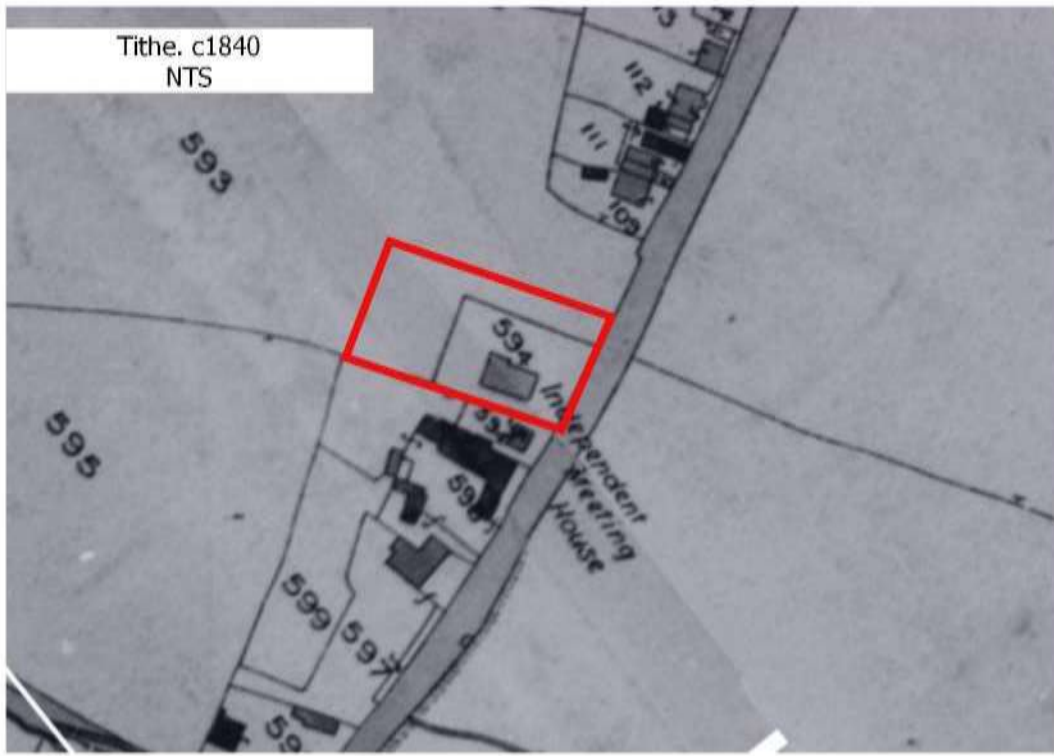
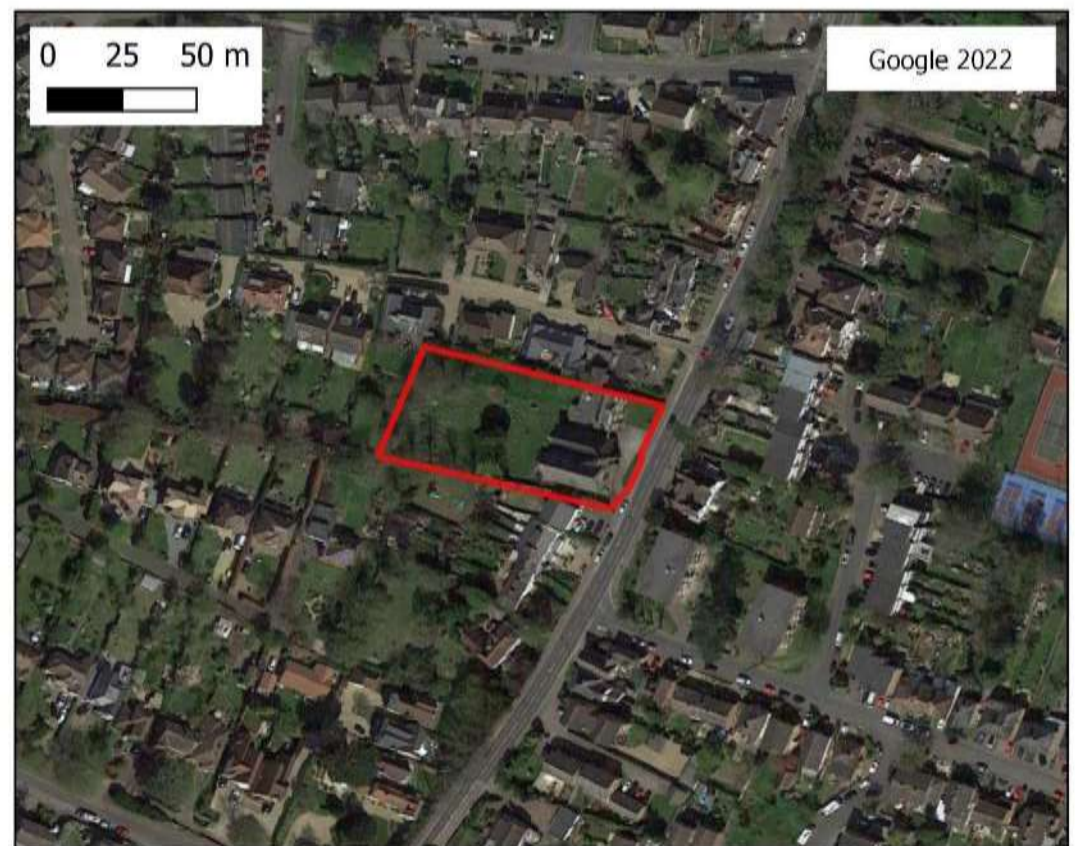
Figure 3: Historic Map Regression

- 4.5 The **1920 25 inch to the mile mapping** shows the classroom block for the first time, labelling it here as *Sunday School*. The building is shown as extending slightly into the church plot, but retains a narrow rear garden shown as bounded from the burial ground.

- 4.6 The **1988-1992 1:2500 scale OS mapping** shows the classroom and kitchen blocks with the site laid out as today.
- 4.7 **An extract of current Google aerial photomontage** is provided for comparison.

- 4.1 **Figure 3** presents a regression exercise of historic maps showing the development of the site.
- 4.2 The **Tithe map** of c1840 shows the ground plan of the 1814 chapel. The burial ground of the site is shown extending less to the east and less to the north than on later maps. Plot 593 to the northwest and northeast is described as *Cottage Allotments: Root field gardens*. Plot 595 to the southwest is described as an arable field of *Great Beazleys Farm* described as *Rookeys and Barn*. 596 immediately south is described as *Vine Farm, Homestead*.

- 6.6 Historic maps (see figure 3) demonstrate that this land was used during the post-medieval period this land was in agricultural use in 1841, as part of a larger area of allotment gardens in 1880 and 1907, before becoming a separate garden enclosure to the rear of the *Sunday School* ('Classroom Block') by 1920. During the 20th century the surrounding landscape to north, west and southwest has been urbanized as a residential area.

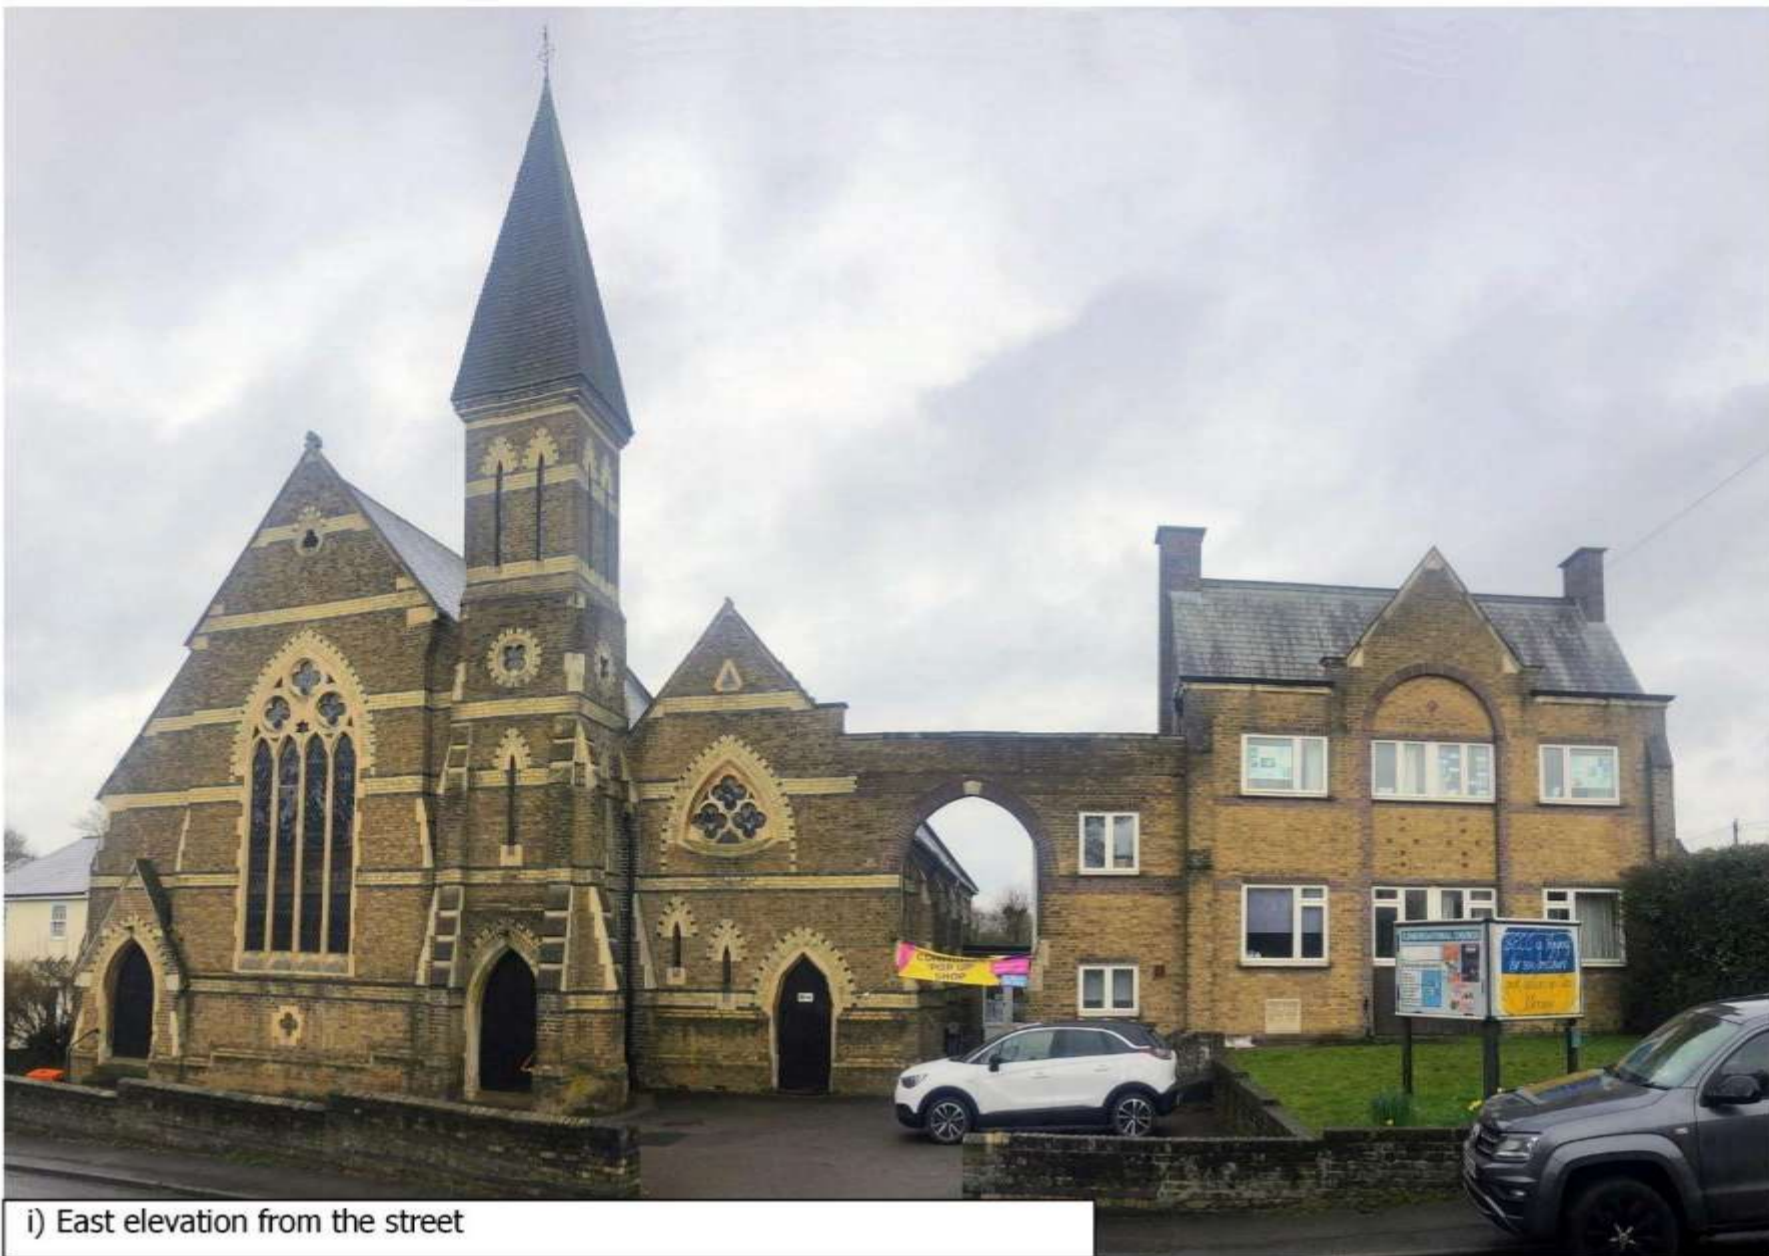
Figure 4
External, general

- 5.7 It is a rectangular block under a simple roof, the east elevation given a rather austere classical treatment with a simple parapet wall with a possibly stone, but more likely concrete cornice also used around the central gable with kneelers. Clear references are made to the principal building, through the use of a gault brick (one of lesser quality which is softer and wearing less well), entirely decorative buttresses to either side of the elevation, and purple brick decorative bands, also edging around a central arched panel. Windows are wide with modern UPVC units. There is a central large door opening, now closed with wood panelling and a further wide UPVC window. A side bay is to the left, under a flat roof concealed by a further, simpler parapet. The building is rather clumsily tied to *Poulton's* building with a simple, slightly pointed arch and wall. Its rear elevation is partially built over by the 1970s **kitchen** block.

i) East elevation from the street

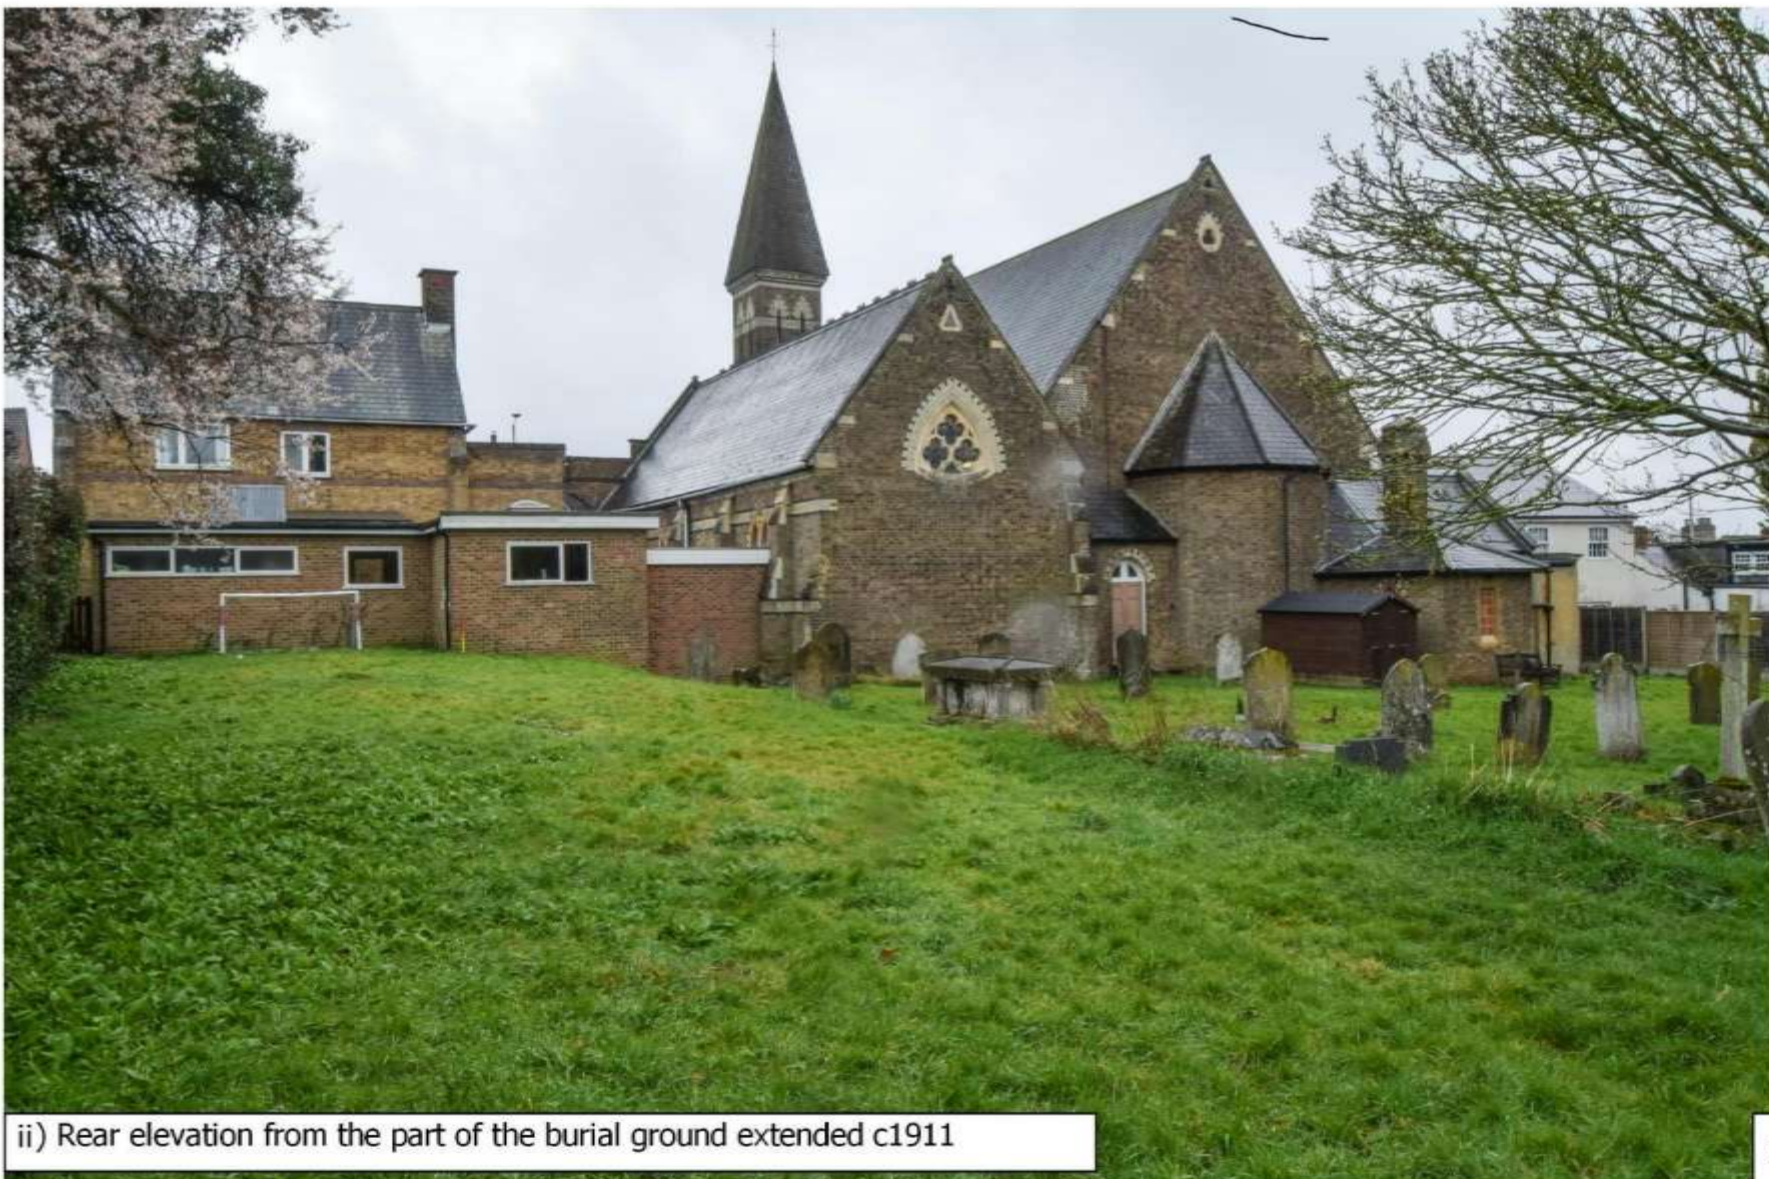
ii) Rear elevation from the part of the burial ground extended c1911

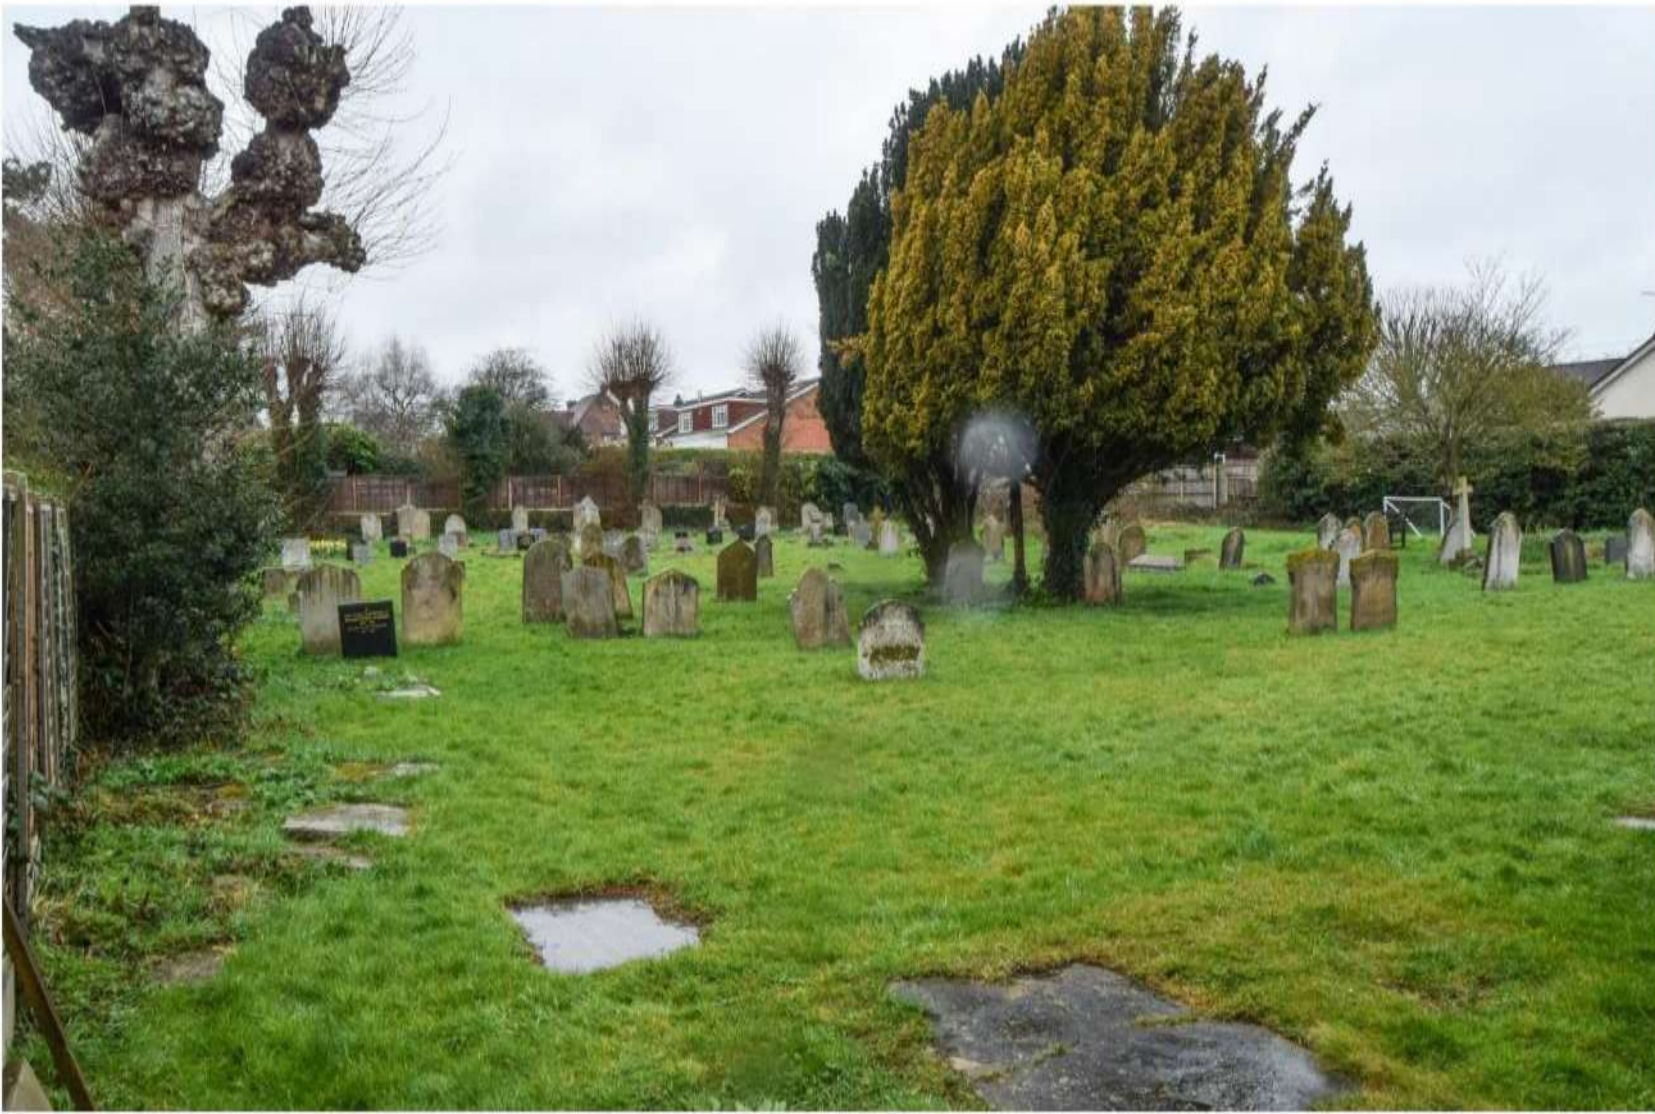
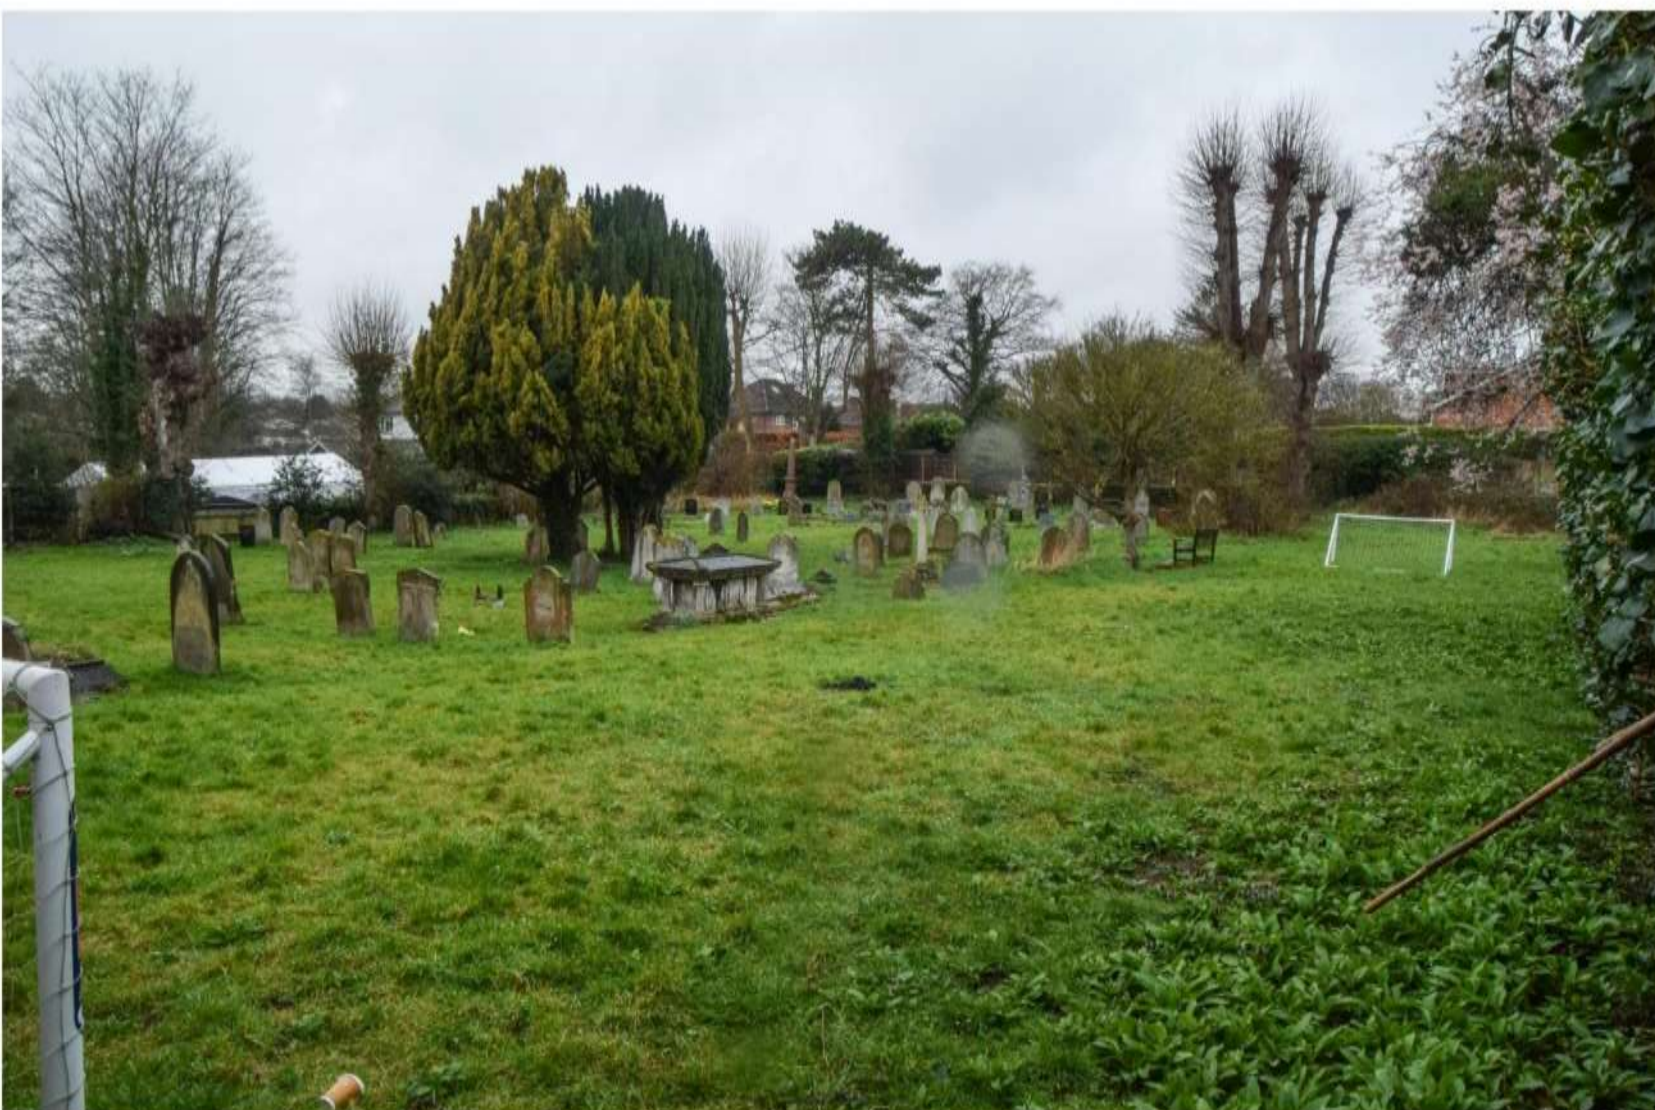
Figure 5
Land to the rear

i) Burial Ground looking northwest

ii) Burial ground, looking southwest

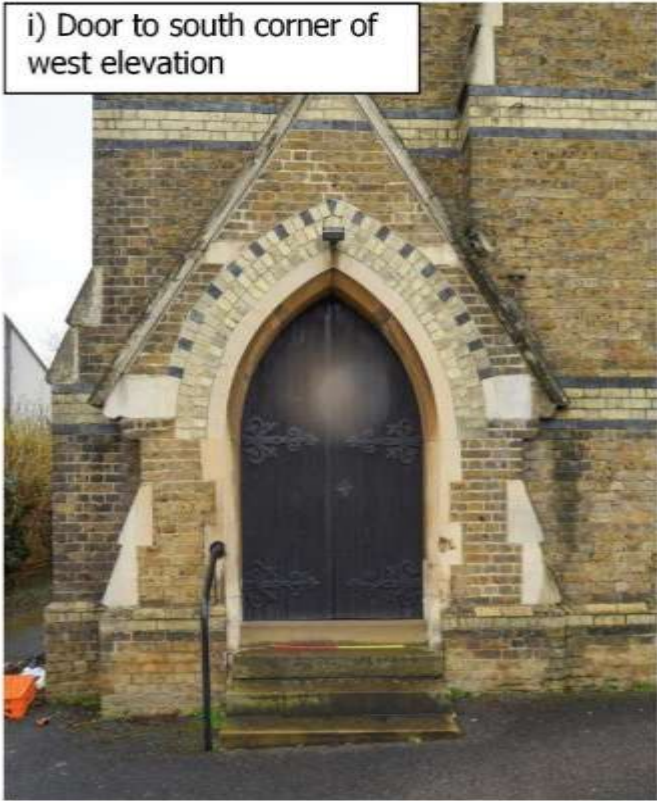
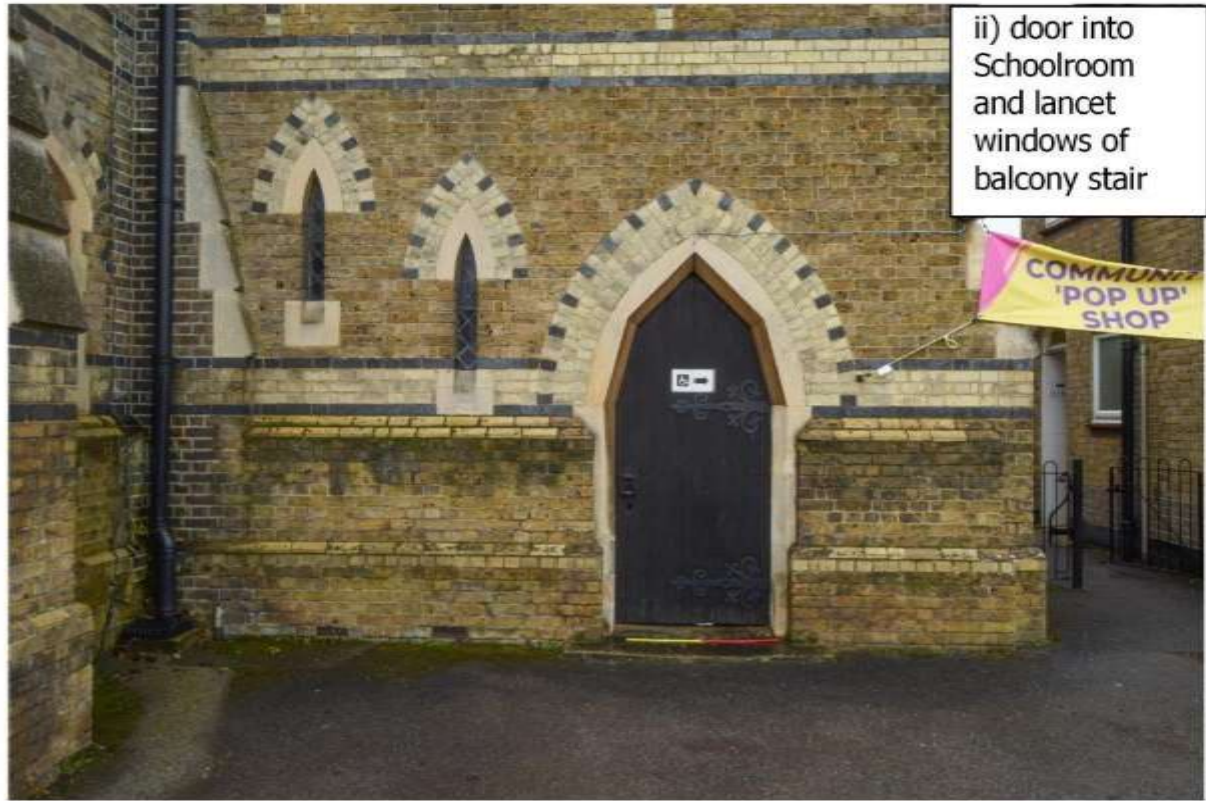
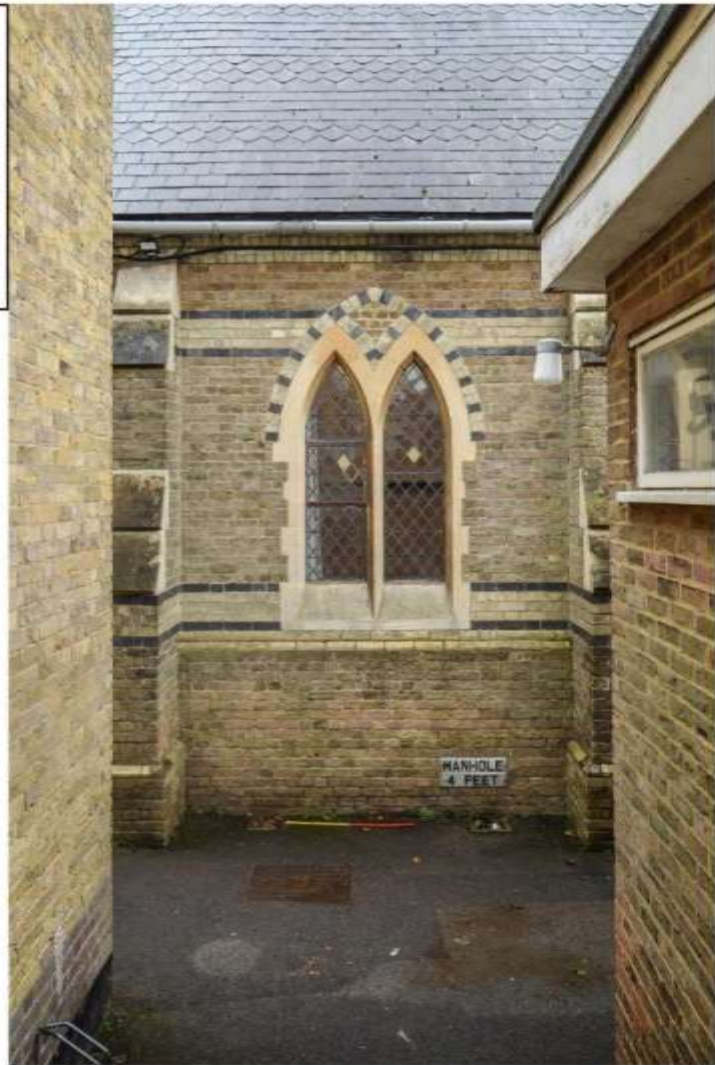
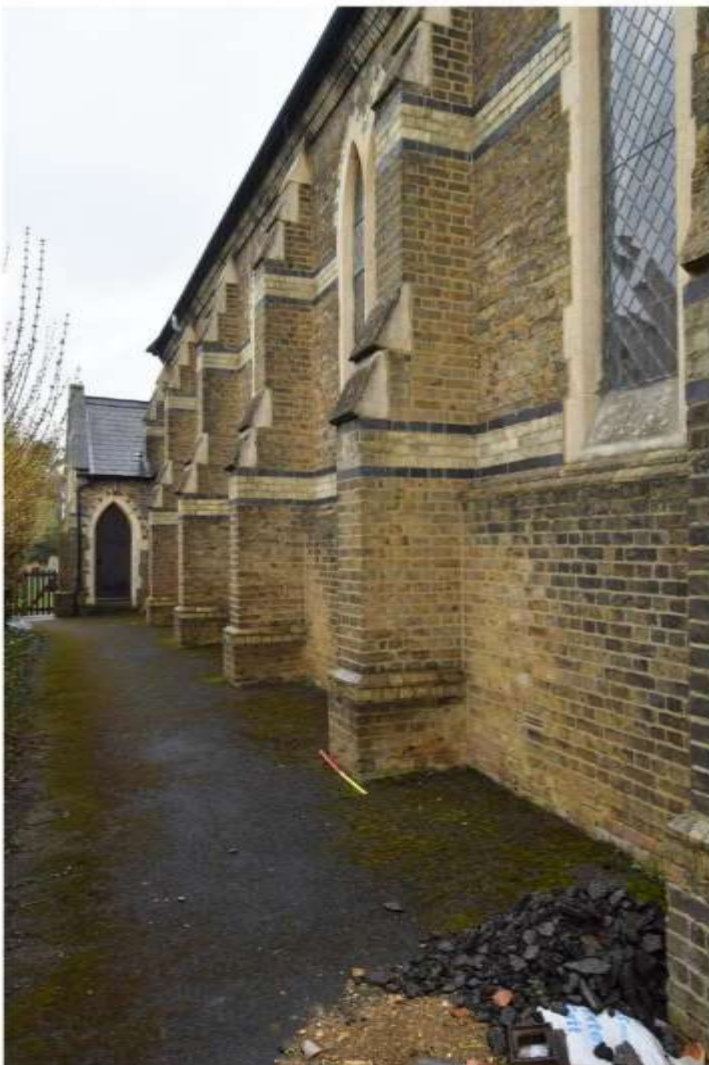
Figure 6
External detailing
1863 building

ii) door into Schoolroom and lancet windows of balcony stair

iii) typical paired lancet of south elevation

iv) smaller paired lancet of north elevation (schoolroom). note slating detail on roof

v) buttress details on south elevation

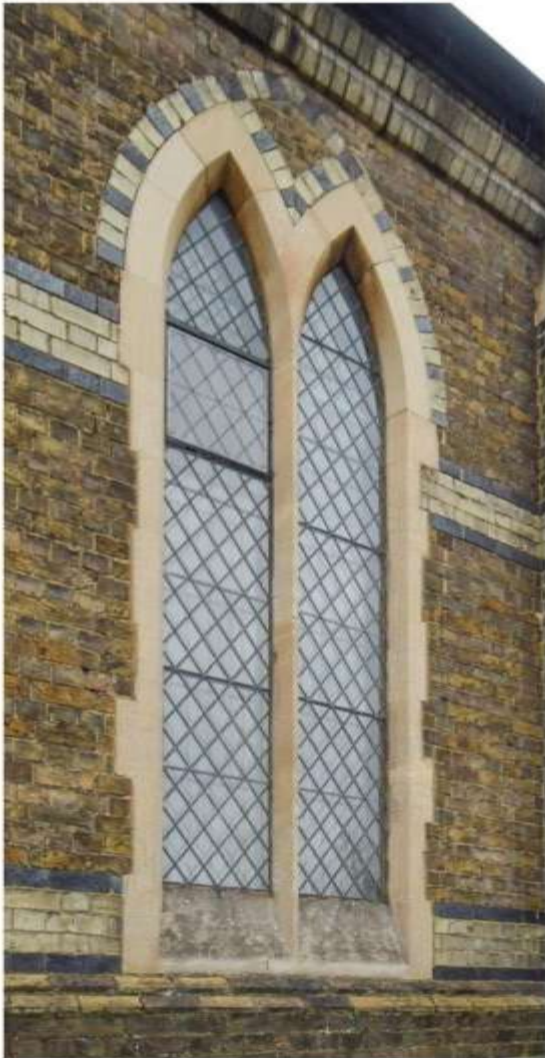
- 5.10 The windows of the chapel are notably plain, with no stained glass, reflecting the general lack of figurative idols anywhere in the building - very much appropriate to the Puritan roots of Congregationalism

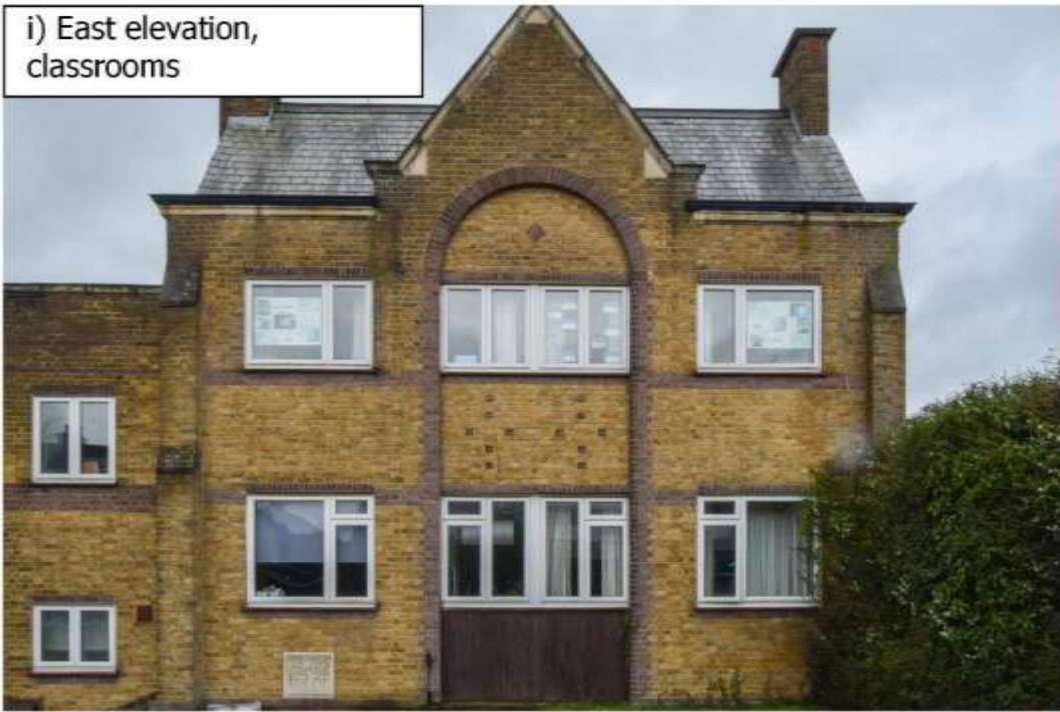
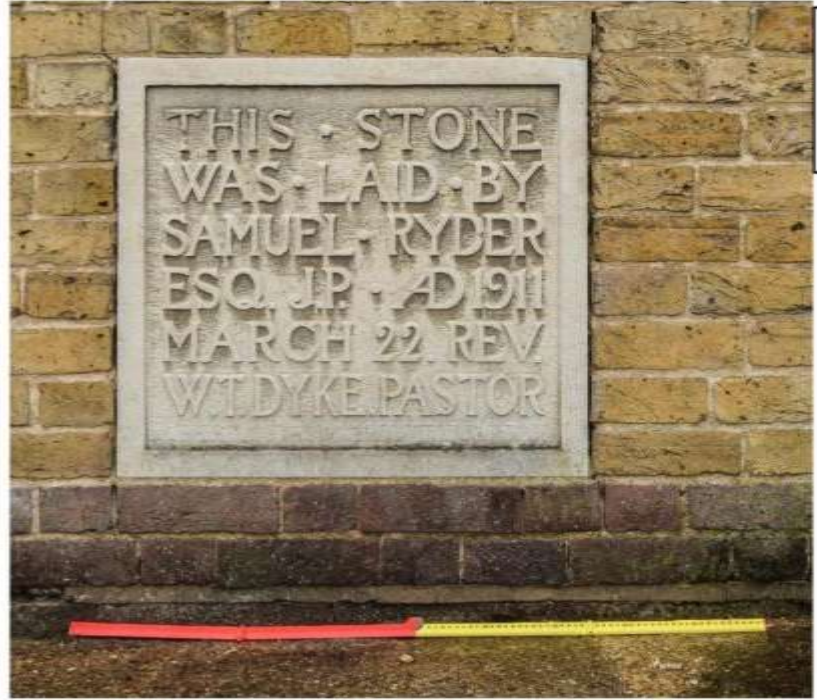
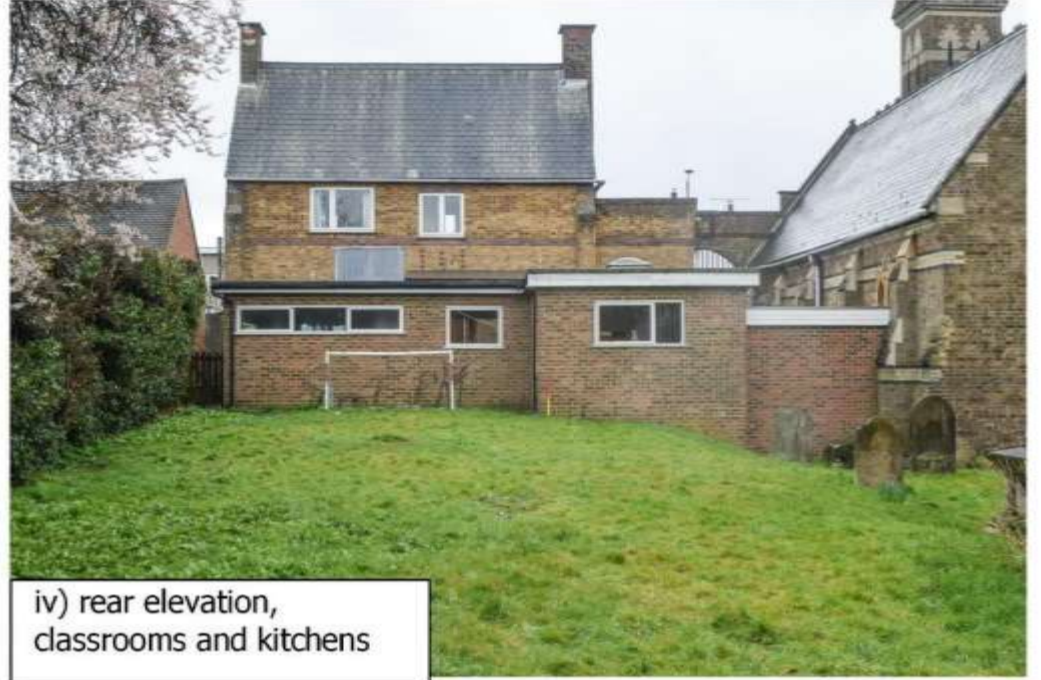
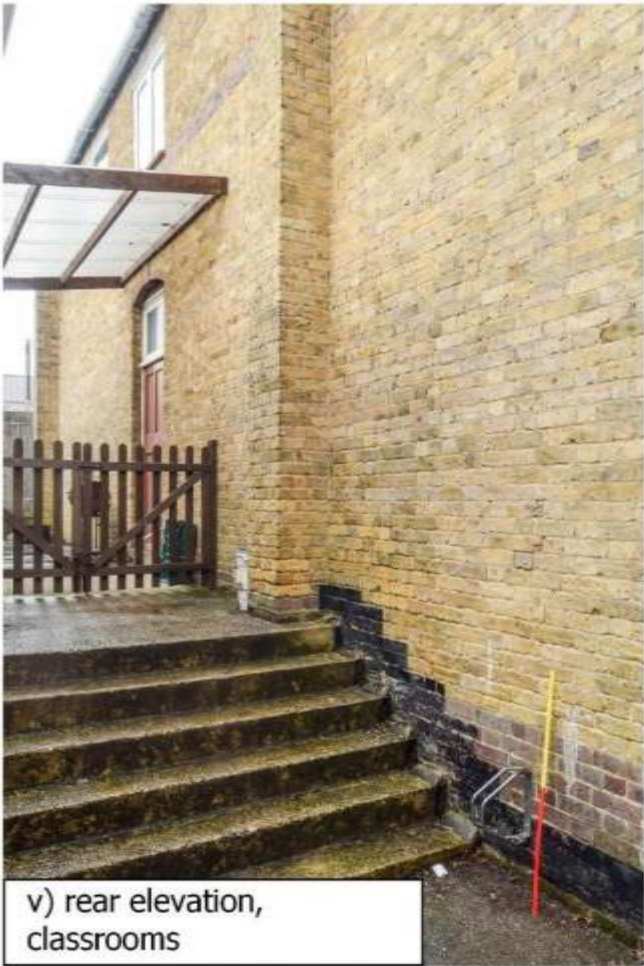
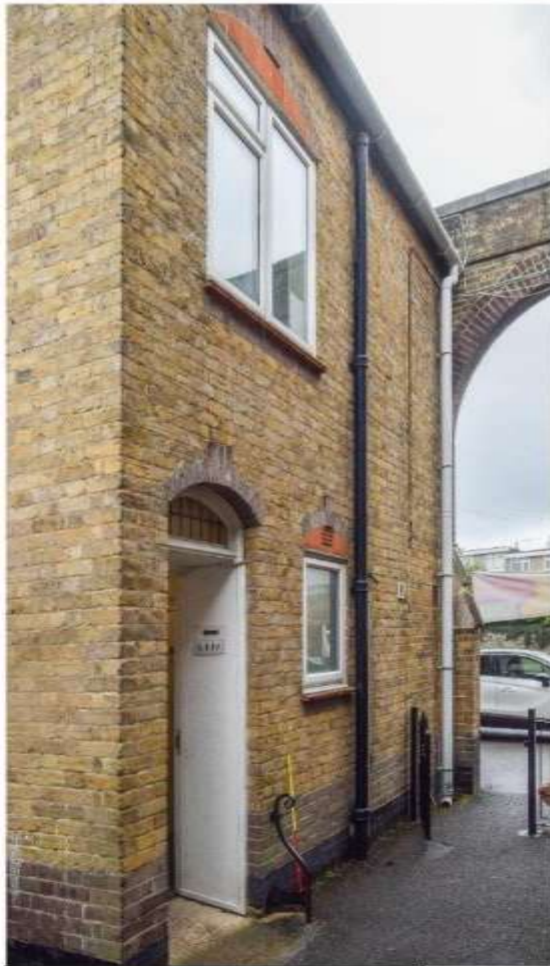
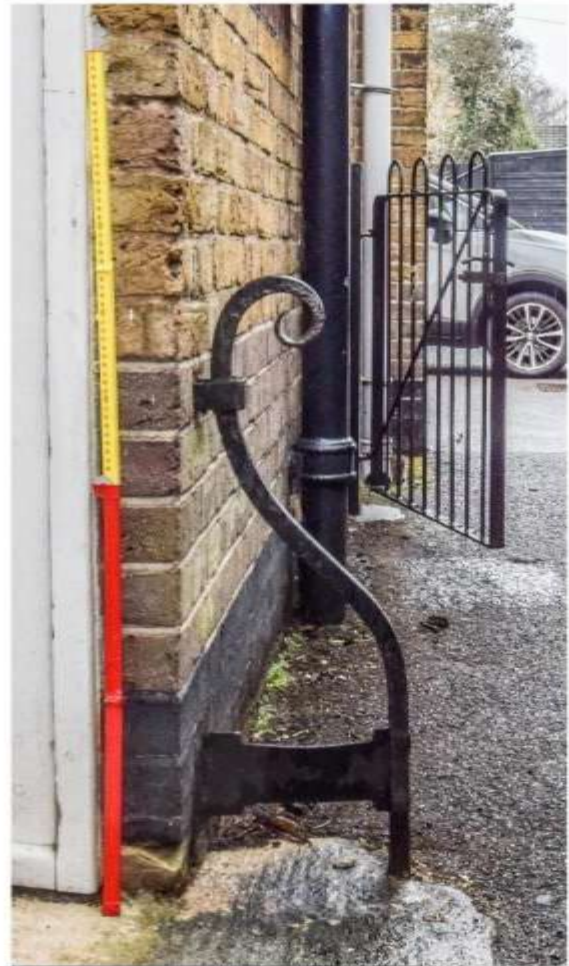
Figure 7
Classrooms
External

i) East elevation, classrooms

ii) detail, east elevation, foundation stone

iv) rear elevation, classrooms and kitchens

v) rear elevation, classrooms

vi) south elevation, door into classrooms

vii) wrought iron boot scraper, classrooms

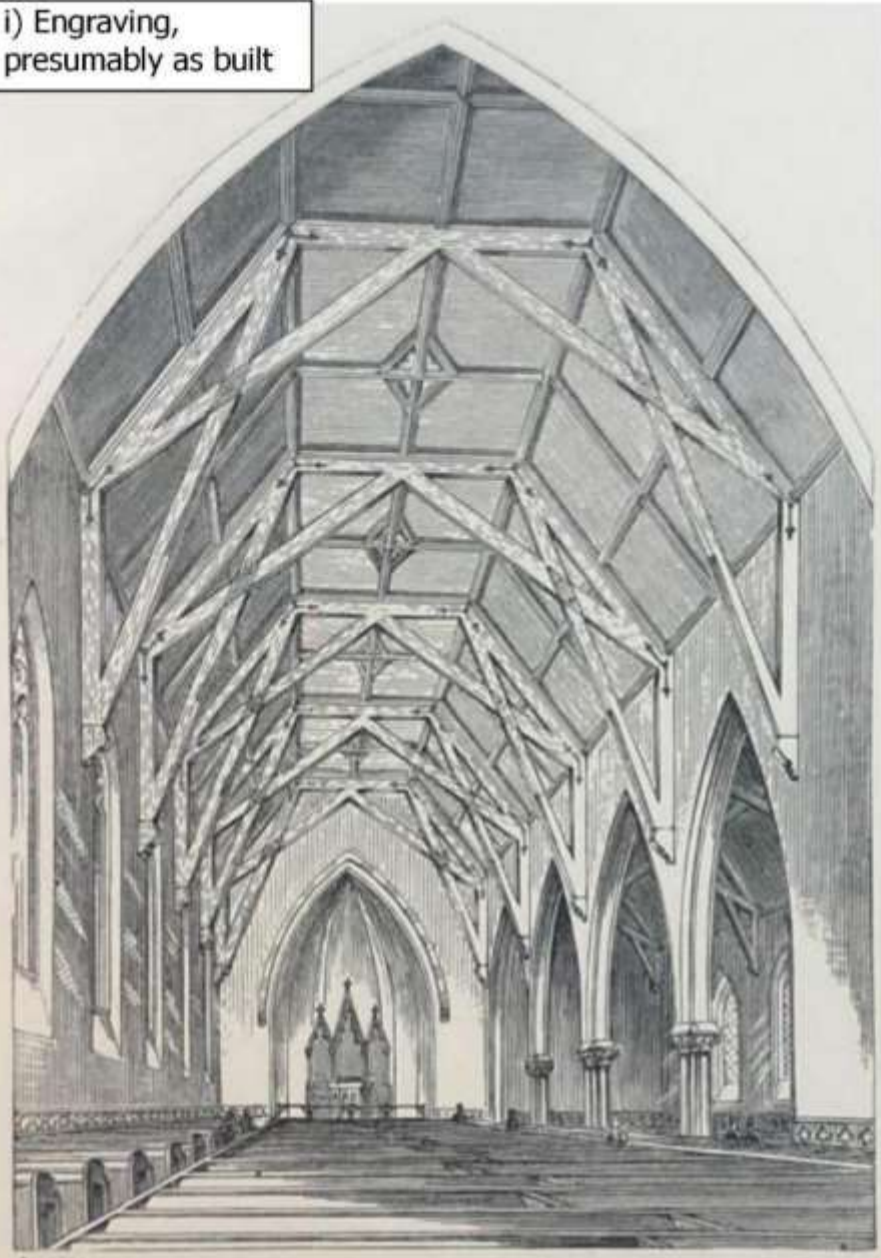
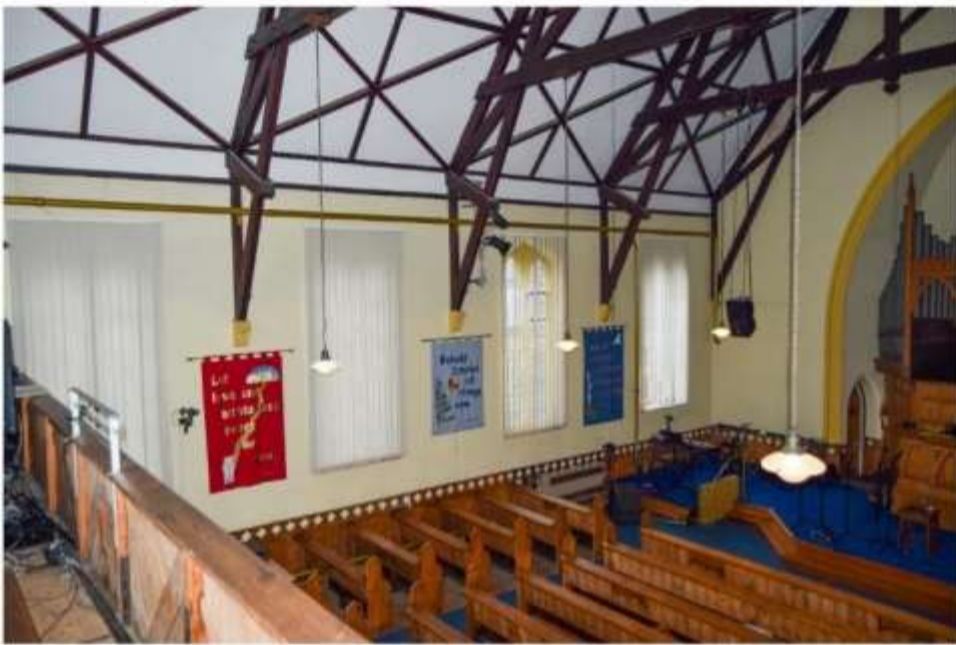
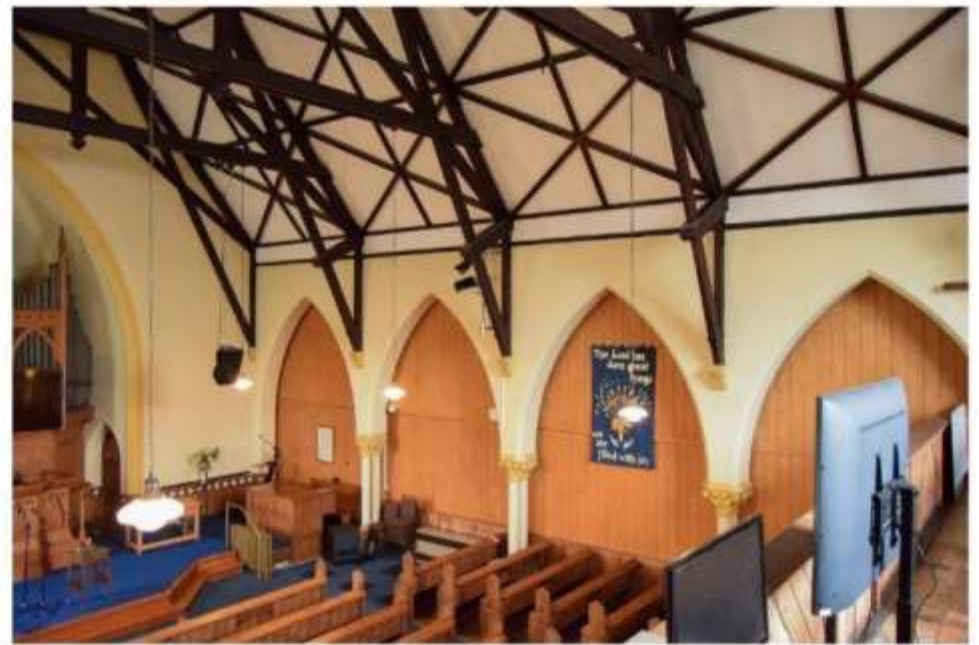
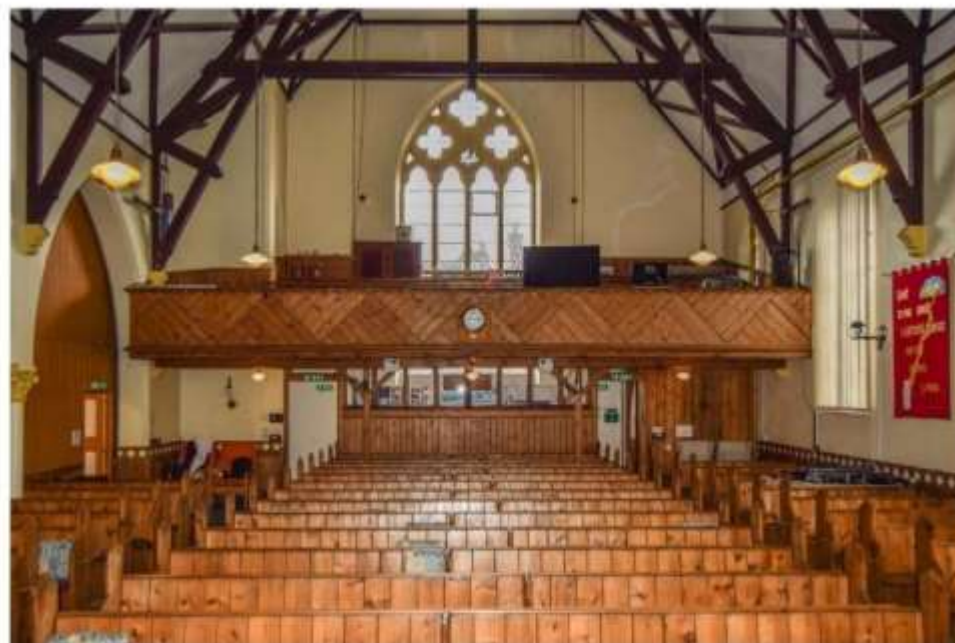
Figure 8
Chapel space
Internal

i) Engraving, presumably as built

iii) Looking southwest

iv) Looking northwest

v) Looking east towards balcony

- 5.8 The historic access into the **chapel interior (figure 8)** is via a pair of doors in the east end which enter into a much modernized vestibule beneath the balcony.

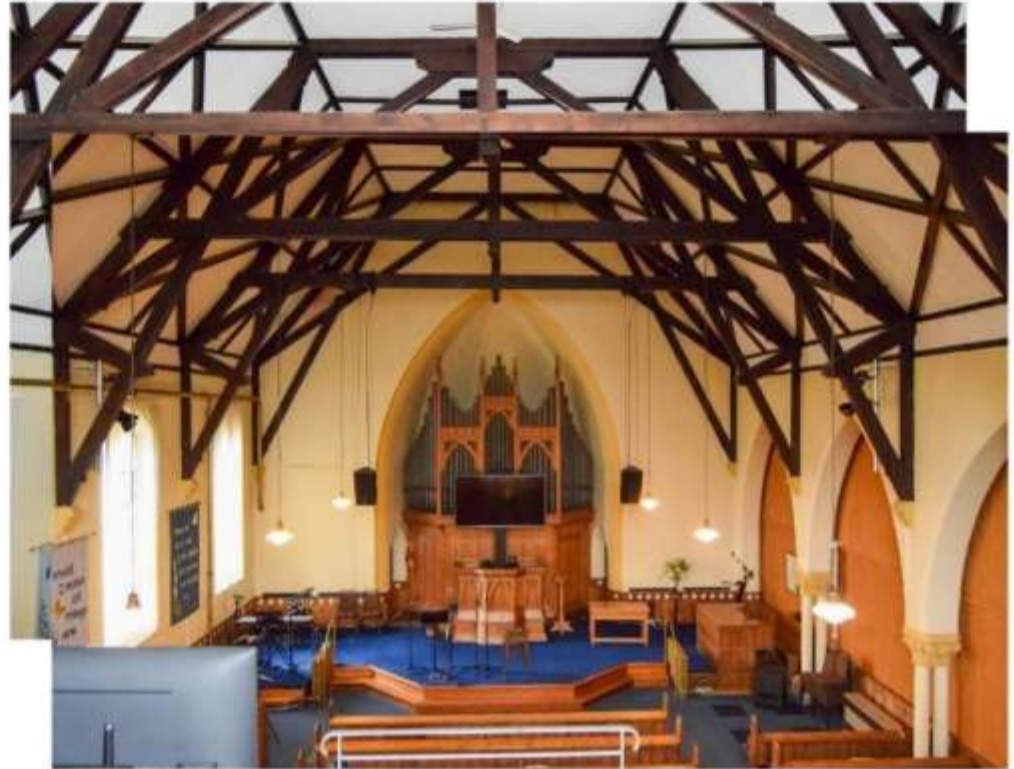
ii) Looking west - note insertion of screens much reducing natural light and strengthening of roof structure with the insertion of double collars bolted to either side of original timbers

- i) the introduction of a later sliding screen which has reduced the aural, visual and physical connection between the schoolroom and chapel as well as the penetration of natural light.
- ii) the introduction of a slightly raised stage at the western end of the chapel and the introduction of a baptistry beneath (proposed for replacement in the current proposals due to the leaking of the current unit.
- iii) the development of buildings in 1911 and c1963 which have harmed the integrity (completeness) and visibility of the north elevation
- iv) minor changes to the vestibule area of the chapel
- v) the replacement of the organ in 1905 and subsequent moving of the console more recently.
- vi) the redundancy in current service practice as agreed by the congregation of the pulpit, probably of early 20th century date
