Sawbridgeworth Evangelical Congregational Church, London Rd, Sawbridgeworth, CM21 9EH

Statement of Heritage Significance and Heritage Impact Assessment

SH Ref SECC0323_HIAv1.1 (revised and updated 2024)

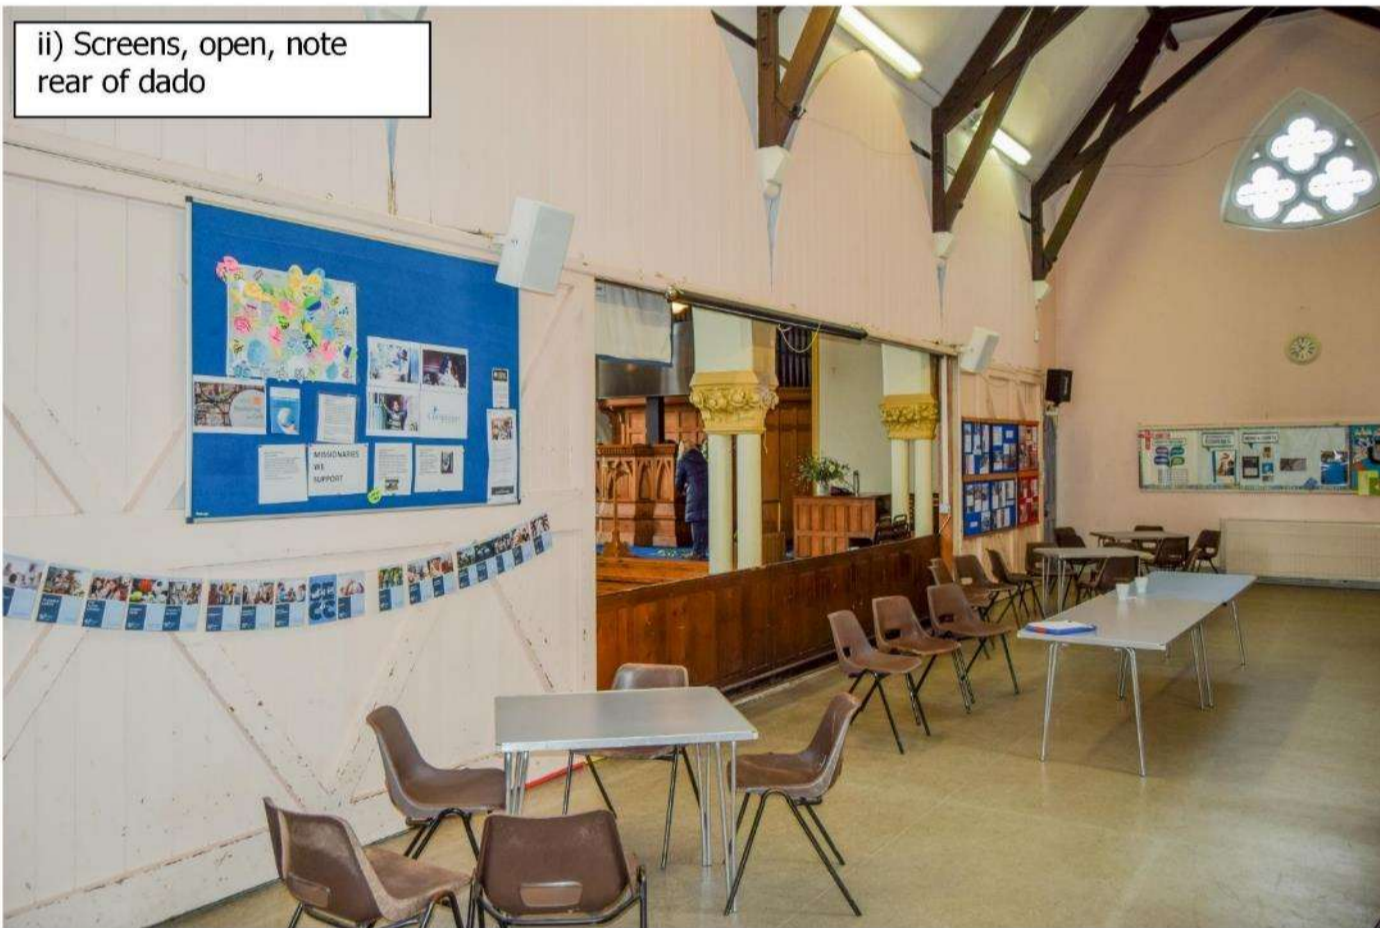
Figure 9
Screen

i) Screens, from Schoolroom

ii) Screens, open, note rear of dado

- i) the introduction of a later sliding screen which has reduced the aural, visual and physical connection between the schoolroom and chapel as well as the penetration of natural light.
- ii) the introduction of a slightly raised stage at the western end of the chapel and the introduction of a baptistry beneath (proposed for replacement in the current proposals due to the leaking of the current unit.
- iii) the development of buildings in 1911 and c1963 which have harmed the integrity (completeness) and visibility of the north elevation
- iv) minor changes to the vestibule area of the chapel
- v) the replacement of the organ in 1905 and subsequent moving of the console more recently.
- vi) the redundancy in current service practice as agreed by the congregation of the pulpit, probably of early 20th century date

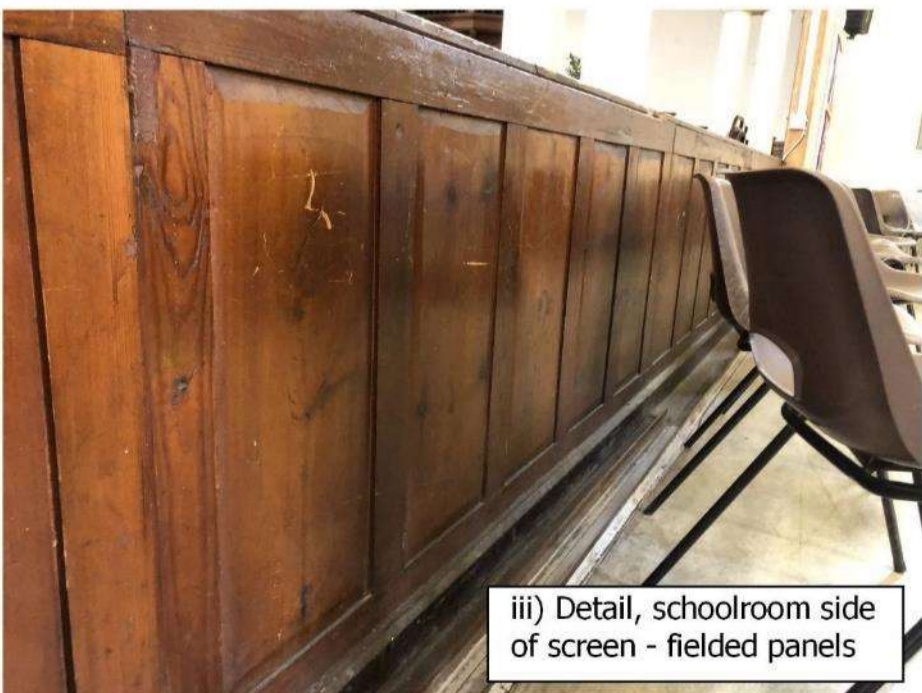
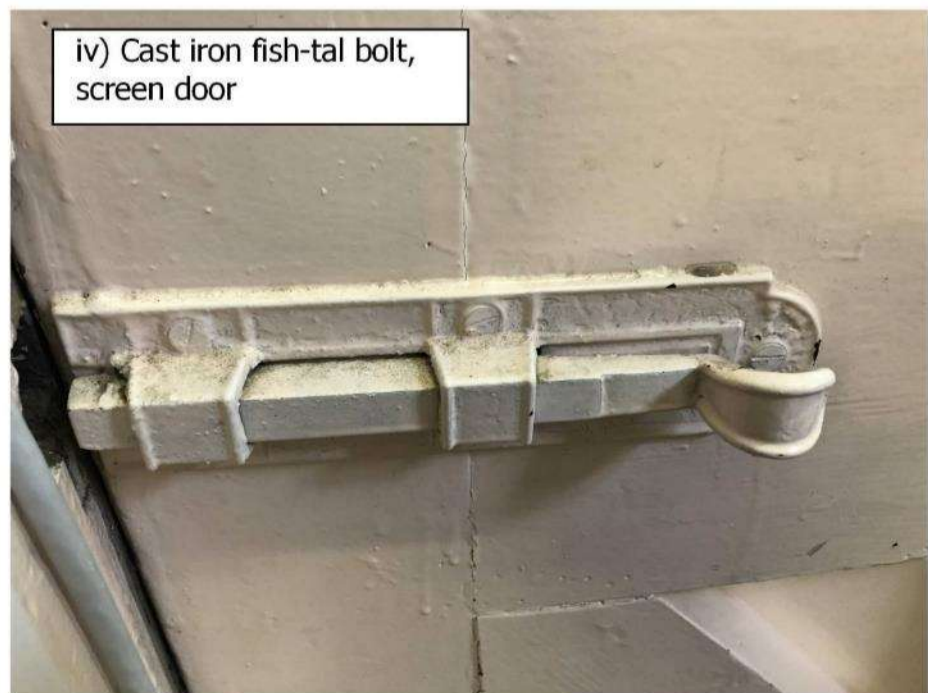
iii) Detail, schoolroom side of screen - fielded panels

iv) Cast iron fish-tal bolt, screen door

- 5.11 Contrary to the list description the **arcade screen (figure 9)** is not considered to be an original feature. It is not shown on the 19C engraving, its roller track is set into the 20th century concrete floor of the schoolroom, and it includes an early 20th century *moderne* styled fishtail bolt, in contrast to the gothic fittings on the Victorian doors. From within the worship space the screens appear heavily behind the more graceful, paired iron columns of the arcade with their foliated capitals.

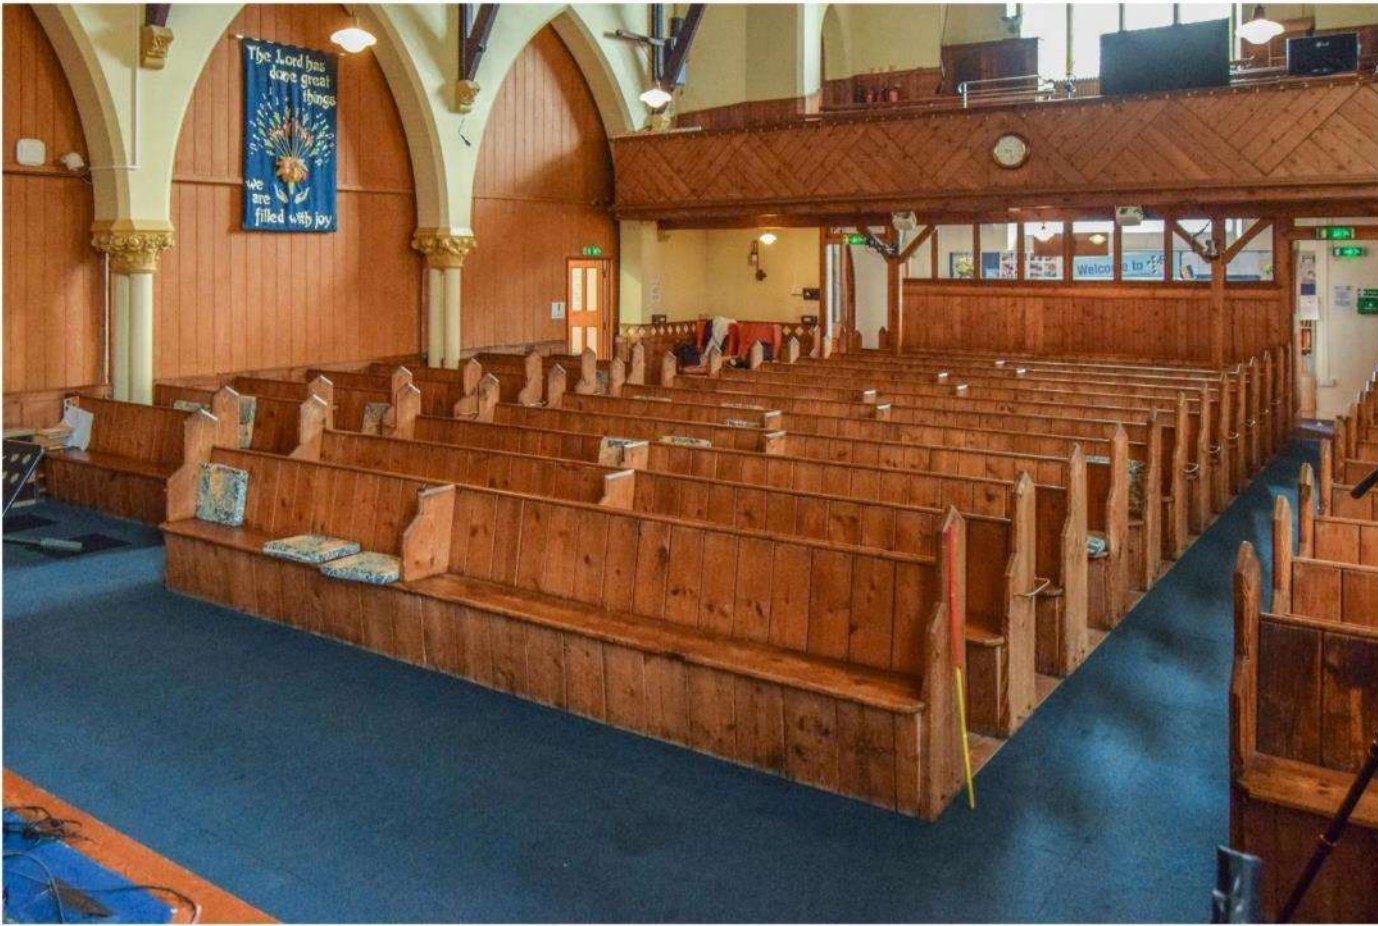
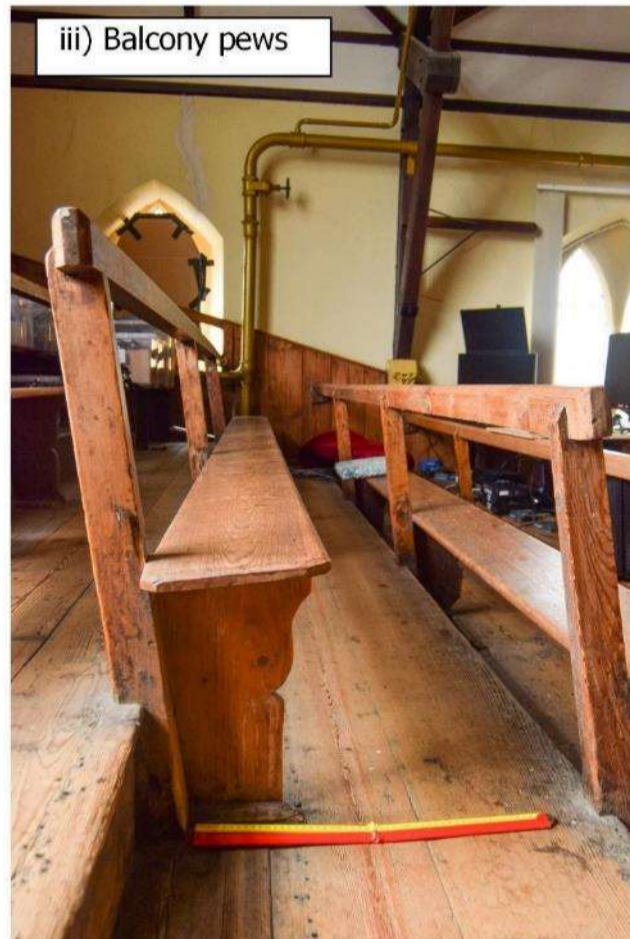
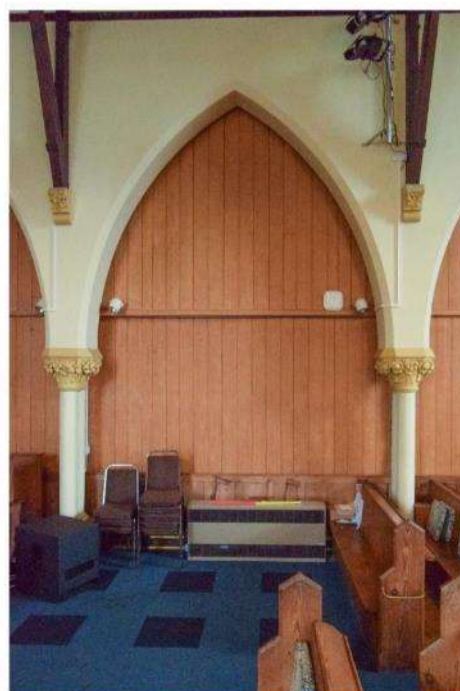
Figure 10
Pews

i) Pews, general

iii) Balcony pews

v) removed pews, north rank, stage end

- 5.12 The ground floor retains much of its **pews (figure 10)**, which are standard pine designs many still fitted with umbrella stands. They are unremarkable and commonplace, although those in the balcony are more unusual, simple rather more vernacular benches. Some have been removed from the northern rank, their outline exposed in scars into an older low screen of fielded panels – interpreted by the List description as reused pews. This seems reasonable and is also a potential origin for the dado panels which survive all around the external walls of the chapel, which are of a different darker wood to the main pews. Congregationalist egalitarianism is perhaps illustrated by the lack of any pew rent numbering (or evidence for its removal).

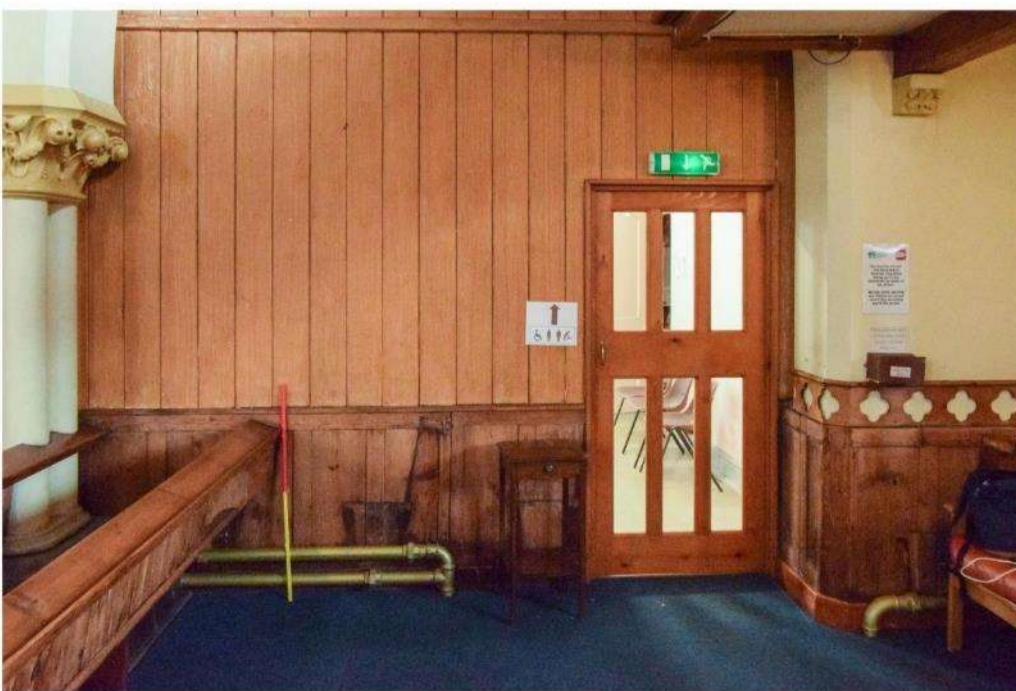
iv) removed pews, north rank, near rear, note scars in dado

- 8.13 Replacement of existing baptismal pool.** The current pool is not original to the building and is not considered of heritage interest.
- 8.14 Removal of most pews from Sanctuary and Hall (former Schoolroom).** Balcony pews to be retained *in situ*. The pews are considered original features of the building and so their loss will constitute moderate less than substantial harm to the architectural values of the interior. Through negotiation with the LPA it has been agreed that representative examples will be fixed to the Sanctuary side of the vestibule panelling. Archive standard photography of the interior in its current form is held by Statement Heritage and suitable for deposit as part of a more detailed archival record if deemed proportionate by the LPA. The more interesting pews of the balcony are to be retained *in situ*.

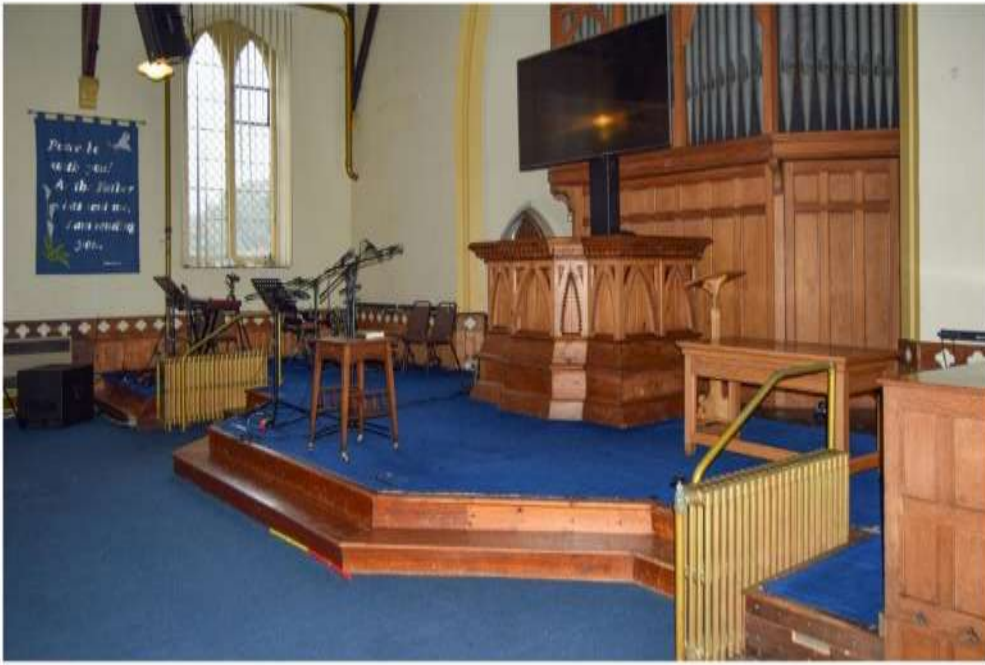
Figure 11
Stage

i) stage, built up around dado and earlier radiators, pulpit is no longer used for preaching now housing AV equipment

8.11 Existing staging and pulpit to be removed and replaced with demountable and movable staging.

Impact: The current stage / dias, is a non-original element of the interior and not assessed to be of special interest. Its loss is assessed here as resulting in negligible less than substantial harm, which may be weighed against the wider benefits of the scheme as a whole. Records of pre-application discussions with the LPA indicate that they have supported this aspect of the scheme, which would be replaced by movable staging, but have requested consideration of the relocation of the pulpit elsewhere in the scheme. It is not considered that additional archival recording of these works would meaningfully advance understanding of the listed building's heritage values.

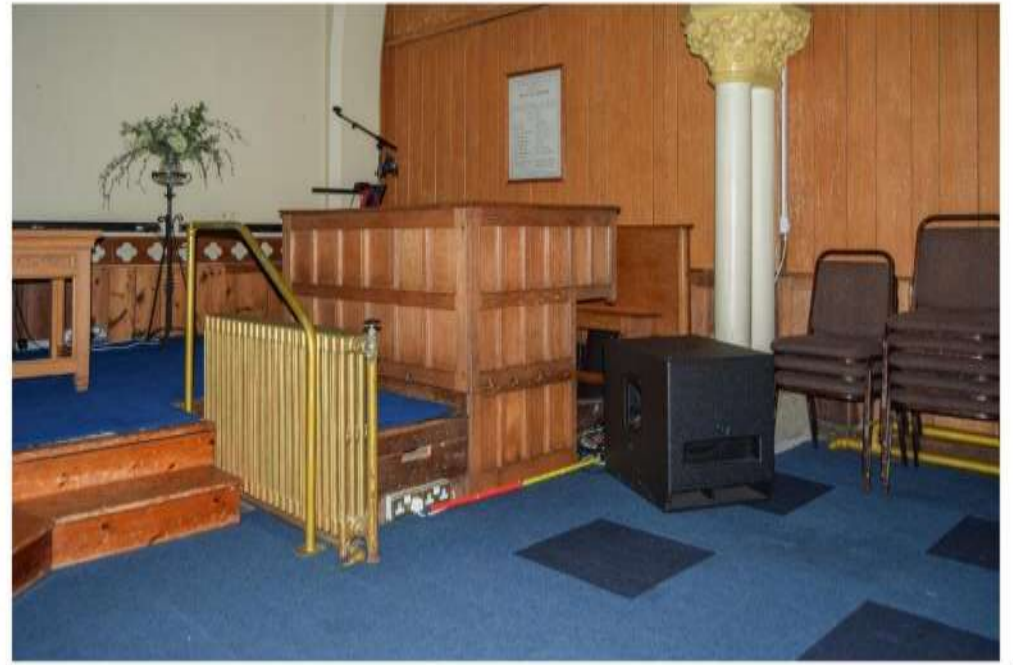
ii) 1905 organ console

The instrument has since been further assessed by *Harrison and Harrison*⁶. Their report indicates that the instrument is a good example of a small organ by *Norman & Beard* but is in poor, unplayable condition, requiring comprehensive restoration to make it playable. They have advised this work would be prohibitively costly due to the complexity of the original pneumatic mechanism and of the intricate work that would be involved in re-siting the console, currently linked by lead piping beneath the dias.

The organ has not been used in church worship for over 10 years and would not be used if in serviceable condition.

- 3.10 van de Bilt notes that a new organ, by *Norman and Beard* of Norwich with two manuals and a detached console, was installed in 1905. This instrument is recorded by the National Pipe Organ Register as entry N14148 <https://www.npor.org.uk/survey/N14148> which last received data from the church in 2006 when the instrument was noted as *present and in use* although more recently *van de Bilt* notes that it is *not in use anymore. The costs of repair would be unjustifiably high.*

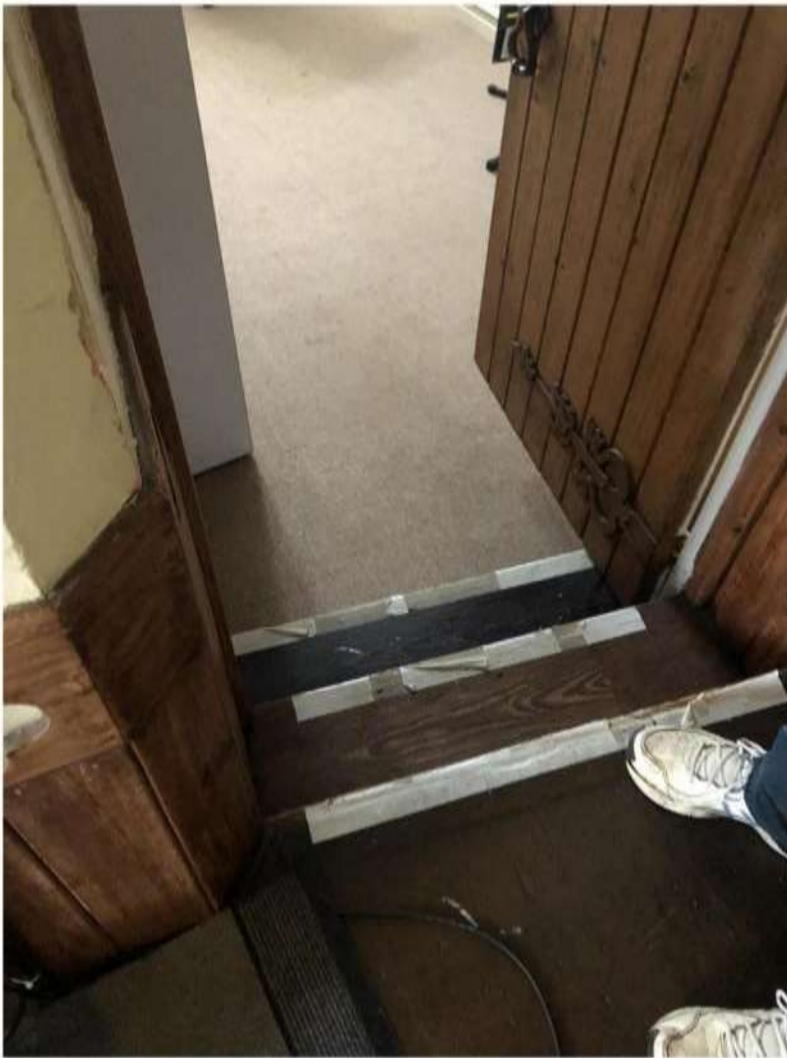
iii) vestry door from stage, showing how the door is set to the original floor height.

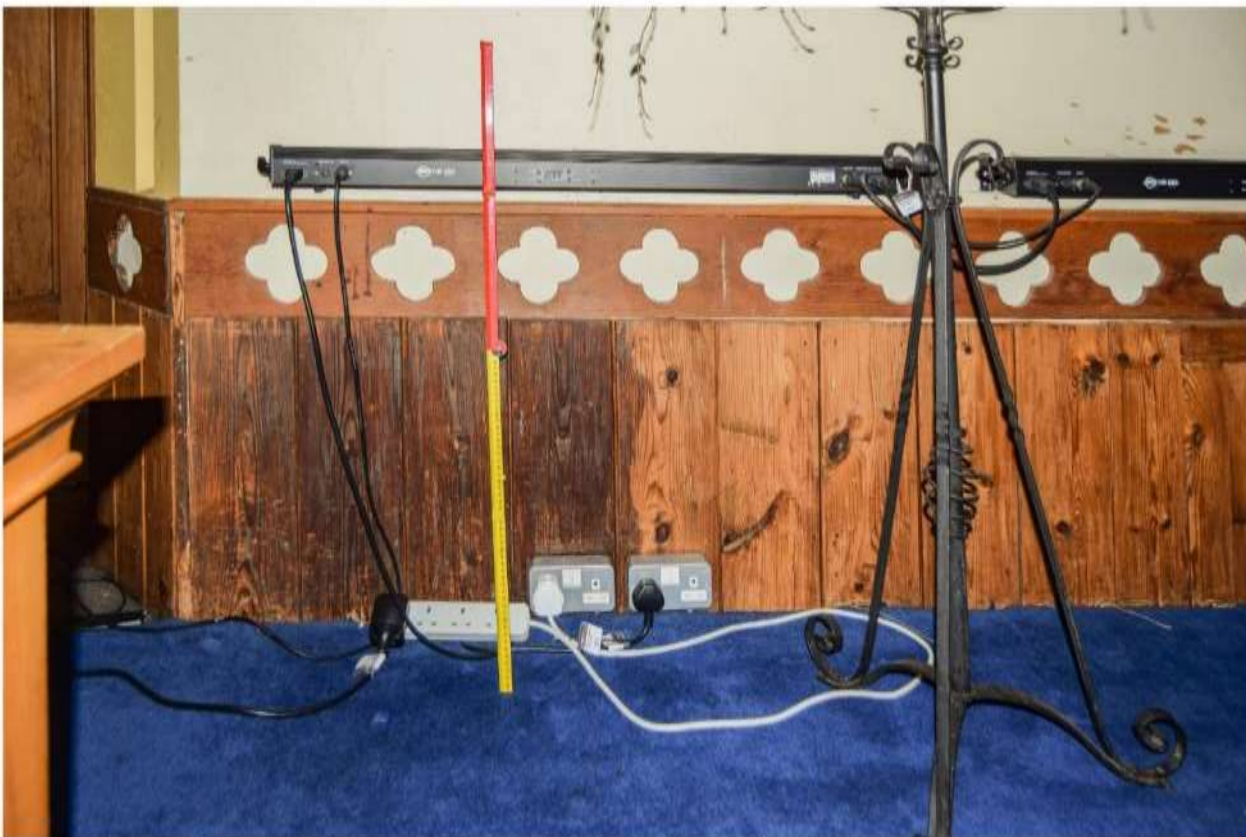
iv) dado, detail

- 5.13 The low **stage (figure 11)** at the west (focal) end of the building appears to be a further insertion. The stage is fitted around 2, probably early 20th century, cast iron radiators (understood from a member of the congregation responsible for fabric matters to have been fitted in the 1930s). The level of the stage half buries the dado at this point, and is also built up above the level of the doors in the rear wall accessing the vestry and a small corridor to the modern *kitchen block*. The stage incorporates the 1930s baptistry but this could not be inspected at the time of my visit because of the presence of musical equipment for the church band which has replaced the use of the 1905 organ. Like the organ the current pulpit is not shown on the Victorian engraving. Today it has been given over to a new role housing audio visual equipment (the church is fully wired for livestreaming) and a large video screen now stands centre stage in front of the organ pipes.

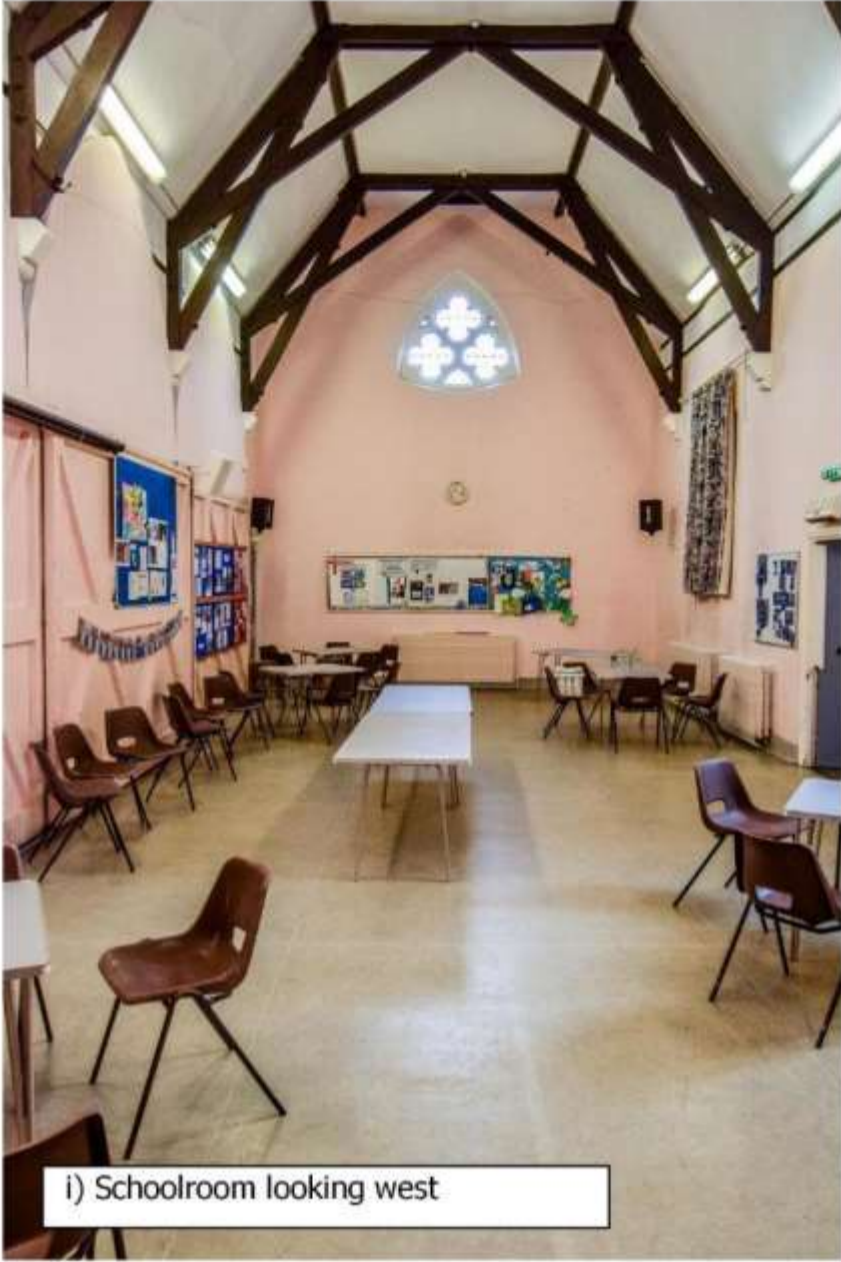
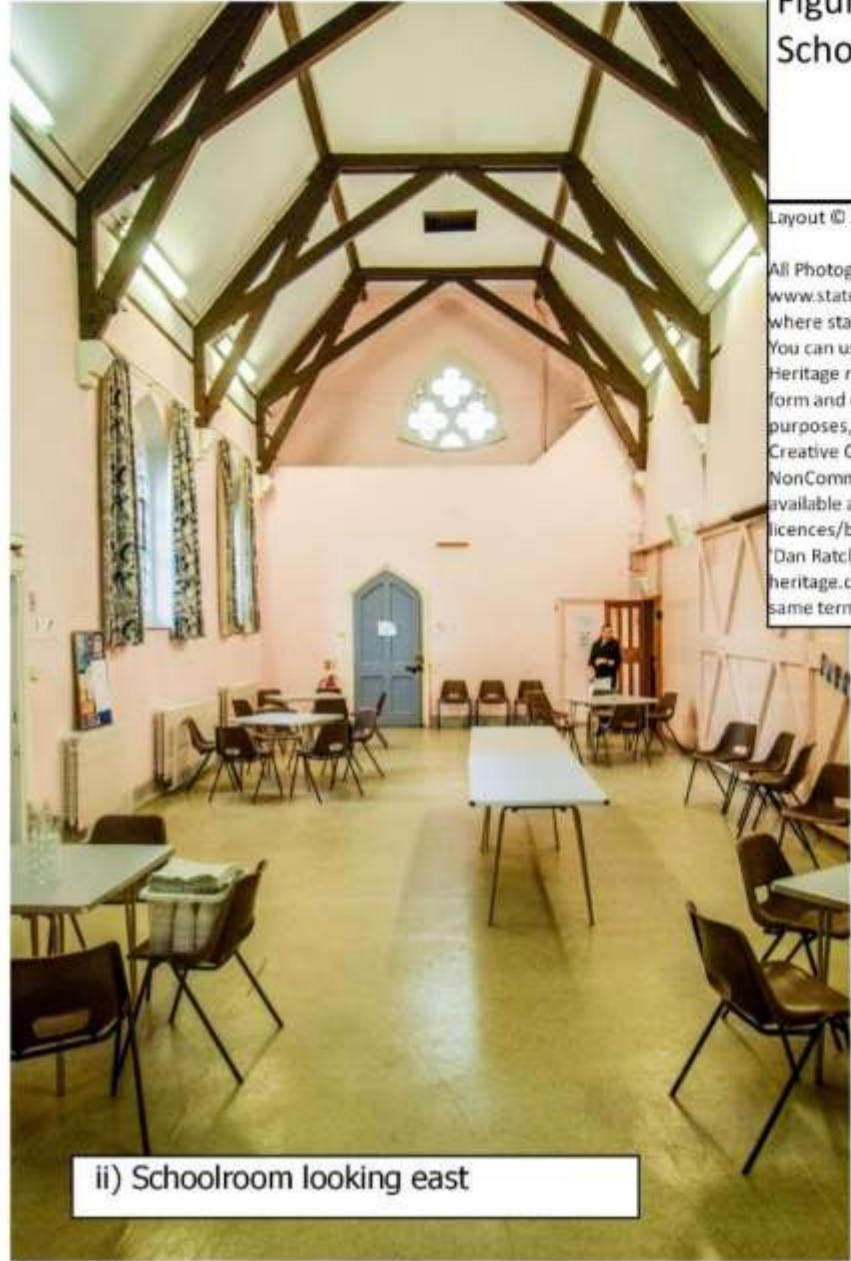
Figure 12
Schoolroom

i) Schoolroom looking west

ii) Schoolroom looking east

- 5.14 The **schoolroom** is shown at **figure 12**. Strengthening of the original roof here has been achieved a little more elegantly than in the chapel, by inserting a ceiling just above the inserted collars. The space has a solid concrete floor and is lit by the high quatrefoil windows to either end, and from paired lancets to north, one of which has been blocked in the 1990s at the time of the construction of the link to the kitchen block against it.

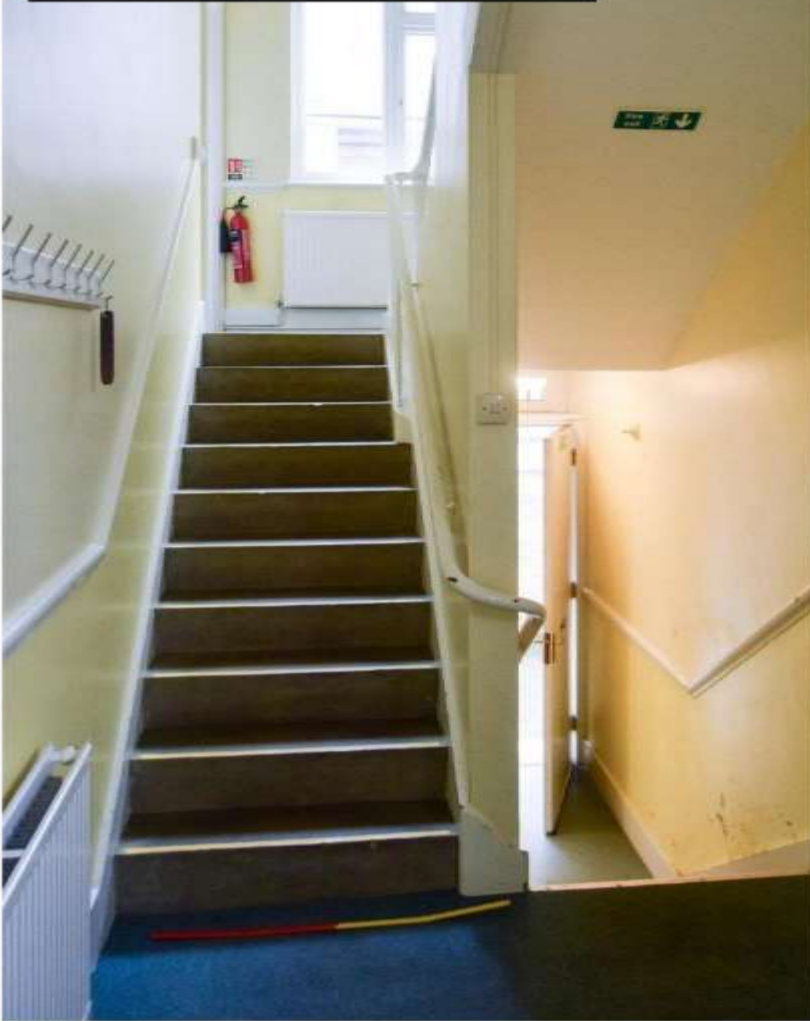
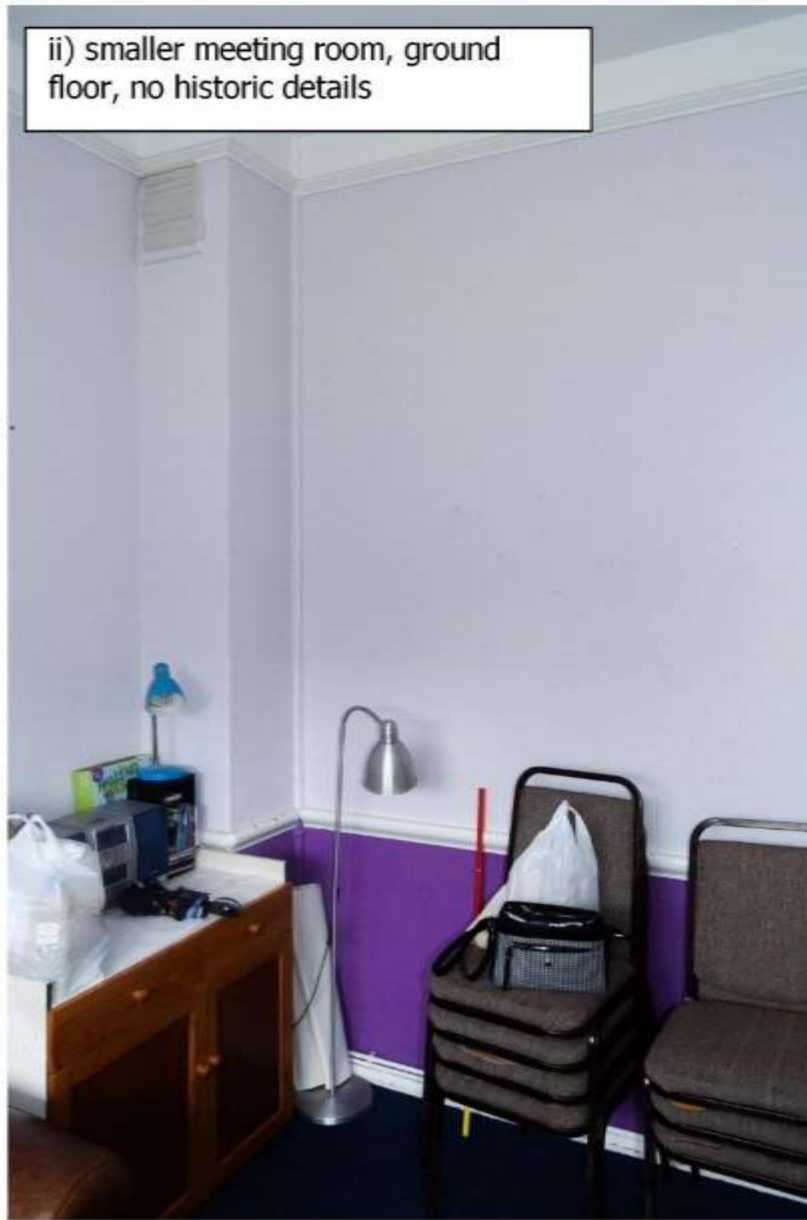
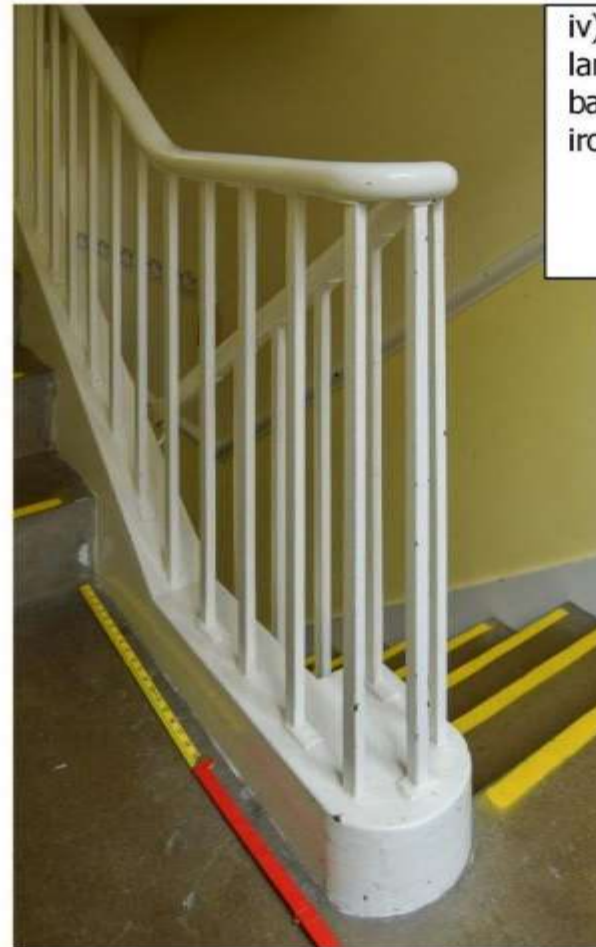
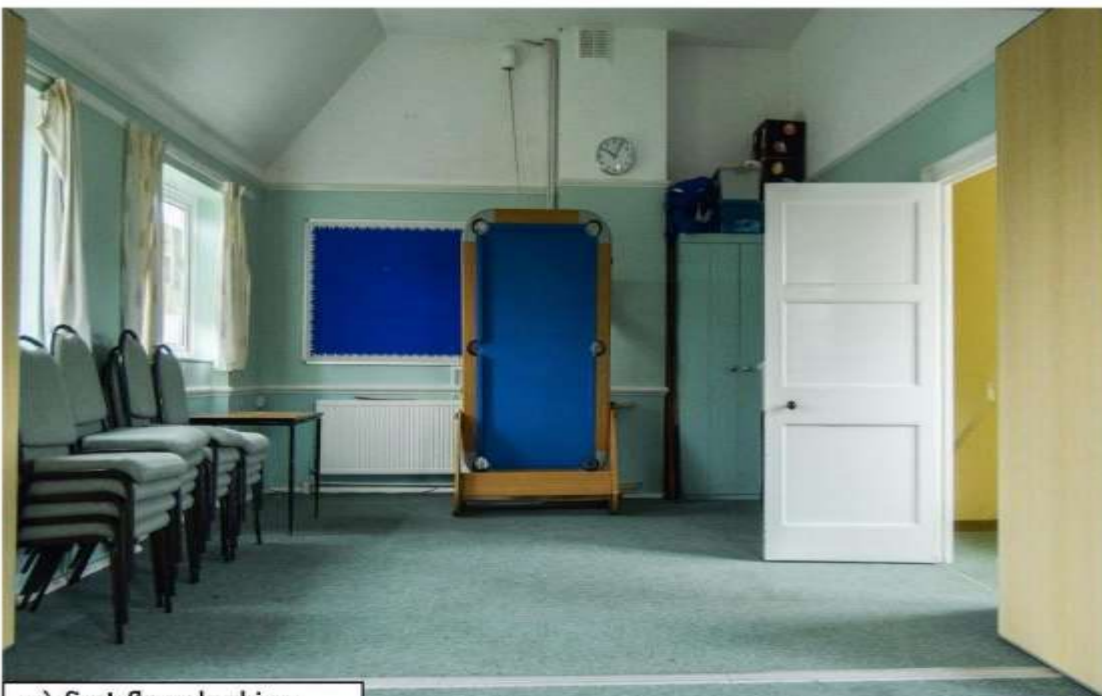
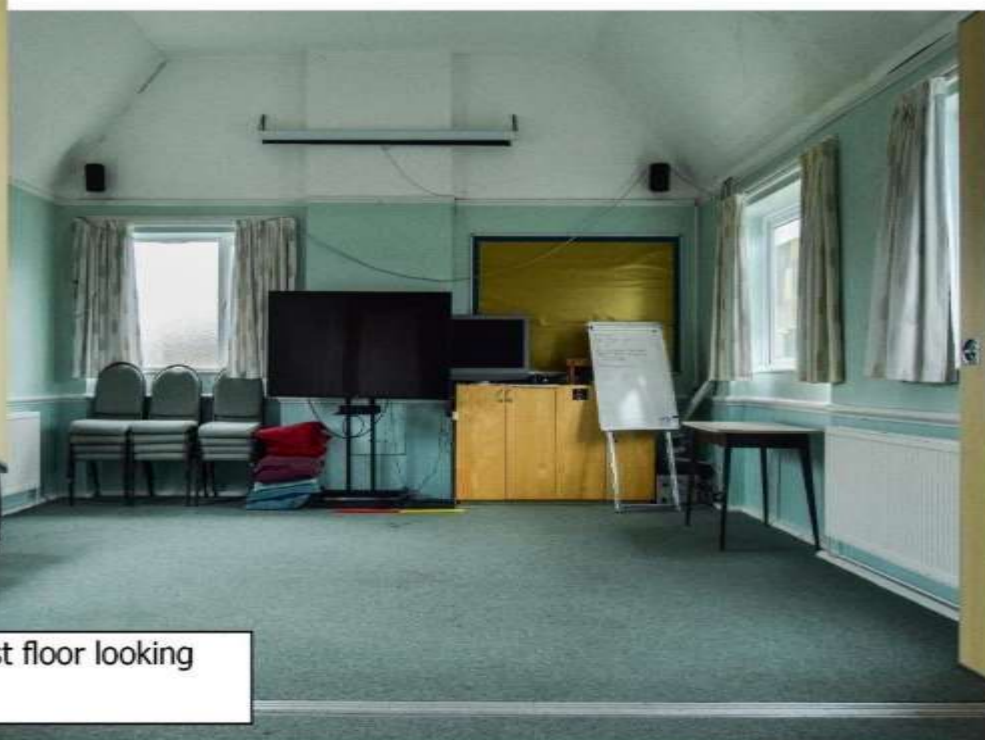
Figure 13
Classrooms

i) the classroom block is accessed (to right) from half a storey below its ground floor rooms via a concrete stair.

ii) smaller meeting room, ground floor, no historic details

iv) stairs, 1.5 storey landing. Concrete base, iron balusters, iron rail

v) first floor looking south

vi) first floor looking north

- 5.15 **The classroom block (figure 13)** interior is still more austere than its exterior. Access to the ground and first floor is via a stair in the flat-roofed section to its south. This stair has concrete treads and steel stick balusters with an iron rail – a traditional 19th century pattern but executed in 20th century materials. Internal spaces have little detail. Ceilings are modern replacements and the only internal fabric to have survived are the buildings original 3 panel early 20th century timber doors.
