Bat Survey Report

Ragstone

16th August 2023

Project No: P5339

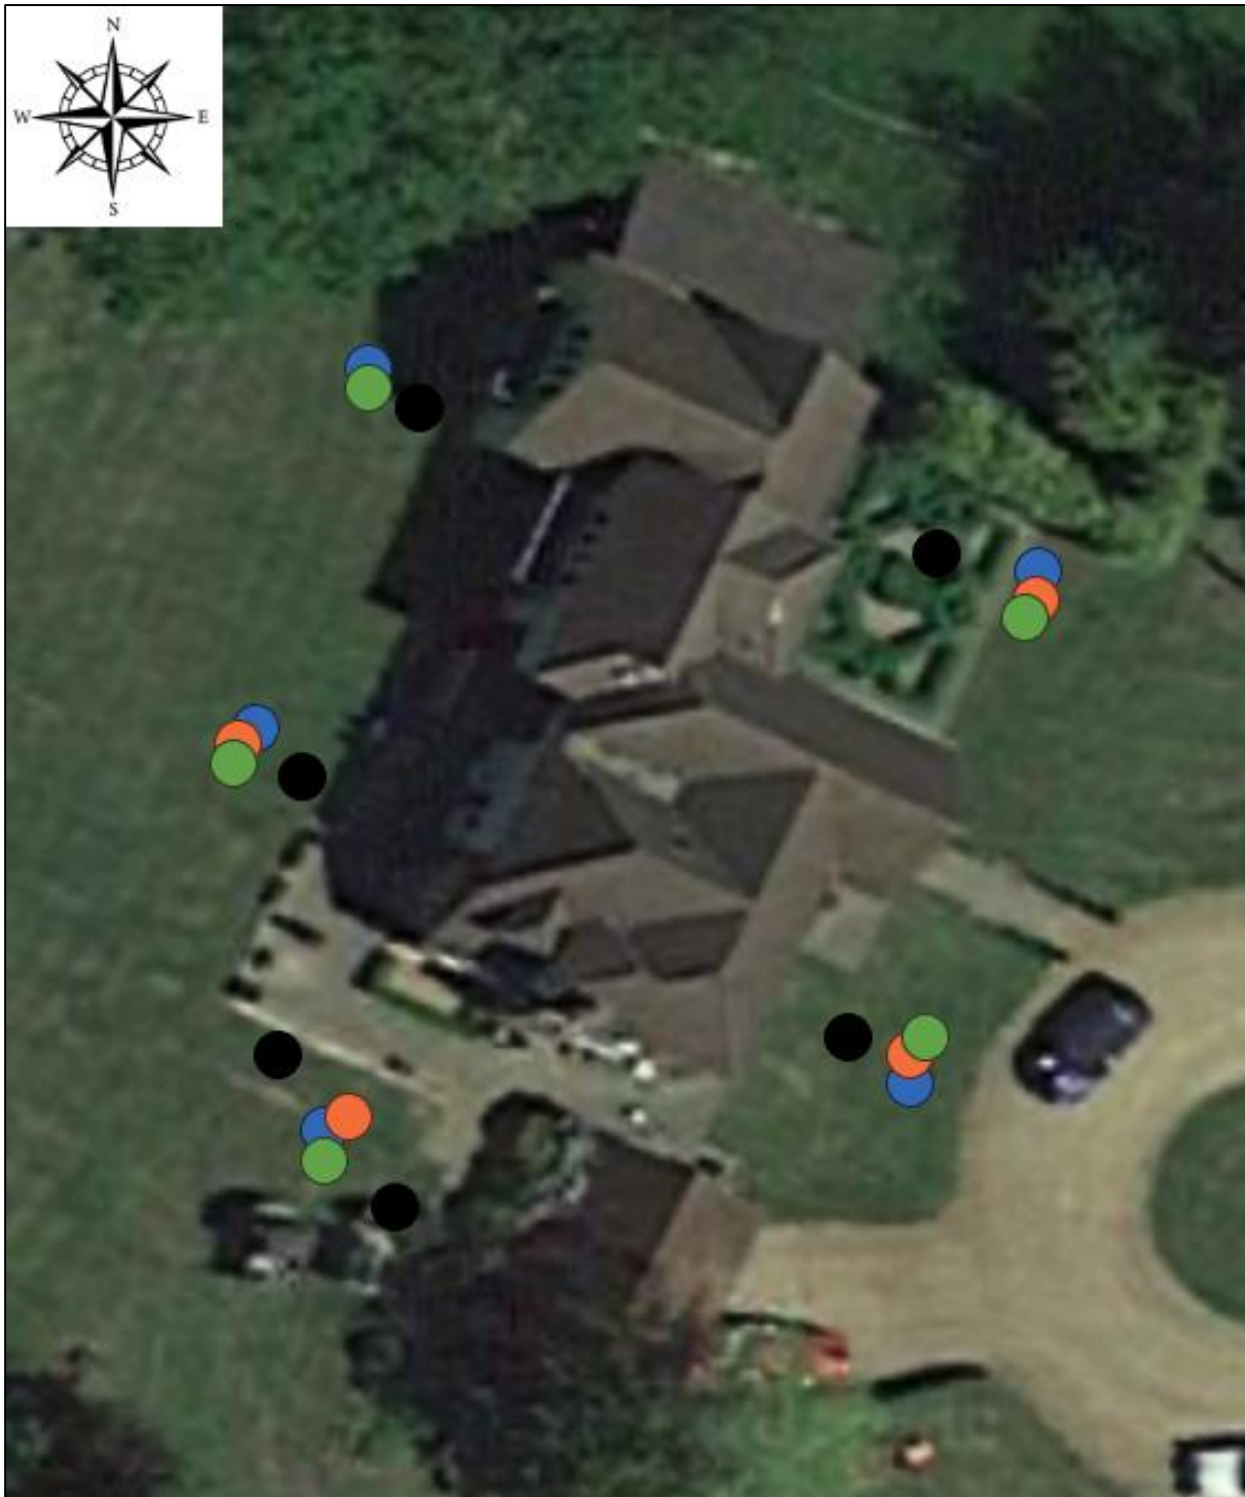
Figure 1. An aerial image of the site, showing the positions of surveyors for 9th May (blue dots), 30th May (orange dots), and 6th July (green dots). Night-vision cameras positioning also shown, two cameras with per survey with positioning changing between give points shown (black dots). Images produced courtesy of Google maps (map data ©2023 Google).

Surveyor coverage for each survey is illustrated in Figure 1. From these positions, surveyors could see all features potentially suitable for roosting bats that were identified during the initial bat scoping survey.

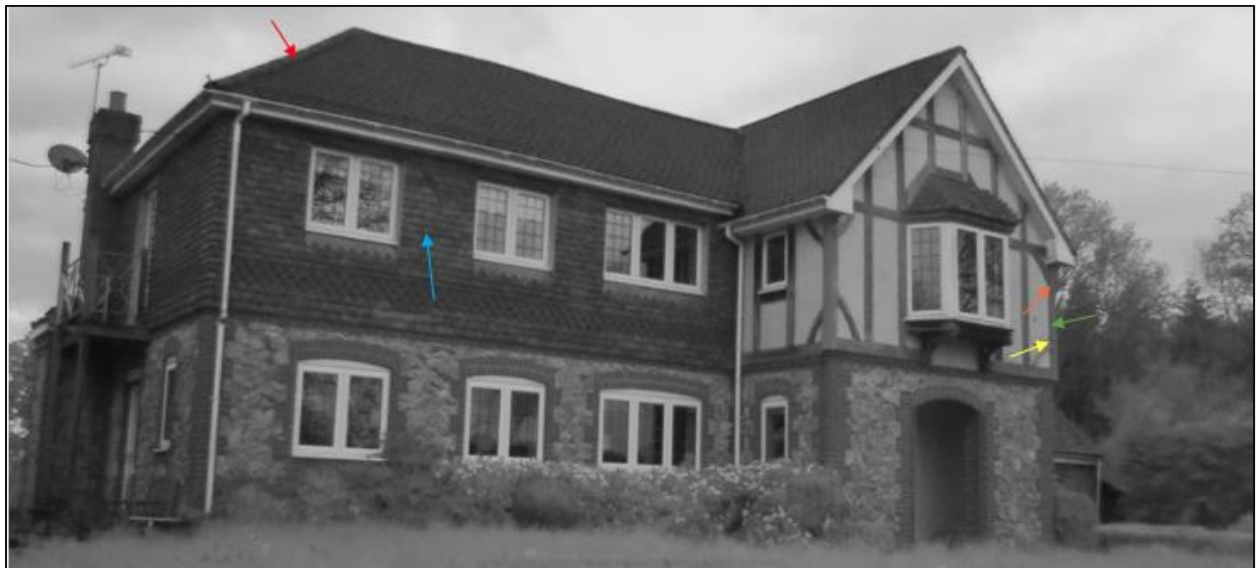
Figure 2. bat emergences from the eastern elevation during the first survey on 9th May. Red arrow two bats, blue arrow three bats, orange arrow 1 bat, green arrow 10 bats, yellow arrow 7 bats.

A total of twenty-four (minimum) common pipistrelle emergences were identified from the main house, and the garage. 23 emergences were recorded from the front of the house on the eastern elevation near the bay window around the wooden boarding, as well as the ridge tiles, and hanging tiles (see Figure 2). One emergence was recorded from the weatherboarding near the middle window on the garage southern elevation.

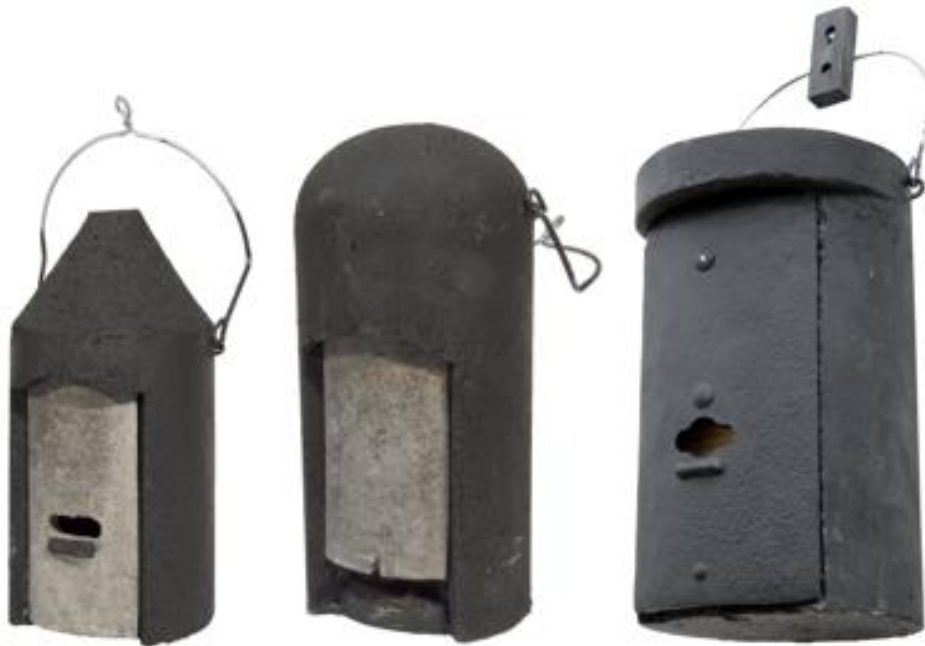
Figure 1. Left to right, the 2F, 2FN and the 1FS bat boxes produced by Schwegler. These and other brands are available at many on-line wildlife stores. These are constructed of ‘woodcrete’ (a mixture of cement and woodchip) and are designed to be durable and replicate the stable thermal properties of trees and buildings. They may be attached to trees or buildings.

All hanging/roof tiles should be carefully hand stripped one by one from the walls under the direct supervision of a licenced bat ecologist. Any bats found shall be gently captured and placed into bat boxes that have been secured to trees surrounding the site in advance.

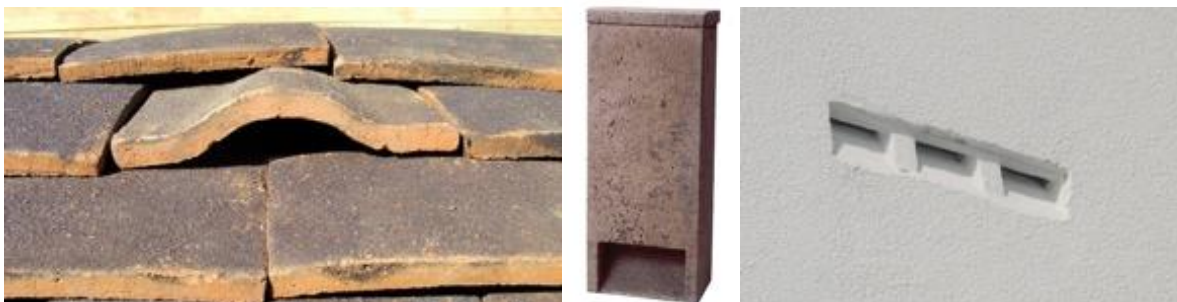
Figure 2. Examples of integral bespoke bat roosting features that may be incorporated into buildings during construction/renovation. From left to right: an example of bat access tile into loft space; the 2FR bat tube; and an example of 2FR bat tubes installed into a house wall in a series of three. Other brands and designs are available.

The detailed design of the new building should incorporate integral bespoke bat roosting features. Purpose-built structures are commercially available, some recommended examples of which are shown in Appendix 3.
