STRUCTURAL APPRAISAL

3444 – Weybread Lakes Barn, Mill Lane Farm, Weybread. IP21 5TP

Report Title: Structural Appraisal

Date: 25th March 2024

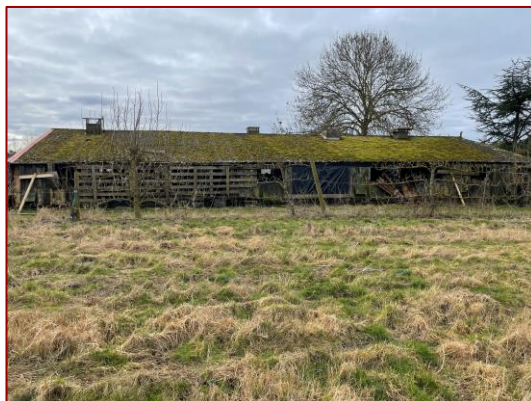
Photo 1 – North Elevation

The north side elevation has deteriorated in several places resulting in some bays where the cladding is partly open and other bays sheathed in using plastic sheet.

The north elevation has some supporting columns and ends of rafters currently exposed and are displaying some signs of structural deterioration and damp which will require repairing. These repairs may be spliced with appropriate timbers and can be undertaken insitu and thus meet the requirements of the GDPO outlined in section 1 of the report.

We can confirm that none of the existing structures will be required to be replaced as part of the proposals, however some of the external columns to the north elevation will need repairs splicing in, which can be undertaken insitu without any requirement to replace full members.

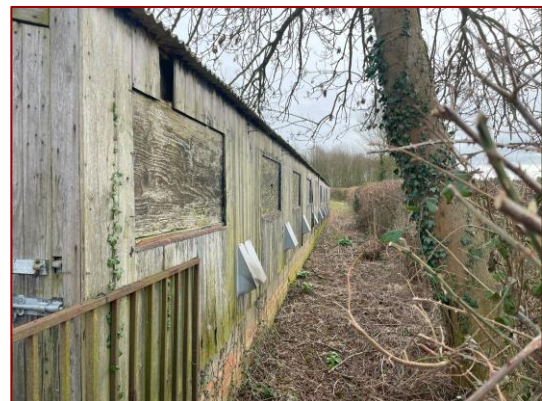
Photo 2 – South Elevation

External elevations to the south, east and west are in good condition with no sign of significant deterioration.
