BAT, BARN OWL AND NESTING BIRD SURVEY

**COTTAGES ATTACHED TO THE OLD VICARAGE,
ST NEWLYN EAST, NEWQUAY, CORNWALL**

March 2024

Report No: 23-121/PC/The Old Vicarage, St Newlyn East_BBONB

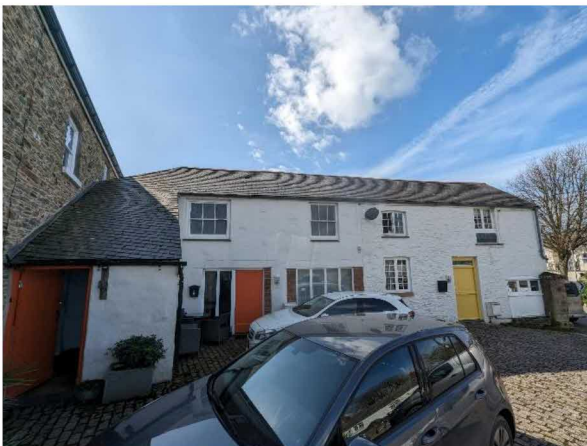
The building subject to this survey is a two storey stone building with a pitched natural slate covered roof, a gable end to the north and is attached to the old rectory to the south with a sloping roof between the two at this end. This building is split into two cottages which are accessed from doors in the eastern side of the building. The western side of the building has no windows and backs onto an adjacent property. The eaves are lined with fascia boards with the northern gable end being lined with a row of hanging slates. The northern and western walls are bare stone with the eastern wall having been painted white, see Photos 1 and 2.

Photo 1. Showing the building from the east

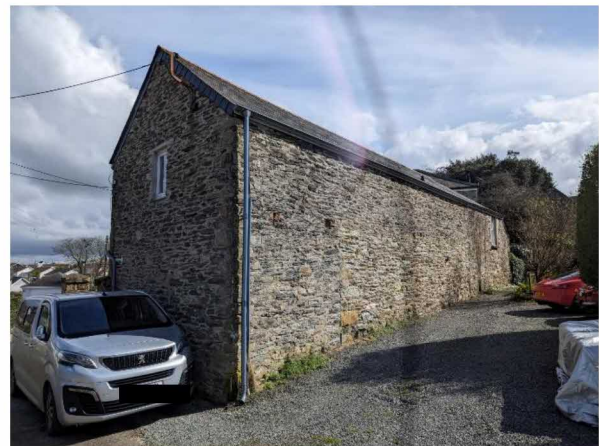
Photo 2. Showing the building from the north east

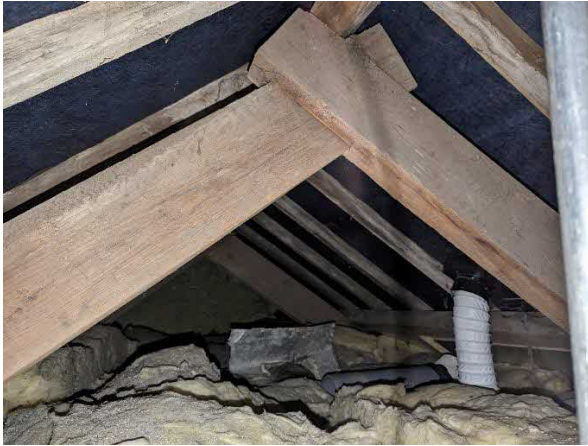
Internally there are two small roof voids above the building, separated by a stone internal partition wall. The rooms on the 1st floor of the building are built into the roof structure, with the small roof void above. The roof voids are open from the floor of the roof void, which is lined with fibreglass insulation, to the underside of the roof which is lined with breathable roofing membrane, see Photos 3 and 4.

Photo 3. Showing the roof void over the southern end of the building

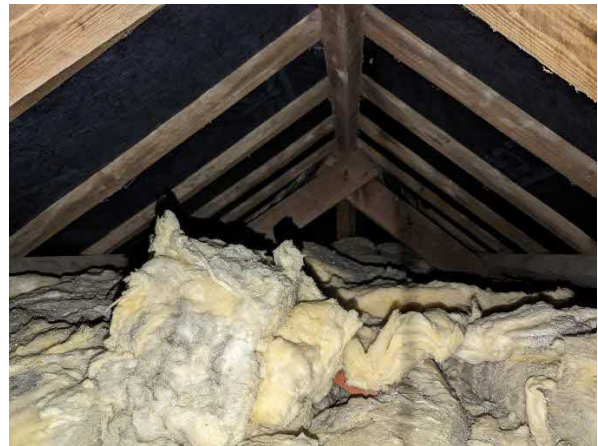
Photo 4. Showing the roof void over the northern end of the building
