ROTTERDAM WHARF, PORT DUNDAS, GLASGOW

GEO-ENVIRONMENTAL DESK STUDY REPORT

Phase I - Geo-Environmental Desk Study Report

Project Reference: P22/27 I

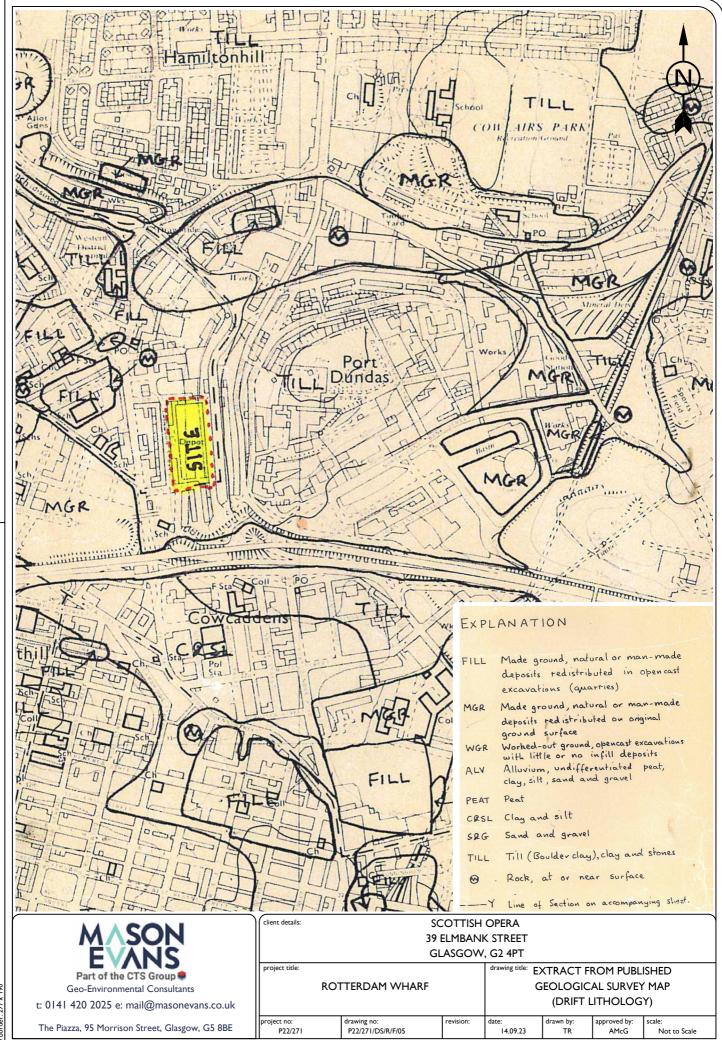
- 4.2.2 The British Geological Survey (BGS) Drift Lithology map (Drawing No. P22/271/DS/R/F/05) recorded the natural soils below the site to consist of glacial till (i.e. boulder CLAY). The BGS drift thickness map (Drawing No. P22/271/DS/R/F/06) indicated these deposits to range between approximately 5 m and 20 m becoming thicker from north-west to south-east.

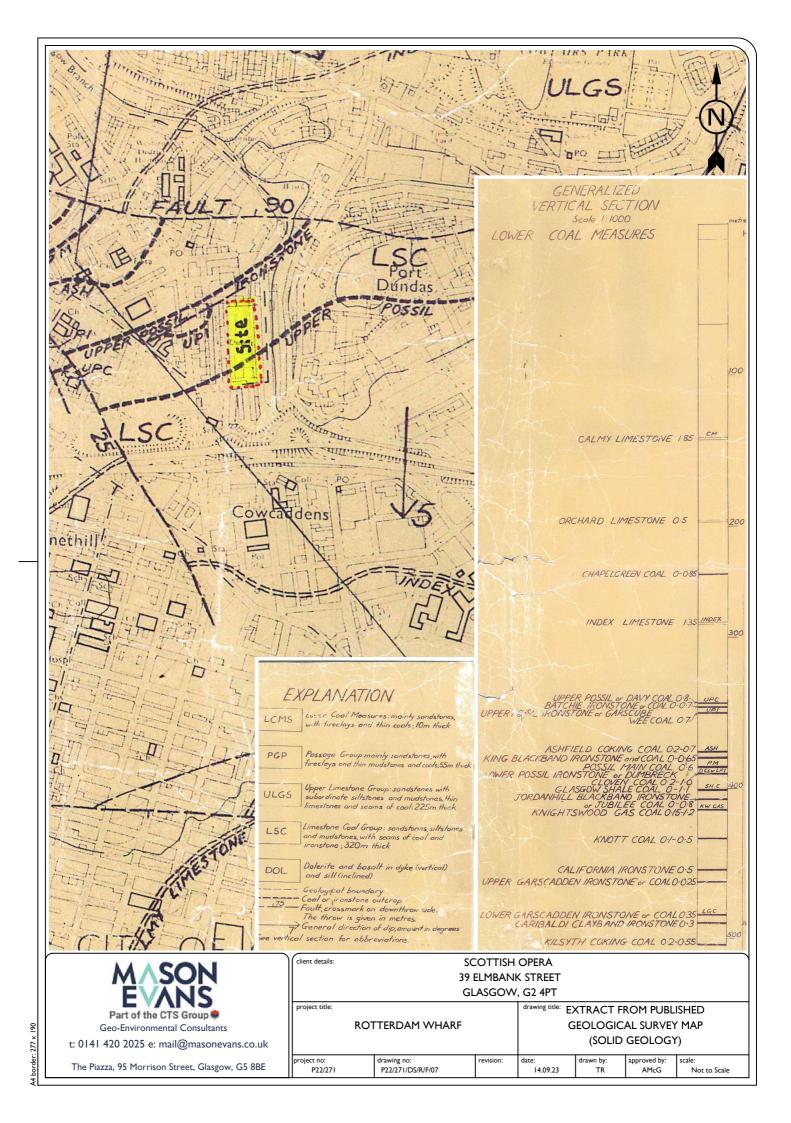
- 4.3.1 The BGS indicated the solid strata beneath the site to be of the Limestone Coal Group comprising of SANDSTONE, SILTSTONE and MUDSTONE with seams of COAL and IRONSTONE (Drawing No. P22/271/DS/R/F/07).
