EXISTING FRONT ELEVATIONS

EXISTING REAR ELEVATIONS

EXISTING LOWER GROUND FLOOR PLAN 1:50

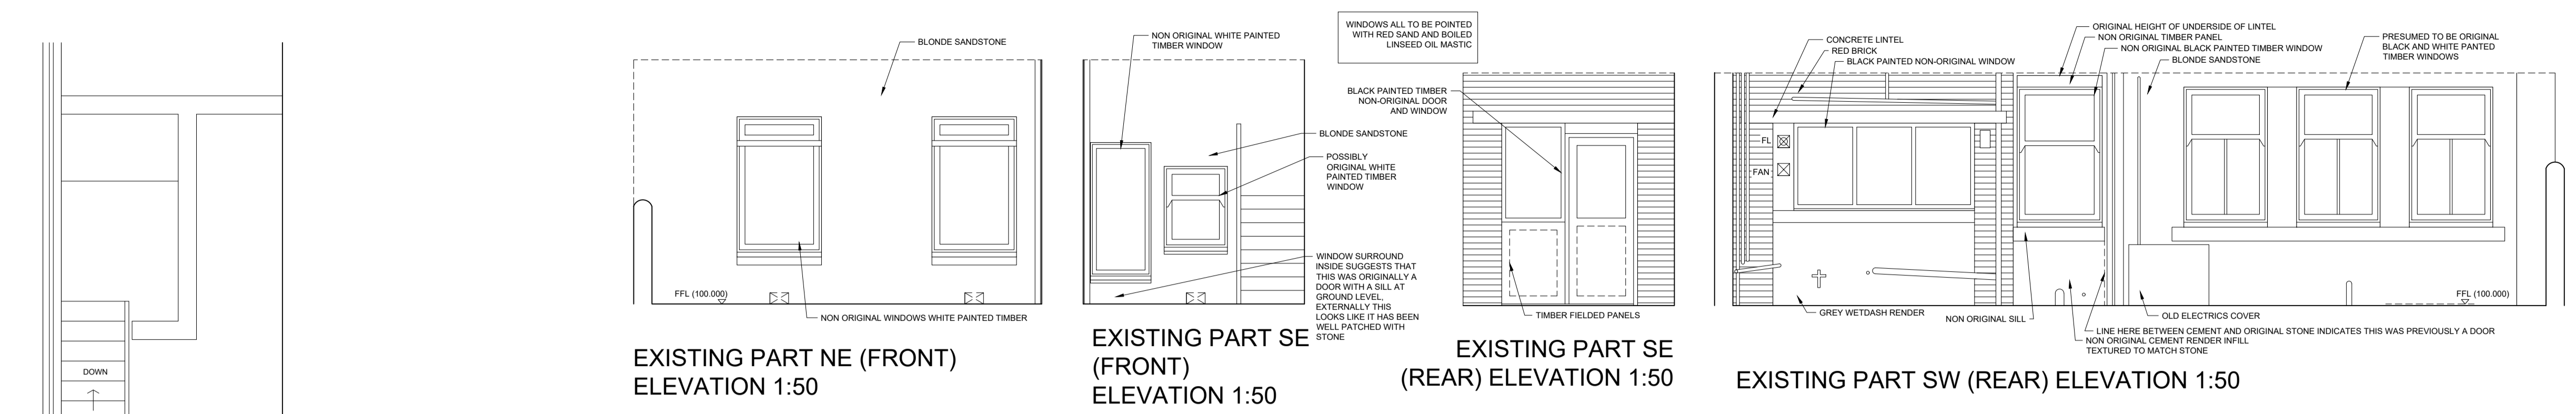
EXISTING PART NE (FRONT) ELEVATION 1:50

EXISTING PART SE (FRONT) ELEVATION 1:50

EXISTING PART SE (REAR) ELEVATION 1:50

EXISTING PART SW (REAR) ELEVATION 1:50
