PROJECT TITLE: Boundary Way, Hemel Hempstead HP2 7LF
DOCUMENT TITLE: Hemel 465

West & North Elevations - Proposed

MSCP - Proposed Section A-A & B-B

TOPOGRAPHICAL SURVEY

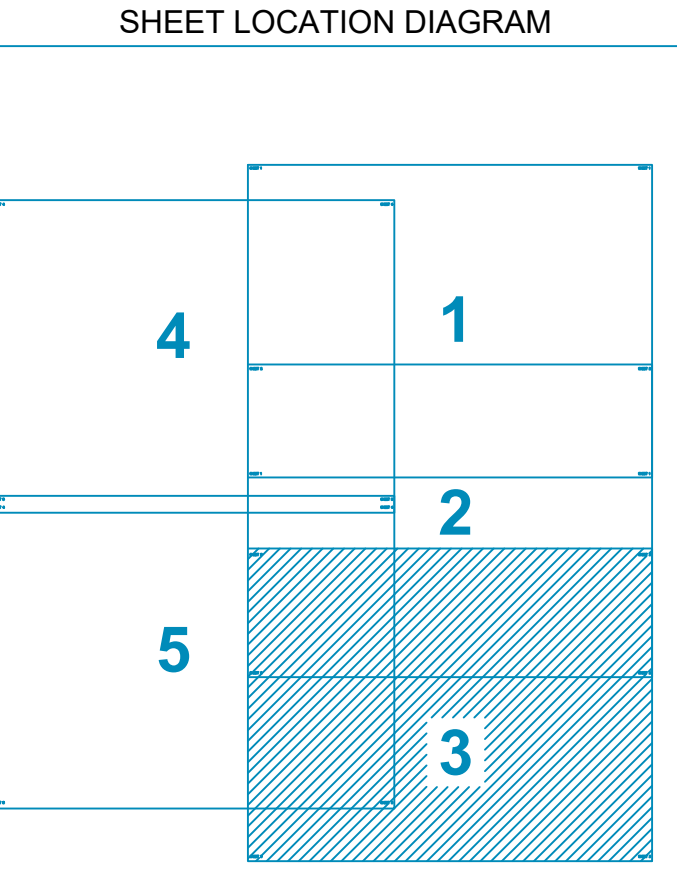
Drawing Number
TS23-706-3

This survey is related to OSGB36(15) coordinate system by GPS 'rapid static' methods. No scale factor has been applied to the survey information. All horizontal distances taken from this drawing are ground distances.

All levels related to Ordnance Survey active GPS network, at survey station 5.

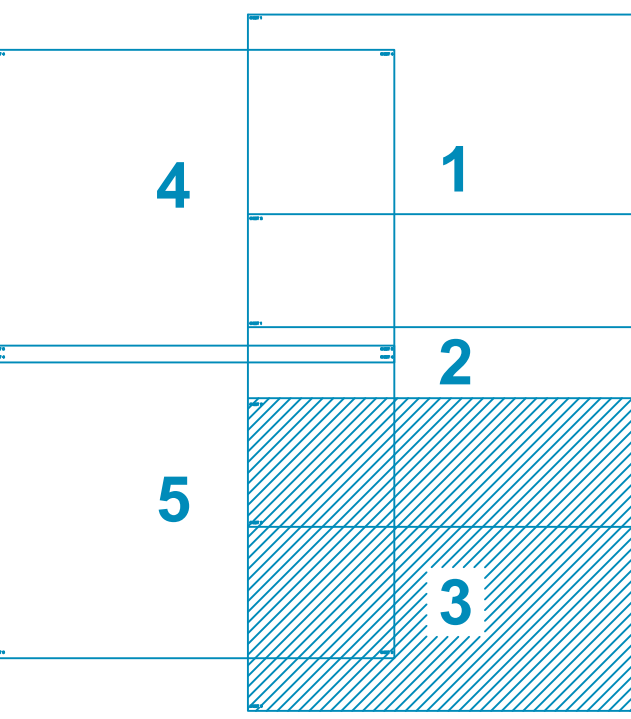
Drawing Number
TS23-706-8

Note: The underground services information has been supplied by Anveit Survey Ltd.

THE UTILITY SURVEY HAS BEEN CARRIED OUT IN ACCORDANCE WITH A PAS 128:2014 WITH SPECIFICATION EXCLUDING POST PROVISION OF GROUND PENETRATING RADAR AND A MANHOLE VISUAL SURVEY. ELECTROMAGNETIC INTERFERENCE AND/OR GROUND PENETRATING RADAR HAVE BEEN USED IN THE LOCATION OF UNDERGROUND SERVICES. THE RESULTS ARE NOT FINAL AND THE FINAL LOCATION OF SERVICES SHOULD BE CONFIRMED BY VISUAL REFERENCE TO STREET FURNITURE, SIGNPOSTS, OR EXISTING OR PREVIOUS STREET WORKS. WHERE AVAILABLE RECORD DRAWINGS, THE COMPLETENESS OF THE UNDERGROUND SERVICES INFORMATION CANNOT BE GUARANTEED. THE METHOD OF SURVEY AND THE DEPTH OF SERVICES DETECTED MAY VARY AND SHOULD BE CONFIRMED BY VISUAL REFERENCE TO RECORD DRAWINGS OR MANHOLE VISUAL SURVEY.
