Rotherham Top Farm Whittle-le-Woods Chorley, Lancashire

HERITAGE STATEMENT Report EH263/01 Telephone: 017683 52750 Web: www.eden-heritage.co.uk

Heritage Statement for Primrose Holdings

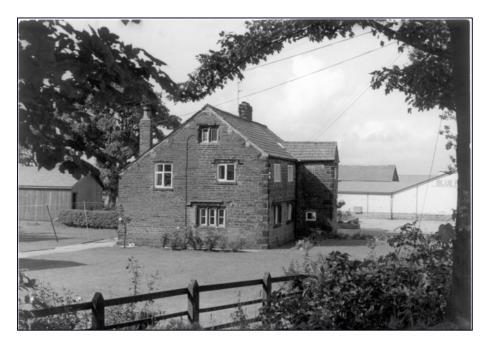
- 4.2.14 An undated photograph of Rotherham Top Farmhouse, possibly dating to the 1960s or 70s, shows the stone-built south-east gable of the house with a modern sheds to the west and north. The south-east gable is asymmetrical, and has a three-light mullioned window on the ground floor with hoodmould, a first floor window with hoodmould (mullion missing), with a possibly inserted window to the west, and mullioned window lighting the roof space. There is a projecting two-storey porch against the north-east elevation which has a blocked two-light mullioned window at first floor level (Plate 3).

Plate 3: Undated view, looking north, showing Rotherham Top Farmhouse (Source: Lancashire Red Rose Collections)

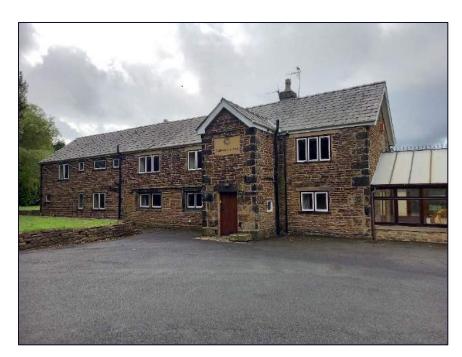
quoins and it has a modern slate roof with three chimney stacks. There are clearly two phases to the building, the older 17th century section to the north-west, and a late 20th century extension to the south-east. The main entrance to the property is through a two-storey gabled porch against the north-east elevation. The doorway is plain, with a simple square head, and above a former mullioned window with hoodmould has been infilled and replaced with a modern plaque with the name of the house and cockerel motif (Plates 9 and 10). There is a small ground floor window in the north-west side of the porch, with another in the south-east side. A former first floor mullioned window (as shown on Plate 3) has been replaced by a modern opening (Plates 9-11).

Plate 9: View looking south-west showing the principal elevation of Rotherham Top Farmhouse

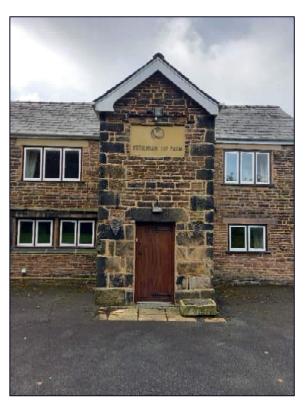
Plate 10: View looking south-west showing the two-storey porch of the 17th century section of Rotherham Top Farmhouse

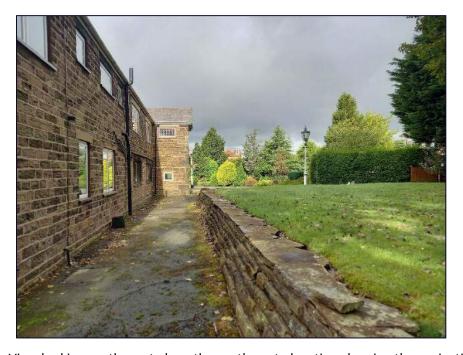
Plate 11: View looking north-west along the north-east elevation showing the projecting twostorey porch

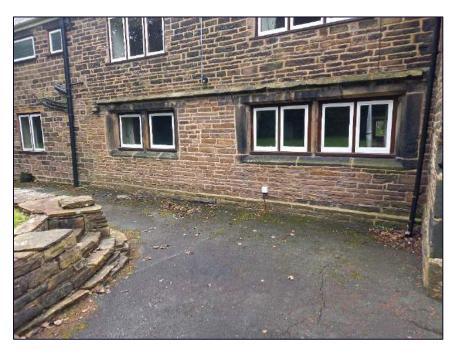
Plate 12: North-east elevation of Rotherham Top Farmhouse showing the ground floor windows with continuous hoodmould

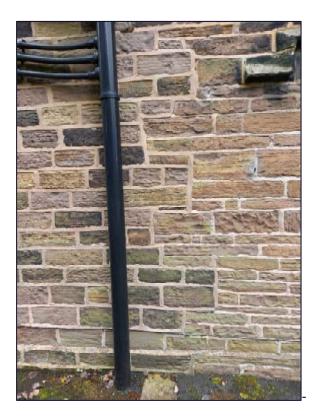
Plate 13: North-east elevation of Rotherham Top Farm showing the construction break between the 17th century fabric (right) and late 20th century extension (left)

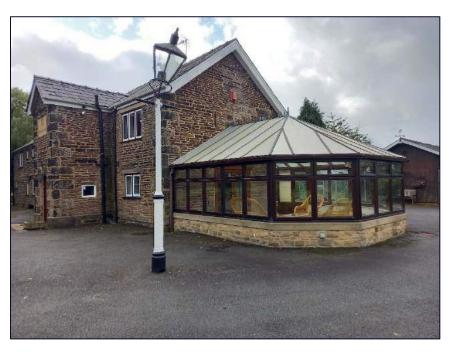
- 4.3.7 The north-west elevation of the house is partly obscured by a modern conservatory with stone plinth, but it was possible to note the presence of a blocked first floor mullioned window and an apparent later first-floor blocked doorway with a modern window to its west side (Plates 14-16). The blocked doorway may have related to the presence of a possible external set of stairs noted on the historic 19th and early 20th century mapping (Figure 4).

Plate 16: North-west elevation of Rotherham Top Farm with modern conservatory

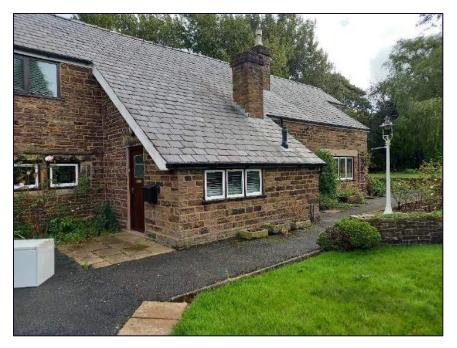
Plate 19: South-west elevation showing modern outshut partly utilising older stonework

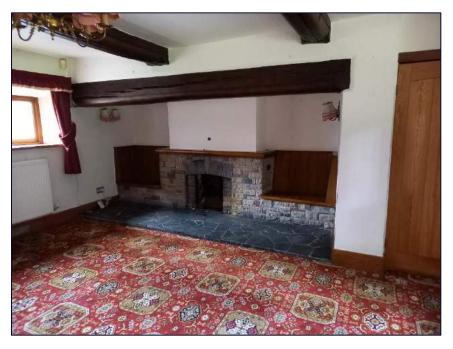
- 4.3.11 It is clear that the interior of the original part of the building has been altered, as noted in the listed building description, although there are some historic features surviving. For example, in the ground floor room in the second bay there is a large inglenook fireplace with ovolo-moulded bressummer, and large beams orientated north-west to south-east (Plates 22 and 23). The south-east end of this room is now occupied by a modern kitchen (Plate 24), however this appears to historically have been a separate room as suggested by the chamfer stops present on the beams.

Plate 22: View looking north-west showing the large inglenook fireplace with modern fireplace, and moulded bressummer, ground floor of the original house

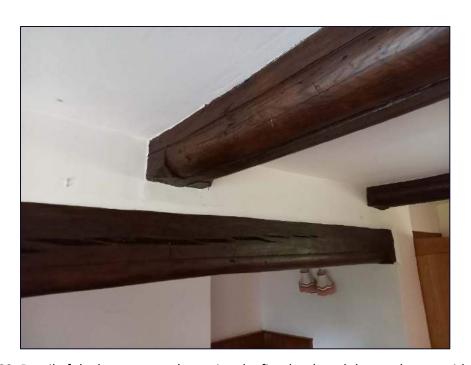
Plate 23: Detail of the bressummer (spanning the fireplace), and the two beams with ovolo moulding and chamfer stops, ground floor of original house

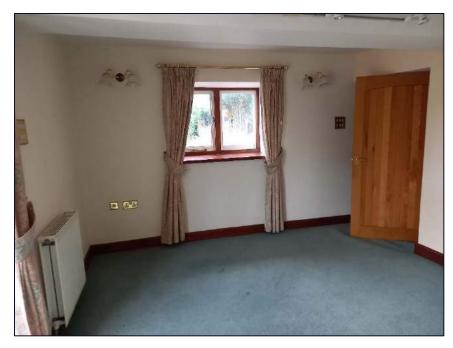
- 4.3.12 There were no features of historic interest noted in the room to the north-west side of the inglenook fireplace, apart from boxed-in beams (Plate 25). It is from this room where access is provided into the conservatory (Plate 26).

Plate 25: View looking north-east showing the northern room on the ground floor of the original house; access to the conservatory is to left of photograph

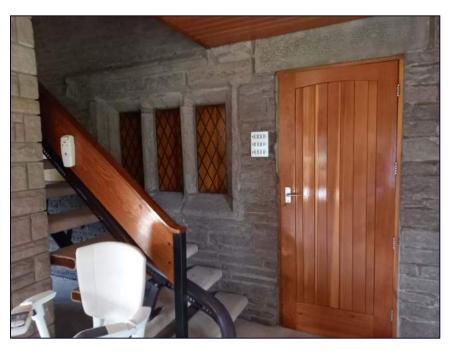
Plate 28: Original mullioned window which survives as a feature within the modern extension

- 6.1.2 The site visit has identified that Rotherham Top Farmhouse is stone-built and consists of two construction phases, with evidence for blocked openings evident. Historic features such as mullioned windows with hoodmoulds, bressummer and inglenook fireplace, and moulded beams survive, along with windows relating to the earlier house still surviving and incorporated as features in the extension. It is recommended that these are incorporated into the new extensions where possible.

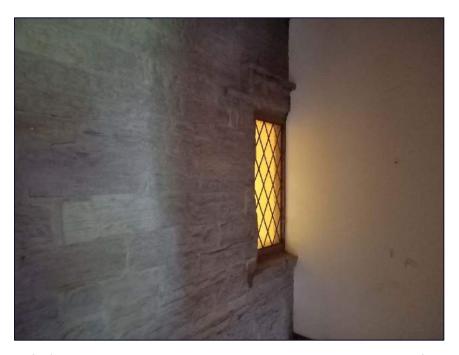
Plate 30: Part of a former two-light window in the original south-east elevation of the house, now incorporated but truncated within the modern extension

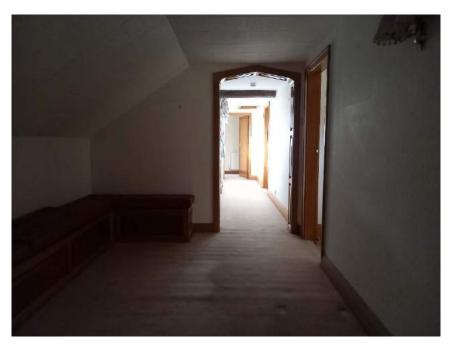
Plate 31: View looking north-west showing the first-floor corridor in the original part of the house.

The doorway has been defined with modern panelling, but may respect an historic opening

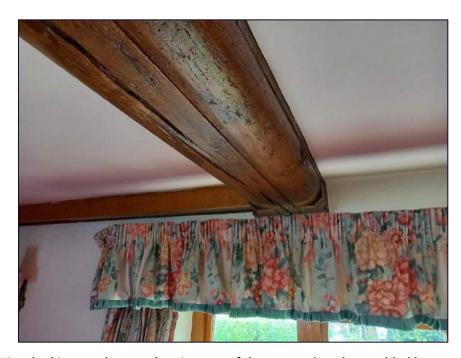
- 4.3.16 The only other historic features noted on the first floor were the presence of the same form of ovolo moulded wooden beams already seen on the ground floor, although on the first floor they are orientated north-east to south-west (Plate 32) (some are boxed-in). Plates 33 to 35 are images of the bedrooms within the oldest part of the house, all of which have washing facilities whether its an ensuite or provision of wash-hand basin (the first floor of the projecting two-storey porch has been converted to an en-suite for one of the bedrooms).

Plate 32: View looking south-west showing one of the exposed ovolo-moulded beams on the first floor
