**The Hill, Burrington Combe, BS40 7AR**

**Arboricultural Report containing:**

- **Arboricultural constraints**
- **Arboricultural impact assessment (AIA)**
- **Tree protection**
- **Arboricultural method statement**

*Prepared by:*  
**Deb Randall BSc TechArborA**  
**Arboricultural Consultant**  
**March 2024**

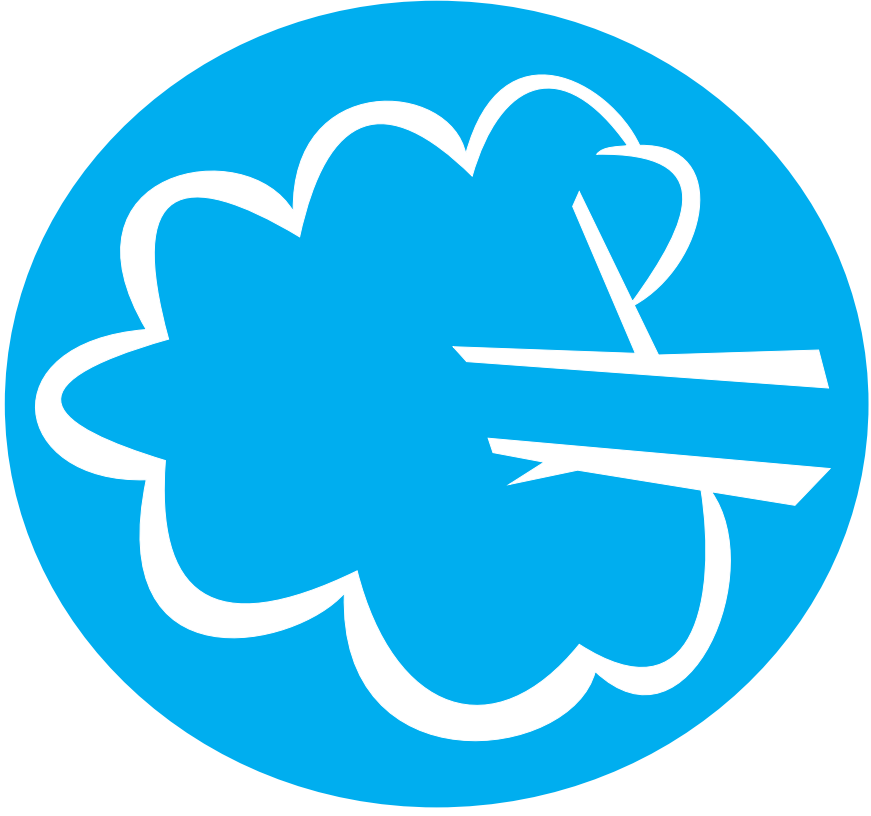
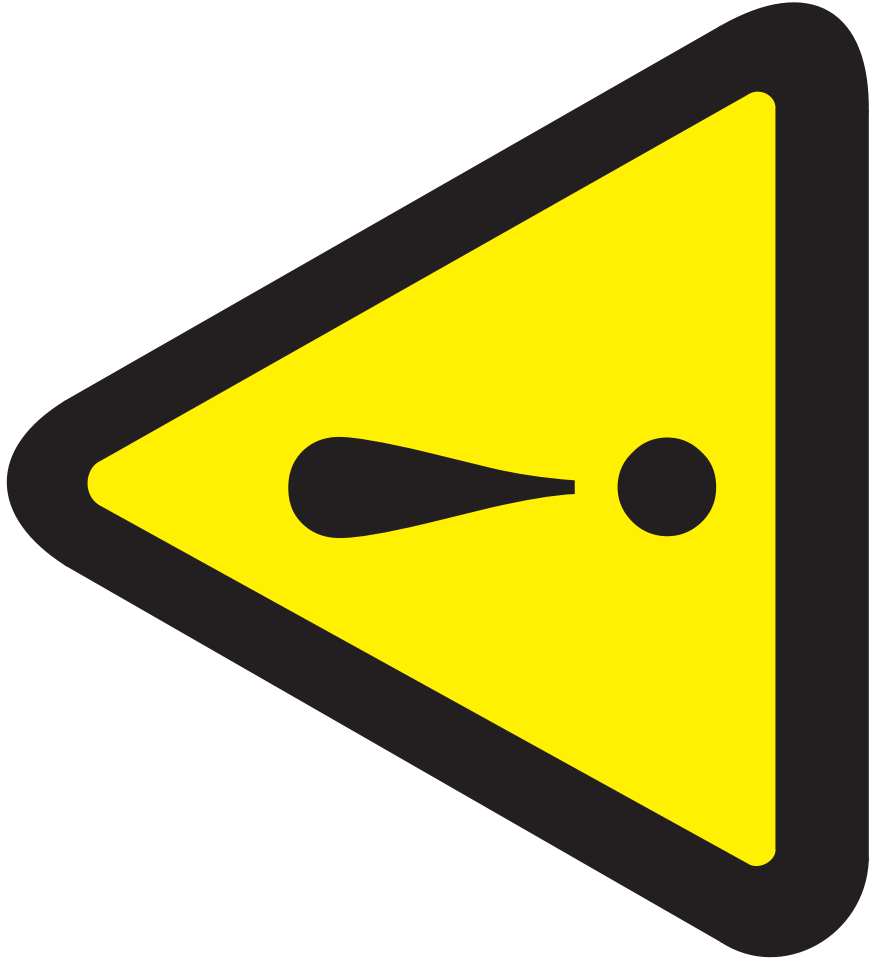
9.2.3 Weatherproof signage will be attached to the fencing indicating its function as illustrated (appendix 6).

**PROTECTIVE FENCING. THIS  
FENCING MUST BE  
MAINTAINED IN ACCORDANCE  
WITH THE APPROVED PLANS  
AND DRAWINGS FOR THIS  
DEVELOPMENT.**

**TREE PROTECTION AREA  
KEEP OUT !**
