ARBORICULTURAL SURVEY

**Eagle Brewery Wharf
Kingston Upon Thames
KT1 1HH**

Document date: 19th April 2023

Document ref: PJC/6289/23-01 Rev -

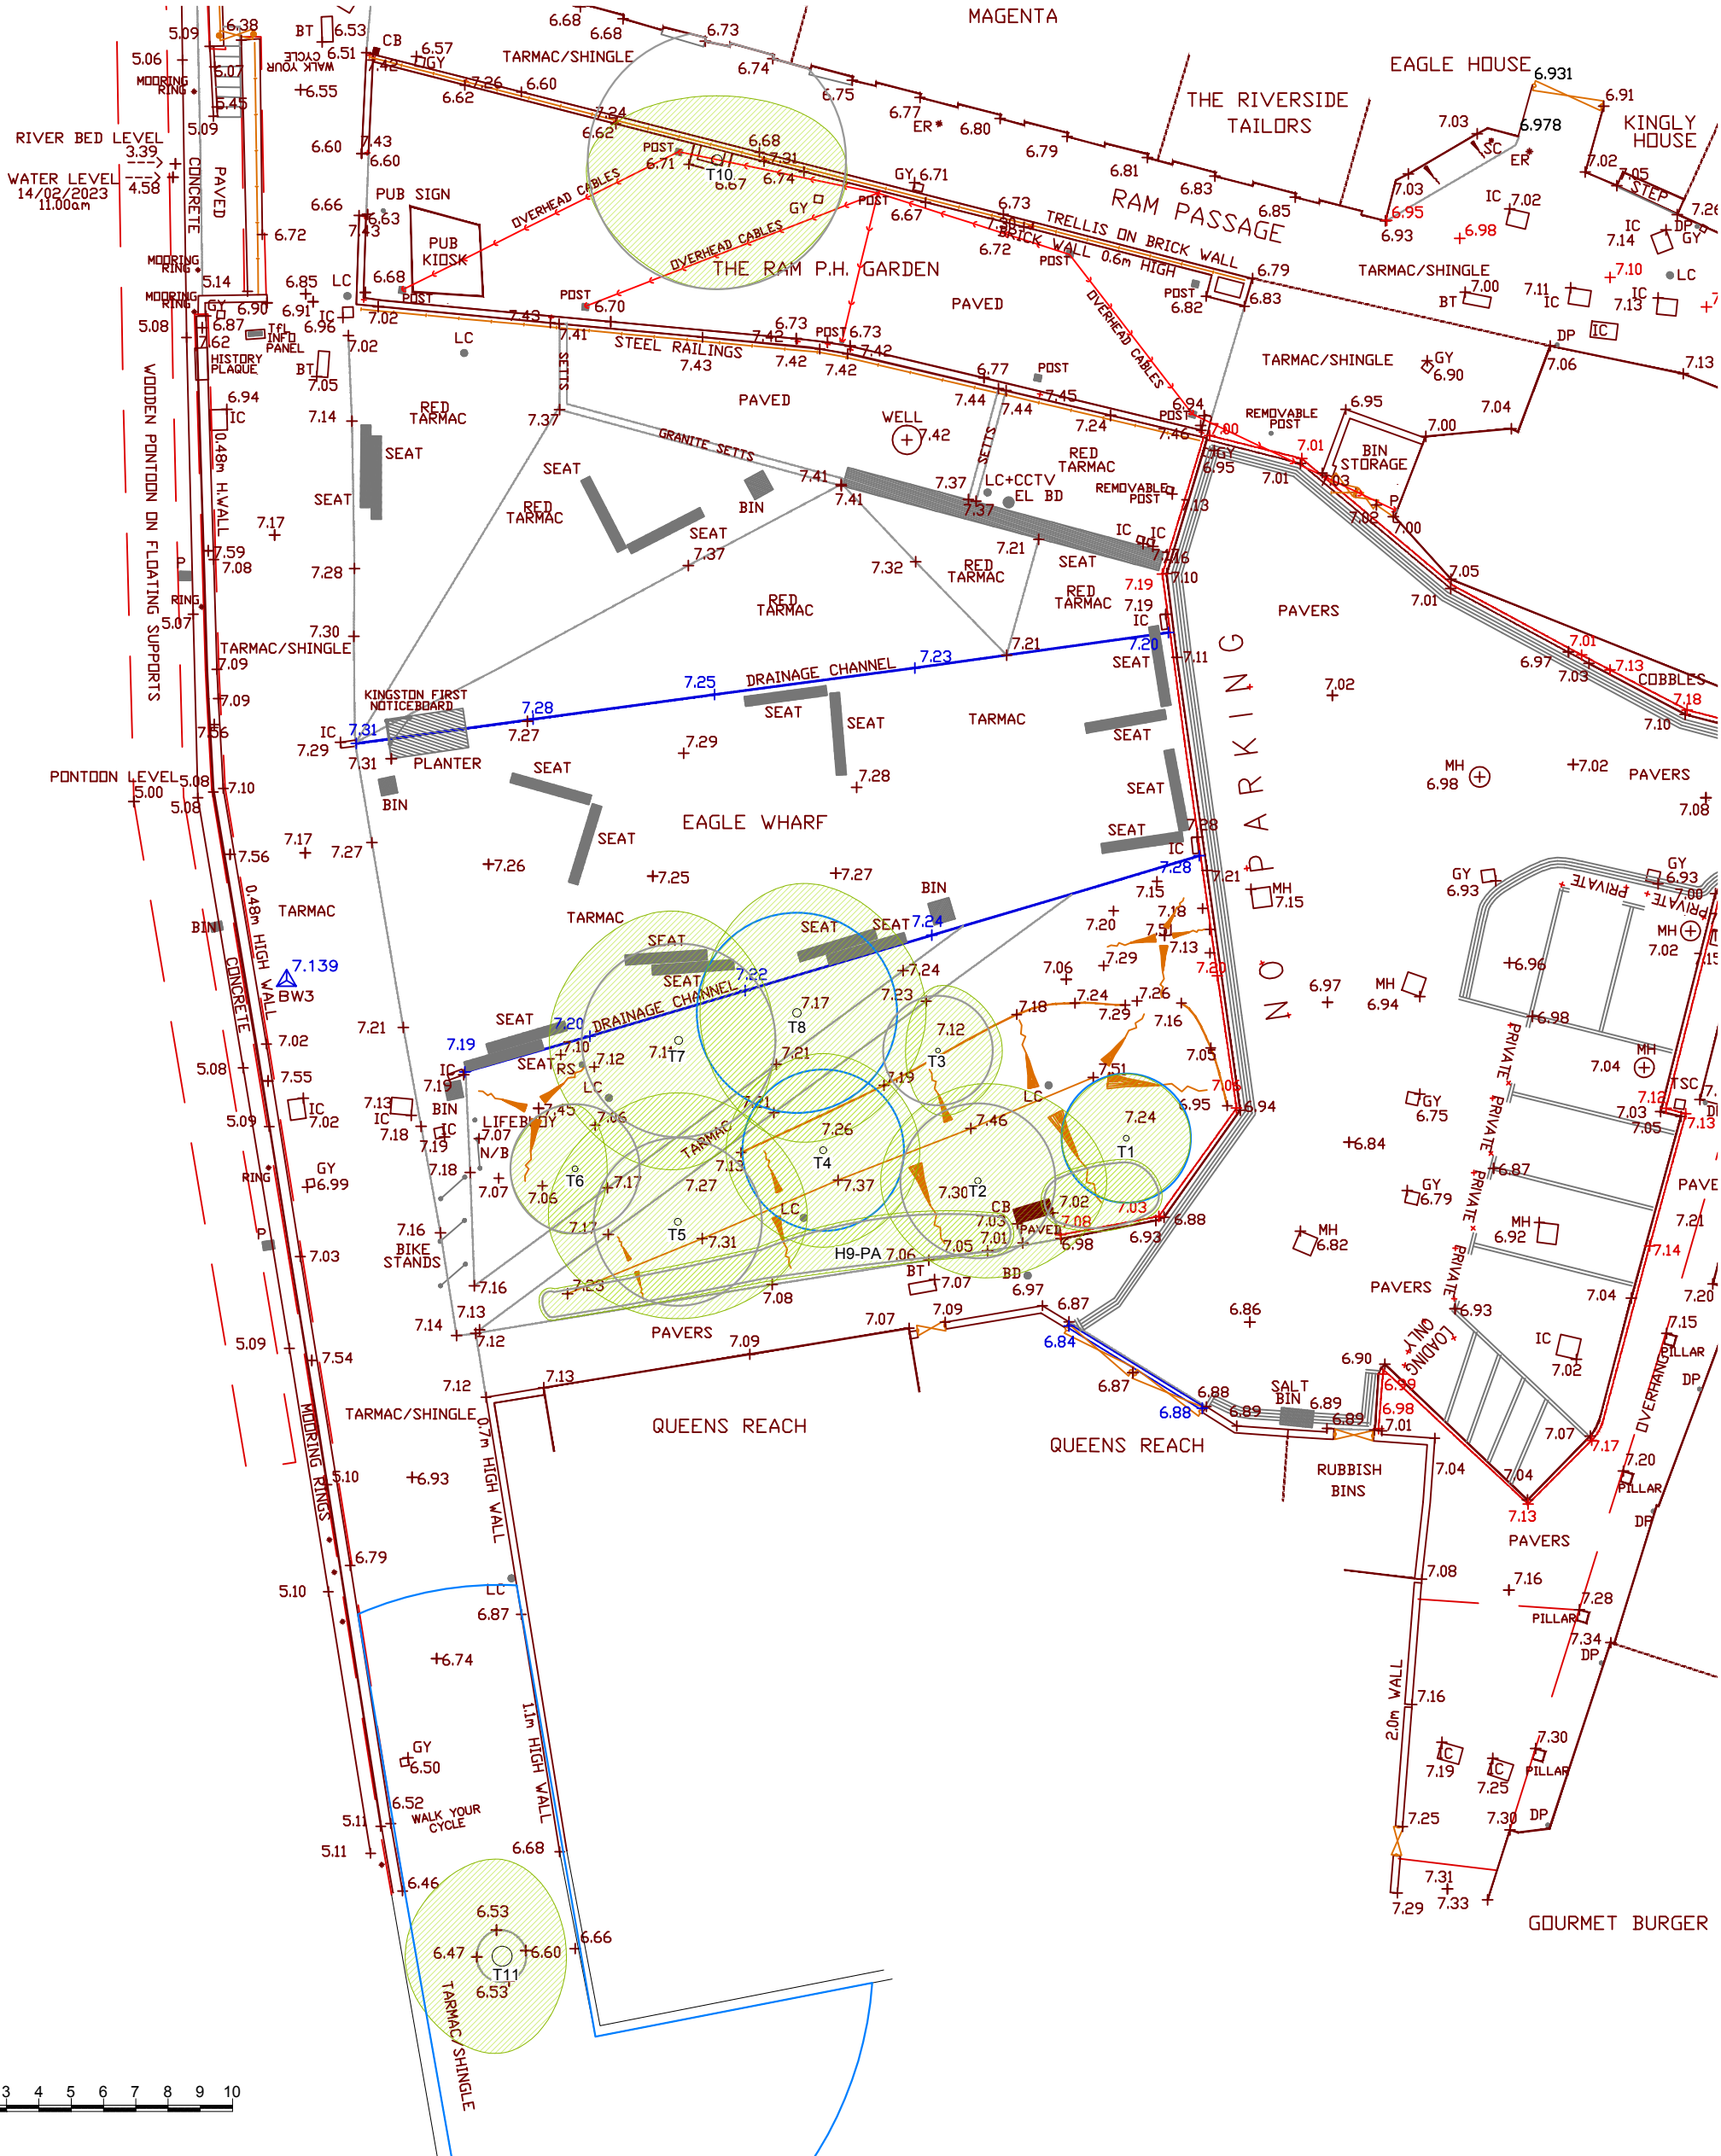
Drawing title: Tree Constraints Plan

2.3.2 The root protection areas are plotted onto the tree constraints plan in Appendix 1 and are recorded in the tree survey schedule in Appendix 2. These are represented as a circle on the plan (unless significant rooting constraints are present), and are colour coded depending on the category the tree has been awarded. Where existing site conditions/features are present that are deemed likely to have affected the root morphology, the root protection areas have been represented as a polygon of equivalent area.

3.4.1 A total of ten trees and one shrub groups were surveyed. Their locations are shown on the tree constraints plan at Appendix 1 and details and measurements are shown in the tree survey schedule at Appendix 2.

Tree numbers suffixed with PA indicate the tree position is approximate.

- Key:**
- Root protection area for category B* tree
 - Root protection area for category C* tree
 - Tree canopy
