## ***22 Frome Road, Beckington***

**Preliminary Ecological Appraisal Report**

**Date: November 2022**

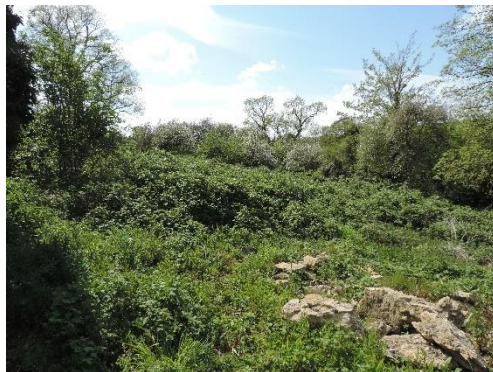
**Plate 1: Dense Scrub**

Much of the Site was covered by dense, continuous bramble (*Rubus fruticosus* agg.) scrub (Plate 1). Scrub was also encroaching on the tall ruderal vegetation and semi-improved grassland. A line of tall scrub was present adjacent to the northern boundary and included hazel (*Corylus avellana*), hawthorn (*Crataegus monogyna*), elder (*Sambucus nigra*) and dogwood (*Cornus sanguinea*).

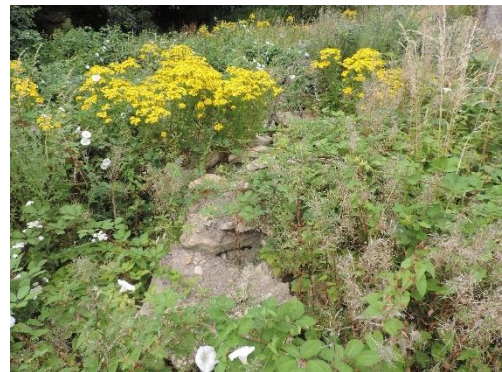
**Plate 2: Tall Ruderal Vegetation**

Tall ruderal herb vegetation was located centrally within the Site, with a small area adjacent to the south-eastern corner (Plate 2). The habitat was dominated by stinging nettle (*Urtica dioica*) and hedge bindweed (*Calystegia sepium*) with frequent broadleaved dock (*Rumex obtusifolius*), creeping thistle (*Cirsium arvense*), ragwort (*Senecio jacobaea*), hogweed (*Heracleum sphondylium*), cocksfoot (*Dactylis glomerata*) and false oat-grass (*Arrhenatherum elatius*). Sycamore (*Acer pseudoplatanus*) saplings were developing to the north of the house.

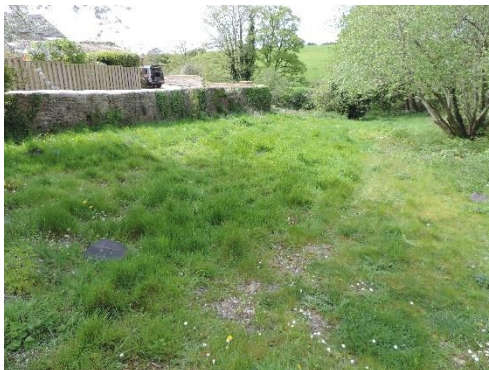
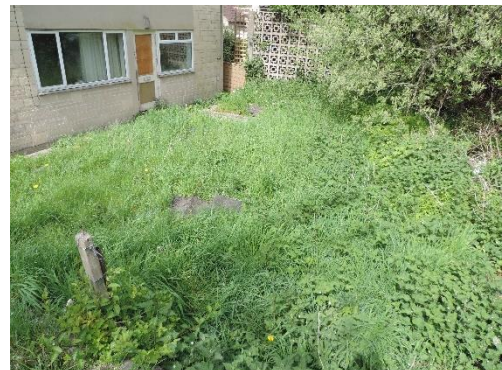
An area of neutral, semi-improved grassland was present in the south of the Site (Plates 3 & 4). The grassland was formed from two separate lawns in which management has ceased. The grass was tall ( $\leq 1\text{m}$ ) and species depauperate. Species recorded included cocksfoot, perennial rye-grass (*Lolium perenne*), Yorkshire fog (*Holcus lanatus*) and false oat-grass. Forbs were frequent and included daisy (*Bellis perennis*), dandelion (*Taraxacum officinale* agg.), stinging nettle, hogweed, ragwort, oxeye daisy (*Leucanthemum vulgare*) and herb-Robert (*Geranium robertianum*).

**Plate 3: Neutral Grassland (west of house)**

**Plate 4: Neutral Grassland (south of house)**

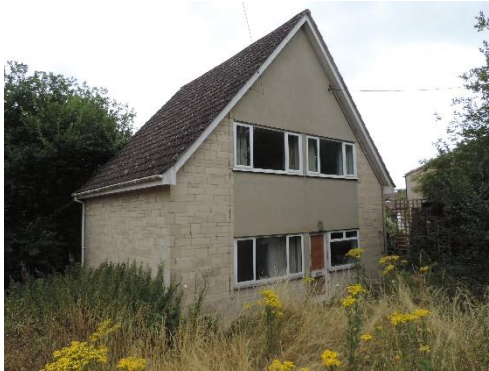
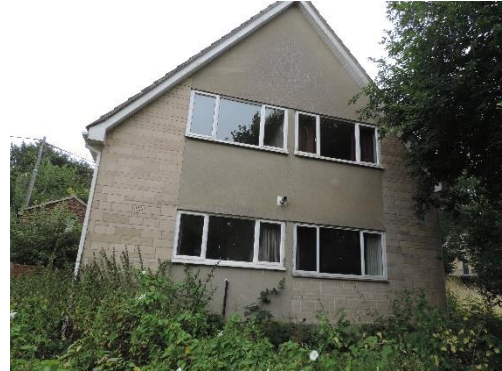
The Site included a residential house (B1, Figure 3) and a Garage (B2, Figure 3). The house was detached, two-storey and unoccupied at the time of survey (Plates 5 & 6). The walls were constructed from stone and were partially rendered. Intact double-glazed doors and windows were present throughout. Plastic soffit boxes were located at the wall tops and were flush with the adjacent walls. The roof was pitched and clad in double roman tiles. The roof was in a good condition.

**Plate 5: House (B1) Southern Aspect**

**Plate 6: House (B1) Northern Aspect**

A historical survey of B1 (First Ecology, 2019) identified a day / night roost of soprano pipistrelle. The location of the roost was not confirmed but thought to be beneath a roof tile. The current survey did not find any evidence of bats within the property. However, given that bats historical were recorded, an updated survey is recommended. Until further surveys are completed, the house was assessed as having High BRP.

An updated survey of the house is required to ascertain whether it contains a bat roost.

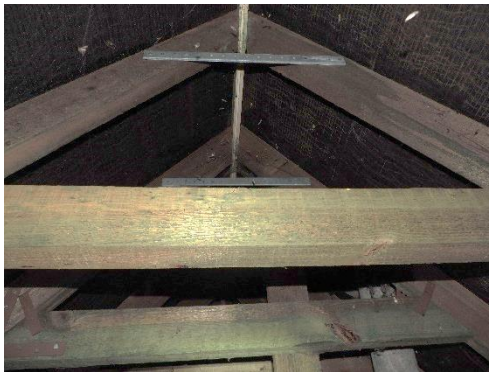
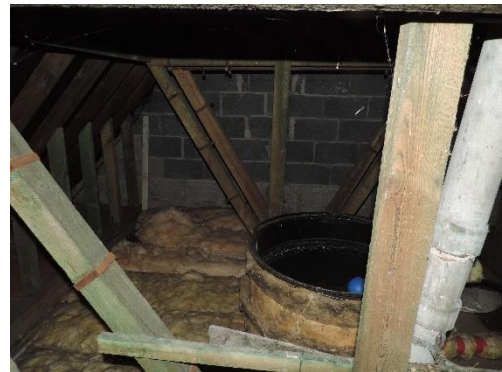
Internally, the property contained a single loft space that measured c. 10 m x 6 m x 2.5 m (Plates 7 & 8). The roof was lined with bitumen felt that was torn in places. Dense cobwebs covered the roof and extended down to the boarded / fibreglass floor. The gable walls were constructed from block. A water tank was present in the loft.

**Plate 7: B1 Loft Space**

**Plate 8: B1 Loft Space**

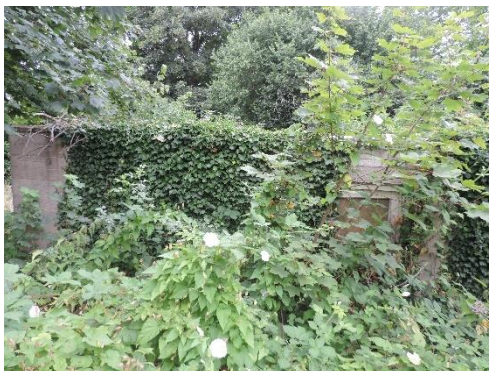
**Plate 9: Garage (B2)**

The garage (B2) was detached and constructed from block; the exterior walls were partially rendered. Ivy (*Hedera helix*) bindweed and sycamore saplings had encroached on the building. The roof was sloping and clad corrugated concrete / asbestos and plastic sheets. Internally, the roof was unlined.

The garage did not contain any external roost locations. The single-skinned block walls did not include any cavities. Overall, the garage was assessed as having Negligible BRP.
