BAT SURVEY REPORT

Preliminary Bat Roost Assessment & Owl Survey
The Barn, Warlands Farm, Shalfleet, Isle of Wight

NN1688R01
26th October 2023

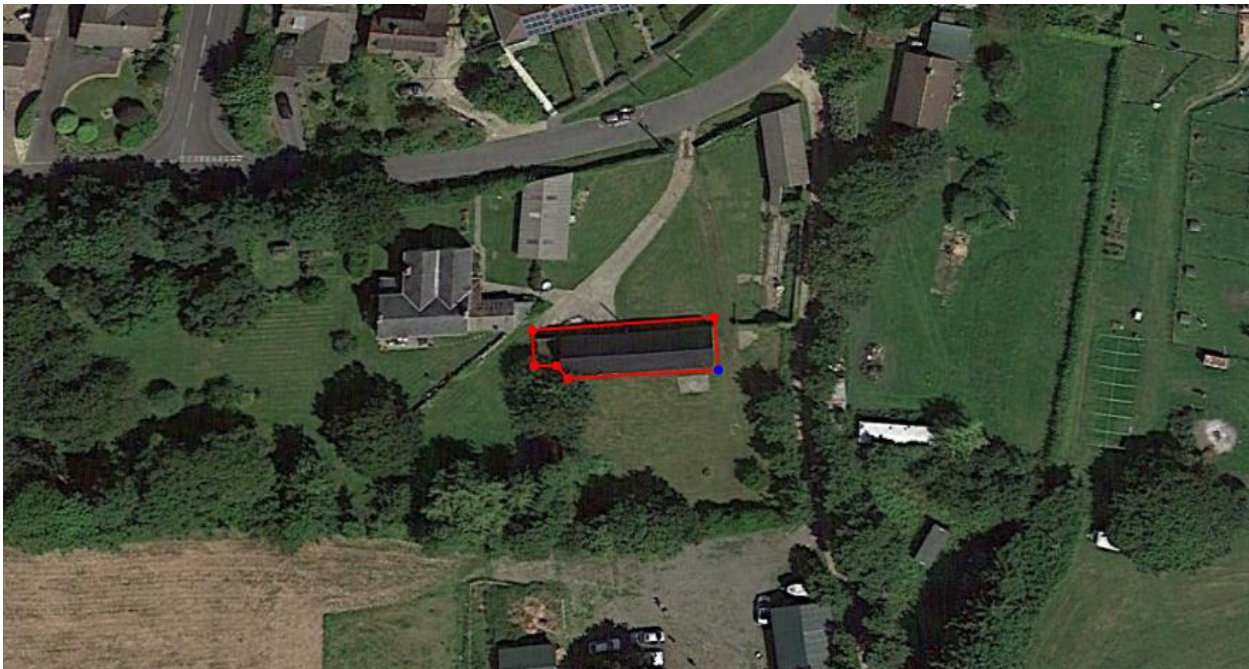
Appendix 2 The site

- 7.3.1 The building is a large barn with a lean-to garage on the west end. The building is constructed of Concrete blocks stone and brick, with a sheet tin roof. The building has multiple openings where there are gaps in the structure, and there is no loft void. The roof is not constructed with a membrane or internal skin. All gaps in the tin and wood observed were further inspected, with none leading to a suitable void. The surveyor considered the interior of the building would be too light for favorable roosting of bats, and the lack of a roof void also made the structure sub optimal.

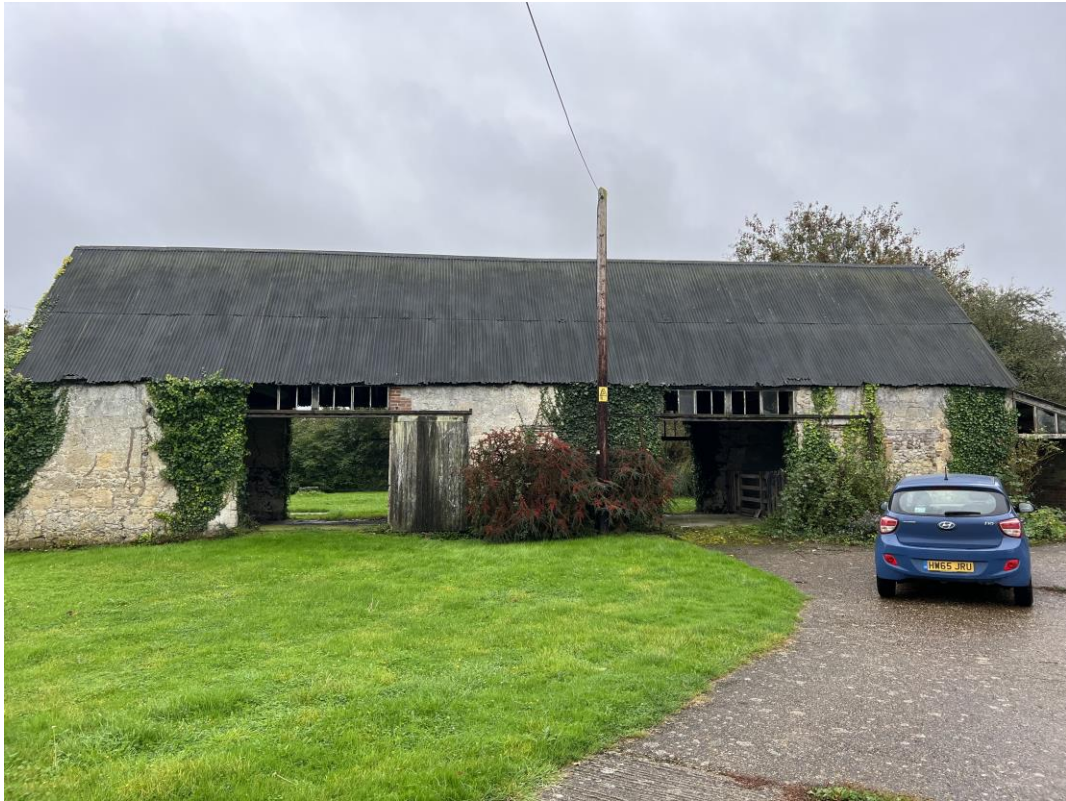
Appendix 3 Site photographs
Photo 1 The exterior of the barn

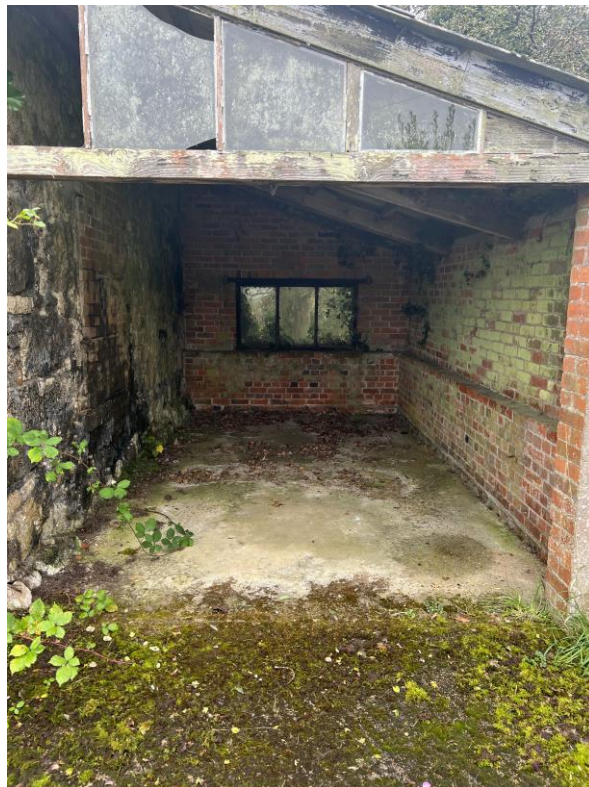
- 7.3.2 The interior was fully accessible to the surveyor who found no evidence of bat use such as recent droppings, feeding remains, or urine splashes indicating no current bat habitation. Furthermore, the roof had no internal structure suitable for a bat roost. (**Figure 3 – photo 2, and 3**).

Photo 2 The exterior/ interior of the garage on the right hand side of the barn

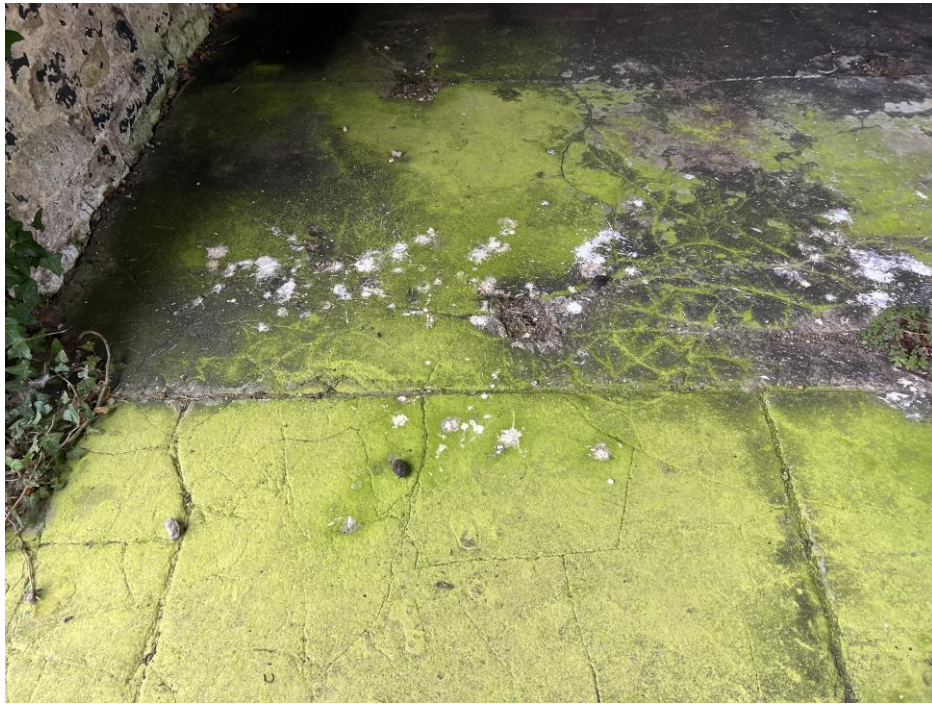
- 7.4.1 There was evidence of Barn Owl in the form of pellets and potentially guano. Evidence of Feral Pigeon *Columba livia* was also present. No birds were seen during the internal survey, though a sighting of a single Barn Owl was reported to the project ecologist.

8.1.3 Barn Owl was seen to be using the building, though there was no evidence of breeding. On this basis the building is considered to be an occasional roost.

Photo 3 the floor of the barn showing evidence of barn owl roosting

9.1.3 A single barn owl box should be installed on a suitable nearby tree with a nesting area and an external exercise ledge included in the design.

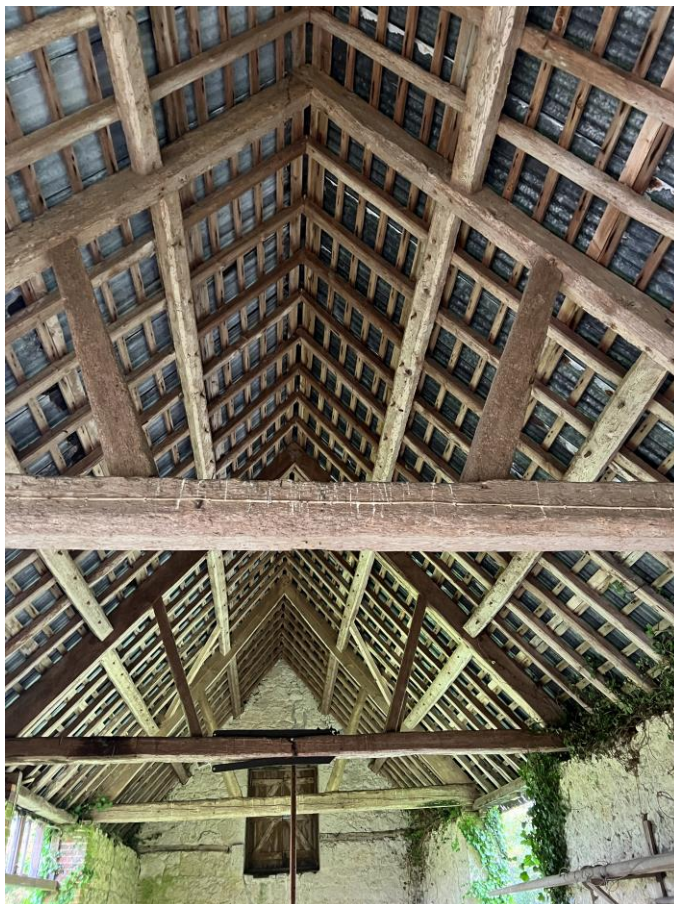
Photo 4 The interior of the roof of the barn
