**BARN AT WARLANDS FARMHOUSE  
WARLANDS FARM,  
WARLANDS LANE,  
SHALFLEET  
PO30 4NQ**

**HERITAGE STATEMENT**

- 1.3 The proposal is to convert the redundant former agricultural barn into residential accommodation with a sensitive approach to the scheme, preserving as much of the fabric and heritage of the Listed building as possible.

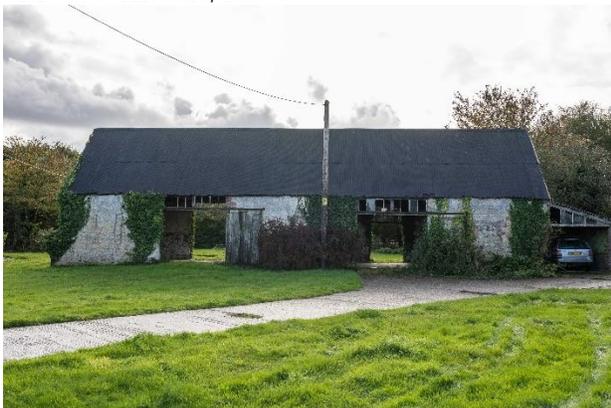
FIG 2: FRONT ELEVATION, BARN

- 2.12 The barn is predominantly Isle of Wight stone, mirroring the materials present on the main Farmhouse. There are four large openings, two on the front elevation and two on the rear that sit in line with each other. The openings on the front elevation are larger in size and show evidence of timber sliding panels. On the east elevation, there is a high-level opening that currently contains timber doors, covering the opening. There are remnants of the timber window frames above some of the large openings with some panels still including glass. A small ventilation slit is present on the west elevation.

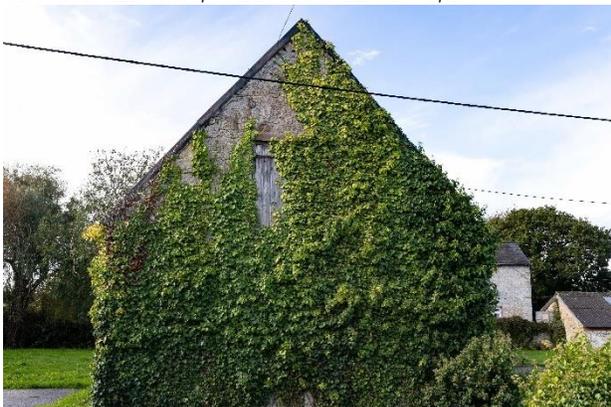
FIG 6: EAST ELEVATION, TIMBER DOORS BEHIND IVY, BARN

- 3.3.4.7 Timber doors on elevations, **LIMITED**: Adds character to the building however not in a current state of use. Adds to the agricultural appearance to the barn.

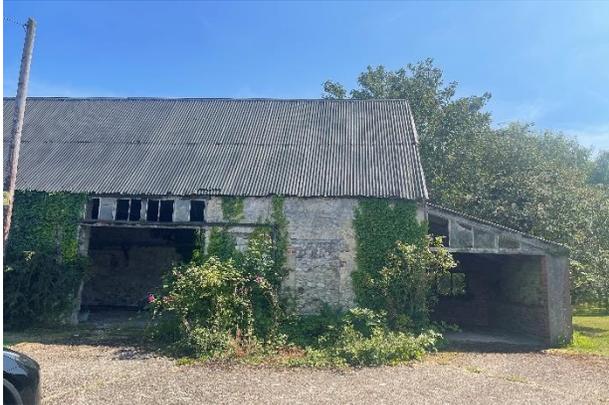
FIG 10: LEAN-TO GARAGE, BARN

- 2.13 The lean-to is a brick structure with a concrete render on the exterior. The roof is corrugated sheet material that includes a high-level timber window on the front and a timber window on the rear.

- 4.3.10 To improve the appearance of the lean-to structure and therefore provided a benefit to the Listed Building, a natural timber cladding is proposed to be installed, tying into the large sliding doors that are also proposed. Although a more modern material, the existing concrete render does not provide a visual benefit to the main barn structure.

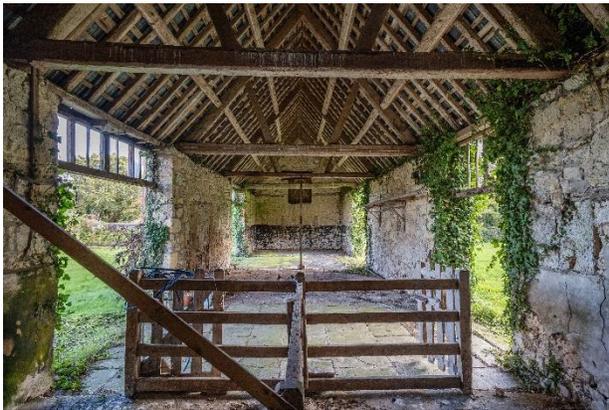
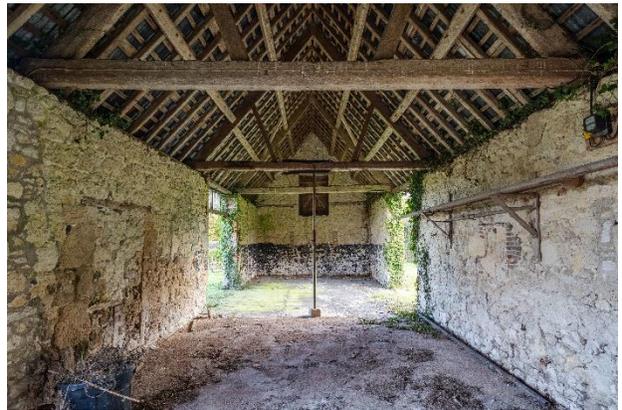
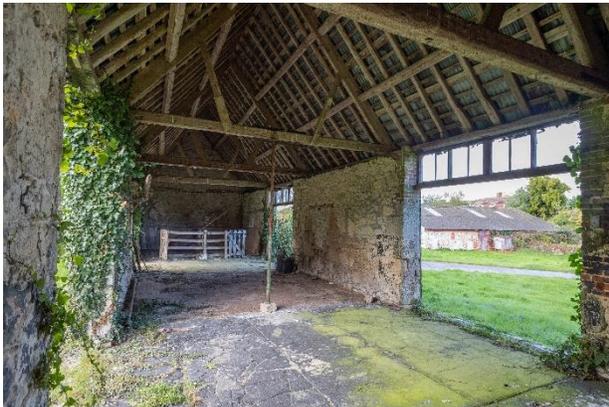
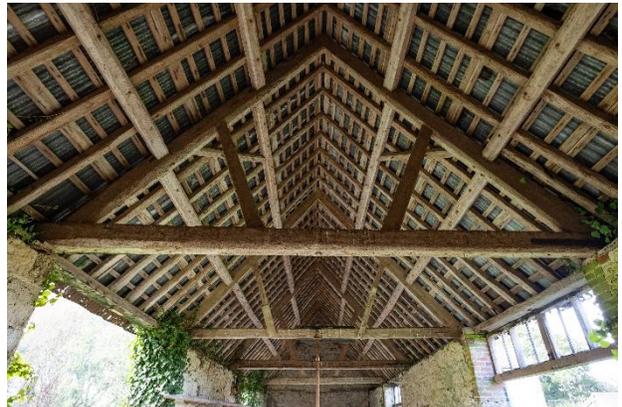
- 2.15 Four Queen post timber roof trusses dissect the plan to give five bays of the barn. The cart entrances mostly align within these bays. As noted in the Listing, there is an additional row of timber purlins connecting the structure, as shown in FIG 13-16.

- 3.3.4.3 Timber roof supports, **SIGNIFICANT**: Four queen post timber roof trusses, leading to the creation of five defined bays within the barn. Openings align with the location of the cart shed bays. Two tiers of timber purlins exposed. Noted within the Listing and significant to the internal appearance of the barn.

- 4.3.8 As the roof trusses were noted as having significant impact to the heritage value, these have been a driver for the division of the internal space, maintaining the bays that are present. The decision to not connect the two first floor levels was made as it was deemed that the impact on the roof structures would be significant resulting in alterations to the appearance of the trusses as well as being overbearing and dominating within the space. Therefore, two separate staircases have been proposed at either end of the barn to allow for each area to be accessed independently, having no impact on the roof trusses. Additionally, the proposed wall is set behind the roof truss allowing the four trusses to be read within the same space.

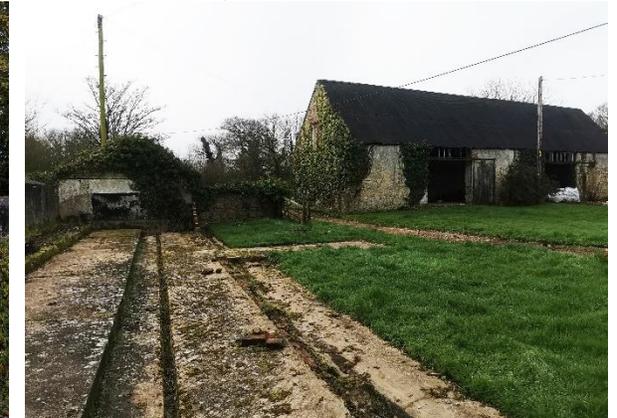
FIG 27: CONCRETE BASE, SITE

- 2.6 A concrete base is present where a building once stood within the site. From the remnants of the stone gable, connected to the stone wall running east, and the size of the stepped concrete, it can be inferred the building was connected to the existing stable building and was around 18m long.

- 4.3.13 The location of the proposed garage & workshop has been decided using the existing concrete base and evidence of a structure present on the historic maps. Proposing this structure aims to keep any paraphernalia often associated with dwellings condensed and in keeping, avoiding the need to have sheds and storage boxes within the gardens. This also will reduce the potential impact that cars can have on the Listed building by being tucked away in a well screened area of the site. The materials have been chosen to work alongside

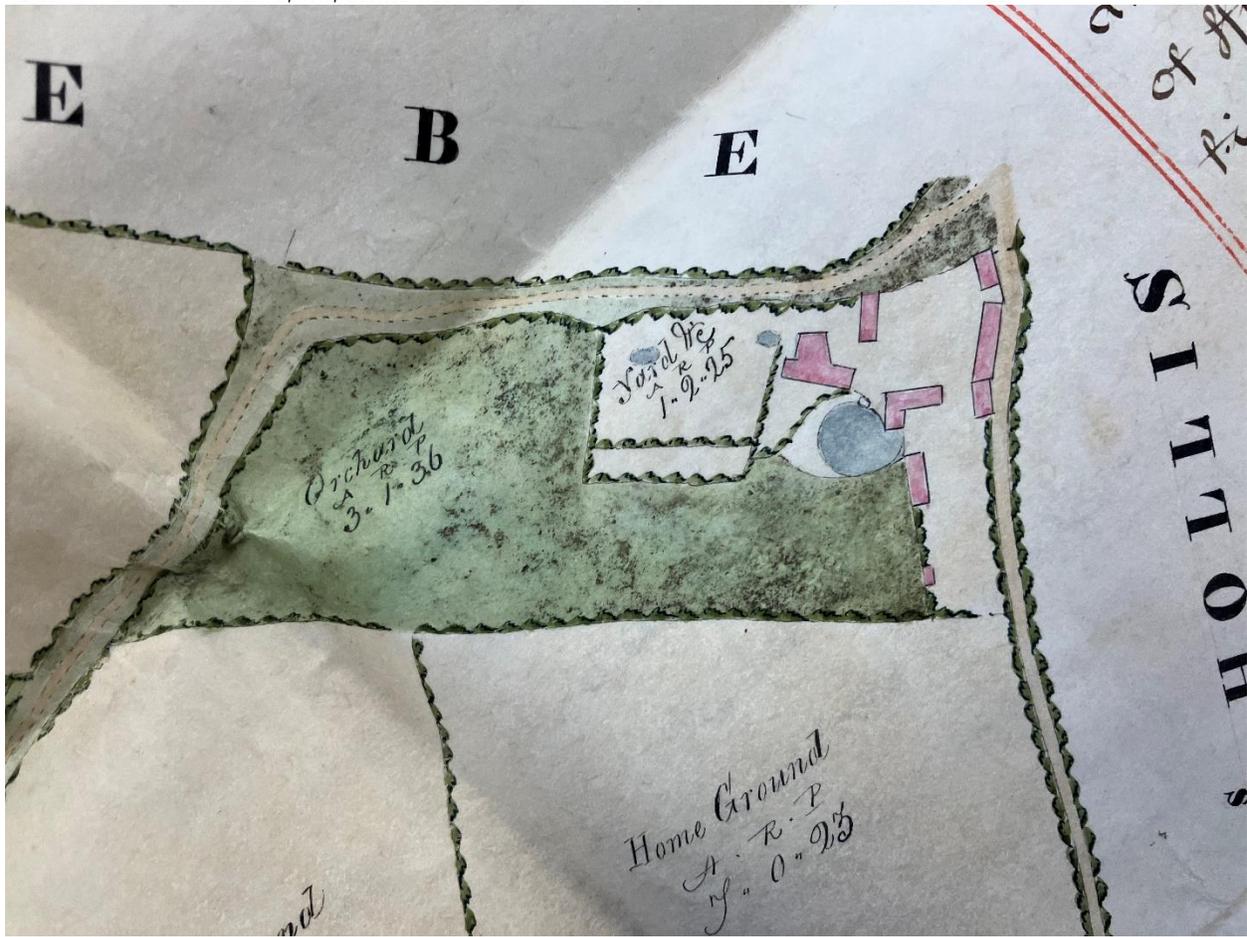
FIG 33: MAP OF WARLANDS LAND, 1819, SOURCE WEST SUSSEX ARCHAEOLOGY VIA THE ISLE OF WIGHT RECORD OFFICE.

- 3.2.7 There is evidence within historic maps shown in FIG 33 & FIG 34 that the block plan of the barn has altered over time with portion to the south of the barn having been lost prior to 1862. With a stone wall running to the south evident within the site at present, where there has been a boundary here noted on many of the historic maps, it is unknown if parts of the wall remaining formed part of the building area that was lost. There was a small square structure to the west of the barn that was last evidenced in FIG 36 in 1898. The form of the barn appears to have remained as that shown in FIG 38 with the area of the single storey garage structure shown as currently on site.

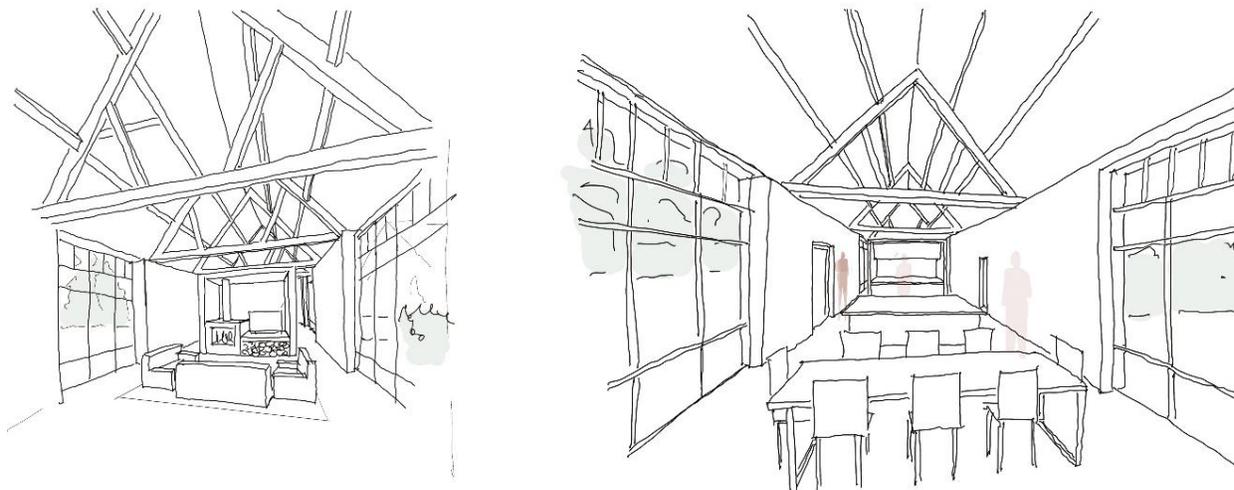
FIG 39: INTERNAL SKETCHES OF LOUNGE &amp; DINING AREA

- 4.3.6 Entering the vaulted lounge space, a central 2.3m tall wall that houses a log burner and storage space, separates the kitchen and lounge without feeling like an imposing addition given its lower height. Heading to the west, the kitchen and dining area floats in the centre of the vaulted space, connecting to the gardens to the north and south. This area lies within the central three bays of the barn, denoted by the historic roof structure (3.3.4.3). FIG 39 shows two internal sketches, highlighting how the trusses will remain the most visually striking part of the design with the vaulted roof, and how the internal spaces connect with the surrounding gardens.
