ALEX WENHAM LTD

Heritage Statement

Magdalen College

Replacement of missing carved beast to the Muniment Tower

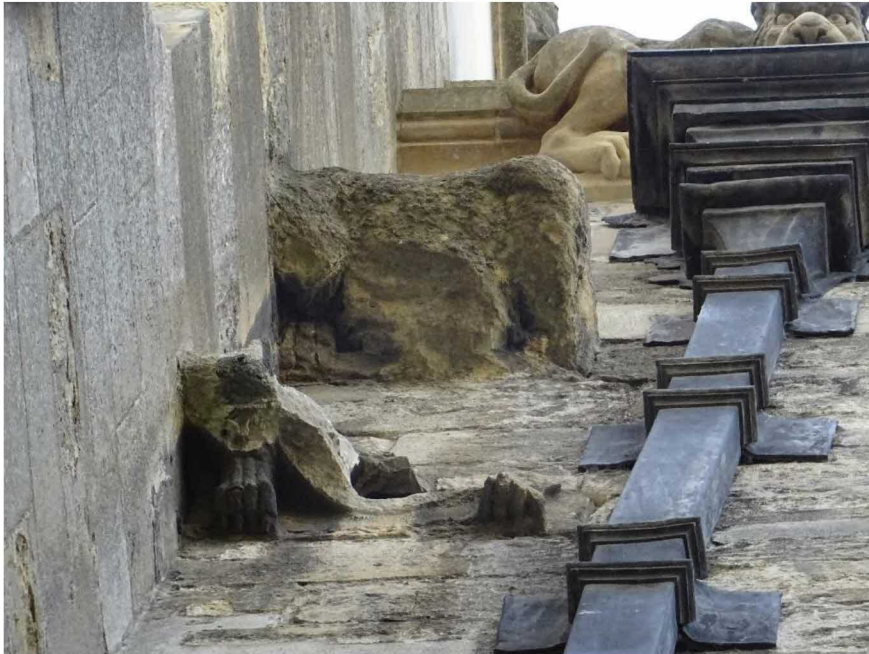
Fig 4: clawed paws and rear haunches

The remaining shapes offer the following evidence in support of this. The upper fragment appears to show the haunches and hind feet of a creature (only one now remaining). The lower fragment has two front paws with claws:

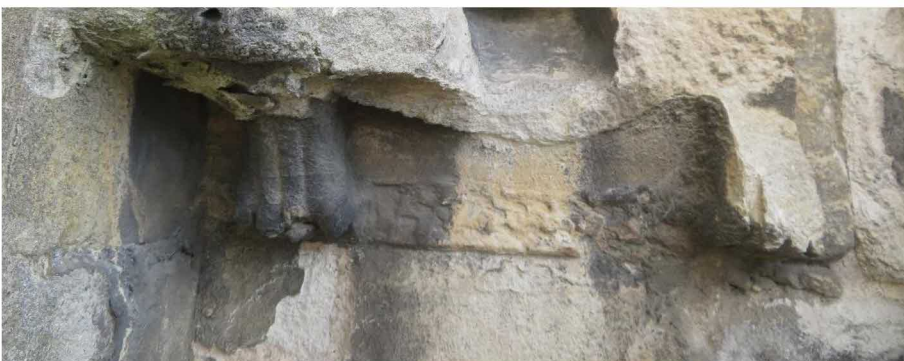
Fig 8: textured band

Other evidence on the lower stone includes a band of textured detail along the lower edge of the face of the stone between the paws – this is not part of the carved creature, but is suggestive of locks of hair:

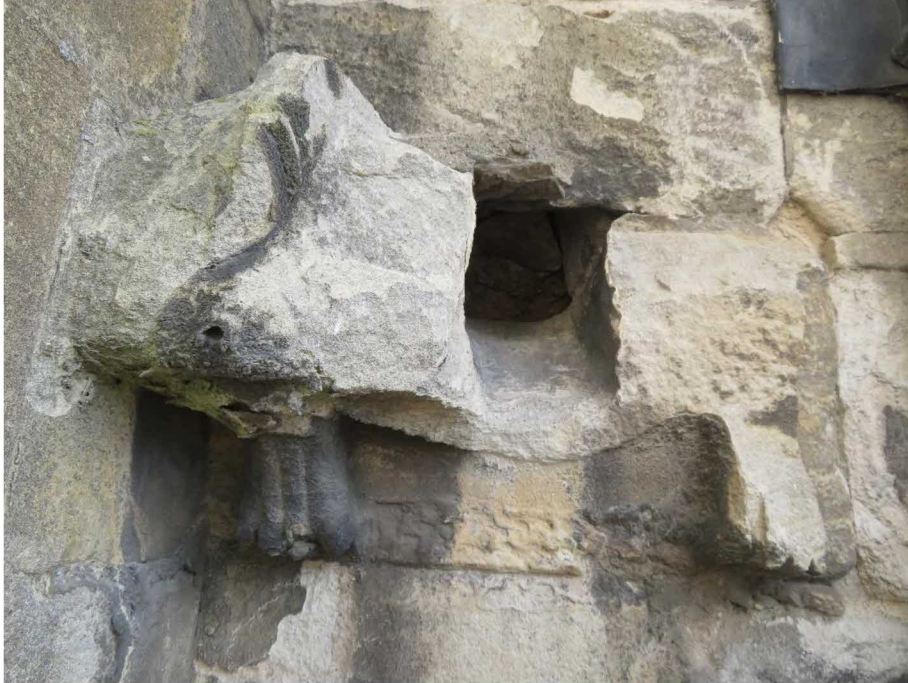
Fig 9: central hole/spout

In the centre of the lower stone a large hole rakes back and upwards behind the wall-line up to the top bed of this stone, at which point it is capped-off with lime and rubble:

The strong implication of this hole is that it was once a water-spout evacuating rainwater from the roof above, and that the carved creature was, in fact, a true gargoyle.

The outlet is now closed, and evacuation now happens via an adjacent lead downpipe – also indicating that the roof gulley drains towards this corner: further evidence in support of this creature being a water-spout.

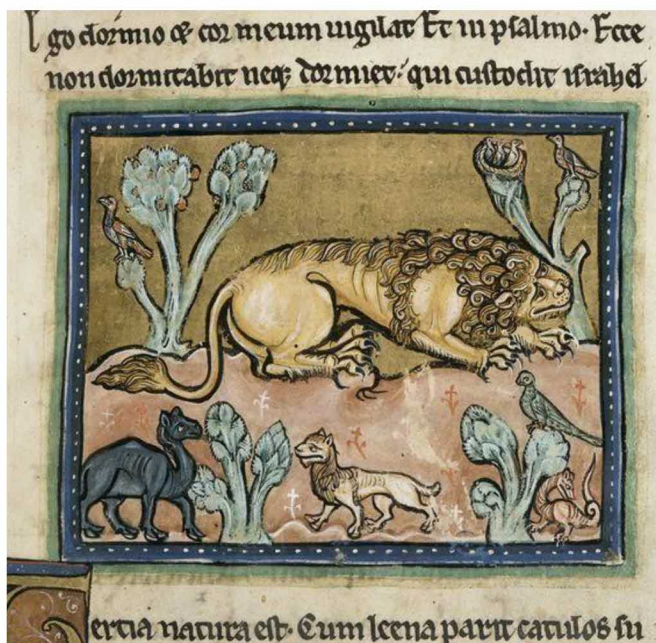
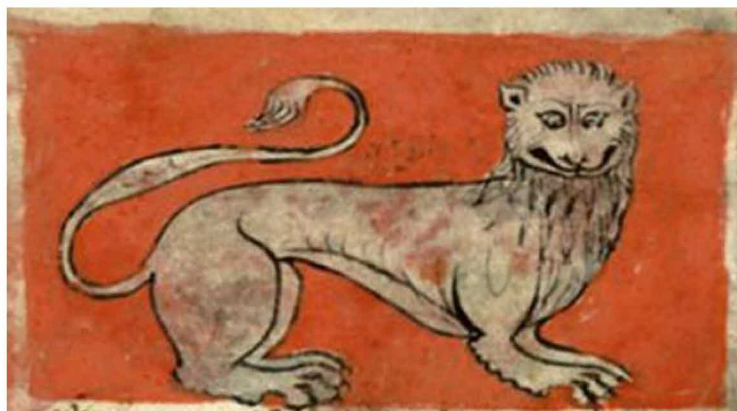
Figs 12,13,14: late medieval lions with pinched waists

It may seem strange that the carving did not engage with the wall-line in this area. However, when we consider that (a) William Orchard had already been experimenting with suspended flying stonework in the flying spandrels of the Founder's Tower and Chapel door, and (b) in the Middle Ages lions were often portrayed with very elongated, pinched waists, it is possible to imagine that the missing area was a slim waist of a lion, engaged only with the top and bottom ends of the carving, and not the wall:

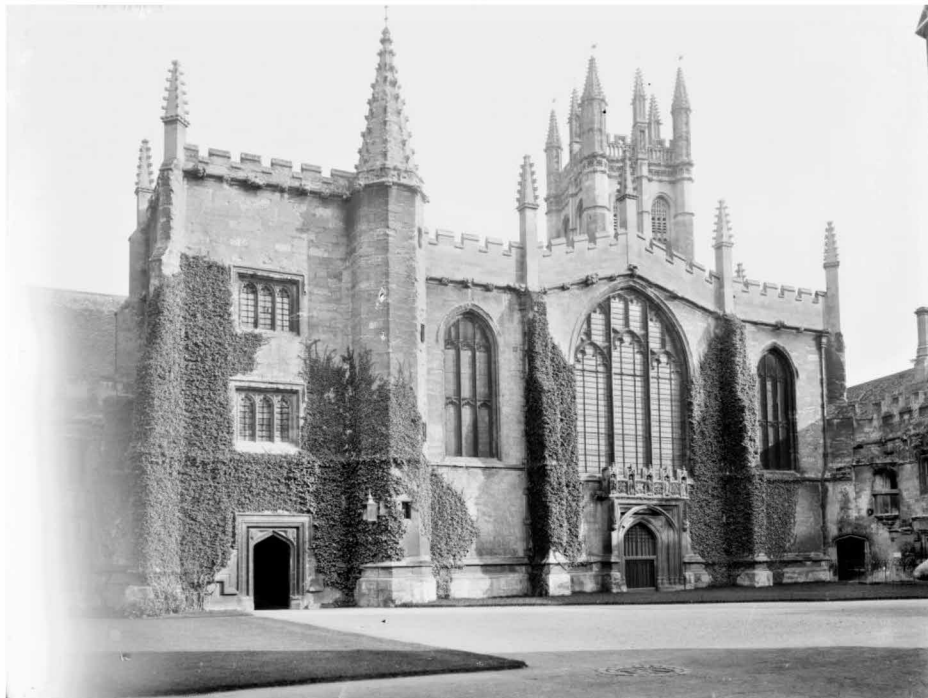
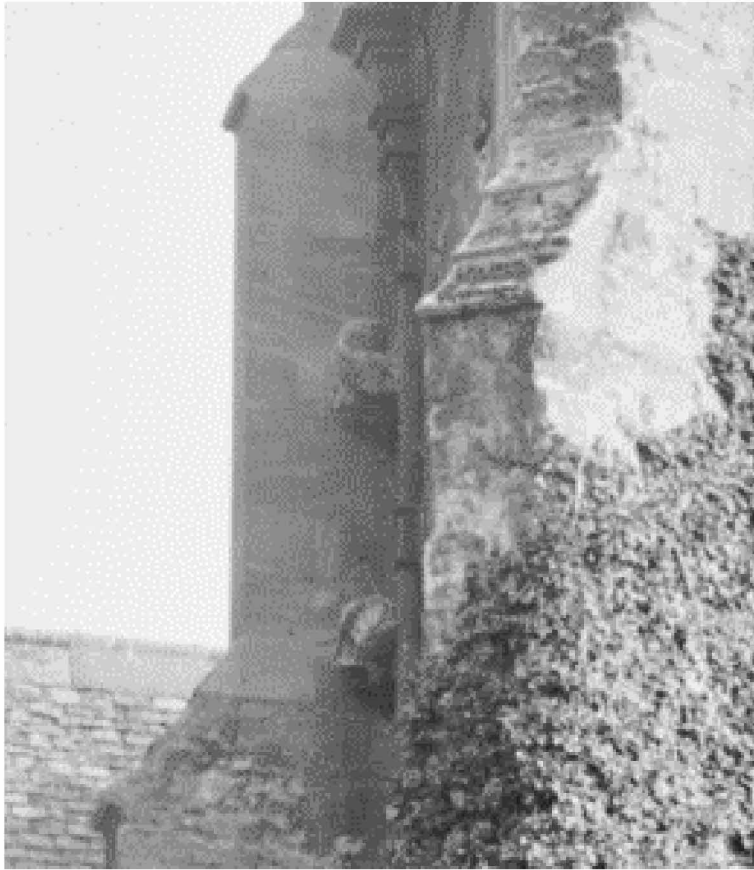
Fig 16: Historic England archive cc50_00168

The first is this photograph (this one is the clearest of a series of three, of which only one is shown here), from the ever-giving Henry Taunt archive held by Historic England:

The above photograph was used to create the mock-up sketch of the lion shown above. It appears to show clearly in profile the haunches of a large animal in the upper stone, and the open-mouthed face of the same creature lowermost.

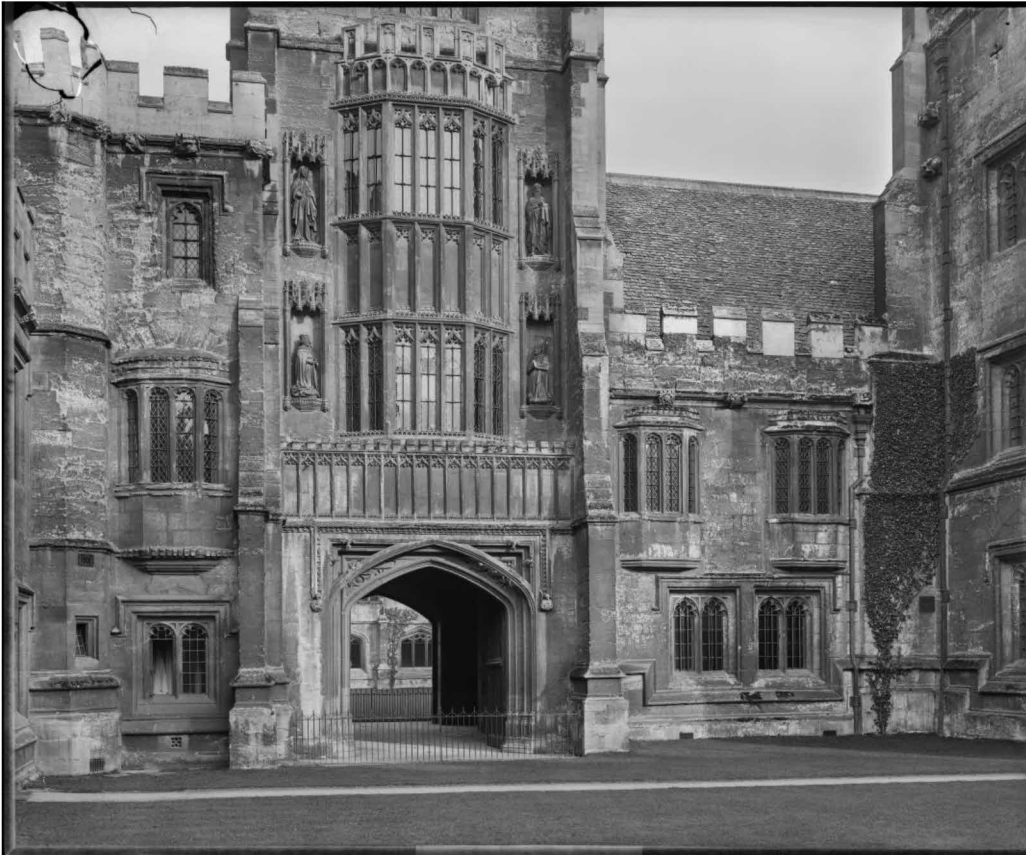
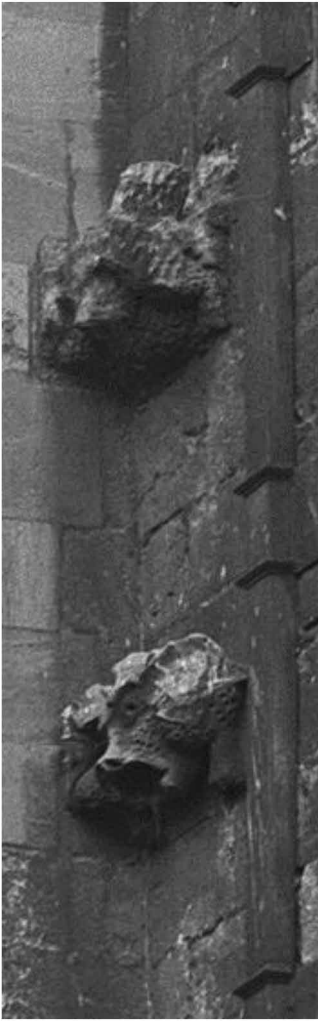
Fig 18. *Country Life*, June 26th, 1915 – from Historic England archive image 4910_100

This image shows a bit more detail of the remaining face area of the creature, with an open mouth around the water-spout. A bulged area in the foreground of the lower stone may represent a weathered area of lion's mane, overhanging the foremost paw here.

The upper stone is more problematic here. It is already fairly decayed by this date. Foremost and rearmost in the upper area in this image are the haunches of a creature. What is more problematic is that the central area of this remaining fragment appears to be in the rough shape of a decayed animal's face – which is problematic for our interpretation of this fragment as the hind-quarters of a single larger animal.

On balance we have concluded that this area shows an area of the creature's waist, with the broken-off remnant unfortunately decayed in a shape suggestive of a face. However, I acknowledge that this is not a clear-cut interpretation and either reading may be possible.

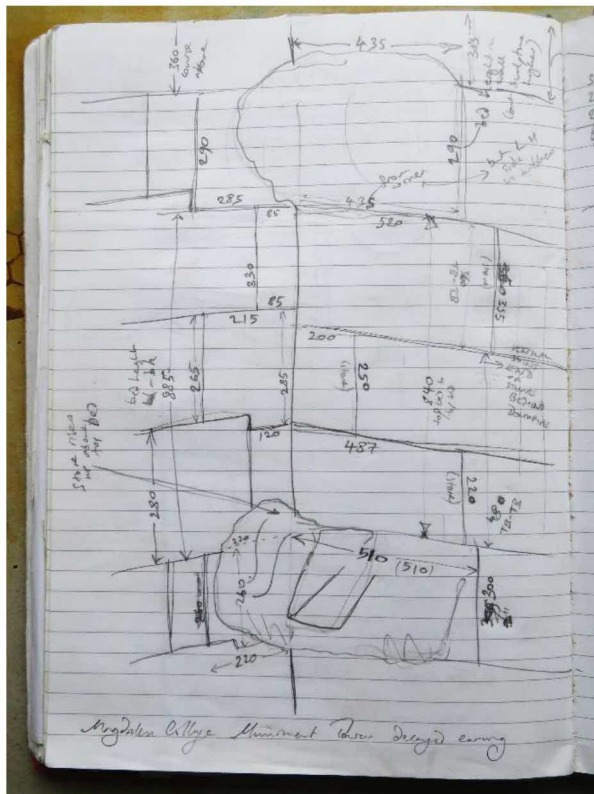
Figs 20,21: stonemason's notebook

An access scaffold was erected in May 2023. First, the joints and all relevant dimensions and distances were measured and recorded. See below for stonemason’s notebook images showing all measurement data from original stonework:

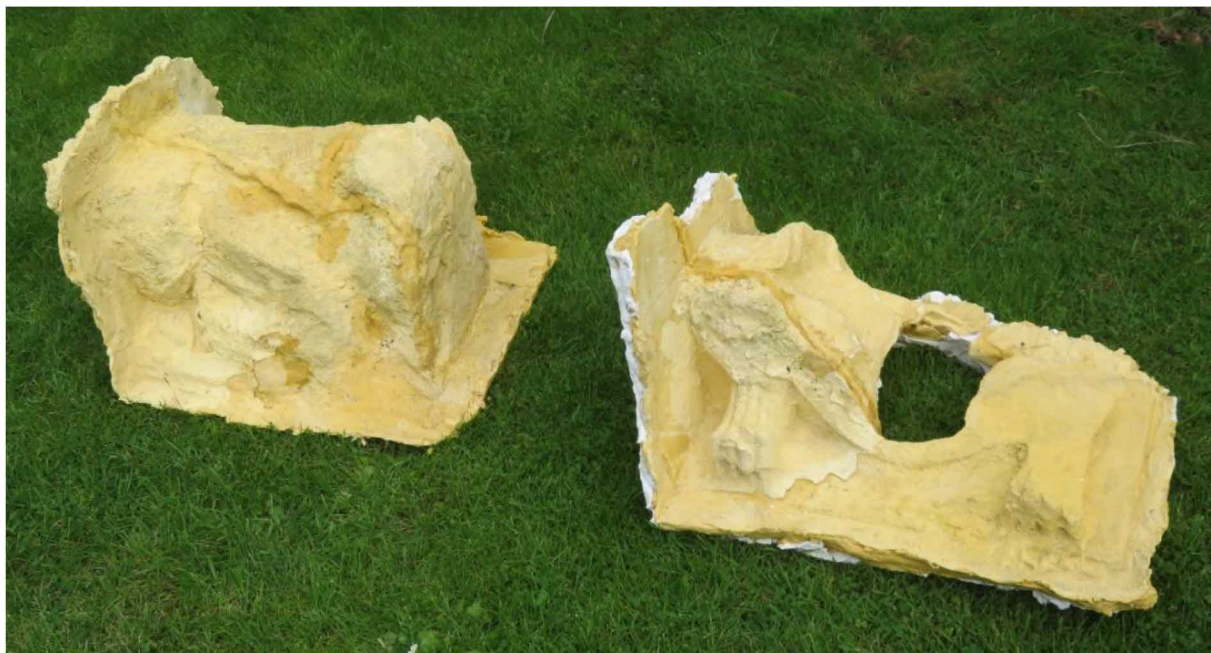
Fig 22: cast copies of upper (L) and lower (R) remaining fragments of carved detail

Next, silicone moulds were made of the remaining fragments of the original stonework, and at the workshop these moulds poured with plaster to create faithful replicas. A buff-coloured pigment was added to the casting plaster:

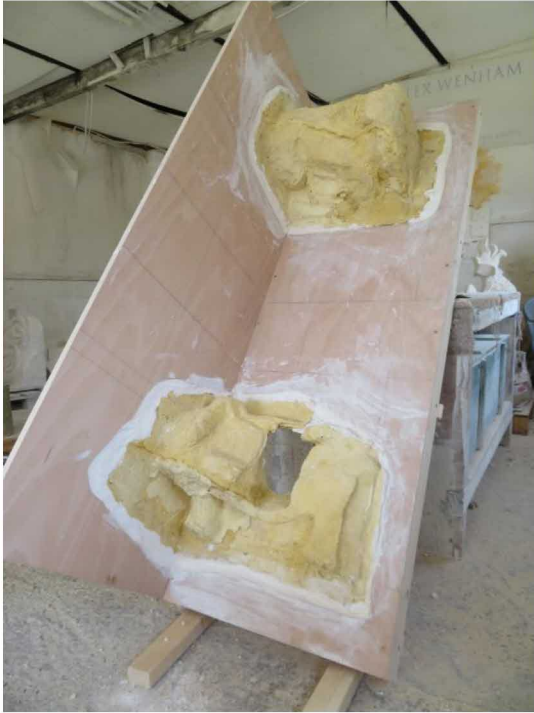
Fig 23: casts set into replica of wall area

3. Mounting casts: A plywood structure was created replicating the nook of the wall/buttress. Joint positions were marked onto this, and the plaster casts were mounted into this in their respective orientation and location:

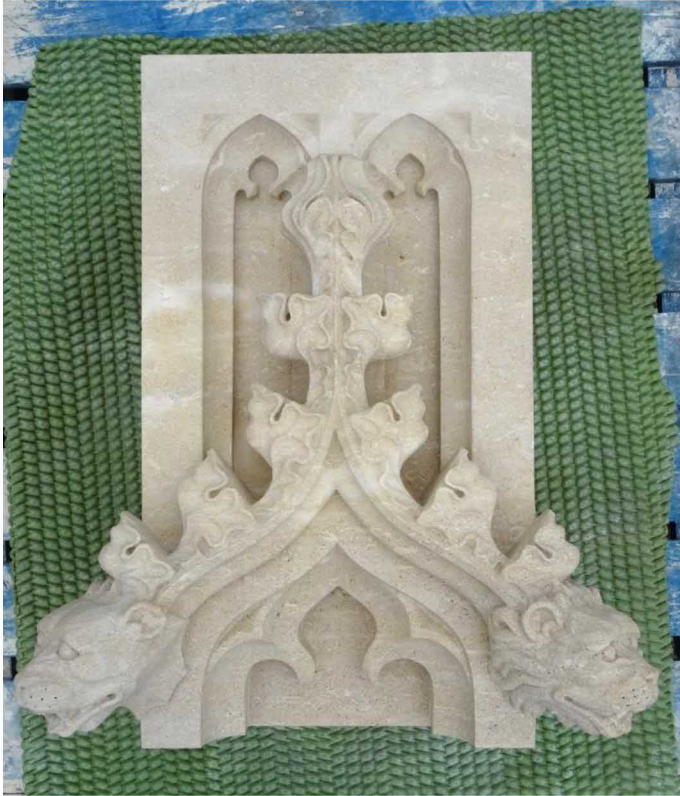
Fig 29: Cadeby bed 4 in use for Parliament project (carving by me)

This stone also has the advantage of good bed height of the available blocks, being able to reach a little over a metre.

This stone has been used successfully recently for the ongoing restoration works at the Houses of Parliament:

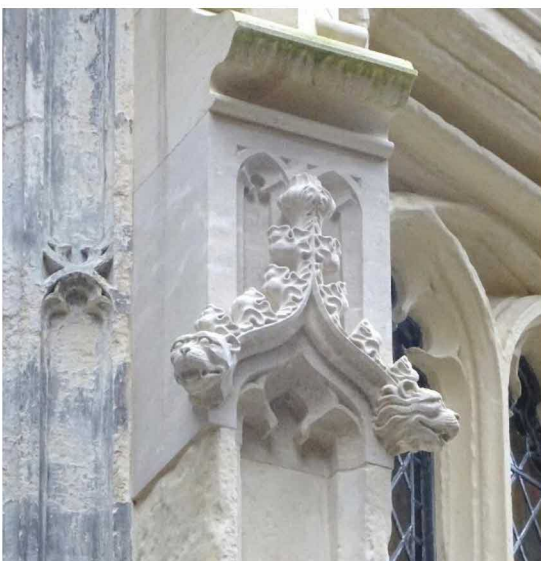
Fig 30: Cadeby bed 4 in use in Houses of Parliament (Cloister Court)
