GEO-ENVIRONMENTAL SITE ASSESSMENT  
UYS FACILITY  
GARSINGTON ROAD  
COWLEY. OX4 2BW

DATE OF ISSUE: AUGUST 2021

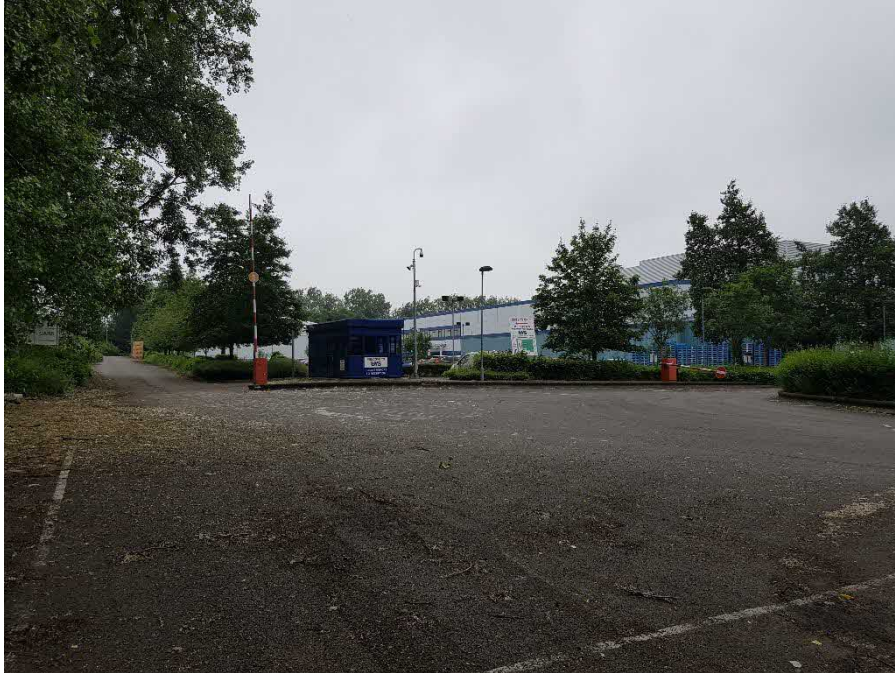
Photo 1: Access to the UYS building, facing NE

The site is approximately square shaped, measuring 2.33ha with maximum dimensions of ~150m NE to SW and ~160m NW to SE at the maximum dimensions. Access to the site is via Oxford Road along Transport Way through the Unipart Security Gate. Access to the site is in the western corner (Photo 1). It currently comprises a central industrial workshop (approximately 95m<sup>2</sup>) in the central and southeast area of the site. A second industrial building (approximately 30m<sup>2</sup>) lies in the northern corner. The north-west portion of the site comprises a car park area with hardstanding and hard-standing access road around carpark and both buildings (Photo 2).

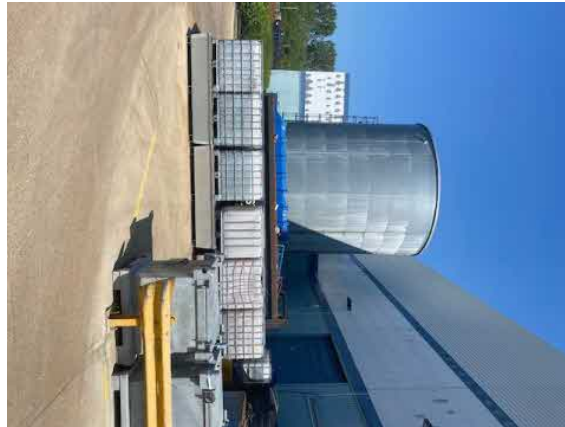
Photo 3: 6no. IBC containers, facing NW

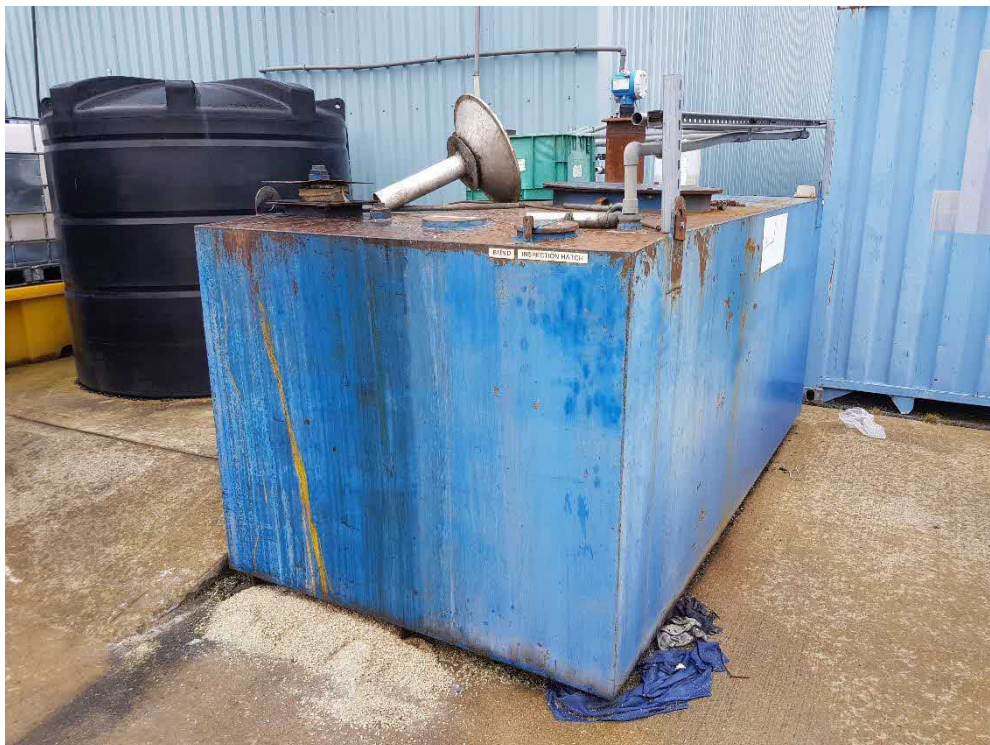
Photo 4: Waste water/oil Above Ground Storage Tank

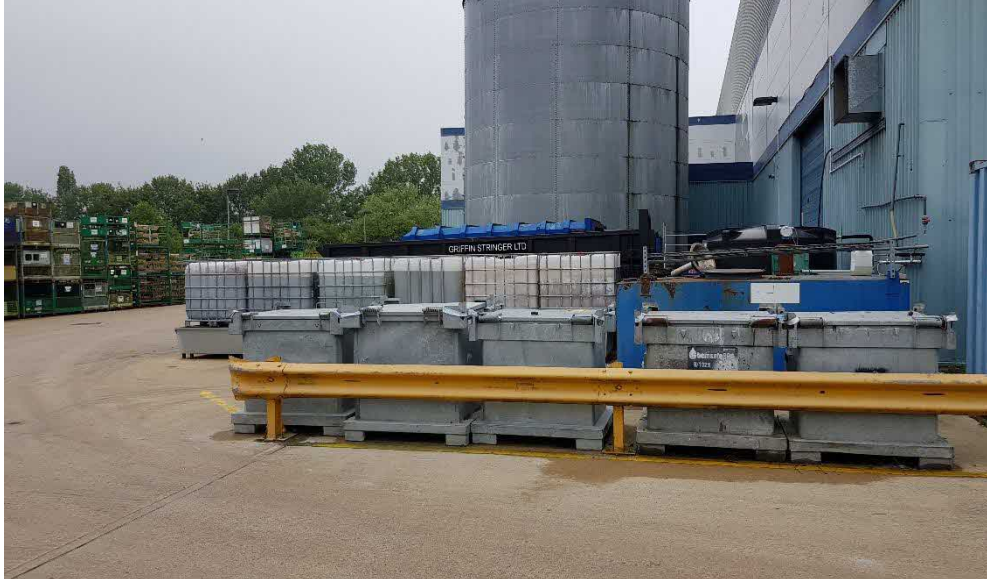
Photo 5: 5no. steel storage containers with IBC's and Storage tank, facing NW

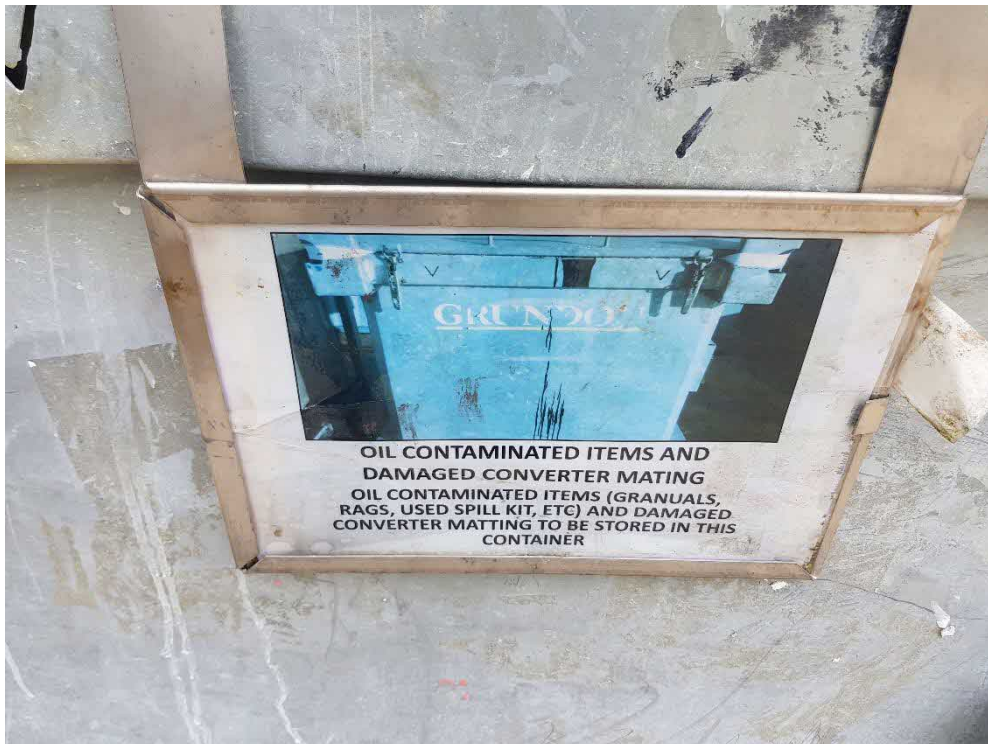
Photo 6: Steel storage container for waste oil materials

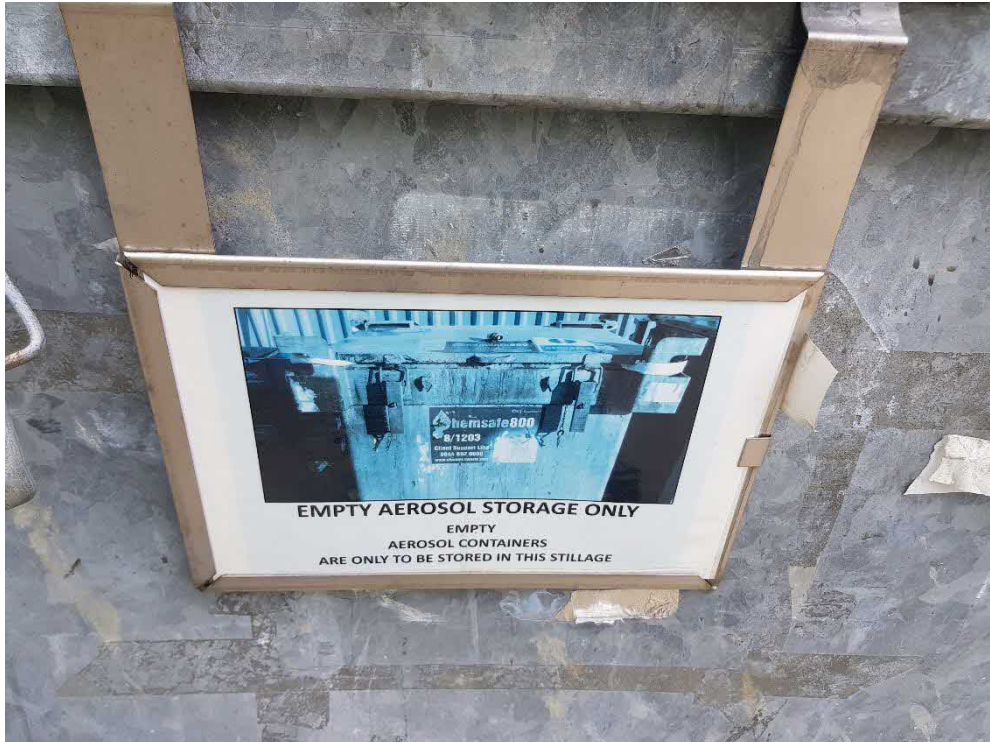
Photo 7: Steel storage container for empty aerosols

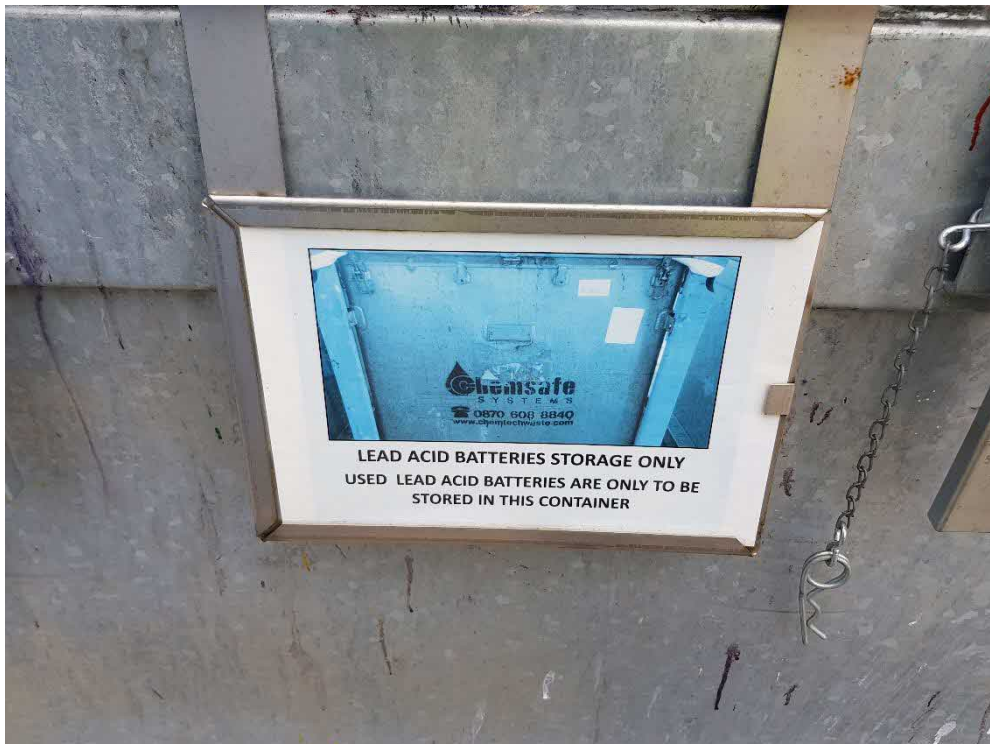
Photo 8: Steel storage container for lead acid batteries

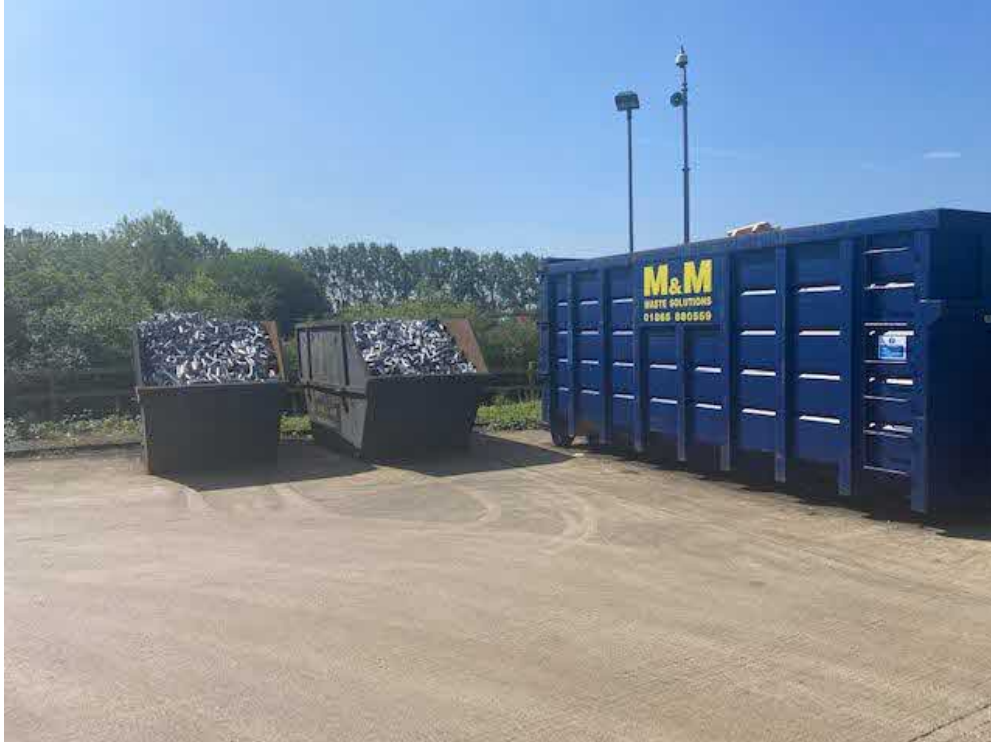
Photo 9: 2no 12-yard skips for metal waste

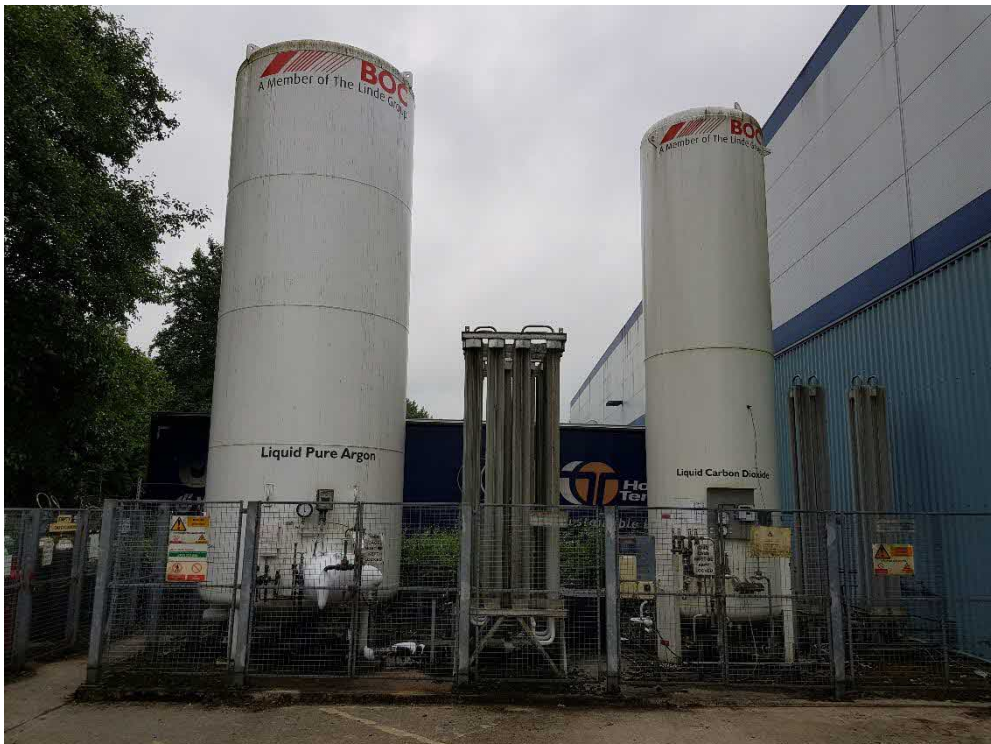
Photo 10: Liquid argon and carbon dioxide tanks, facing SE

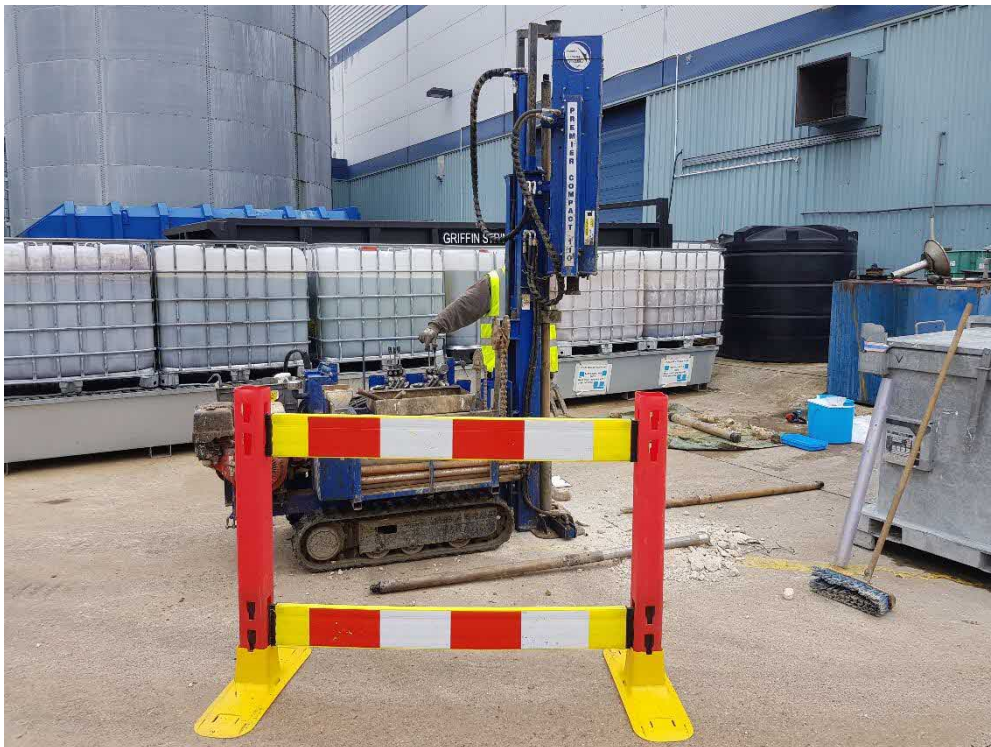
Photo 12: Window Sampler rig at BH4

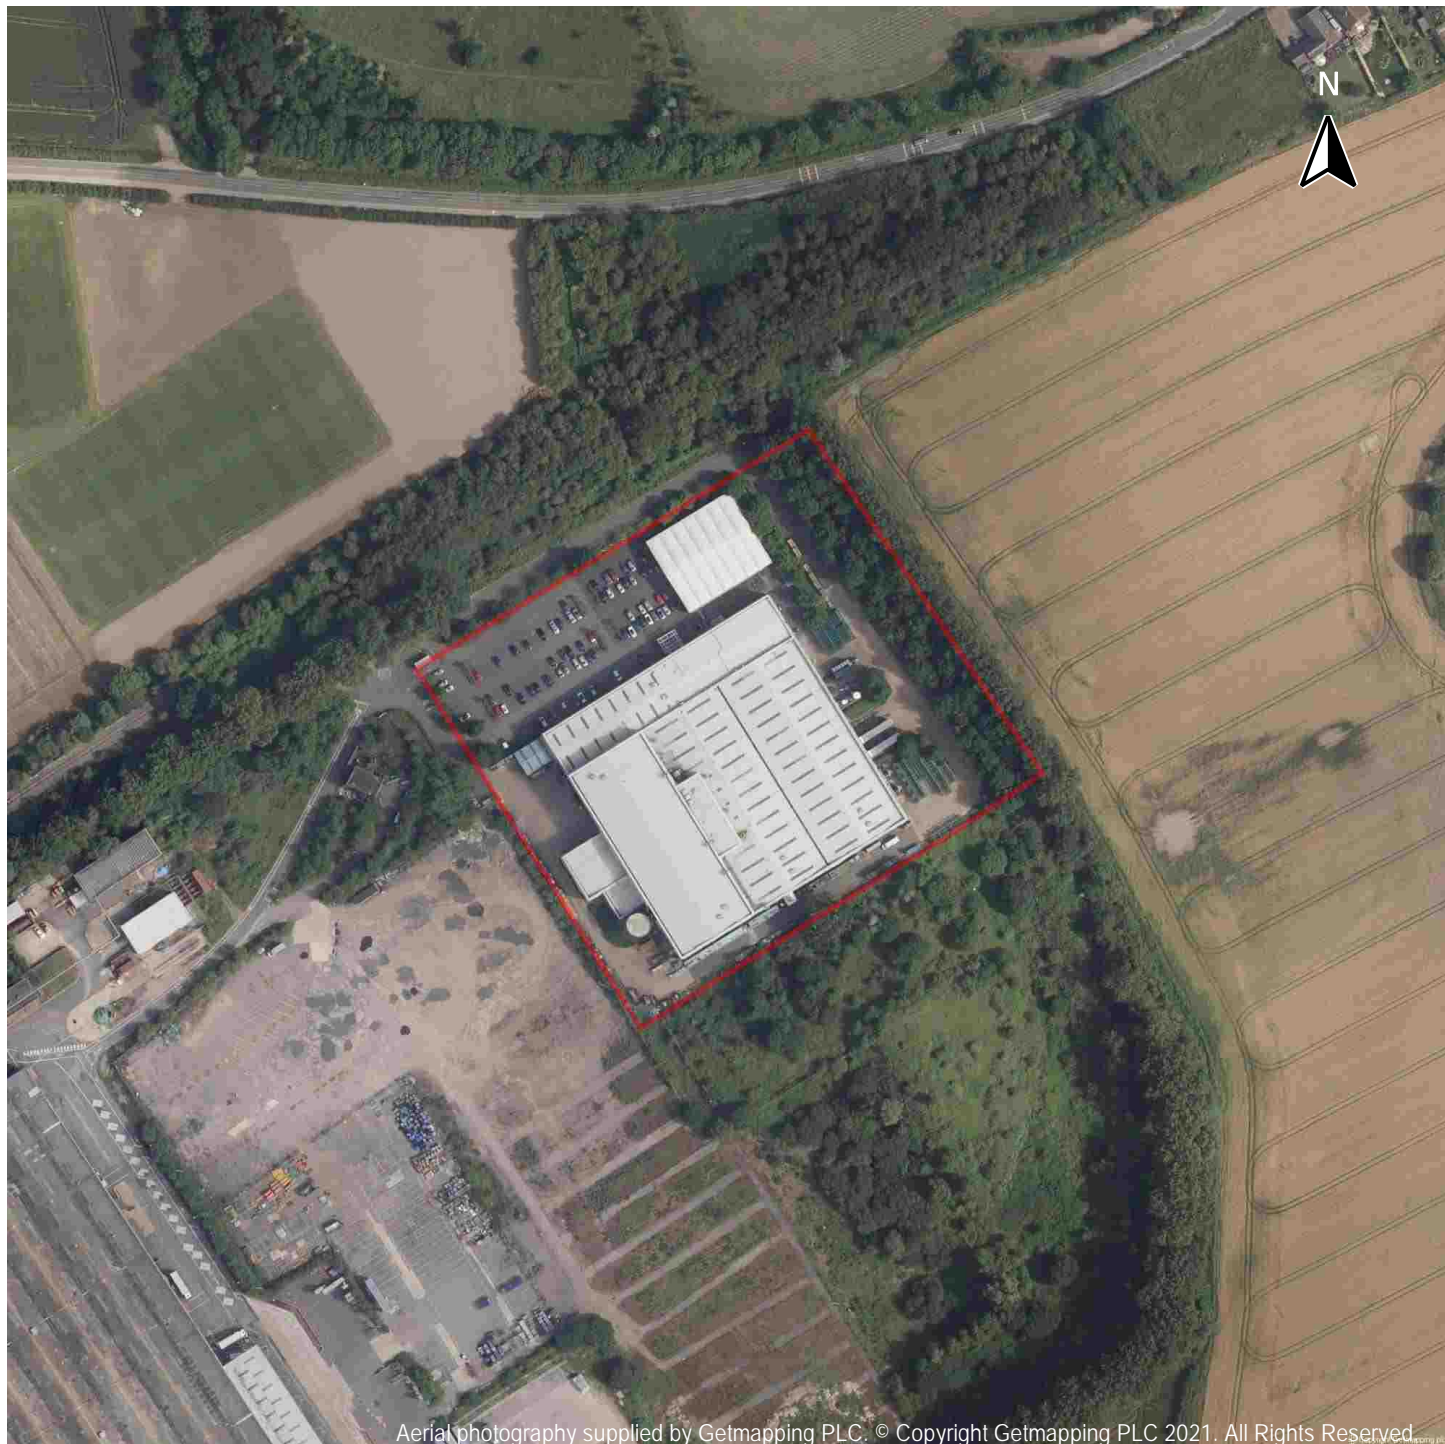
## Recent aerial photograph

Capture Date: 05/07/2019

Site Area: 2.64ha

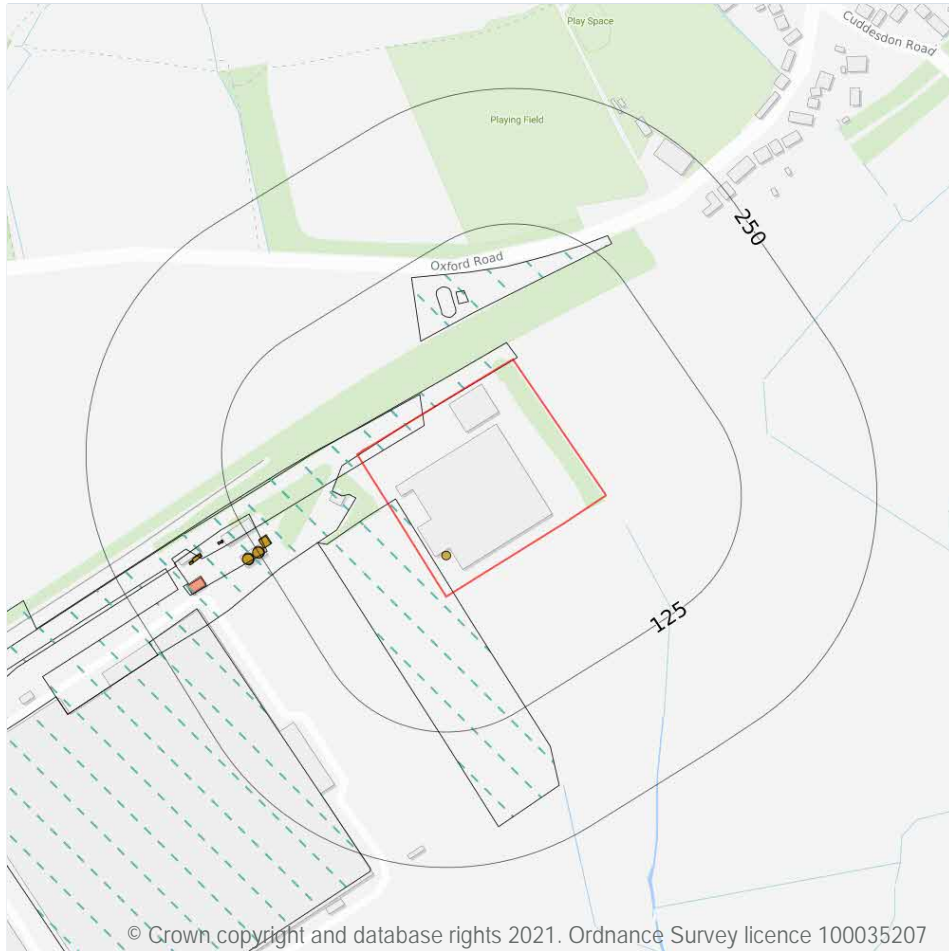
### Past land use

### Former industrial land use (1:10,560 and 1:10,000 scale)

These historical land uses have been identified from 1:10,560 and 1:10,000 scale Ordnance Survey maps dated from the mid to late 1800s to recent times. They have the potential to have caused ground contamination. Please see the Environmental Summary to find out how these could impact the site.

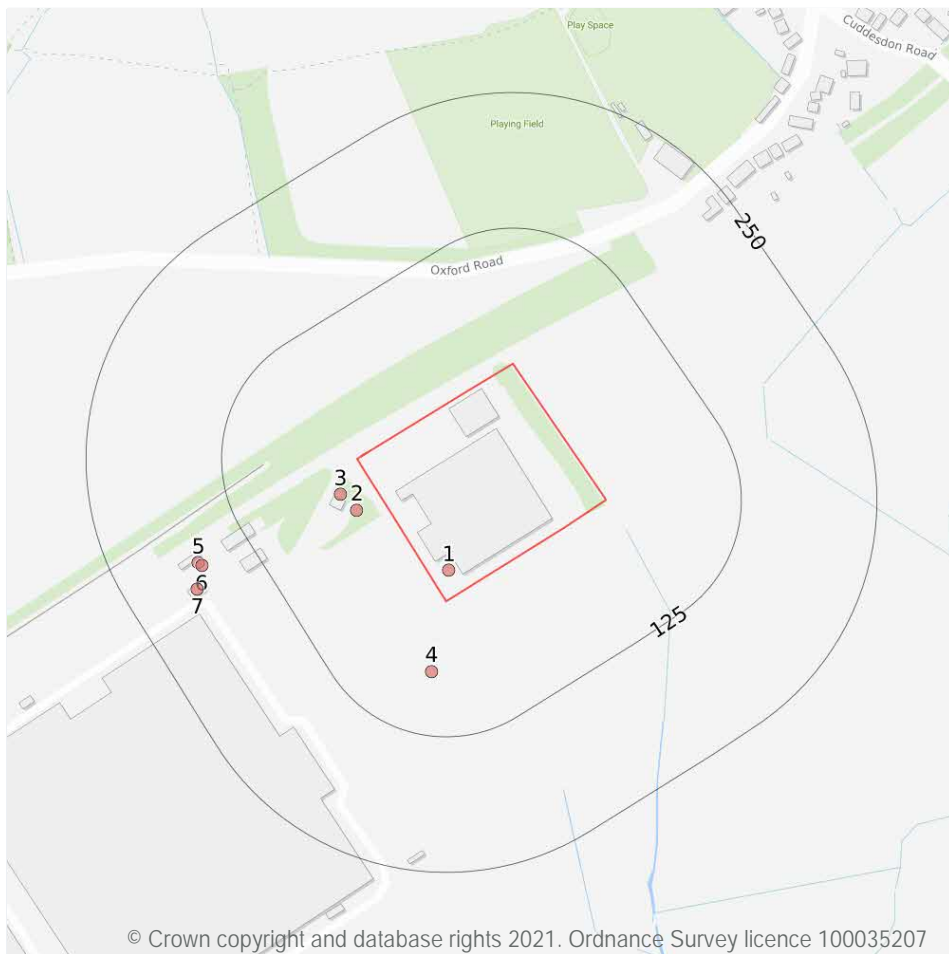
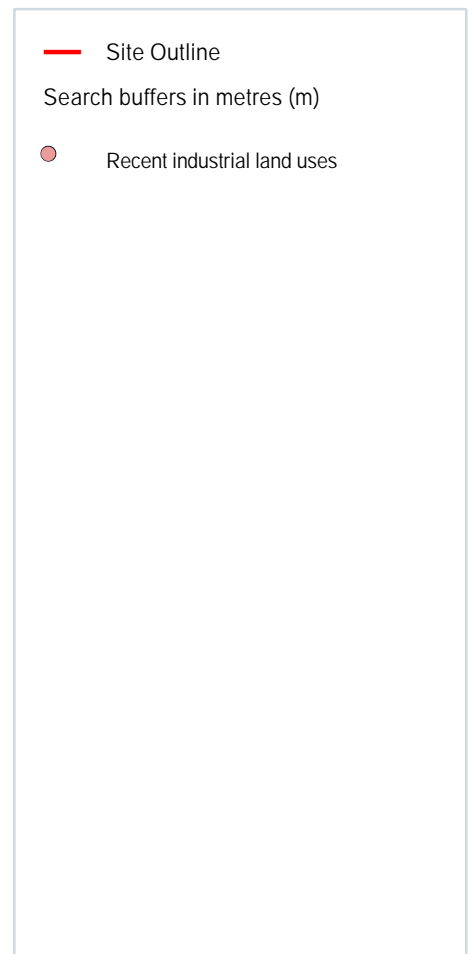
## Current and recent industrial

### Recent industrial land uses

These records show details of businesses that have recently operated, or are currently operating in the area. Depending on the type of activities taking place, some of these businesses could present a risk of contamination.

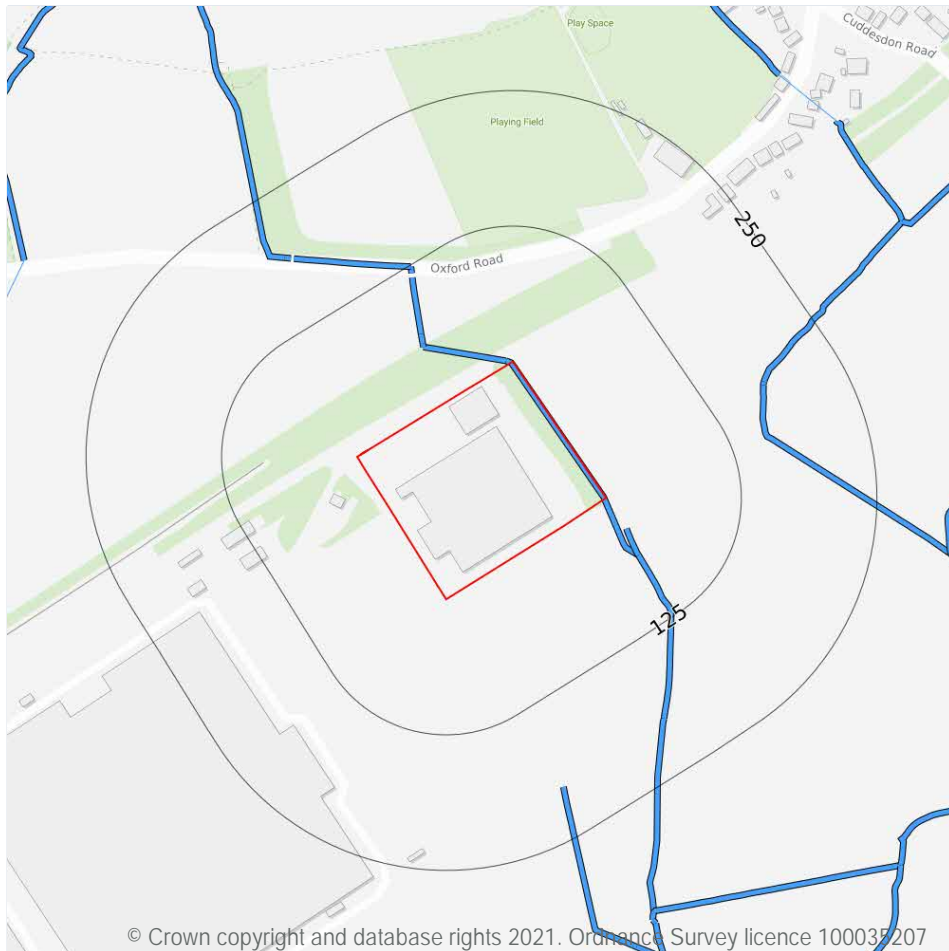
## Hydrology

### Water courses from Ordnance Survey

These are water features such as ponds, lakes, rivers and streams that have been identified by Ordnance Survey. These features may be sensitive to contamination.

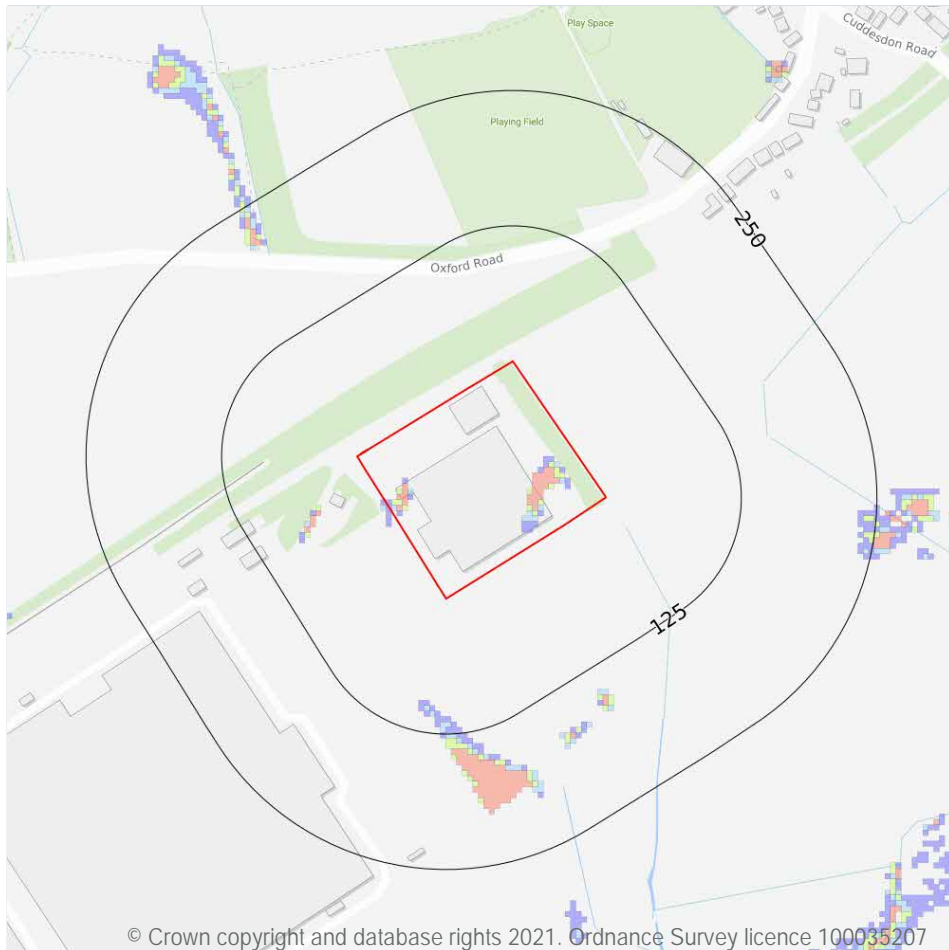
### Surface water flood risk

#### Surface water flood risk

The property is likely to be prone to flooding following extreme rainfall, which may have an impact on insuring the property against flood risk.

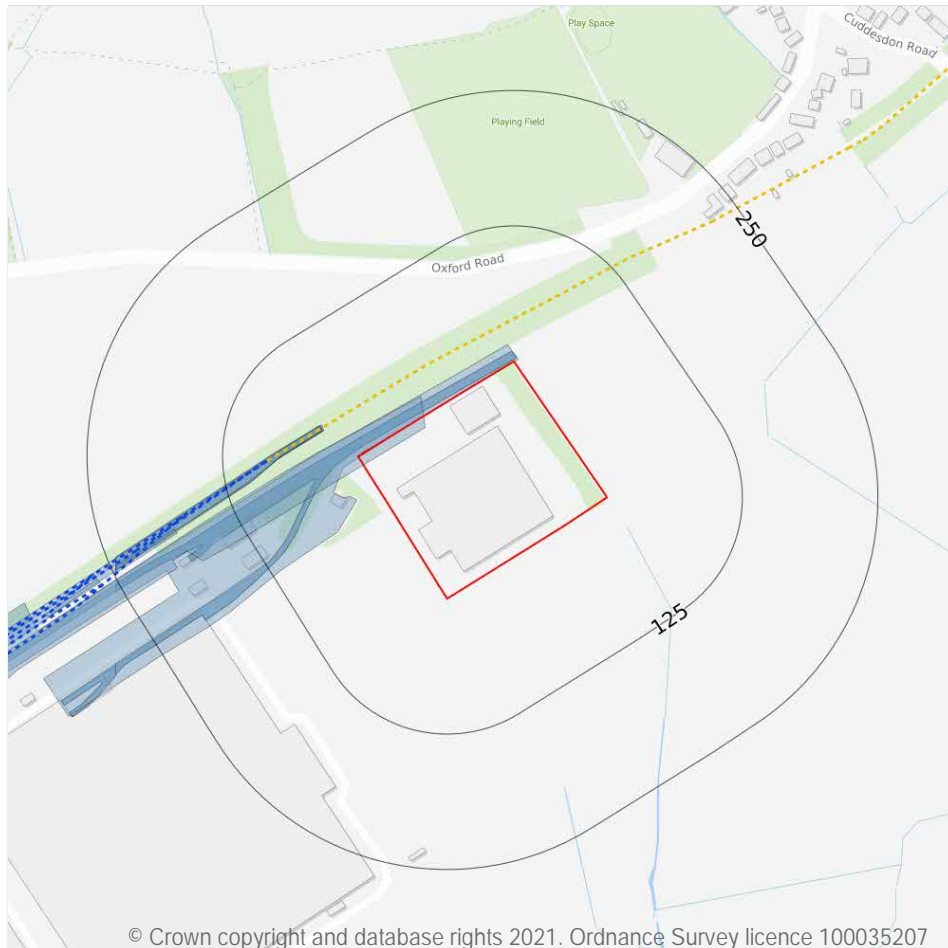
### Railways and Underground

#### Active railways

The property is within 84 metres of an active railway line. Noise from railways varies significantly depending on the condition of the track, the conditions of the trains using the track and the speed of travel.

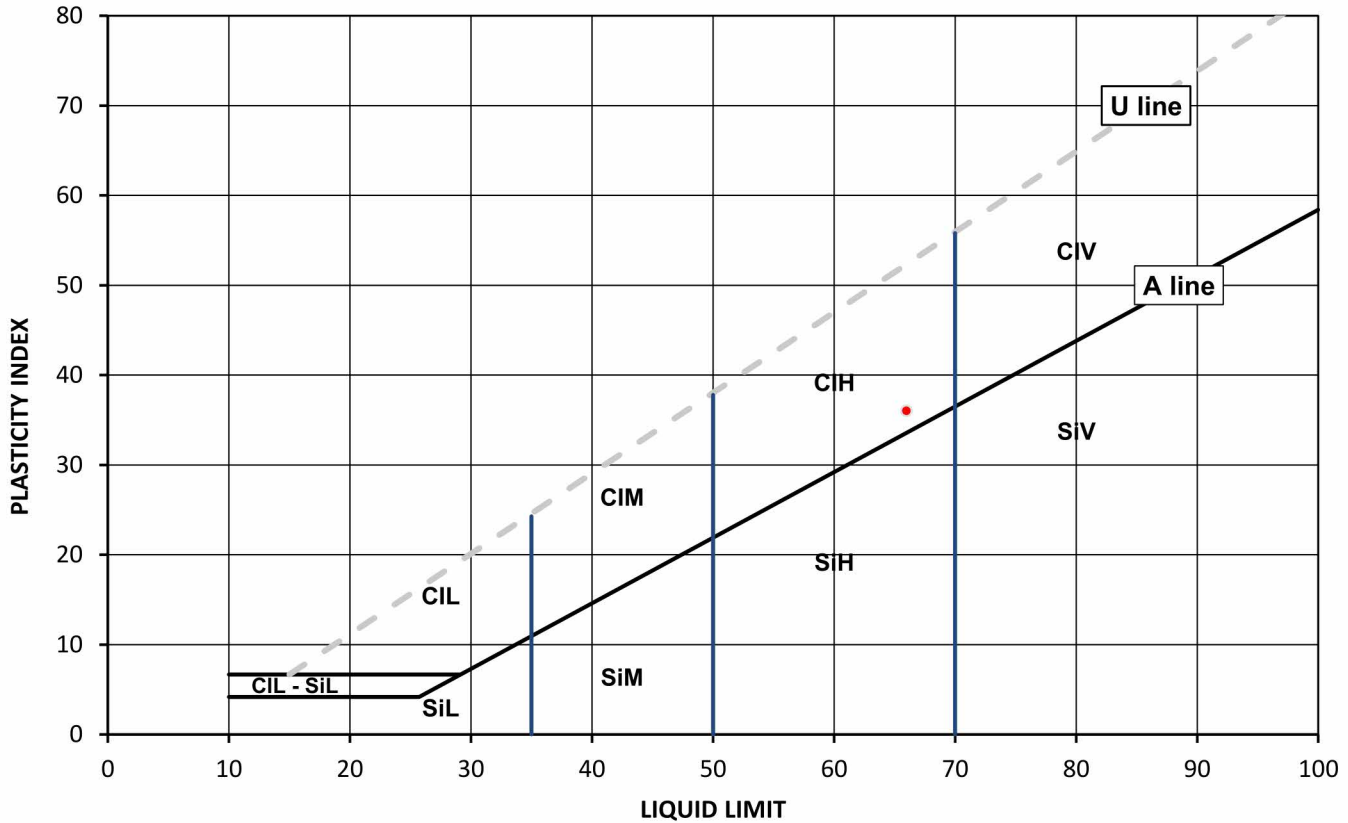
As Received Moisture Content [ W ] %	Liquid Limit [ WL ] %	Plastic Limit [ Wp ] %	Plasticity Index [ Ip ] %	% Passing 425µm BS Test Sieve
34	66	30	36	100

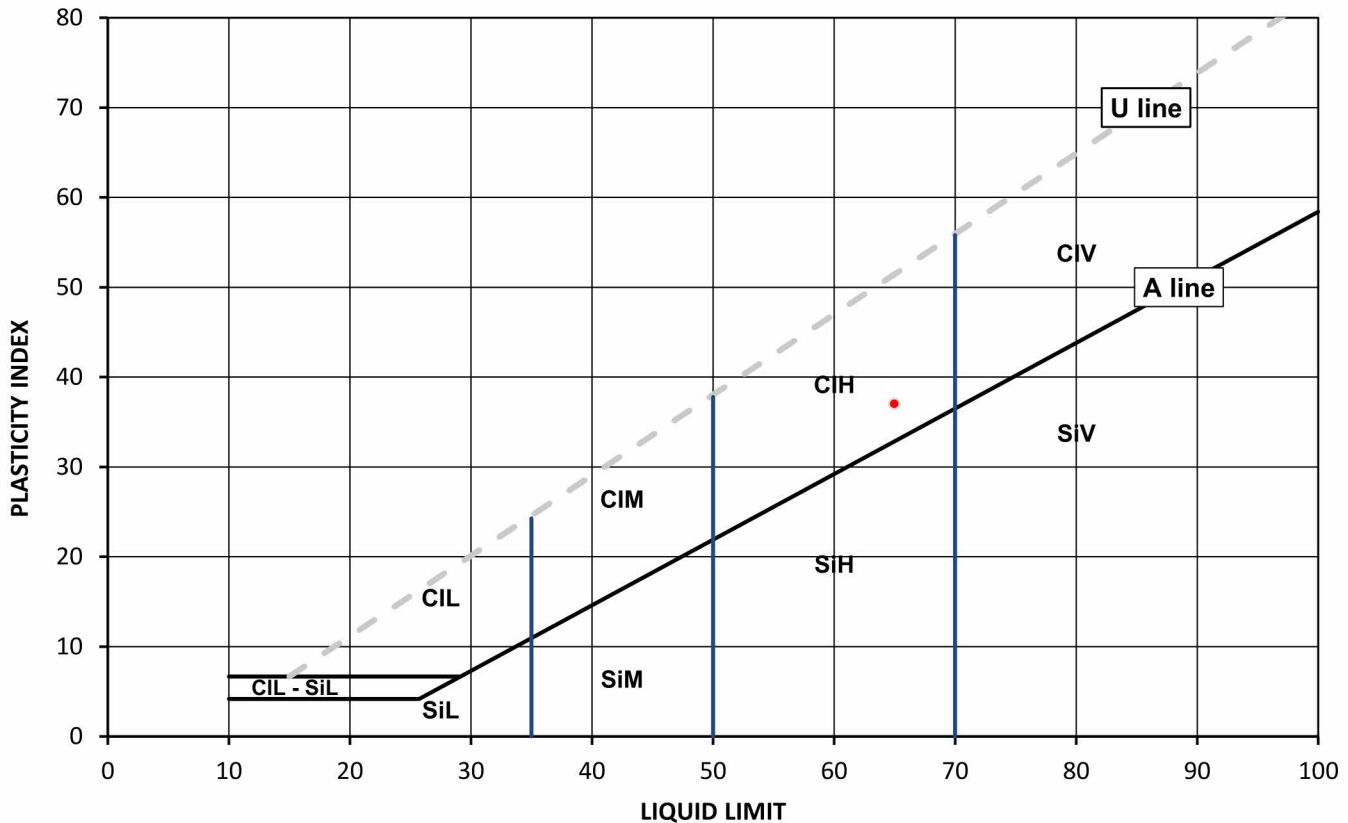
As Received Moisture Content [ W ] %	Liquid Limit [ WL ] %	Plastic Limit [ Wp ] %	Plasticity Index [ Ip ] %	% Passing 425µm BS Test Sieve
30	65	28	37	82

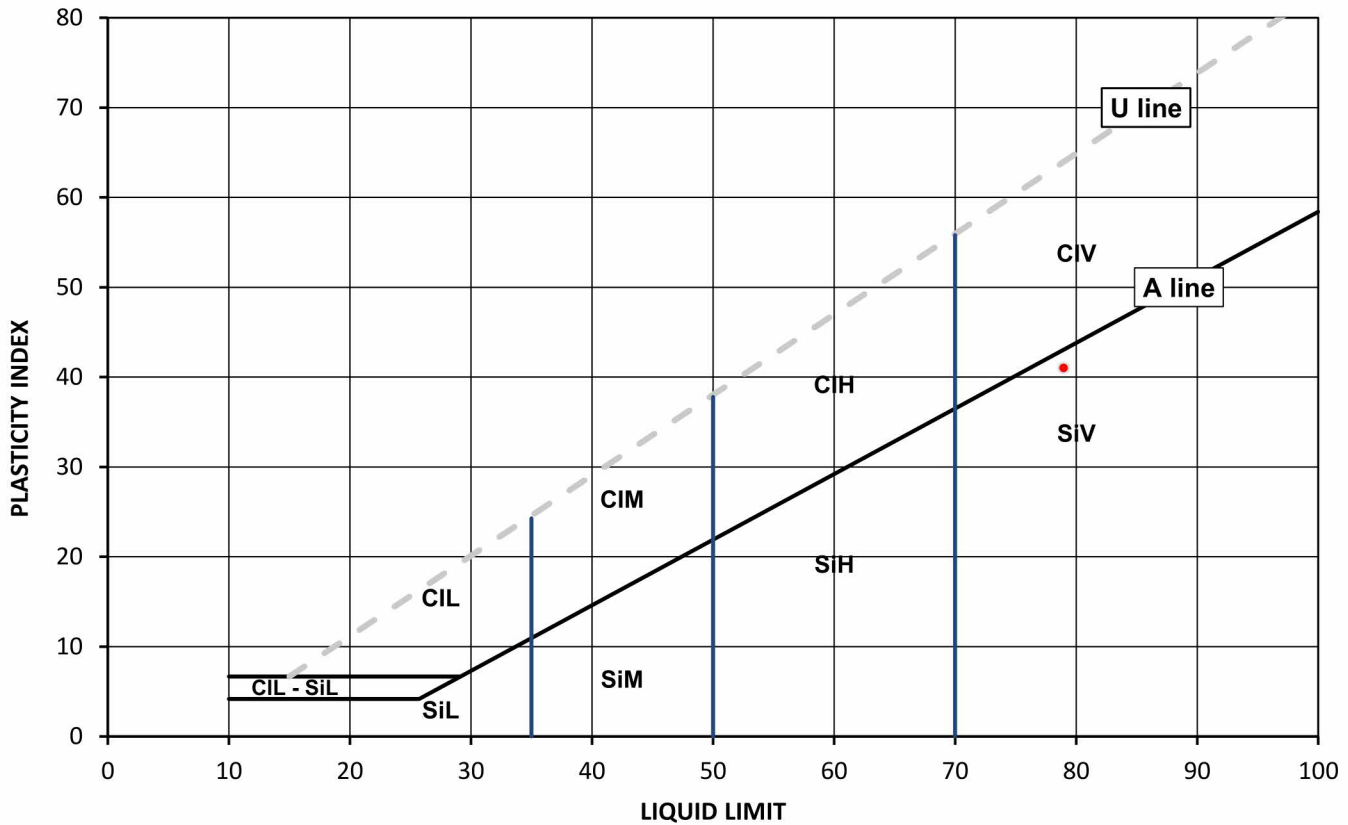
As Received Moisture Content [ W ] %	Liquid Limit [ WL ] %	Plastic Limit [ Wp ] %	Plasticity Index [ Ip ] %	% Passing 425µm BS Test Sieve
38	79	38	41	89

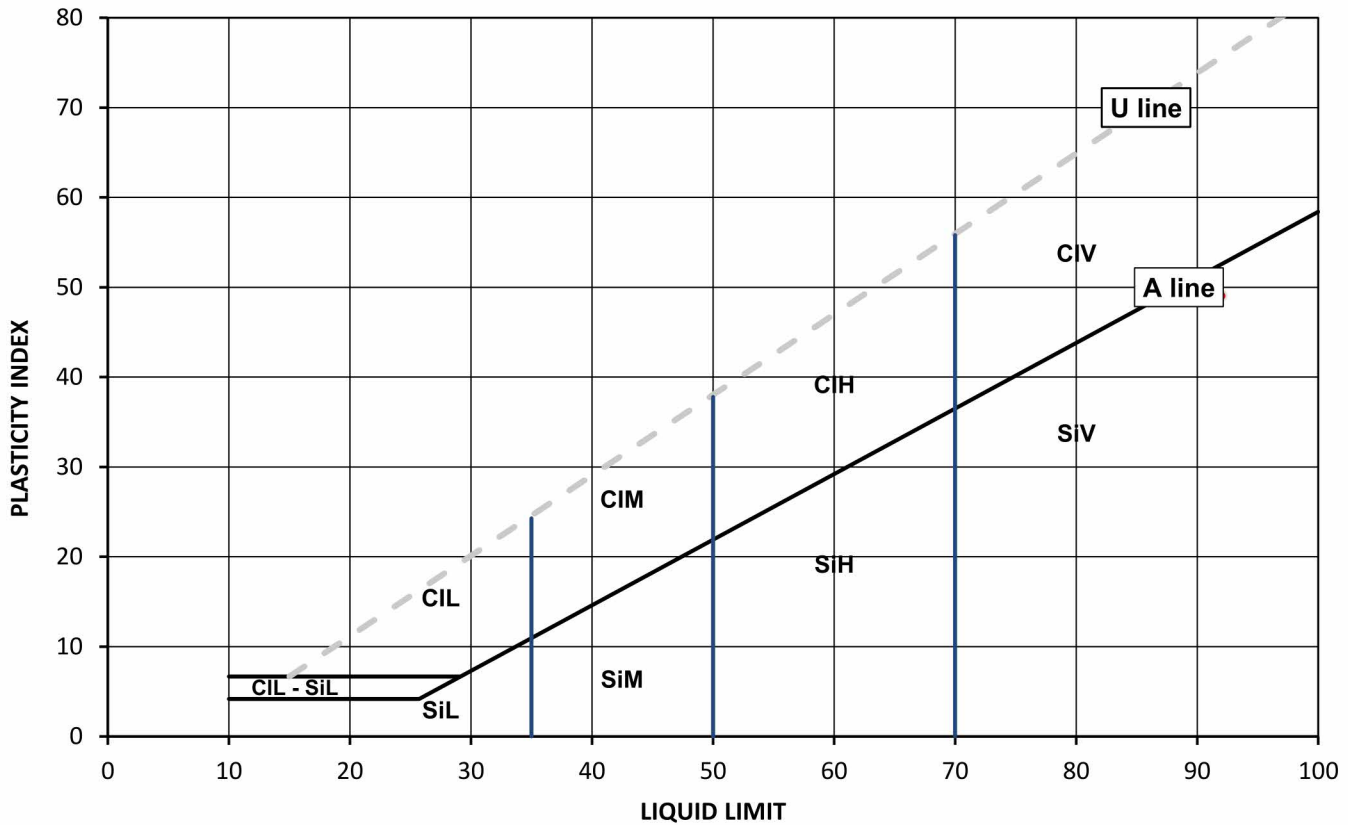
As Received Moisture Content [ W ] %	Liquid Limit [ WL ] %	Plastic Limit [ Wp ] %	Plasticity Index [ Ip ] %	% Passing 425µm BS Test Sieve
27	92	43	49	98

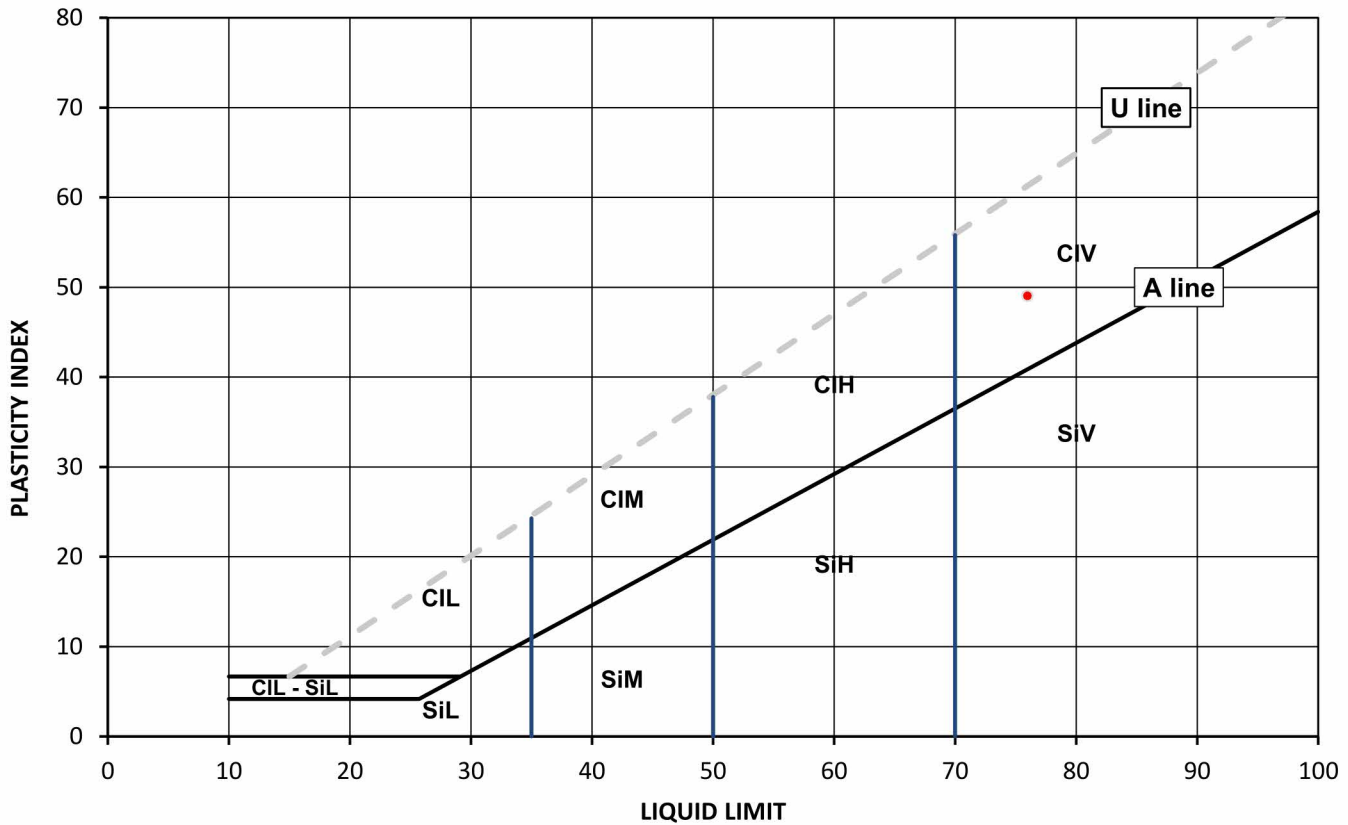
As Received Moisture Content [ W ] %	Liquid Limit [ WL ] %	Plastic Limit [ Wp ] %	Plasticity Index [ Ip ] %	% Passing 425µm BS Test Sieve
27	76	27	49	100

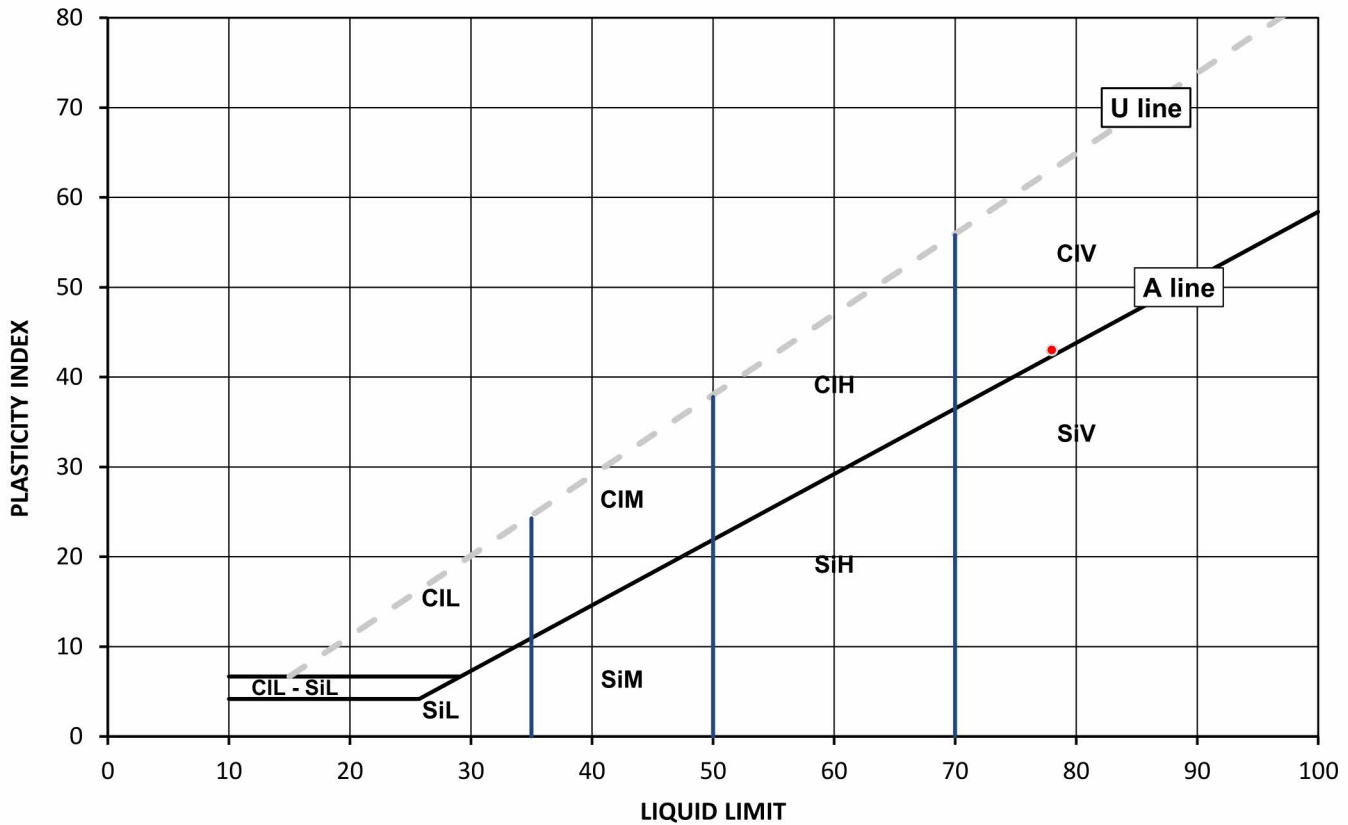
As Received Moisture Content [ W ] %	Liquid Limit [ WL ] %	Plastic Limit [ Wp ] %	Plasticity Index [ Ip ] %	% Passing 425µm BS Test Sieve
39	78	35	43	98

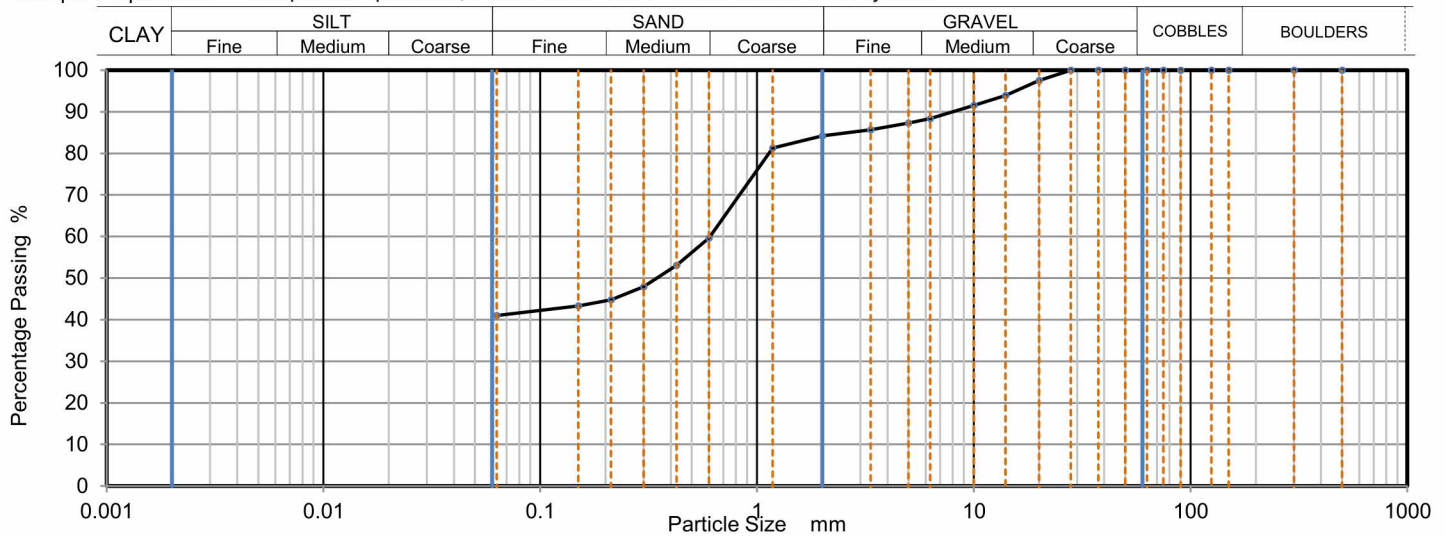
Laboratory Reference: 1926936  
Hole No.: BH2  
Sample Reference: Not Given  
Sample Description: Yellowish brown gravelly very clayey SAND with fragments of shell  
Sample Preparation: Sample was quartered, oven dried at 106.1 °C and broken down by hand.  
Depth Top [m]: 1.00  
Depth Base [m]: 2.00  
Sample Type: C

Sieving		Sedimentation	
Particle Size mm	% Passing	Particle Size mm	% Passing
500	100		
300	100		
150	100		
125	100		
90	100		
75	100		
63	100		
50	100		
37.5	100		
28	100		
20	98		
14	94		
10	92		
6.3	88		
5	87		
3.35	86		
2	84		
1.18	81		
0.6	60		
0.425	53		
0.3	48		
0.212	45		
0.15	43		
0.063	41

Sample Proportions	% dry mass
Very coarse	0
Gravel	16
Sand	43
Fines <0.063mm	41

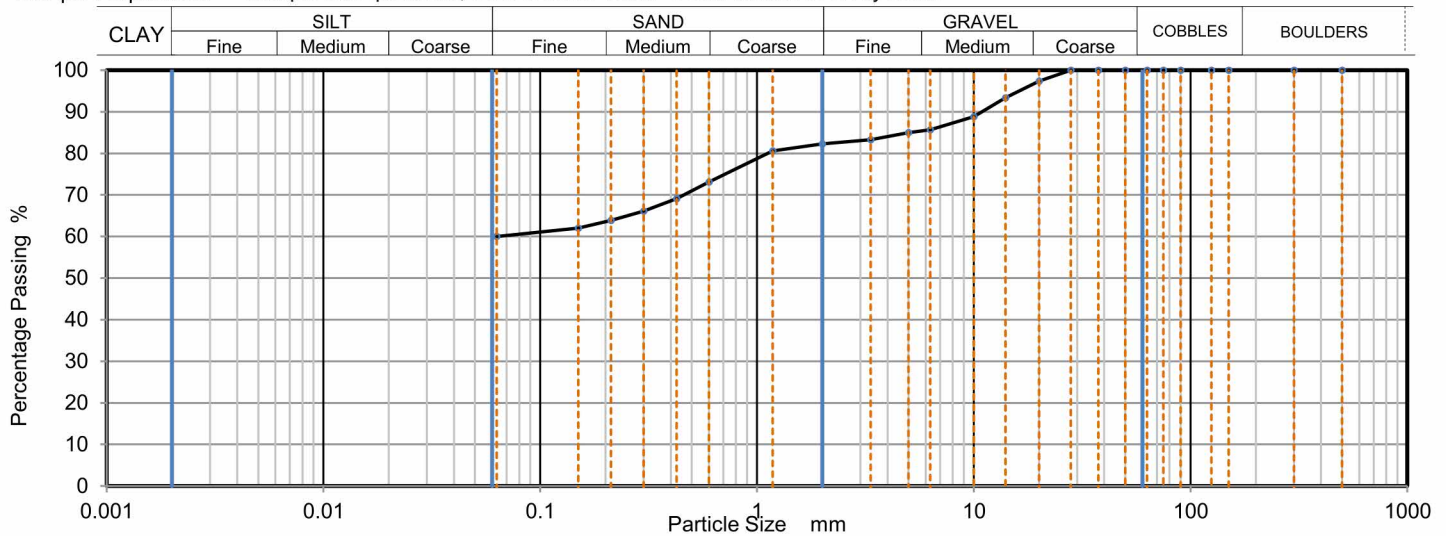
Laboratory Reference: 1926941  
Hole No.: BH5  
Sample Reference: Not Given  
Sample Description: Yellowish brown gravelly sandy CLAY with fragments of shell  
Sample Preparation: Sample was quartered, oven dried at 106.0 °C and broken down by hand.

Sieving		Sedimentation	
Particle Size mm	% Passing	Particle Size mm	% Passing
500	100		
300	100		
150	100		
125	100		
90	100		
75	100		
63	100		
50	100		
37.5	100		
28	100		
20	97		
14	93		
10	89		
6.3	86		
5	85		
3.35	83		
2	82		
1.18	81		
0.6	73		
0.425	69		
0.3	66		
0.212	64		
0.15	62		
0.063	60

Sample Proportions	% dry mass
Very coarse	0
Gravel	18
Sand	22
Fines <0.063mm	60
