GEO-ENVIRONMENTAL SITE ASSESSMENT  
UYS FACILITY  
GARSINGTON ROAD  
COWLEY. OX4 2BW

DATE OF ISSUE: AUGUST 2021

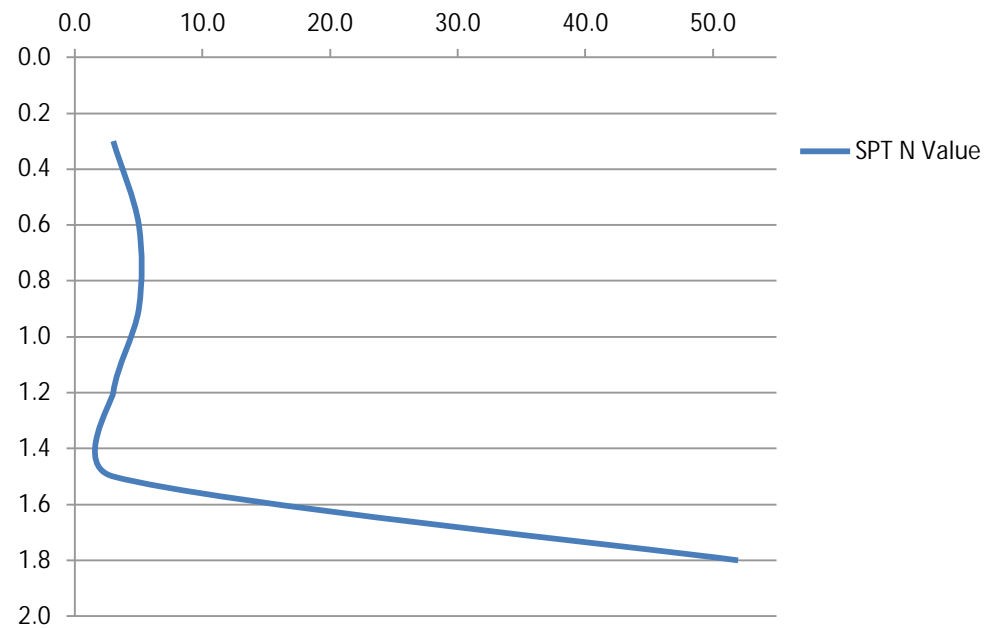
Change in SPT N value with depth (m)

Date of Test 29/07/2021  
Completed by AE  
Site Name Garsington Road, Cowley  
Hole number DP6

Depth (m)	SPT N Value
0.3	4.0
0.6	2.0
0.9	3.0
1.0	50.0

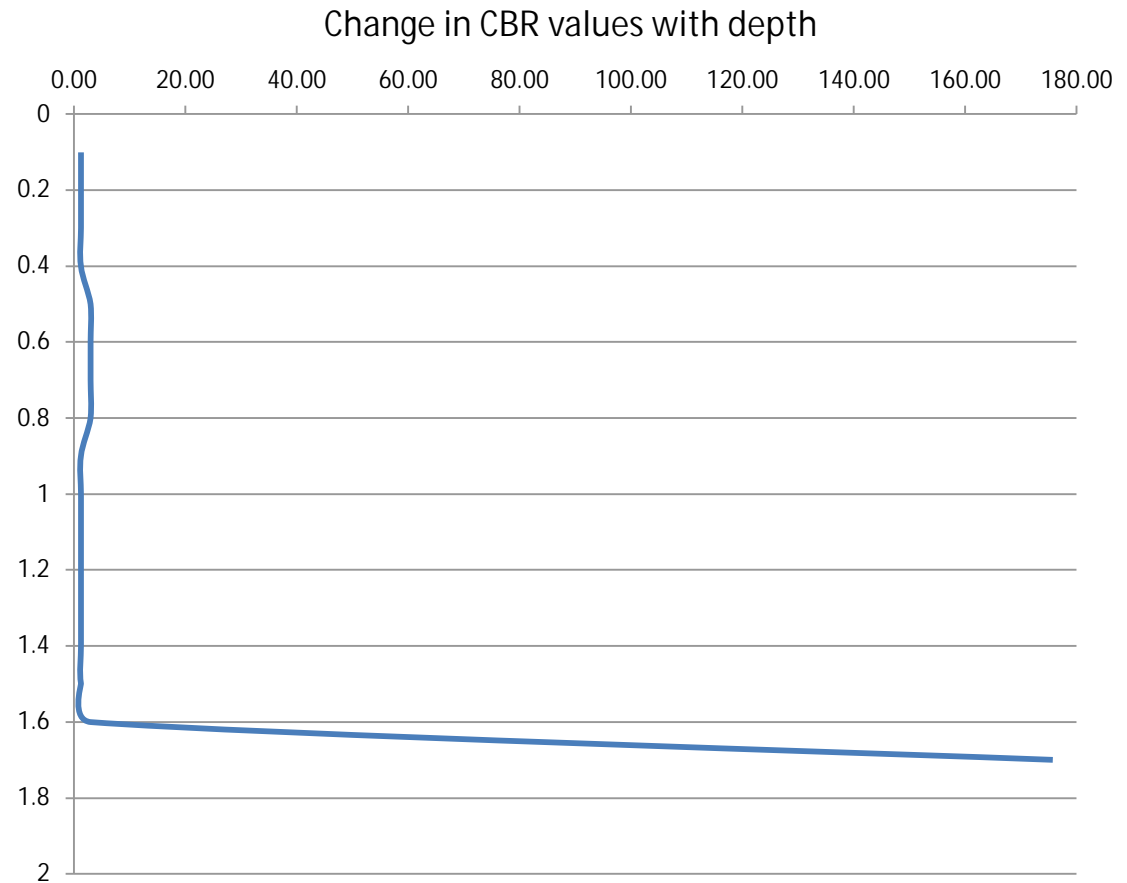
Date of Test 29/06/2021  
 Completed by AE  
 Site Name Garsington road, Cowley  
 Hole number DP5

Values calculated using Kleyn & Van Harden (1983) conversion.  
**CBR Conversion calculation**  $\log CBR = 2.628 - 1.273 \log(DCP)$

Depth (m)	CBR (%)
0.1	1.21
0.2	1.21
0.3	1.21
0.4	1.21
0.5	2.92
0.6	2.92
0.7	2.92
0.8	2.92
0.9	1.21
1.0	1.21
1.1	1.21
1.2	1.21
1.3	1.21
1.4	1.21
1.5	1.21
1.6	2.92
1.7	175.71

It is anticipated that the soils encountered at formation level will be a mixture of cohesive and incohesive materials and will be above the water table. The amount of loading is unknown for the roads and pavements, but for poor to good construction conditions<sup>12</sup>, a CBR design value of 2.5 to 3% is recommended for initial design.

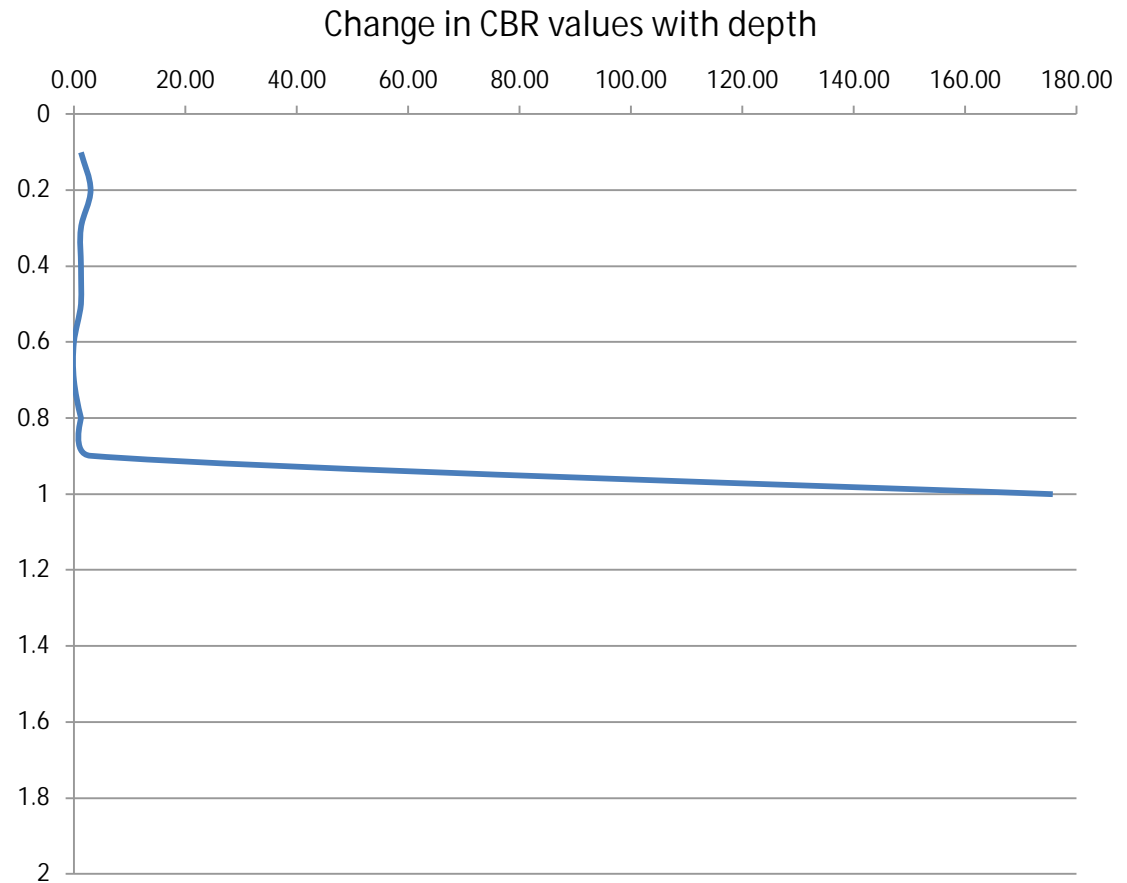
Date of Test 29/06/2021  
 Completed by AE  
 Site Name Garsington road, Cowley  
 Hole number DP6

Values calculated using Kleyn & Van Harden (1983) conversion.  
**CBR Conversion calculation**  $\log CBR = 2.628 - 1.273 \log(DCP)$

Depth (m)	CBR (%)
0.1	1.21
0.2	2.92
0.3	1.21
0.4	1.21
0.5	1.21
0.6	0.00
0.7	0.00
0.8	1.21
0.9	2.92
1.0	175.71
