**Bat Survey Report for
Fulford Farm garage and barn,
Shipton Oliffe,
GL54 4LL**

Cotswold Wildlife Surveys

28th July, 31st August and 26th September 2022

Report Number: 4238-CWS-02

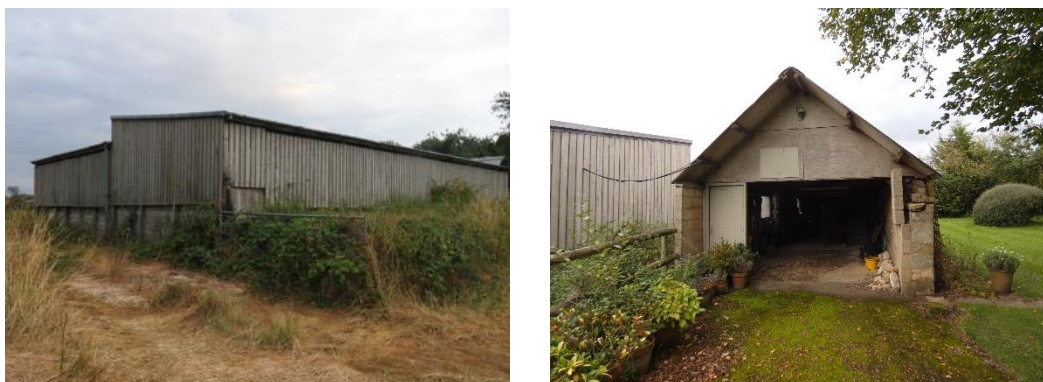
Figs. 1 & 2 Barn (L) and garage (R)

The survey site comprised an 'L-shaped' modern barn and a pitched roofed garage with an open northwest end (Figs. 1 and 2).

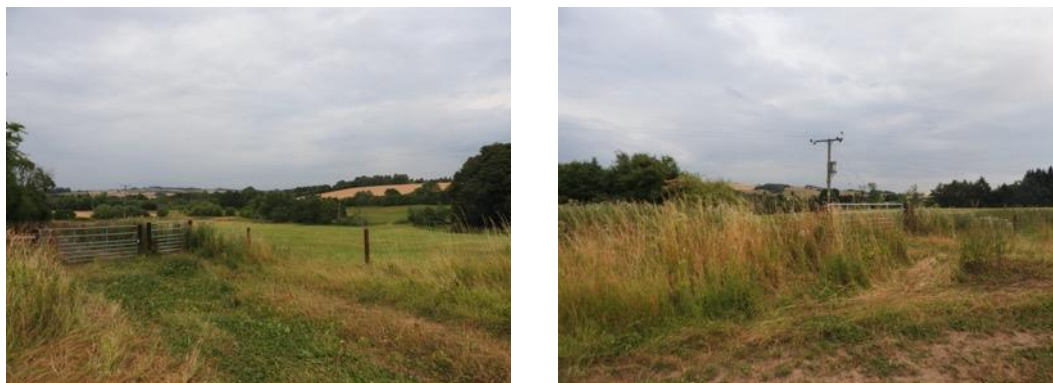
Figs. 3 & 4 Views to the northeast (L) and southeast (R)

To the north, east and south of the barn and garage were open fields and mature trees and to the west was the farmhouse (Figs. 3 and 4).

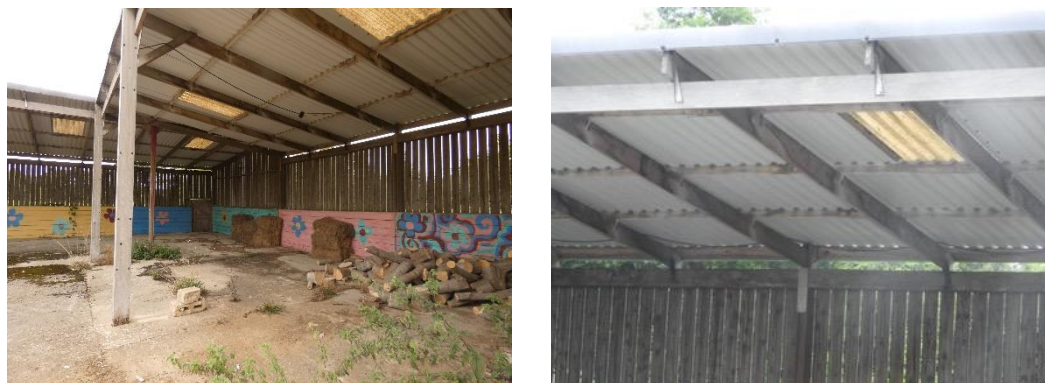
Figs. 5 & 6 External (L) and internal (R) views of the barn

The barn was ‘L-shaped’ and open-sided, with walls comprising railway sleeper bases and slatted timber uppers. The roof consisted of corrugated metal panels, with a steel support frame (Figs. 5 and 6).

Light penetrated the barn through the open side, and no evidence of bat activity or occupation was found either inside or outside the barn.

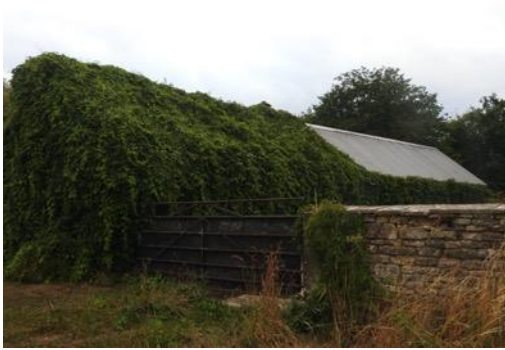
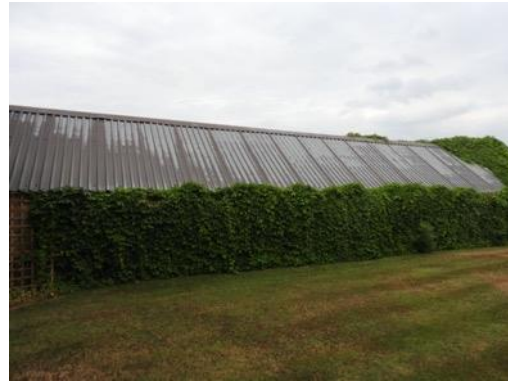
Figs. 7 & 8 Ridge and roof panels to the east (L) and west (R)

The ridge was intact and sealed and all the corrugated metal roof panels were tightly overlapping (Figs. 7 and 8).

The eaves and walls were also covered with vegetation (Ref. Figs. 7 and 8).

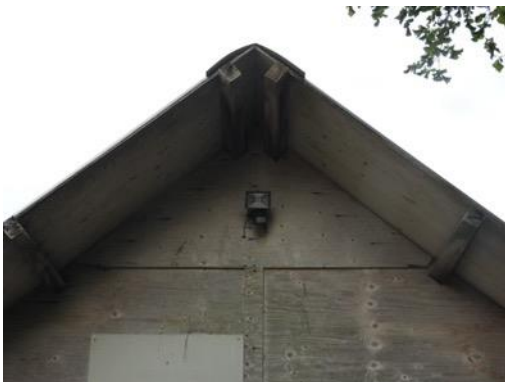
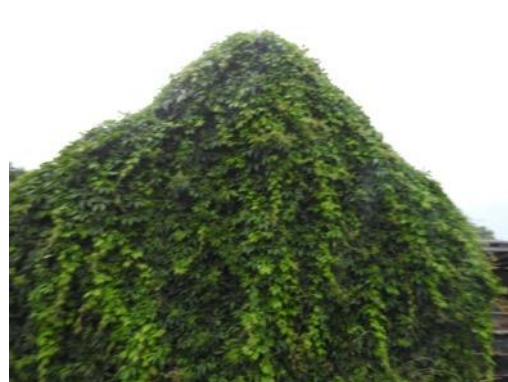
Figs. 9 & 10 Sealed north gable (L) and vegetation covered south gable (R)

The north gable was finished with the roof verge tightly fitting against the gable wall plate (Fig. 9) it also had a large open doorway (Ref. Fig. 2). The south gable was covered with vegetation (Fig. 10).

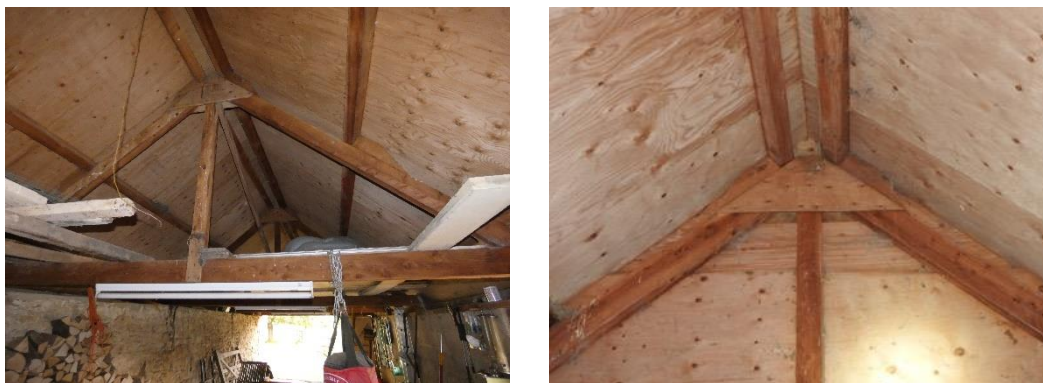
Figs. 11 & 12 Hardboard lined underside of garage roof

Internally the building was open to a hardboard lined underside of the roof (Figs. 11 and 12).

The only light to penetrate the garage was through the open doorway in the northwest gable and this only penetrated about half the length of the building.

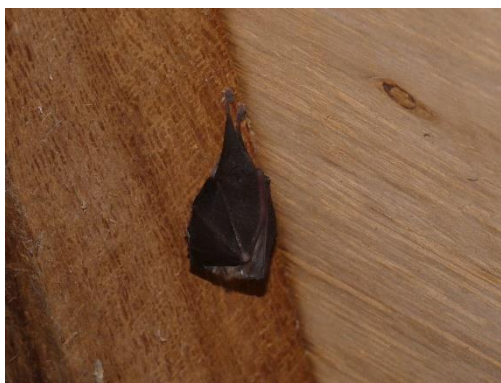
Fig. 13 Roosting Lesser Horseshoe Bat

During both inspections, close to the southeast gable, a Lesser Horseshoe Bat was found at roost (Fig. 13). A small number of Lesser Horseshoe Bat droppings were also noted.

No evidence of Brown Long-eared Bat activity was found either in the garage or barn, but small numbers of Lesser Horseshoe Bat droppings were noted in the garage, with a single roosting Lesser Horseshoe Bat recorded on 14th October 2021 and 28th July 2022.

Since the roost will be lost with the re-development of the garage a licence from Natural England. Given the low status of the roost, the site is eligible for registration under Natural England's Bat Mitigation Class Licence (BMCL) scheme.

Mitigation measures will include a 'toolbox talk' by a Registered Consultant (RC) to contractors about bats and what to do if one is unexpectedly encountered, a pre-works inspection of the garage by the RC, supervision of the destructive roof works by the RC, and the provision of a suitable roost site for Lesser Horseshoe Bats.

This will be a new bat loft with a volume of 17.5 m³ which will be created before the re-development of the garage.

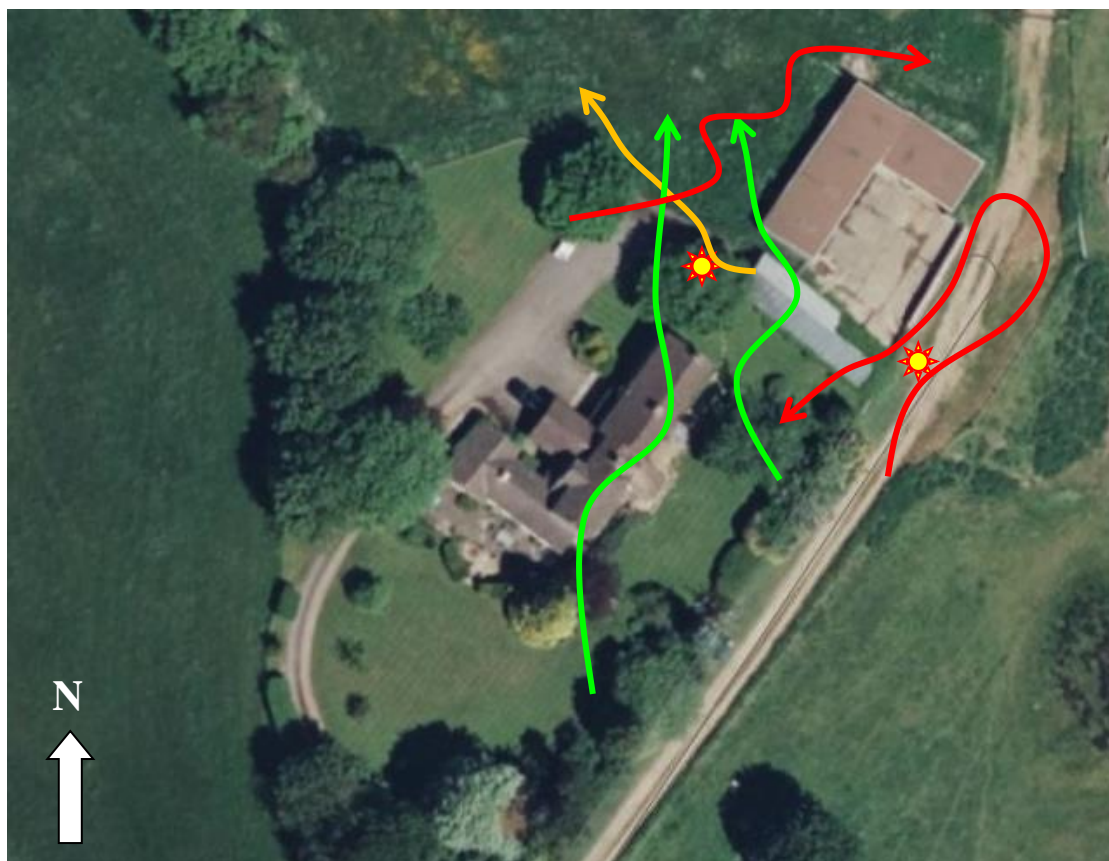
Plan 1 Bat flight paths at emergence on 28th July 2022

A Lesser Horseshoe Bat emerged from the open doorway of the garage. Common Pipistrelles and Noctules flew round and over the site.

The bat flight paths at emergence are shown on Plan 1.

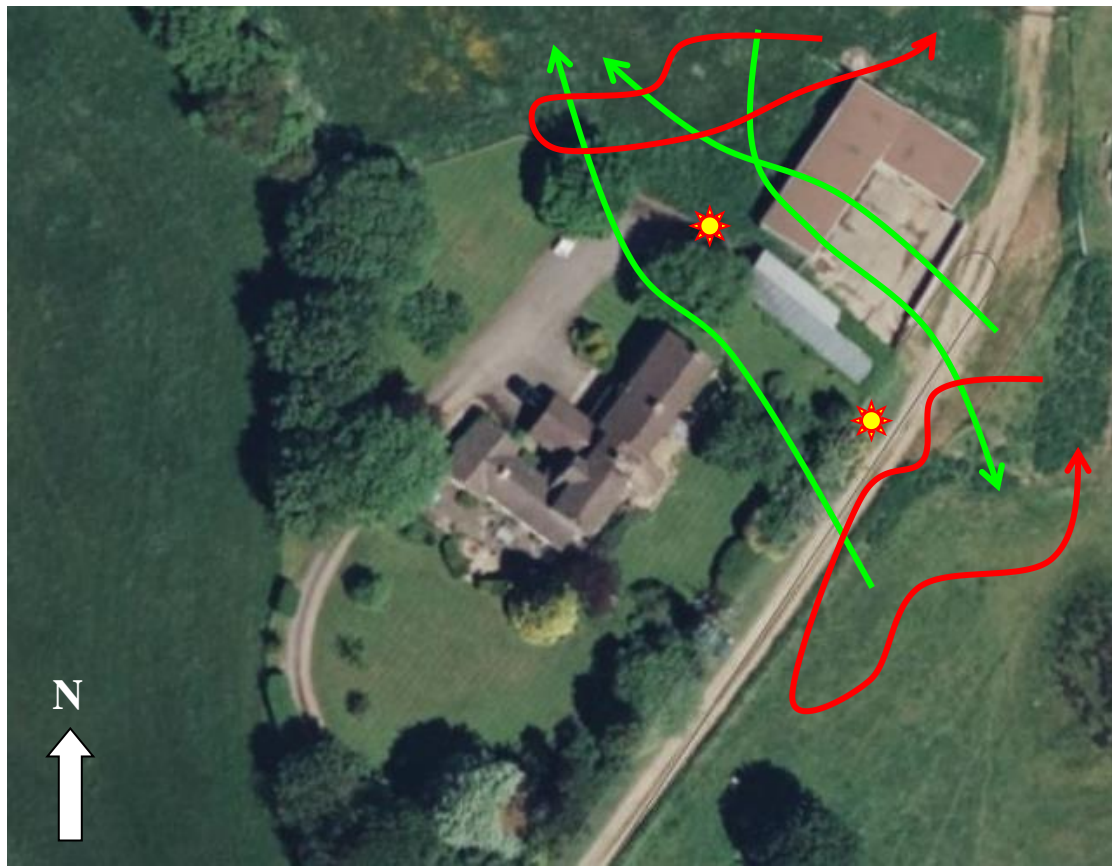
Plan 2 Bat flight paths at emergence on 31st August 2022

Common Pipistrelles and Noctules again flew round and over the barn and garage. No bats emerged from the garage.

The bat flight paths at emergence are shown on Plan 2 overleaf.

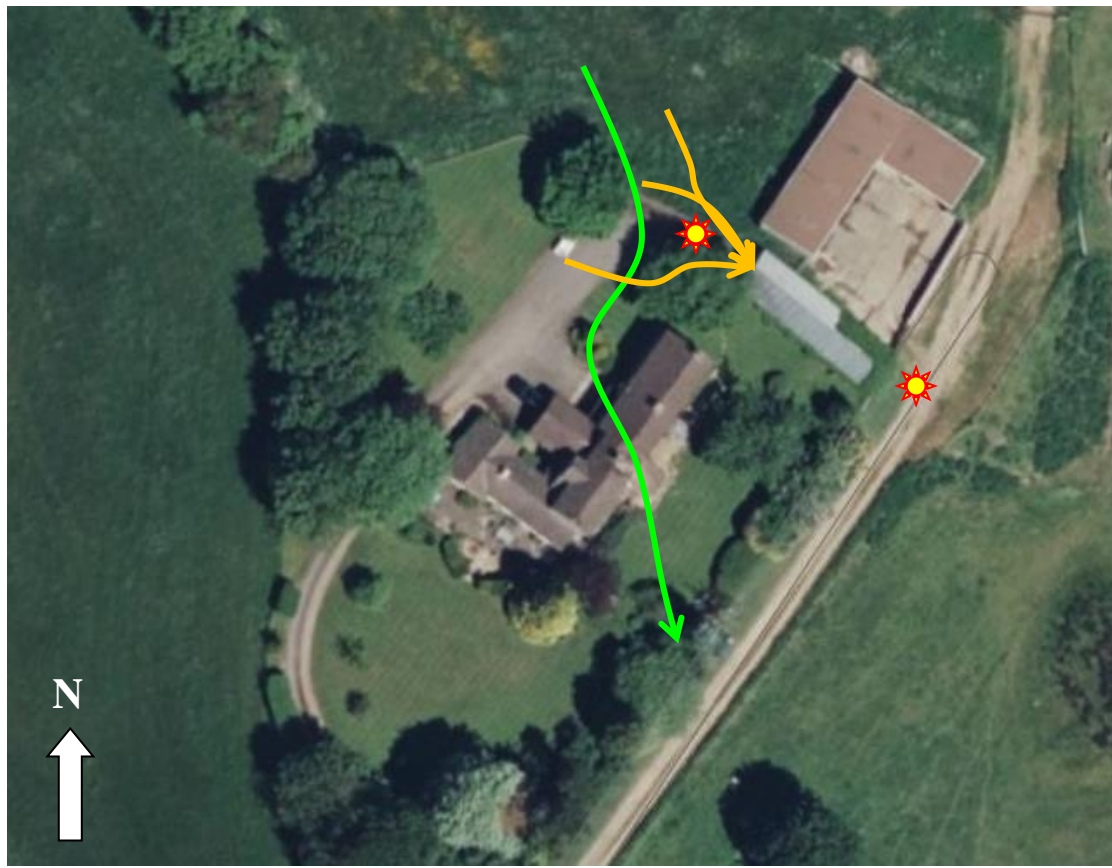
Plan 3 Bat flight paths at dawn return on 26th September 2022

Three Lesser Horseshoe Bats went to roost in the garage and a Noctule flew overhead.

The bat flight paths at dawn return are shown on Plan 3 overleaf.

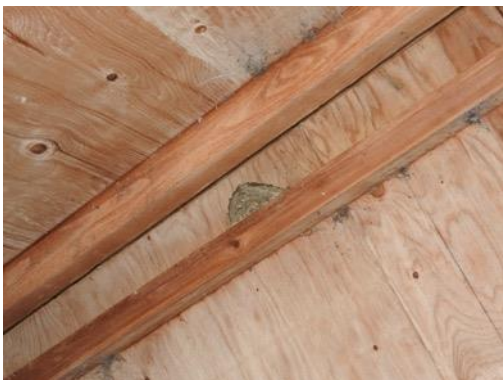
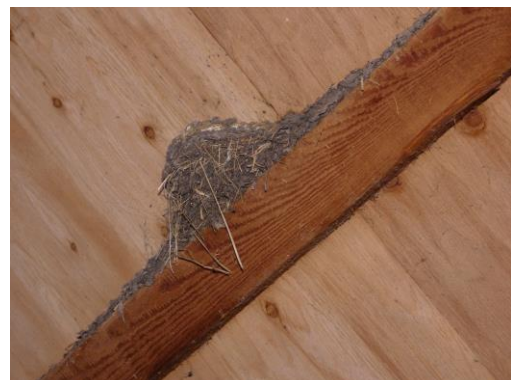
Figs. 14 & 15 Barn Swallows' nests

Several Barn Swallows' nests were observed in the garage (Figs. 14 and 15).

Since all in-use bird's nests and their contents are protected from damage or destruction, any works which affect buildings should ideally be undertaken outside the period March to August inclusive. If this time frame cannot be avoided, a close inspection of the buildings affected will be undertaken prior to clearance.

Work will not be carried out in close proximity to any in-use nest, and a minimum buffer of 5.0 metres will be established, although this could be more depending on the sensitivity of the species.

Any in-use nest will be allowed to fledge before it is disturbed.

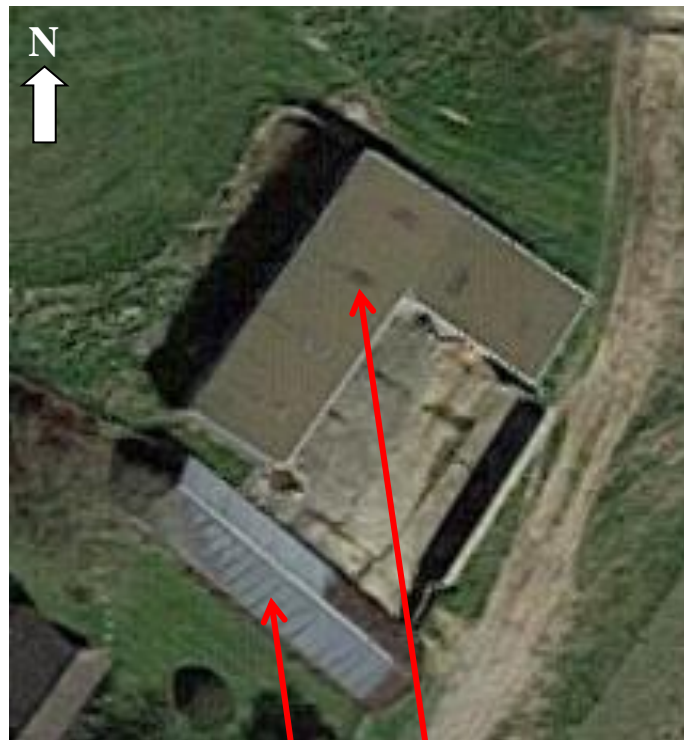
Appendix 2: Site layout

Garage and barn

The layout of the site is shown in the aerial photograph in Appendix 2.

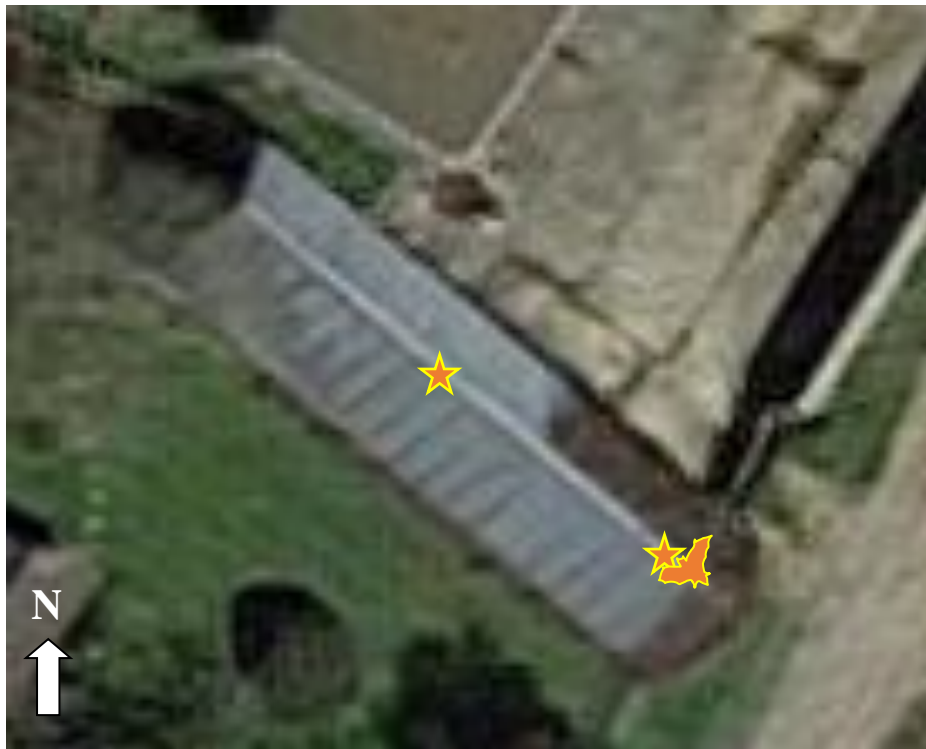
Appendix 3: Location of bat droppings & roosting bat

The location of the roosting bat is shown in Appendix 3.

Lesser Horseshoe Bat droppings ★

Lesser Horseshoe Bat at roost 🦇
