Bat Survey Report

Old Kingsham Farm

28th July 2023

Project No: P4262

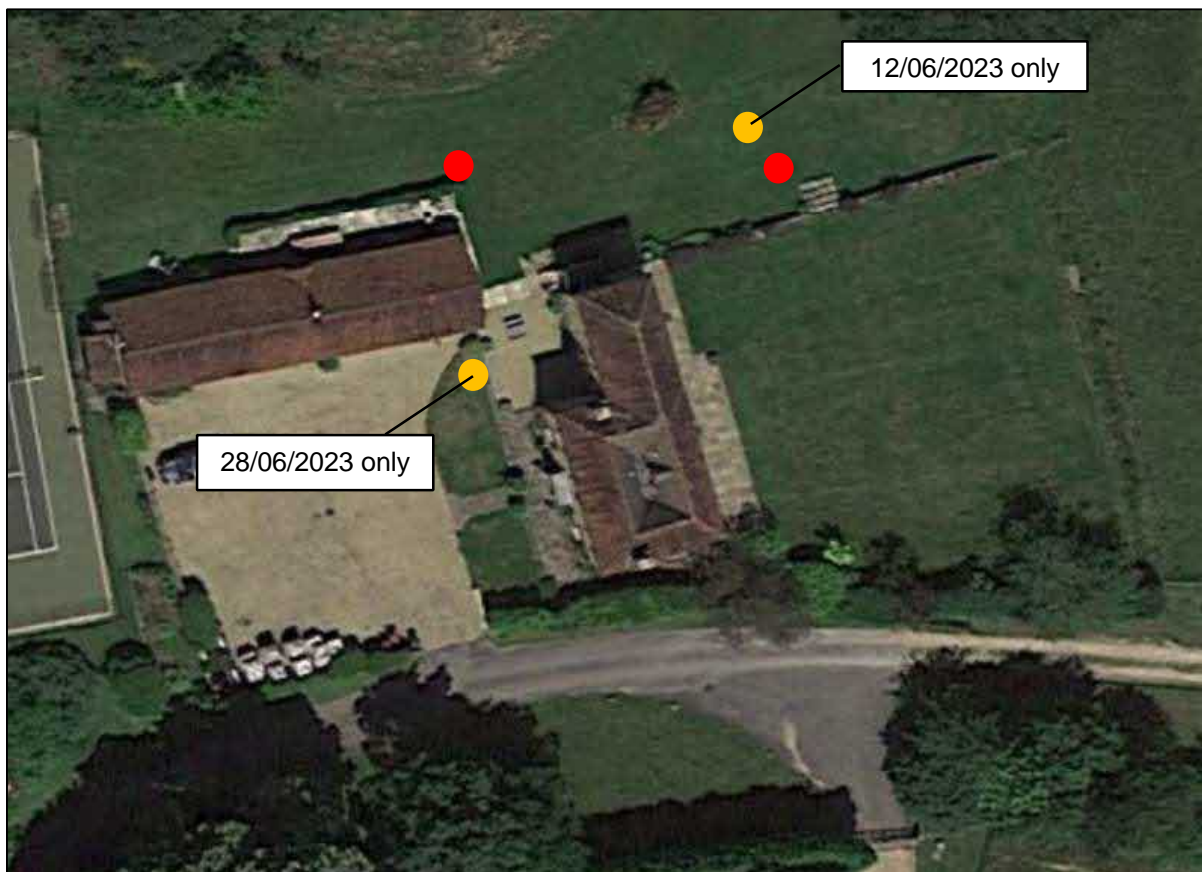
Figure 3. An aerial image of the site, showing the positions of surveyors (red dots) and a night-vision camera (orange dot). Images produced courtesy of Google maps (map data ©2023 Google).

The surveys focused upon the suitable features on the northern sections of the dwelling using two surveyors positioned according to Figure 3. From these positions, surveyors could see all features potentially suitable for roosting bats that were identified during the initial bat scoping survey that are to be directly impacted by the works.

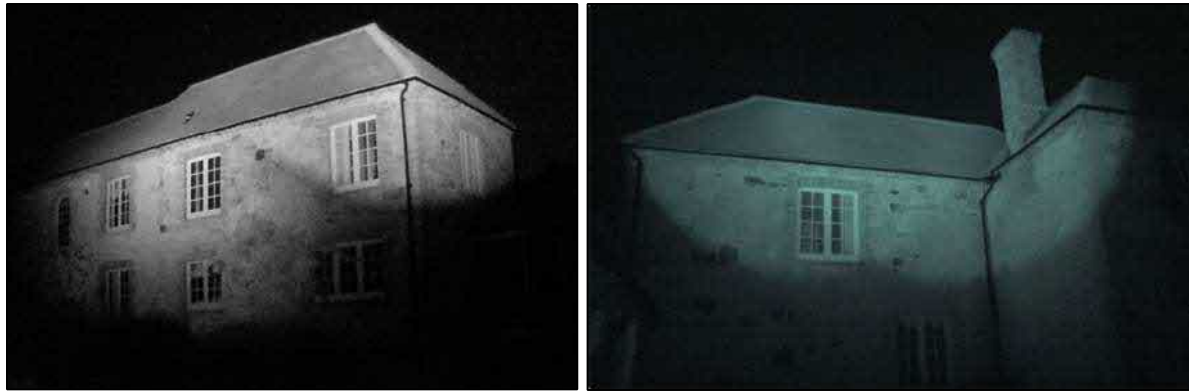
Figure 4a (left) & b (right). Left – Darkest point for the emergence survey on 12th June 2023, screenshotted from a Nightfox Red camera. Right – Darkest point for the emergence survey on 28th June 2023, screenshotted from a Canon AX20 camera.

- 1 x Nightfox red night vision camera paired with a surveyor viewpoint on 12th June 2023 (darkest point shown in Figure 4a)

- 1 x Canon XA20 Night vision camera paired with a surveyor viewpoint on 28th June 2023 (darkest point shown in Figure 4b)

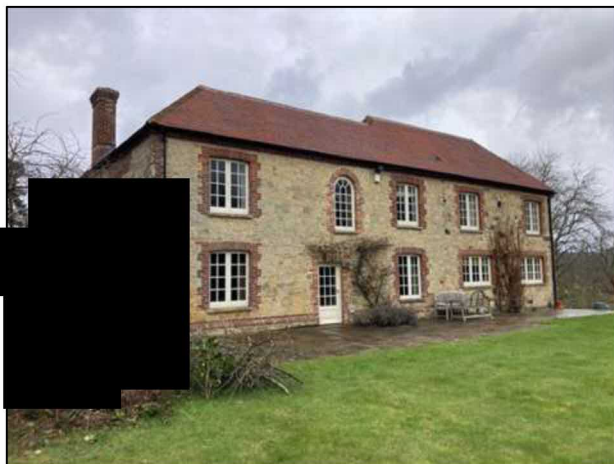
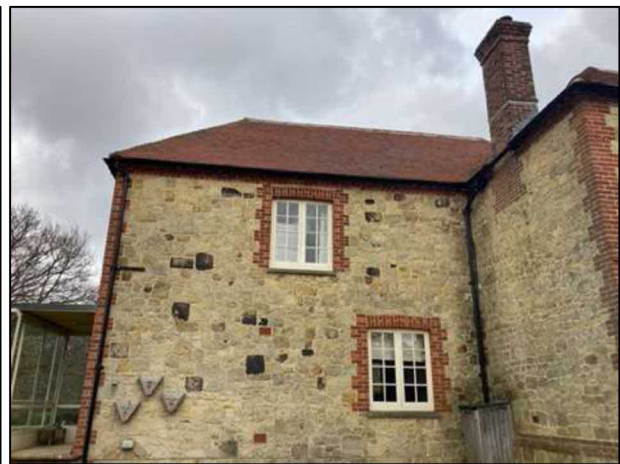
Photograph 1a (left) & 1b (right). Left – View of the east and southern elevation of the dwelling. Right – View of the western elevation of the existing extension.

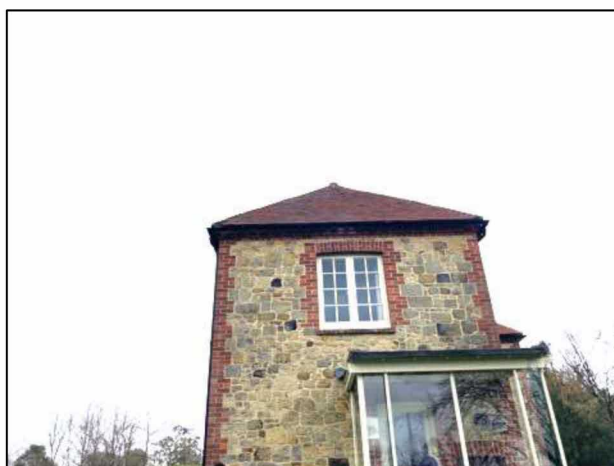
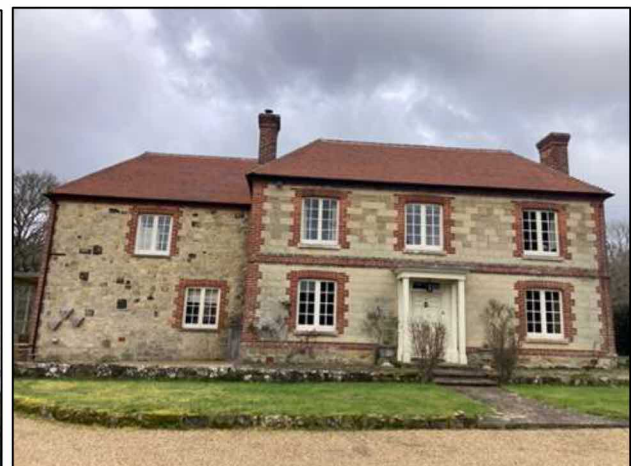
Photograph 2a (left) & 2b (right). Left – View of the northern elevation of the dwelling. Right – View of the western elevations of the dwelling.

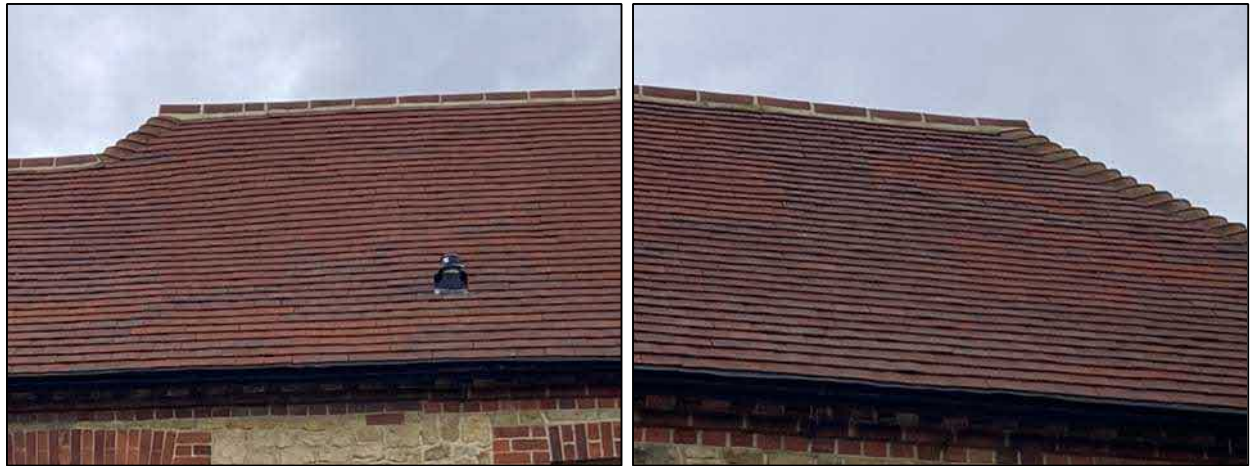
Photograph 3a (left) & 3b (right). Views of the eastern pitch of the roof, showing lifted tiles with suitable features for roosting bats.

All roof tiles to be removed to facilitate the extension should be carefully hand stripped one by one from the walls under the direct supervision of a licensed bat ecologist. Any bats found shall be gently captured and placed into bat boxes that have been secured to trees surrounding the site in advance.

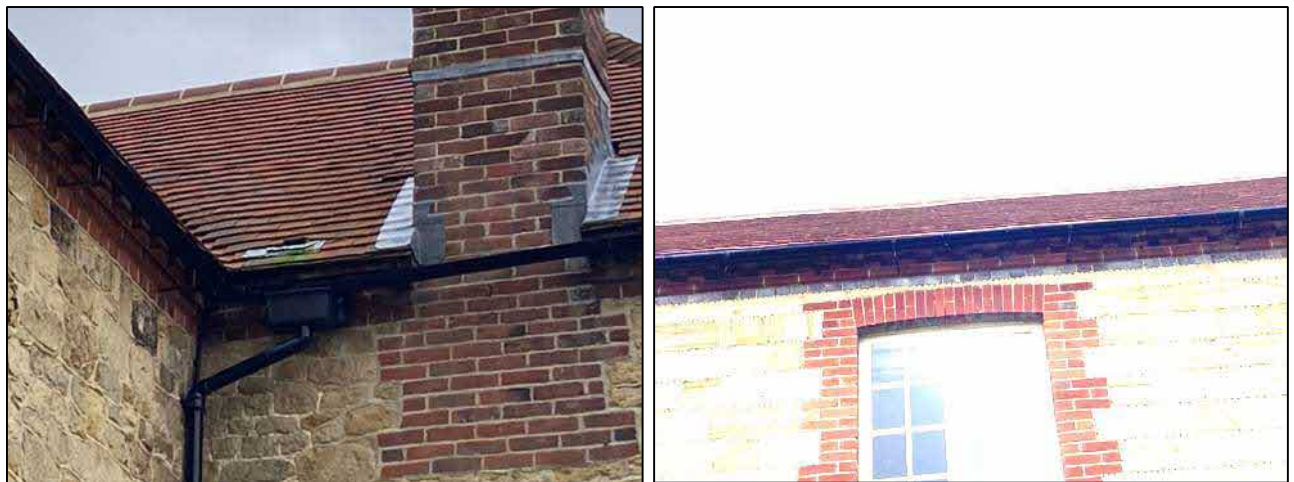
Photograph 4a (left) & 4b (right). Left – View of the northern elevation of the building, showing gaps around hips and the chimney. Right – View of the eastern eaves with possible access gaps into the loft voids.

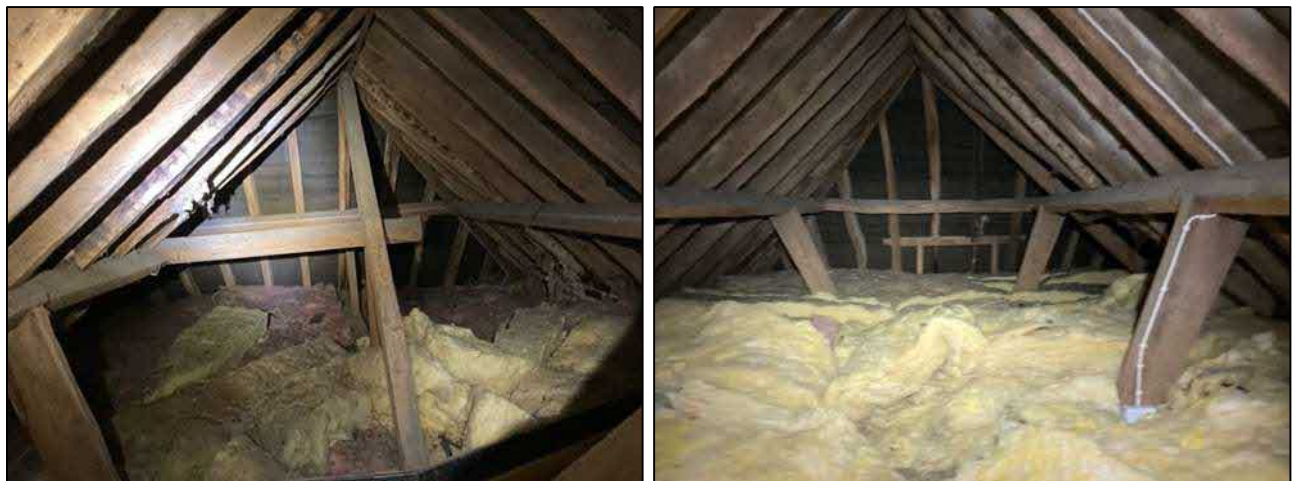
Key findings	The inspection of the building confirmed a bat roost through the presence of brown long-eared bat <i>Plecotus auritus</i> droppings within the main loft space and connecting void. In addition, two emergence surveys were carried out of the building and a common pipistrelle <i>Pipistrellus pipistrellus</i> bat was seen to emerge from a lifted tile on the southern section of the eastern elevation. Other bats including soprano pipistrelle <i>Pipistrellus pygmaeus</i> , serotine <i>Eptesicus serotinus</i> , long-eared bats <i>Plecotus</i> sp. and noctule <i>Nyctalus noctula</i> were detected foraging or passing through the garden of the property from time to time during all survey visits.
Interpretation	The surveys of Old Kingsham have identified one common pipistrelle solitary day roost associated with the southern section of roof tiles on the east face of the building. An occasional brown-long eared bat day roost was also detected through the presence of droppings in the loft void, likely belonging to a single individual.

Photograph 5a (left) & 5b (right). Views of the main void space, where scattered bat droppings were identified.

A thorough internal inspection of the loft void will be carried out by a licensed bat ecologist or accredited agent immediately prior to works commencing. This will identify if any bats are roosting within either the main or connecting loft voids. Any bats found should be gently captured and placed into a bat box that has been secured to an impacted area of the site in advance. If no bats are identified during the inspection, then the gap in the bitumen between the main and connecting loft voids will be blocked up with tarpaulin or bitumen felt to reduce the likelihood of the main, unimpacted loft void becoming draughty or internally lit during works and therefore unsuitable for roosting bats. In the connecting loft void, the subsequent 'soft strip' of the roof tiles above the loft will change the microclimate resulting in the bats leaving of their own accord, where they may be present internally but have not been found.

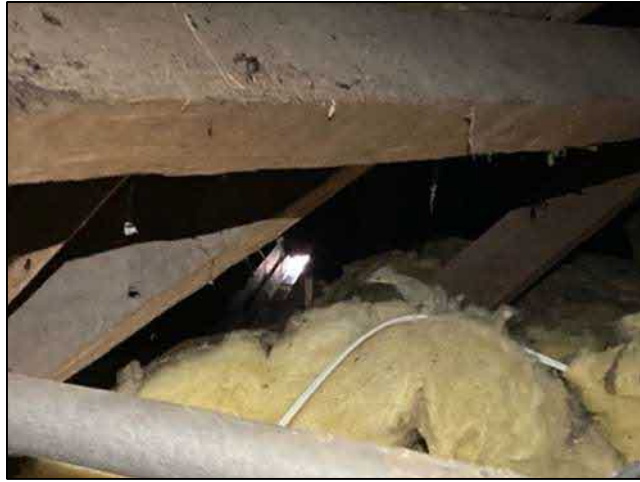
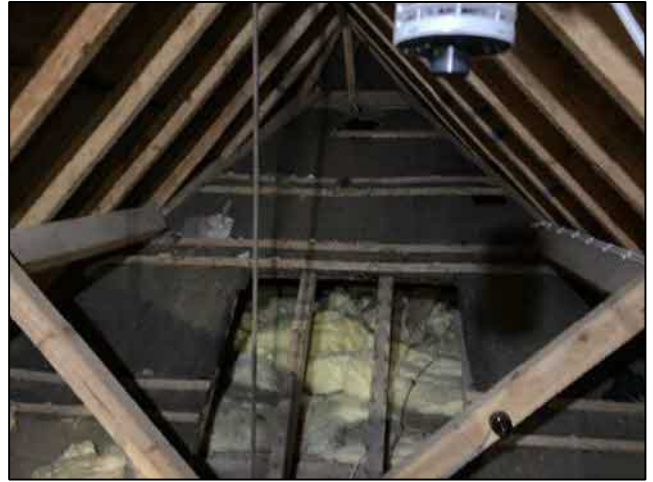
Photograph 6a (left) & 6b (right). Left – View of internal guttering in the loft void, which provides gaps. Right – View of the bitumen felt and crossbeams separating the main and connecting voids, and the gap present close to the floor.

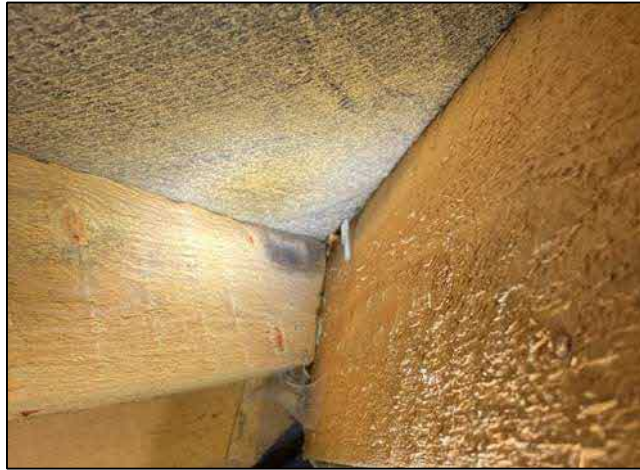
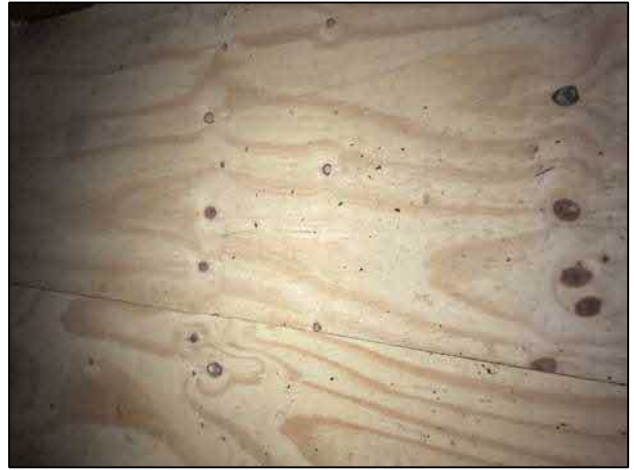
Photograph 7a (left) & 7b (right). Left – Rub mark seen on the hip beams above the collection of scattered droppings in the connecting void. Right – Collection of scattered droppings in the connecting void.

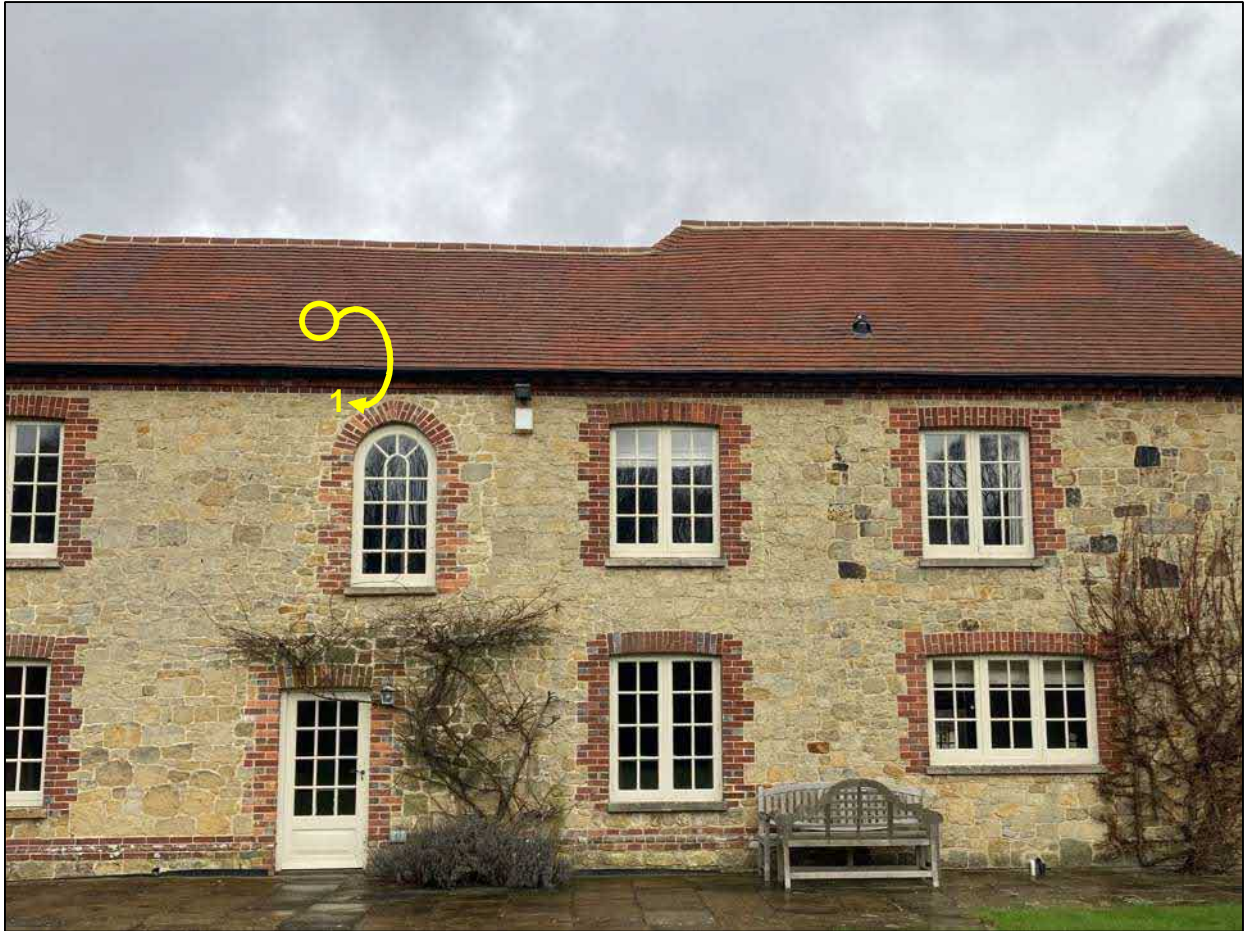
Figure 7. View of the eastern elevation of the dwelling, showing the emergence location of one common pipistrelle (yellow). This emergence occurred during the survey on 26th August 2023.

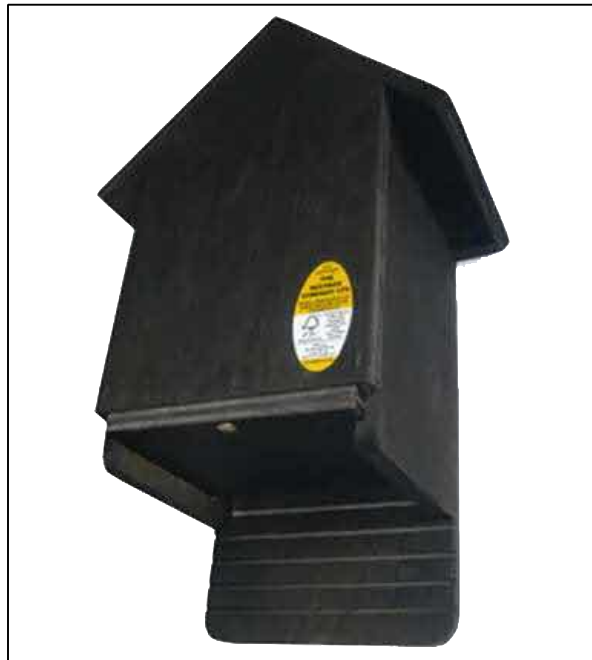
Figure 8. Improved Cavity Box. Image courtesy of NHBS.

Suitable bat boxes will need to be installed either on unaffected areas of the house or on mature/semi-mature trees on the site prior to the commencement of the works. It is recommended that one Improved Cavity Bat Box, suitable for cavity-dwelling species, be installed for this purpose. Other suitable boxes for cavity roosting species are also commercially available. This box will be used to house any bats encountered during works and will be retained in perpetuity. It must be orientated south or east facing at a minimum height of 3.5m from the ground and away from sources of artificial lighting.
