HERITAGE STATEMENT FOR ROSEHILL BARN, OWSLEBURY, SO21 1JS

JOB NO: 439-08

30 AUGUST 2023

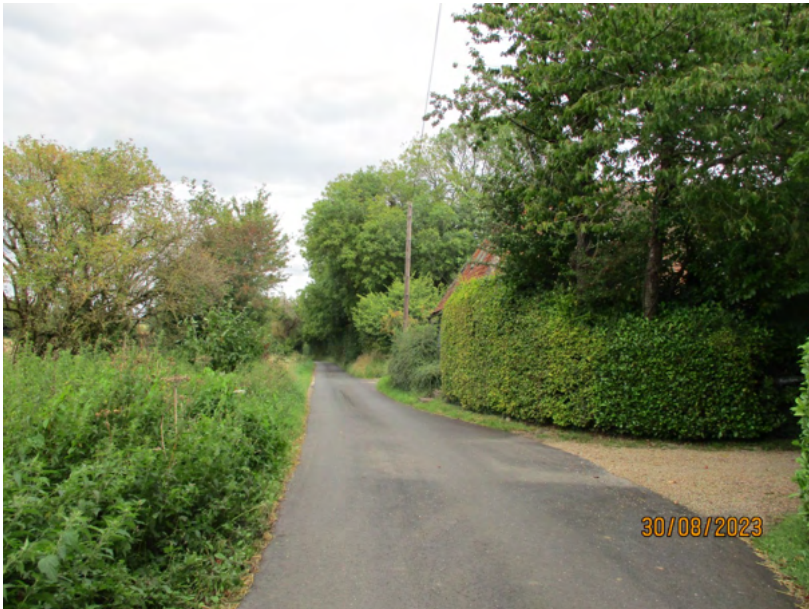
Fig 1:

Rosehill Barn is located on Longwood Dean Lane which is a narrow rural road in the western part of the South Downs in the area between Owslebury and Cheriton. The barn's presence is discrete within the street scene, when looking northeast along the road, due to the presence of trees and vegetation fronting the road.

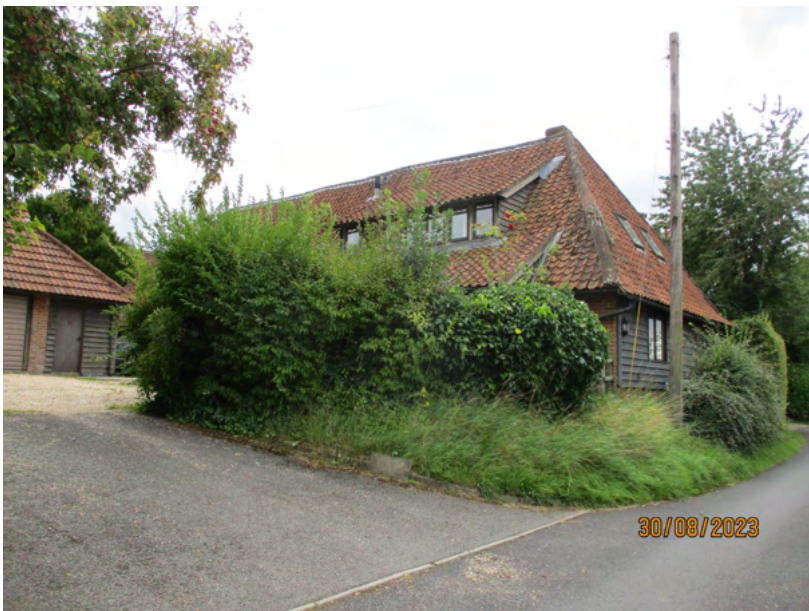
Fig 2:

The hipped west gable end of Rosehill Barn fronts Longwood Dean Lane and this part of the building along with part of the front (north) elevation are visible heading southwest along the road. From this perspective it is obvious that Rosehill Barn is a dwelling, a barn conversion.

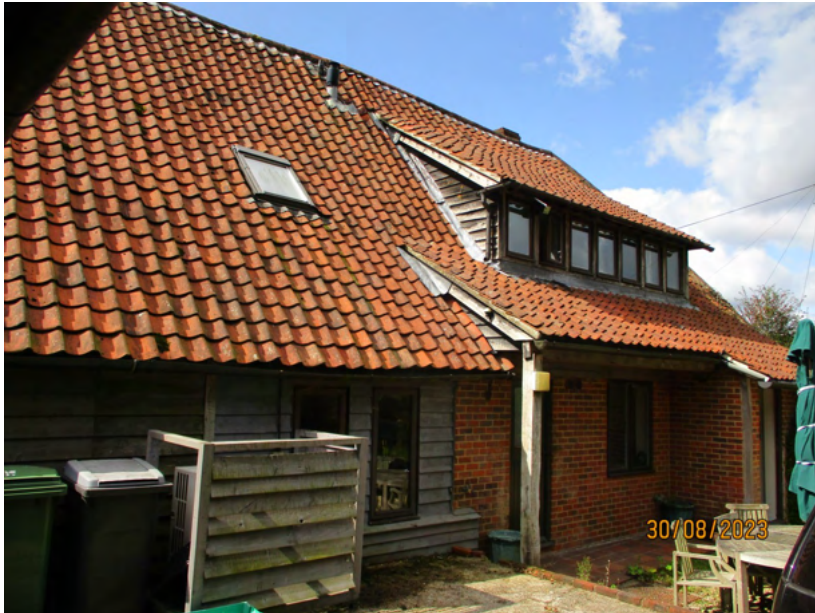
Fig 3:

Rosehill Barn, showing the front (north) elevation. All the external fabric including pantiles, brickwork, weatherboarding and cladding dates from c.1985 or later (c. 2000).

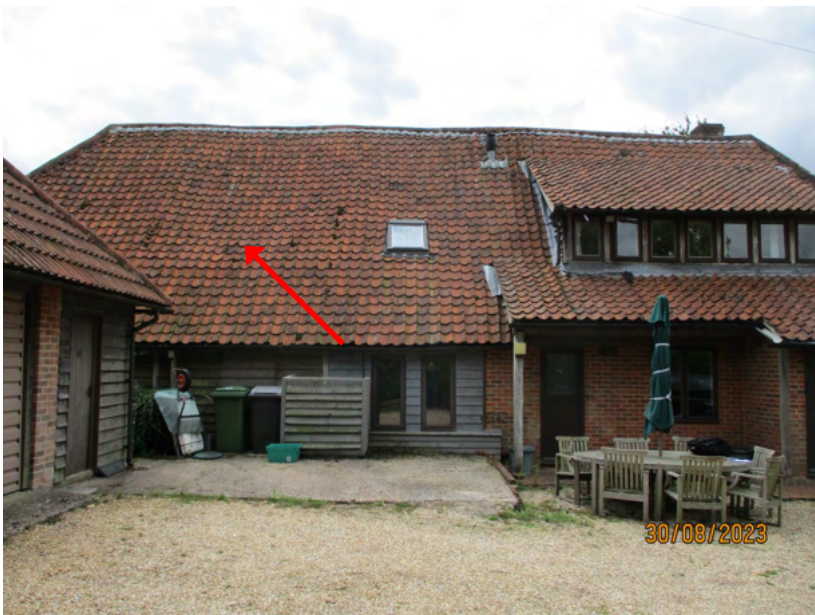
Fig 4:

Rosehill Barn, showing the front (north) elevation. The east part of the barn remains in separate ownership and in use as storage associated with Mays Farmhouse. All the external fabric to the entire barn including pantiles, brickwork, weatherboarding and cladding dates from c.1987 or later.

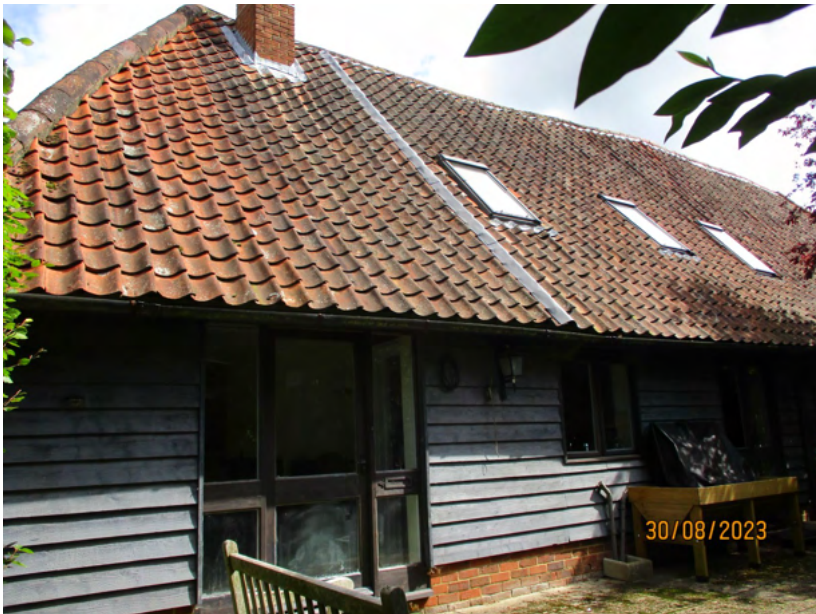
Fig 5:

Rosehill Barn, showing the rear (south) elevation. All the external fabric including pantiles, brickwork, weatherboarding and cladding dates from c.1985 or later (c.2000).

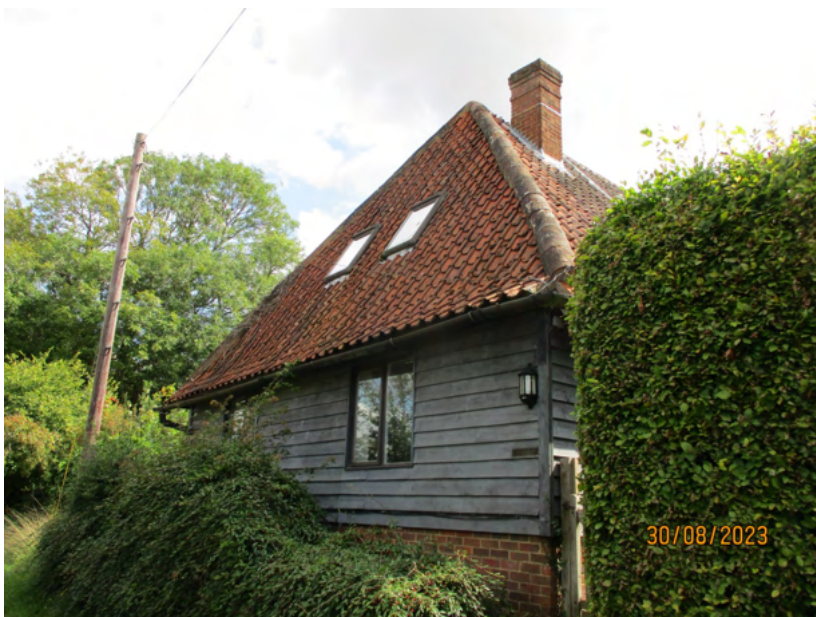
Fig 6:

Rosehill Barn, showing the side (west) elevation. All the external fabric including pantiles, brickwork, weatherboarding and cladding dates from c.1985 or later (c. 2000).

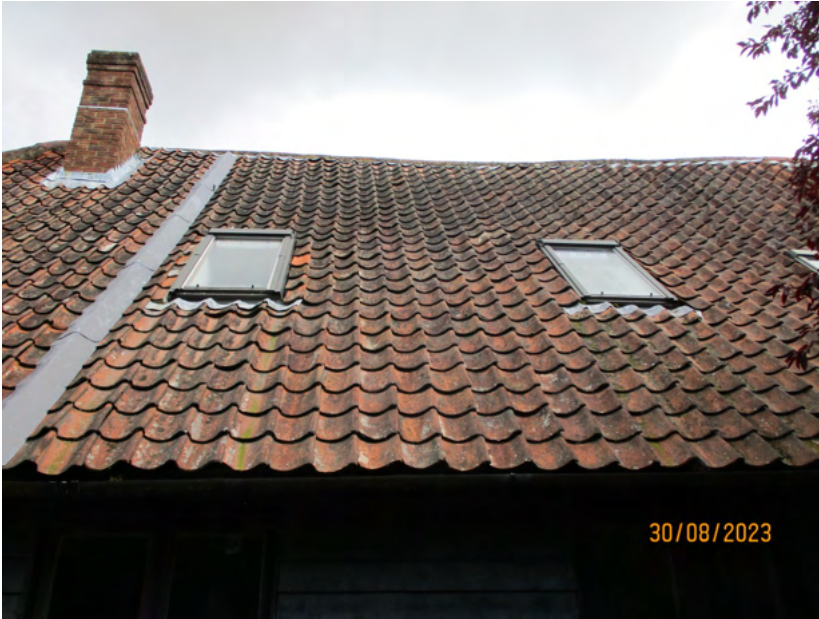
Fig 7:

Rosehill Barn, showing the pantile roof covering. The pantile roof covering replaced an Asbestos sheet roofing in c.1985 when the residential conversion was undertaken.

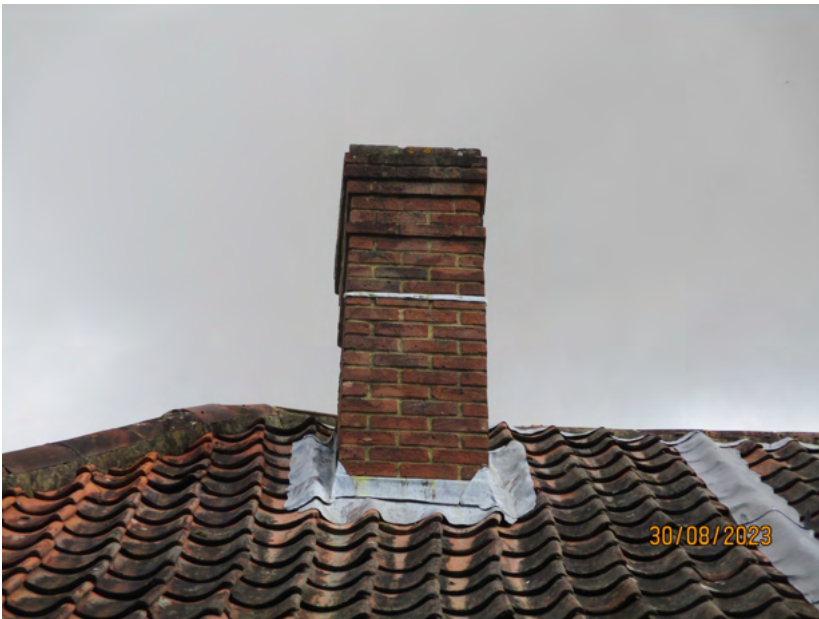
Fig 8:

Rosehill Barn, showing the chimneystack which was introduced to the building c. 1985 when the residential conversion was undertaken.

4.2.2 Remove chimneystack and replace with flue

- No alterations are proposed to the north-east (front) and north-west (side) roof slopes
- Alterations are proposed to the south-west roof slope to remove the extant brick chimneystack and replace this with a black powder coated metal flue

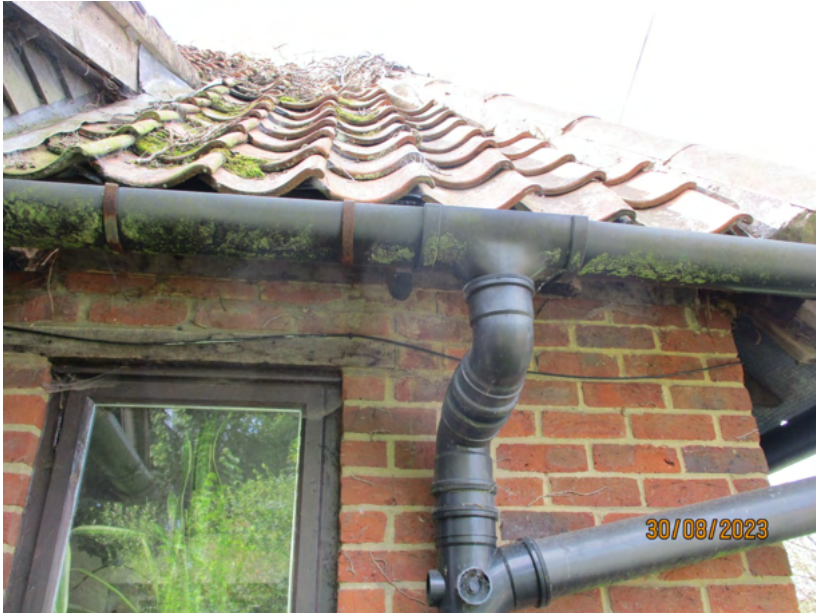
Fig 9:

Rosehill Barn, showing the black plastic rainwater goods which exist throughout the barn.

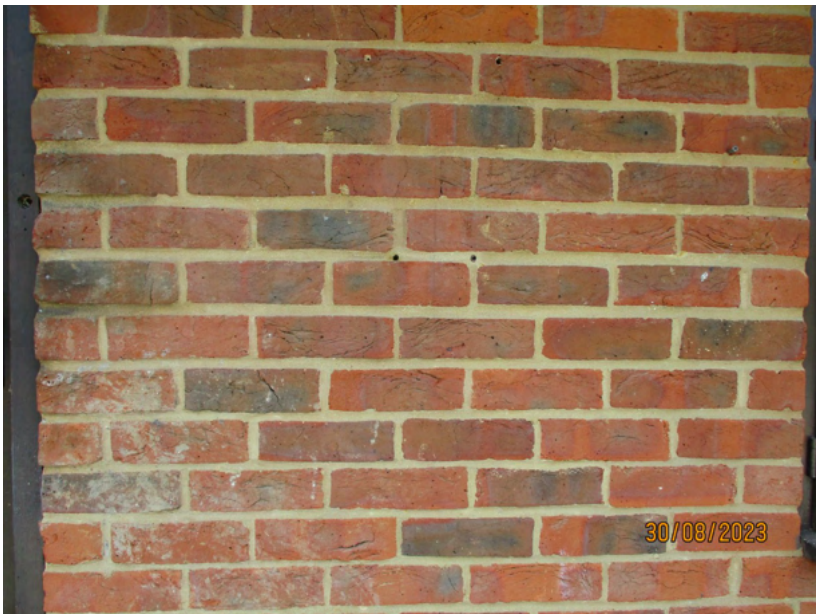
Fig 10:

Rosehill barn, showing the modern brickwork which was introduced c.1985 when the west side of the barn was converted to residential use. The modern brickwork is laid in stretcher bond with cement mortar.

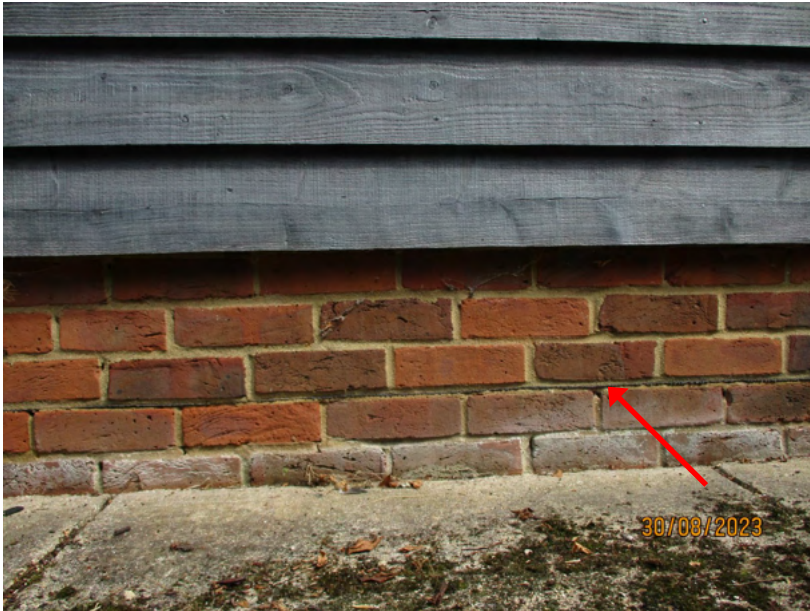
Fig 11:

Rosehill Barn showing the modern brickwork, c. 1985, to the plinth which incorporates a dampproof course. The weatherboarding is all c.1985 of later also.

Red arrow indicates the damp proof course.

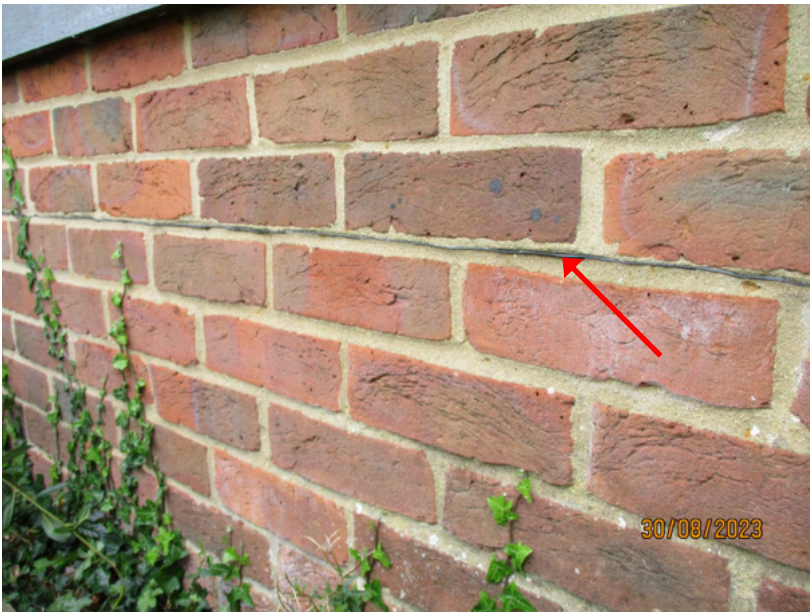
Fig 12:

Rosehill Barn showing the modern brickwork, c. 1985, to the plinth which incorporates a dampproof course.

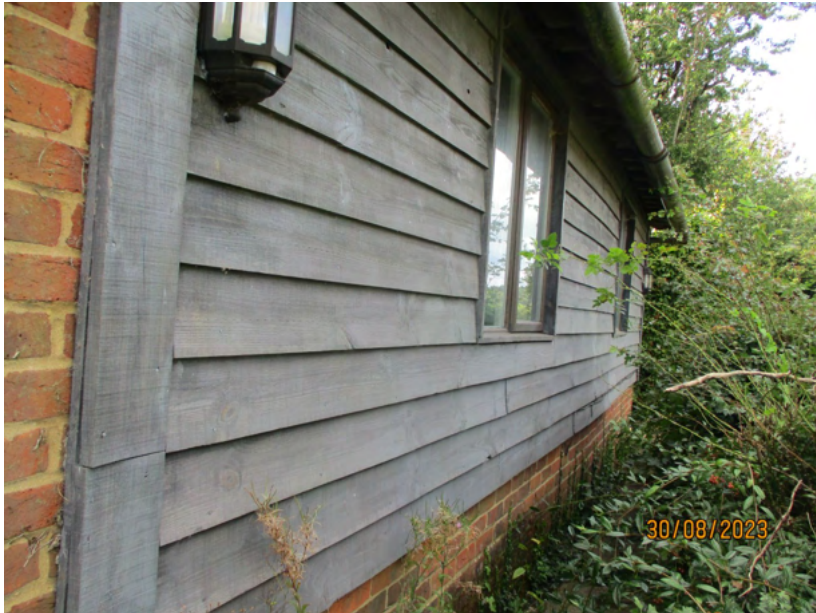
Fig 13:

Rosehill barn, showing the modern uniform weather boarding, c.1985 or later which was introduced when the residential conversion was undertaken.

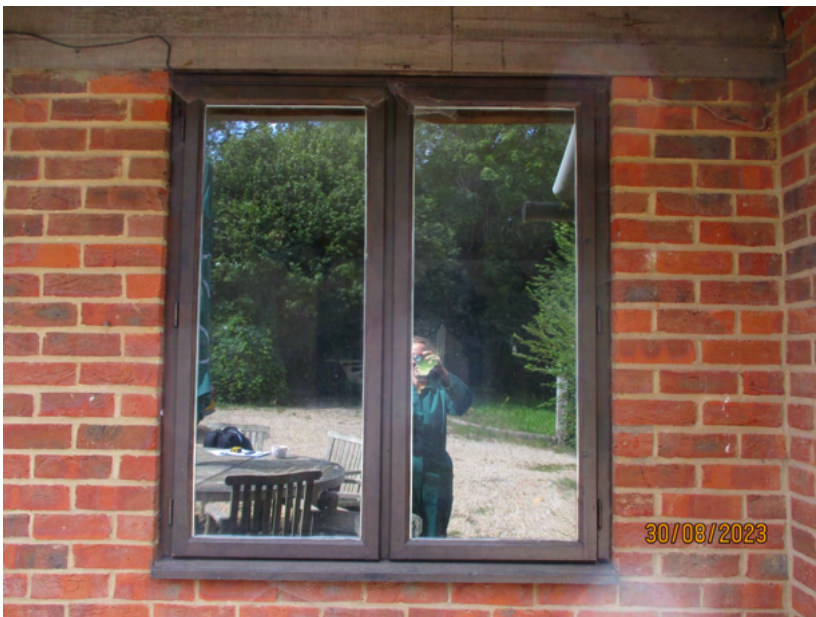
Fig 14:

Rosehill Barn, showing the domestic window openings and c.1985 storm proof double glazed windows which were introduced when the residential conversion was undertaken.

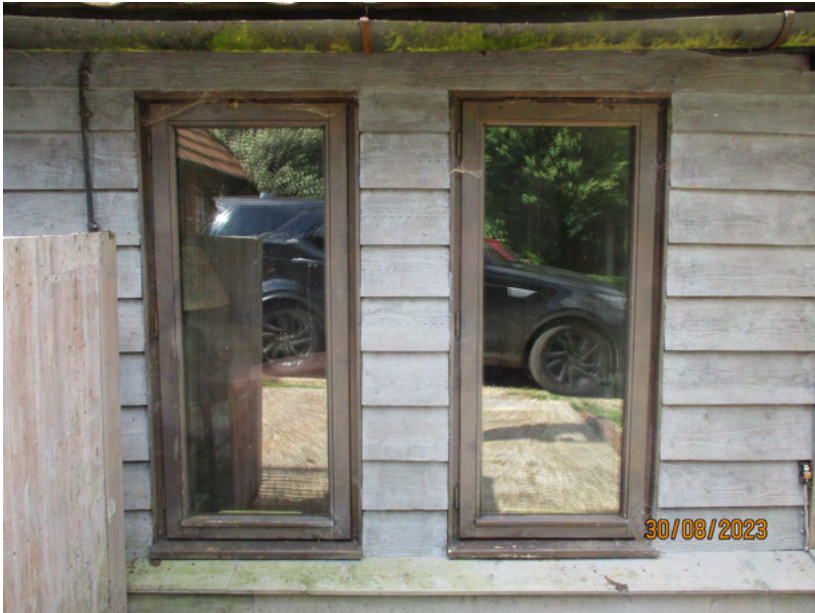
Fig 15:

Rosehill Barn, showing the domestic window openings and c.1985 storm proof double glazed windows which were introduced when the residential conversion was undertaken.

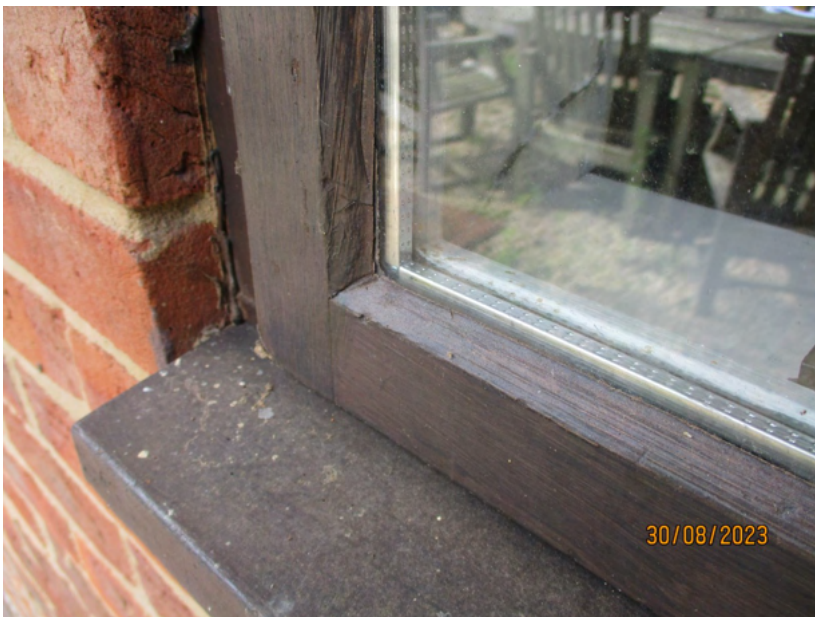
Fig 16:

Rosehill Barn, showing the c.1985 storm proof double glazed windows which were introduced when the residential conversion was undertaken.

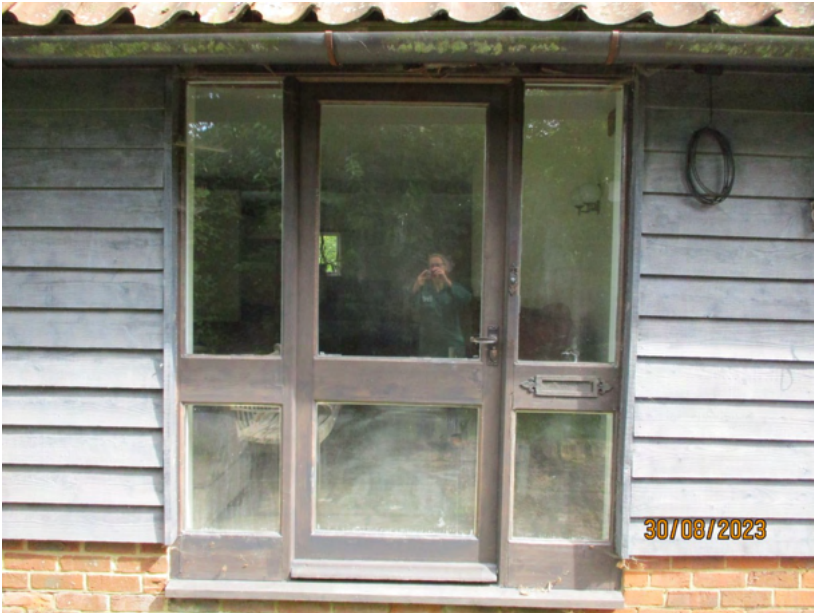
Fig 15:

Rosehill Barn, showing the modern double glazed rear door which was introduced c.2000 when alterations were undertaken to the dwelling.

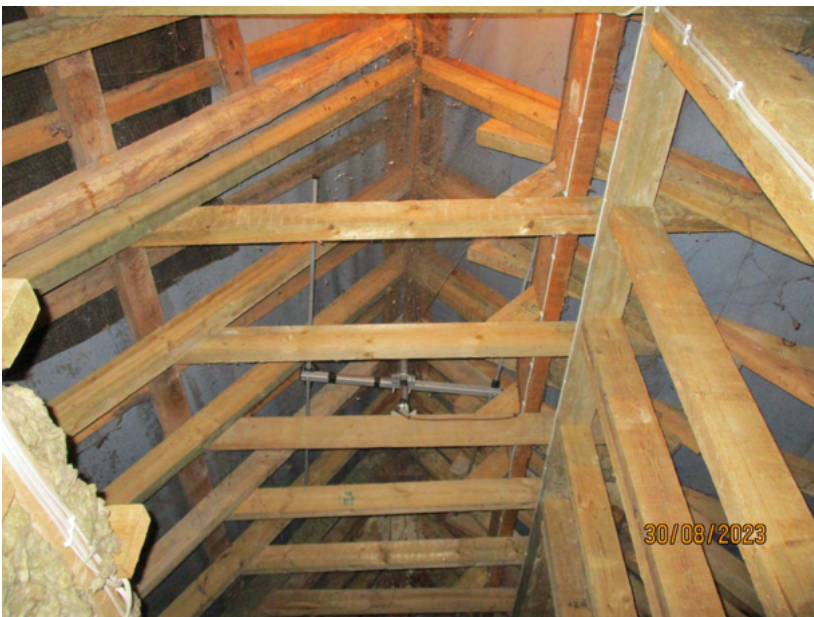
Fig 16:

Roof structure which incorporates a substantial amount of modern, c.1985 timber with a limited amount of historic fabric surviving. The roof structure is overlaid by a sheet membrane.

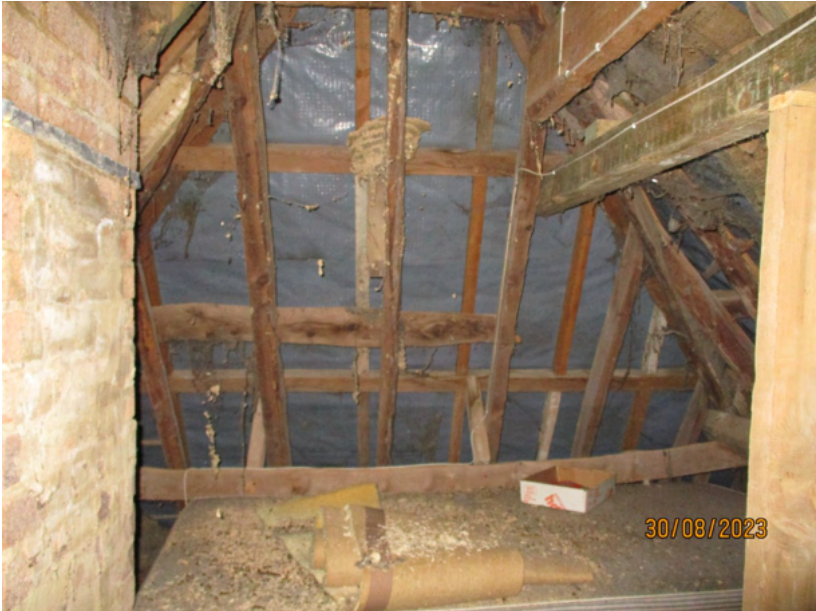
Fig 17:

Roof structure which incorporates a substantial amount of modern, c.1985 timber although some historic timbers do survive particularly in the west hip. The roof structure is overlaid by a sheet membrane.

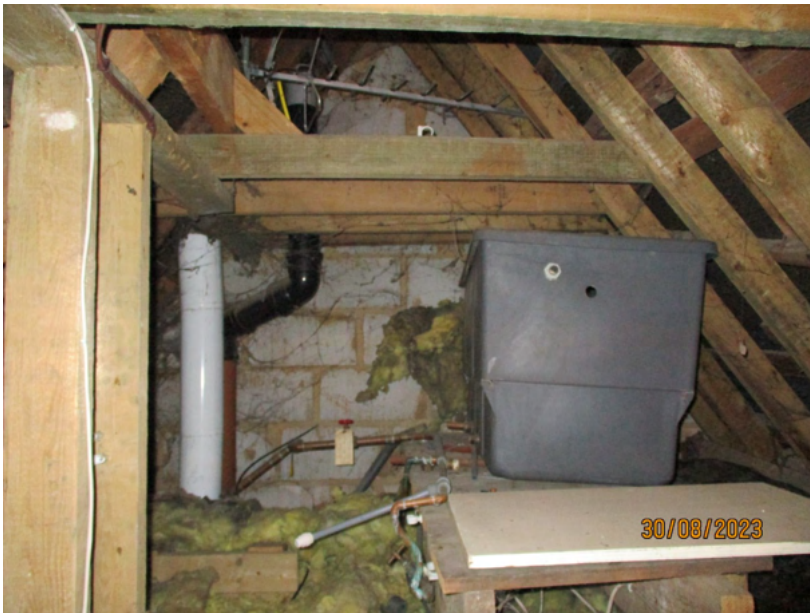
Fig 18:

Roof structure looking east, showing the blockwork wall which separates Rosehill Barn from the east side of the barn which remains unconverted and associated with Mays Farmhouse.

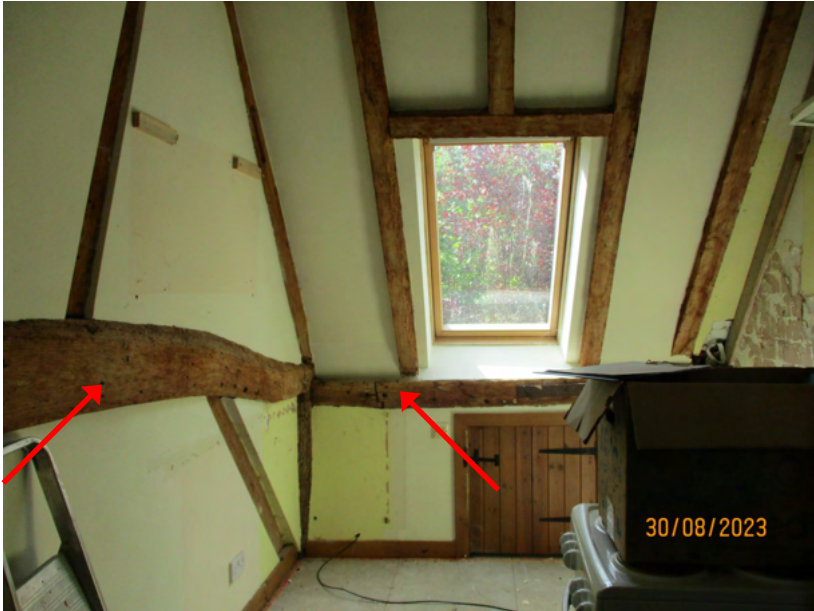
Fig 19:

Room F1, looking south showing exposed roof timbers and rooflight which are modern c. 2000. This part of the dwelling was converted later as an addition to the original barn conversion. Some historic timbers so survive within the structure specifically the wall plate and tie beam.

Red arrow indicates historic timber framing.

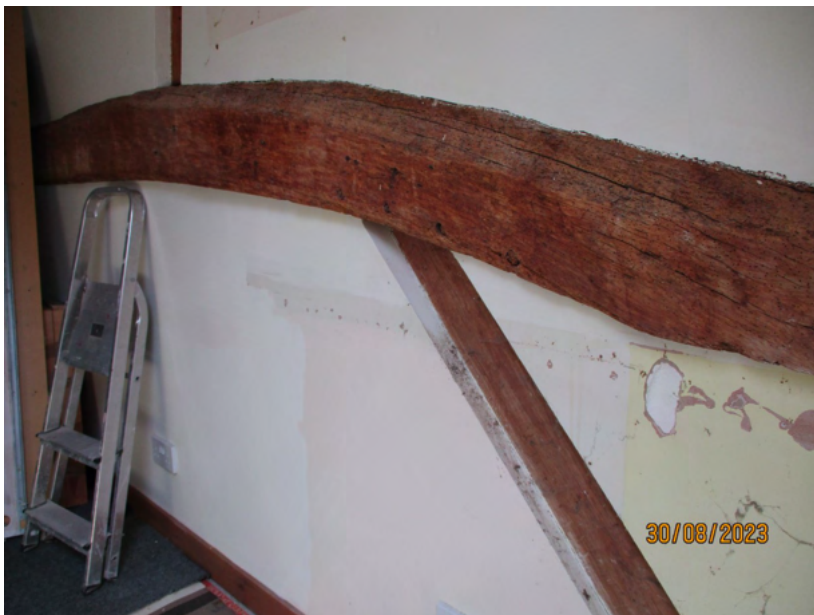
Fig 20:

Room F1, showing the historic tie beam. This part of the dwelling was converted later, c. 2000, as an addition to the original barn

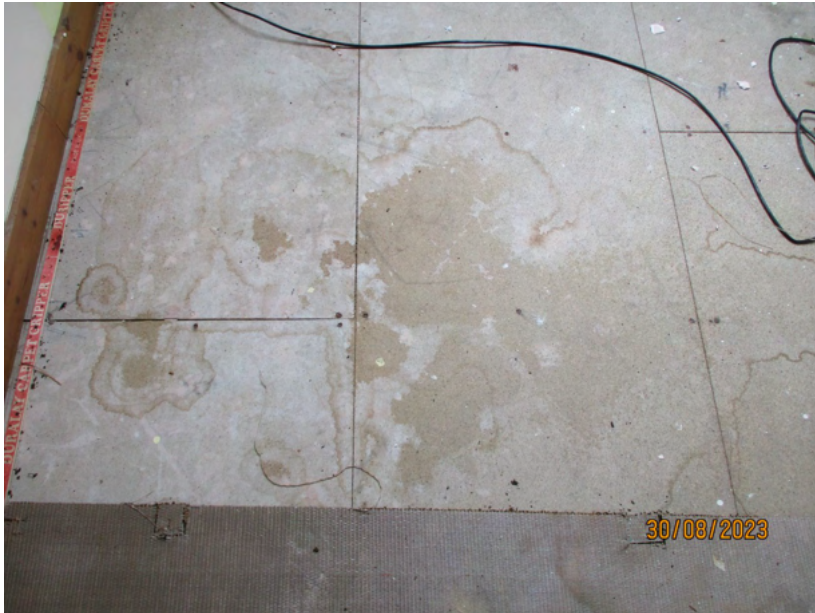
Fig 21:

Room F1, showing the sheet board covering that exists throughout the first floor. The first floor structure was constructed c. 1985 or later (in the case of the floor at the east end of the dwelling which was created c. 2000) when the interior went from being open as an aisled barn to being subdivided to create a dwelling.

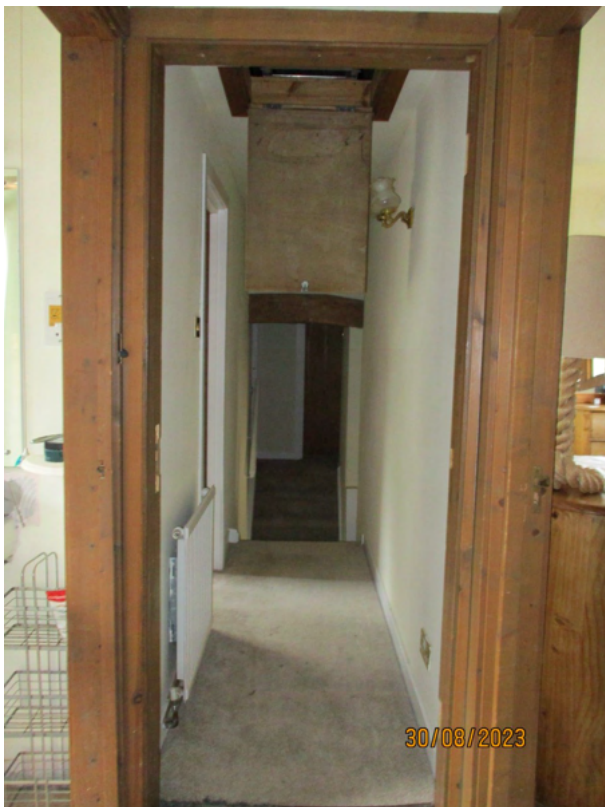
Fig 22:

Room F2, looking west through the hallway. The first floor and arrangement or rooms was created c. 1985 or later (in the case of the floor at the east end of the dwelling which was created c.2000) when the interior went from being open as an aisled barn to being subdivided into a dwelling. The fabric within the internal walls is stud partitioning and plasterboard, ceilings are plasterboard and floors sheet board material.

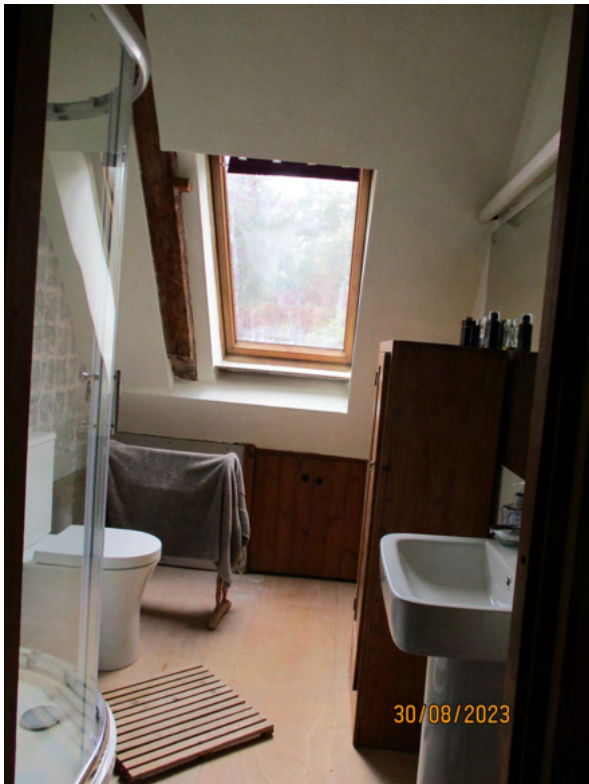
Fig 23:

Room F3, showing the bathroom. The arrangement of room was created c. 1985 when the interior went from being open as an aisled barn to subdivided into a dwelling. The fabric within the internal walls is stud partitioning and plasterboard, ceilings are plasterboard and floors sheet board material.

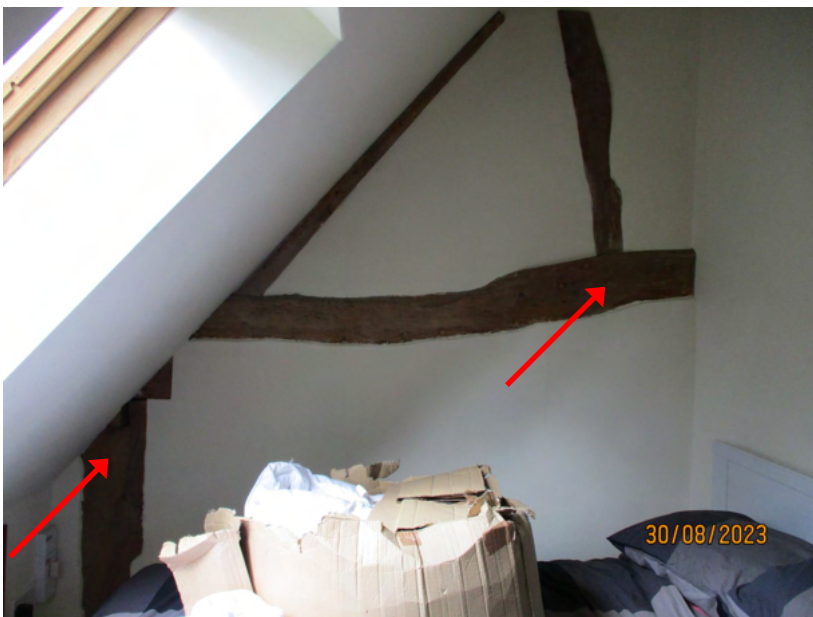
Fig 24:

Room F4, showing the bedroom. The arrangement of room was created c. 1985 or later when the interior went from being open as an aisled barn to subdivided into a dwelling. The fabric within the internal walls is stud partitioning and plasterboard, ceilings are plasterboard and floors sheet board material. Some historic timbers so survive within the structure specifically the wall plate and tie beam. In this room the tie beam has been cut then raised above its original height.

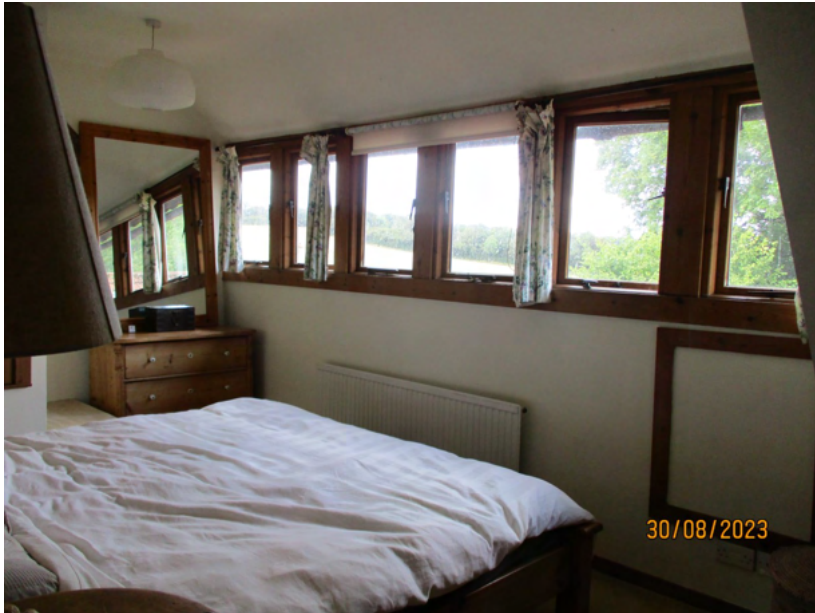
Fig 25:

Room F5, showing the windows within the low catslide dormer which were introduced c.1985 or later. The arrangement of room was created c. 1985 or later when the interior went from being open as an aisled barn to subdivided into a dwelling. The fabric within the internal walls is stud partitioning and plasterboard, ceilings are plasterboard and floors sheet board material.

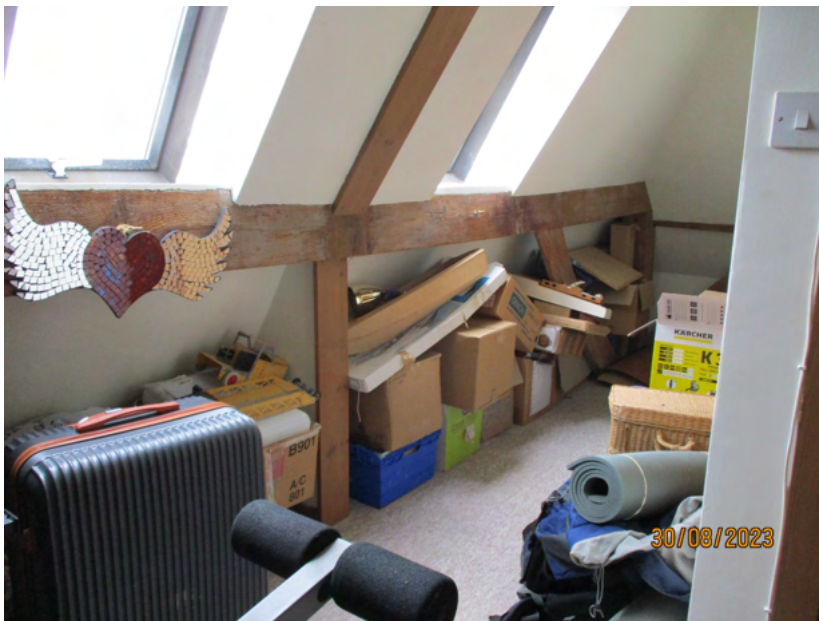
Fig 26:

Room F6, showing the bedroom. The arrangement of room was created c. 1985 or later when the interior went from being open as an aisled barn to subdivided into a dwelling. The fabric within the internal walls is stud partitioning and plasterboard, ceilings are plasterboard and floors sheet board material.

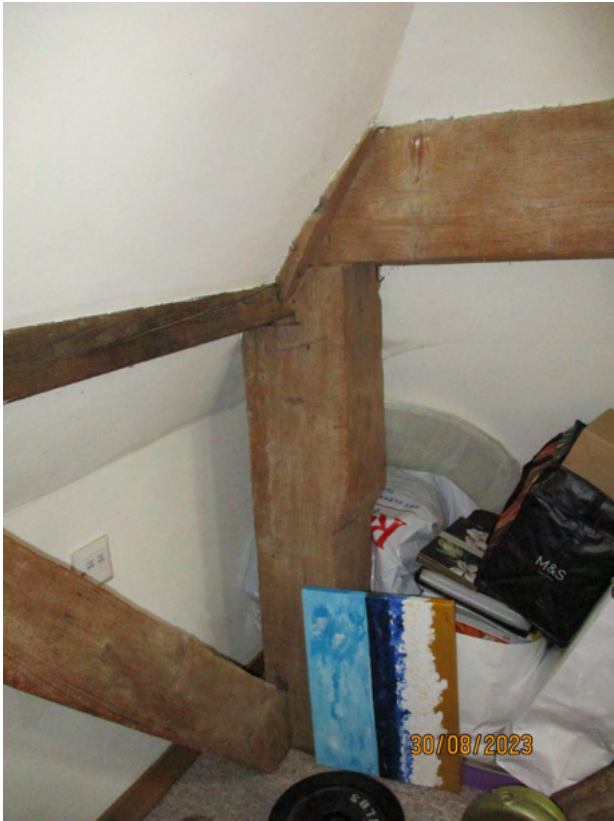
Fig 27:

Room F6, showing historic timber framing which survives in this room.

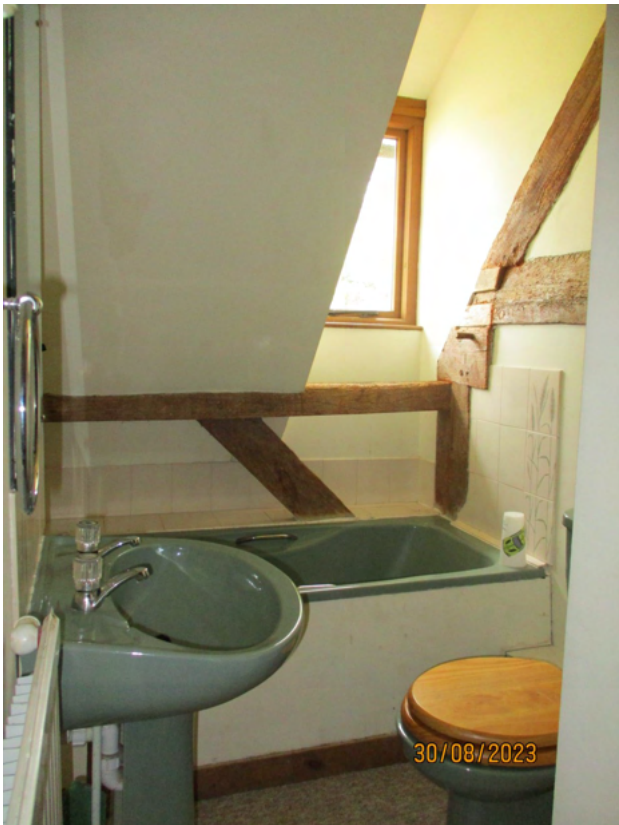
Fig 28:

Room F7, as bathroom. The arrangement or room was created c. 1985 or later when the interior went from being open as an aisled barn to subdivided into a dwelling. The fabric within the internal walls is stud partitioning and plasterboard, ceilings are plasterboard and floors sheet board material. Some historic timber framing survives in the room.

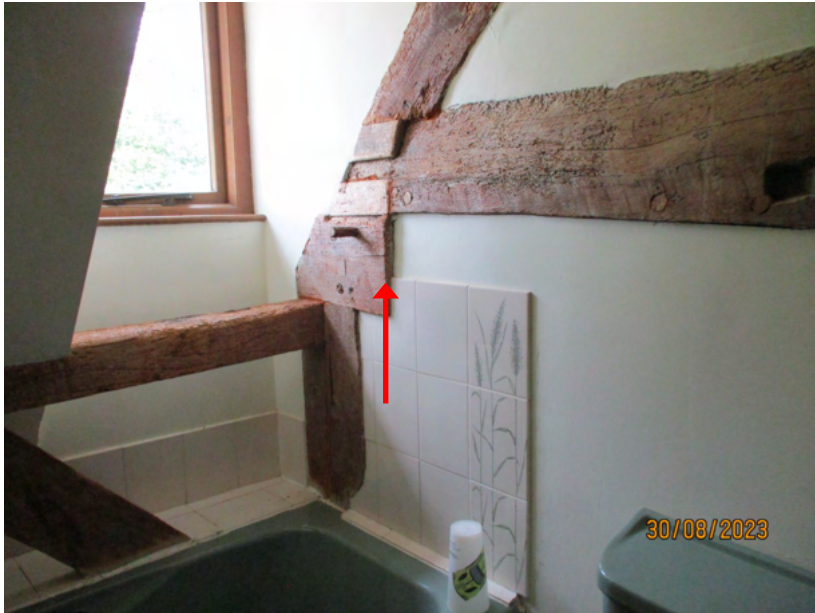
Fig 29:

Room F7, showing historic timber framing which has been modified to facilitate the barn conversion. The tie beam has been cut and raised.

Red arrow shows where the tie beam has been cut then raised above its original height.

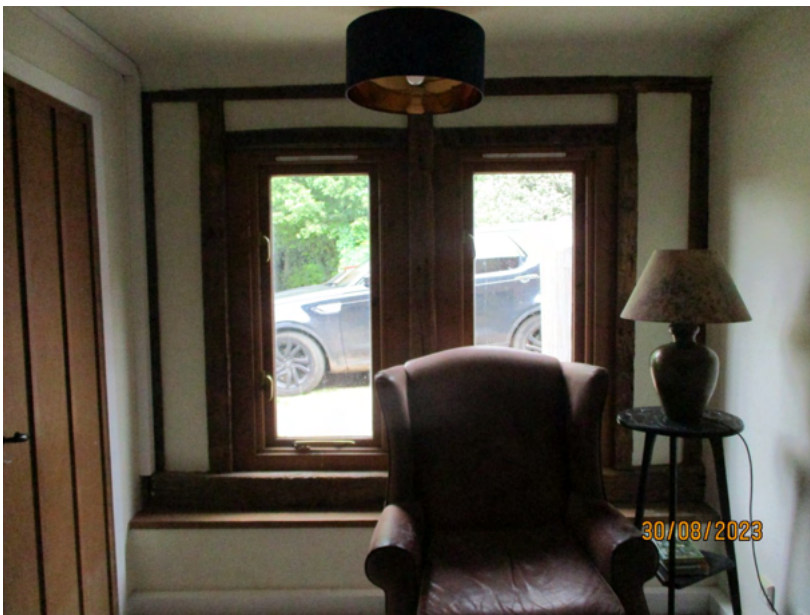
Fig 30:

Room G1, looking north. This part of the dwelling was converted later, c. 2000 as an addition to the original barn conversion. Some historic timbers so survive within the structure specifically the wall plate and tie beam.

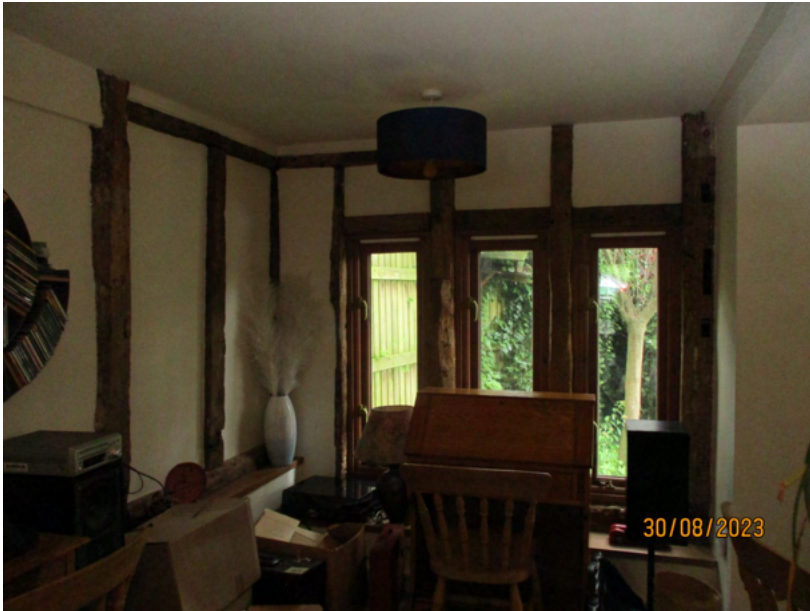
Fig 31:

Room G1, looking south. This part of the dwelling was converted later, c. 2000 as an addition to the original barn conversion. Some historic timbers so survive within the structure specifically the wall plate and tie beam.

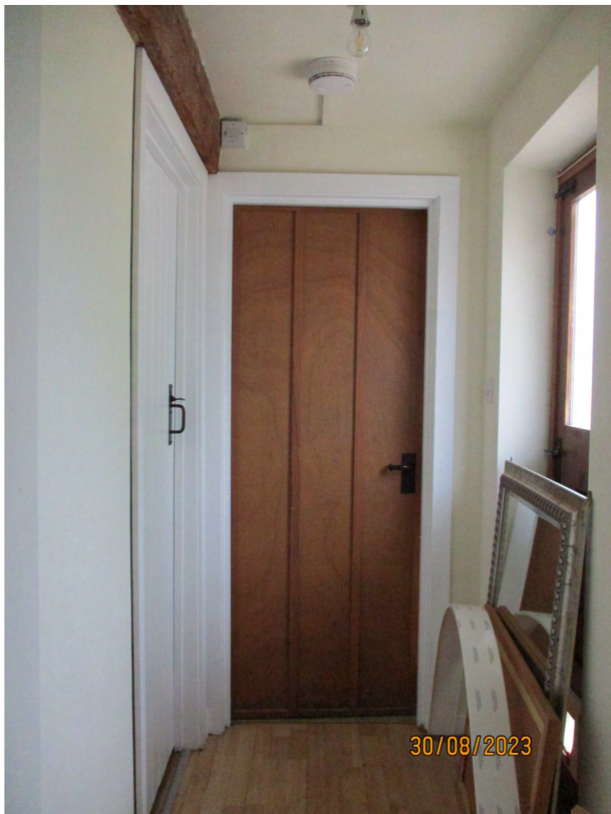
Fig 32:

Room G2. The arrangement of room was created c. 1985 or later when the interior went from being open as an aisled barn to subdivided into a dwelling. The fabric within the internal walls is stud partitioning and plasterboard, ceilings are plasterboard and floors sheet board material. Some historic timber framing survives in the room.

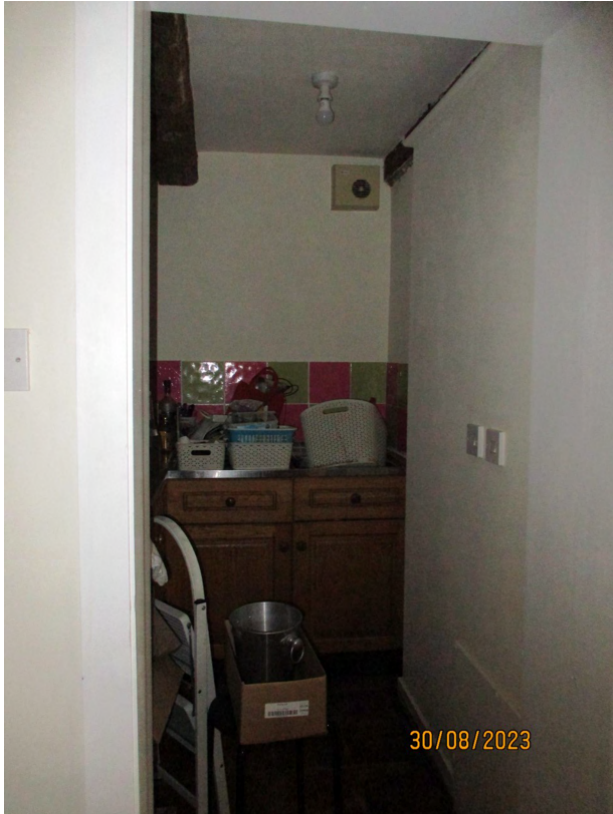
Fig 33:

Room G3, showing the utility storage. The arrangement of room was created c. 2000 after the interior went from being open as an aisled barn to subdivided into a dwelling and after the floor area was extended to the east. The fabric within the internal walls is stud partitioning and plasterboard, ceilings are plasterboard and floors are solid (assume concrete) with floor covering over.

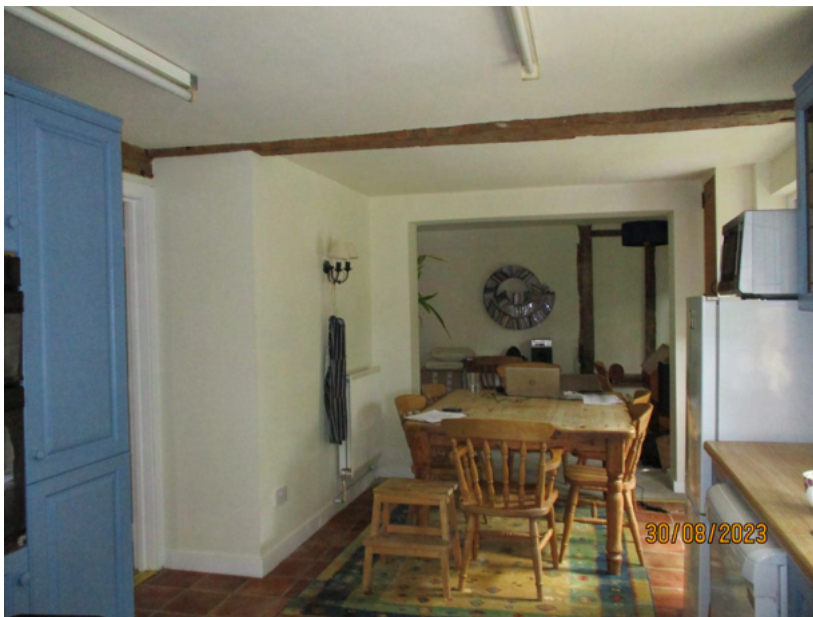
Fig 34:

Room G4, showing the kitchen. The arrangement of room was created c. 1985 or later after the interior went from being open as an aisled barn to subdivided into a dwelling. The fabric within the internal walls is stud partitioning and plasterboard, ceilings are plasterboard and floors are solid (assume concrete) with floor covering over.

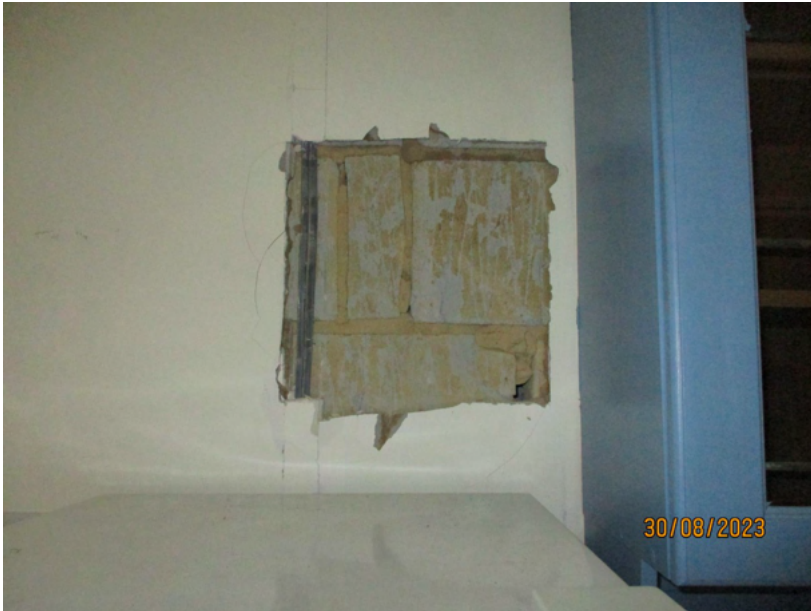
Fig 35:

Room G4 showing an area of the south wall in the kitchen. Where localised opening up has been undertaken and plaster finishes removed in reveals blockwork beneath as c.1985 fabric.

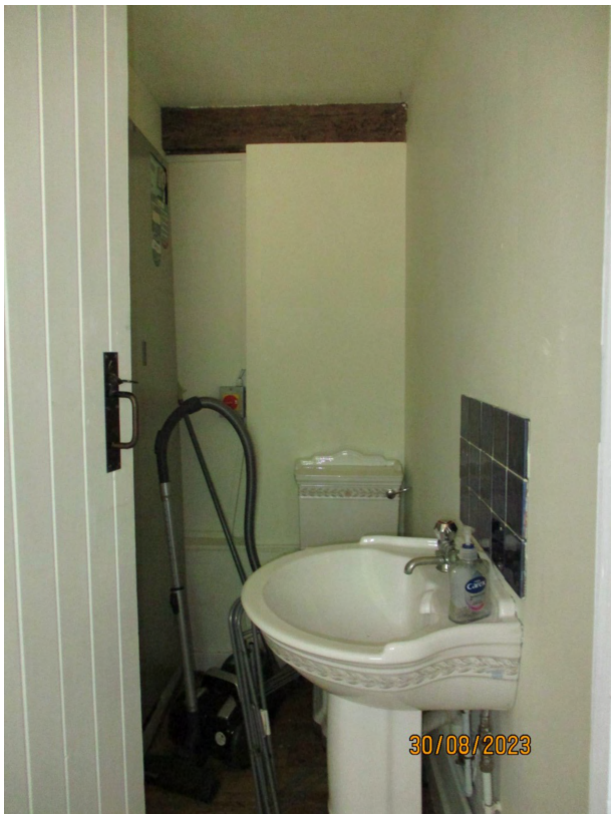
Fig 36:

Room G5, showing downstairs toilet and utility. The arrangement of room was created c. 1985 or later after the interior went from being open as an aisled barn to subdivided into a dwelling. The fabric within the internal walls is stud partitioning and plasterboard, ceilings are plasterboard and floors are solid (assume concrete) with floor covering over.

2.5.21	G5 (toilet/utility)	<p>Ceiling: Decorated plasterboard</p> <p>Walls: <u>North-east</u> and <u>south-east</u> not observed. <u>South-west</u> as decorated plasterboard with exposed timber beam to top of wall. Beam at top of wall as recycled timber positioned for aesthetic purpose and not relating to original arrangement of historic</p>

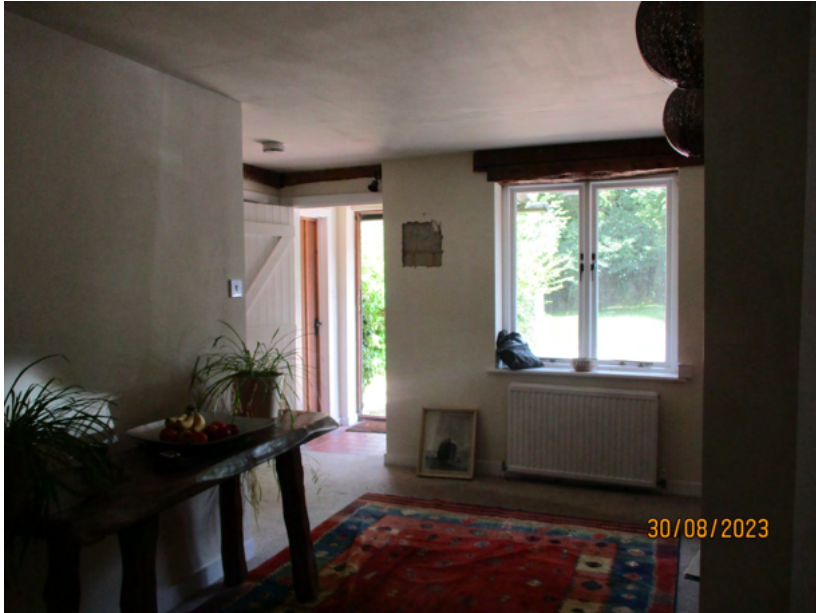
Fig 37:

Room G6, showing the hall. The arrangement of room was created c. 1985 or later after the interior went from being open as an aisled barn to subdivided into a dwelling. The fabric within the internal walls is stud partitioning and plasterboard, ceilings are plasterboard and floors are solid (assume concrete) with floor covering over.

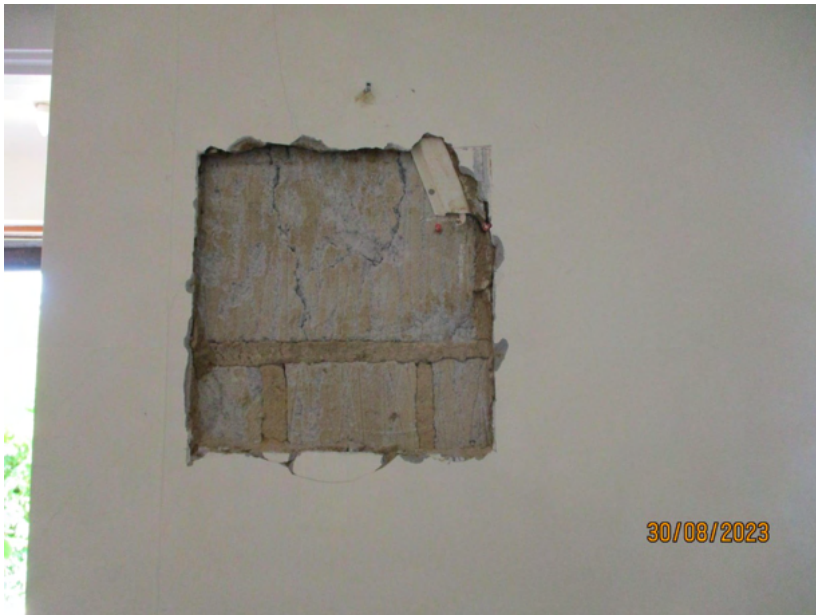
Fig 38:

Room G6, showing an area of the north wall in the hallway. Where localised opening up has been undertaken and plaster finishes removed in reveals blockwork beneath as c.1985 fabric.
