HERITAGE STATEMENT FOR ROSEHILL BARN, OWSLEBURY, SO21 1JS

JOB NO: 439-08

30 AUGUST 2023

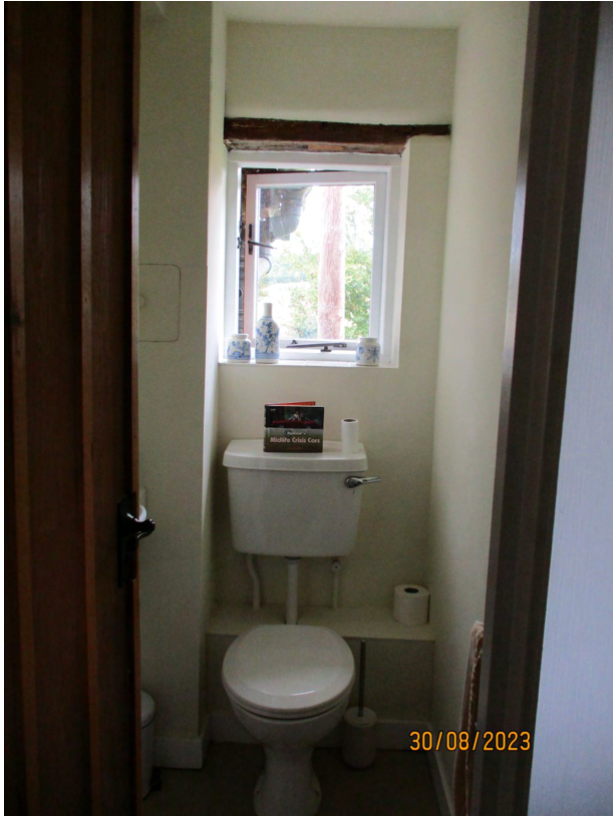
Fig 39:

Room G7, showing downstairs toilet. The arrangement of room was created c. 1985 or later after the interior went from being open as an aisled barn to subdivided into a dwelling. The fabric within the internal walls is stud partitioning and plasterboard, ceilings are plasterboard and floors are solid (assume concrete) with floor covering over.

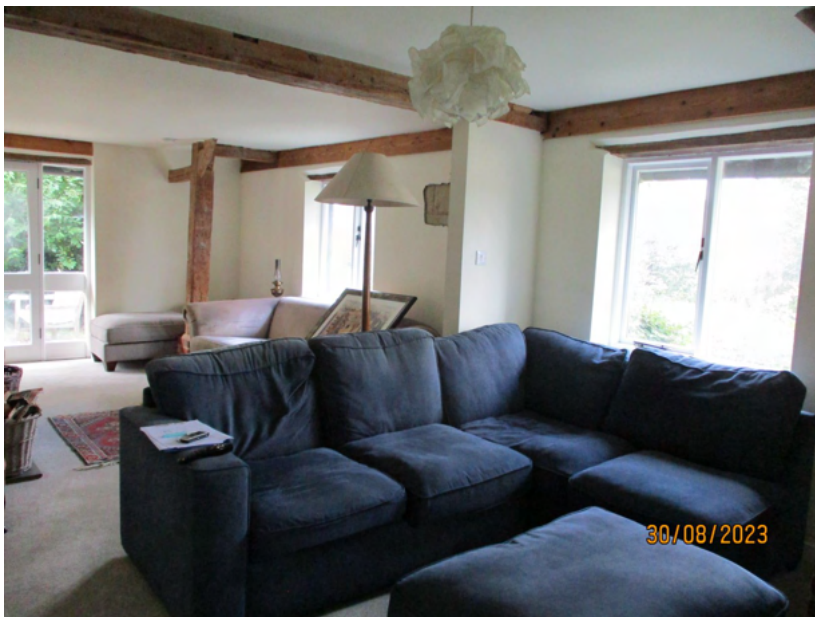
Fig 40:

Room G8 the living room. The arrangement of room was created c. 1985 or later after the interior went from being open as an aisled barn to subdivided into a dwelling. The fabric within the internal walls is stud partitioning and plasterboard, ceilings are plasterboard and floors are solid (assume concrete) with floor covering over.

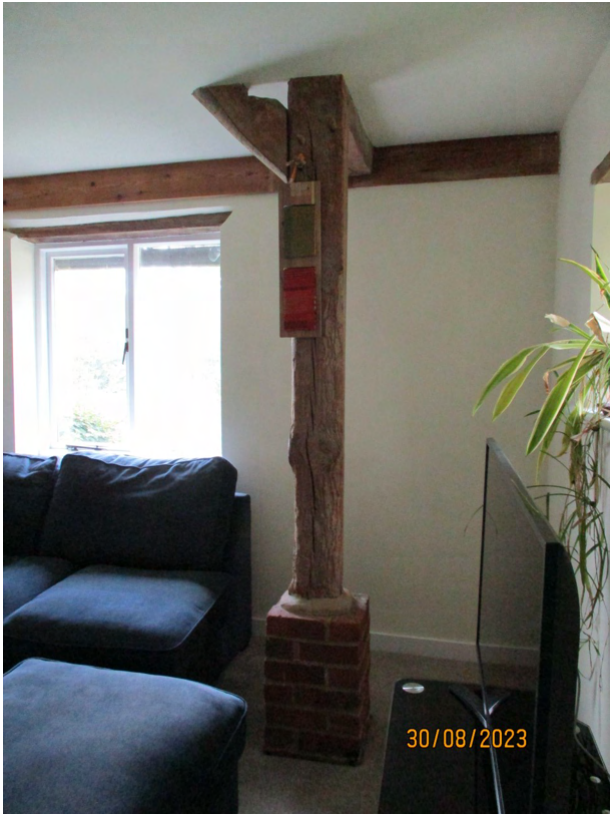
Fig 41:

Room G8 showing historic timber framing which survives in this room in the form of aisle posts. The posts have been truncated and now sit on modern c. 1985 brickwork.

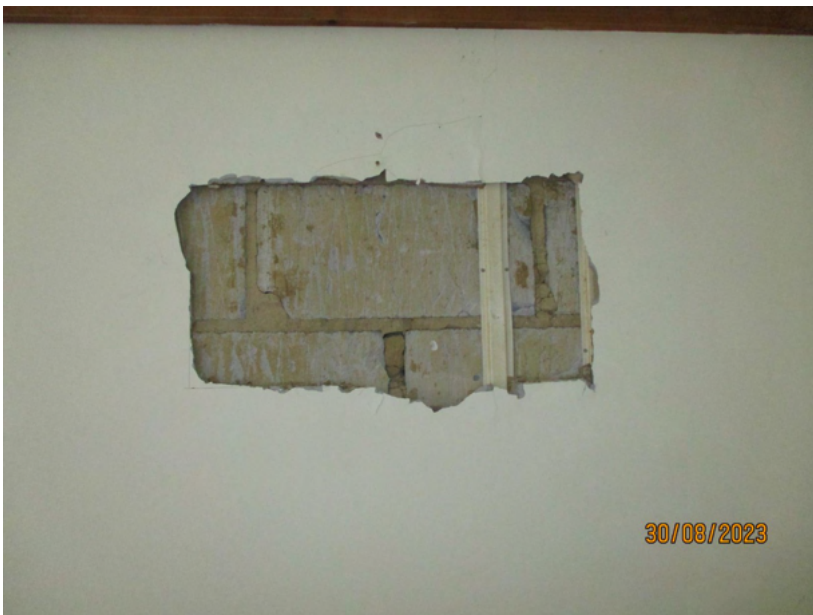
Fig 42:

Room G8, showing an area of the west wall in the living room. Where localised opening up has been undertaken and plaster finishes removed in reveals blockwork beneath as c.1985 fabric.

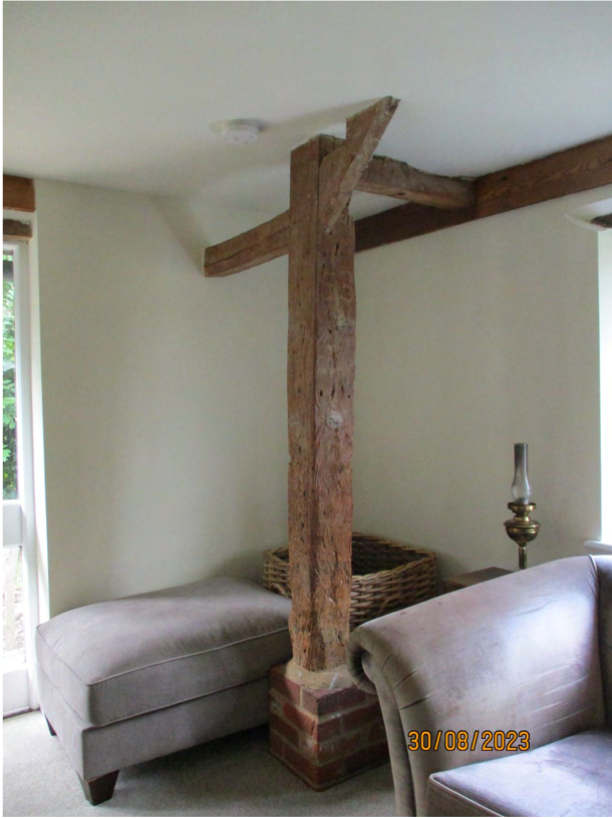
Fig 43:

Room G8, showing historic timber framing which survives in this room in the form of aisle posts. The posts have been truncated and now sit on modern c. 1985 brickwork.

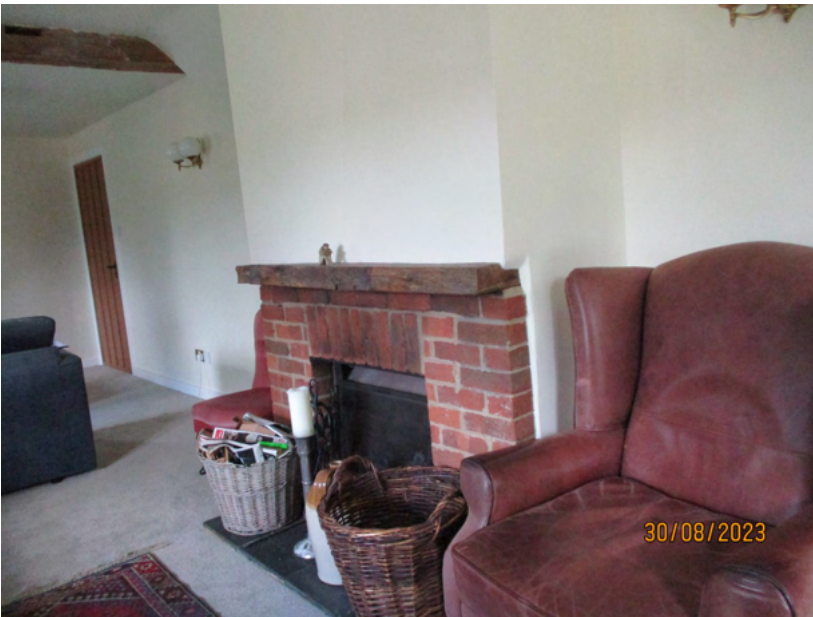
Fig 44:

Room G8, showing the living room fireplace. This was introduced c.1985 after the interior went from being open as an aisled barn to subdivided into a dwelling.

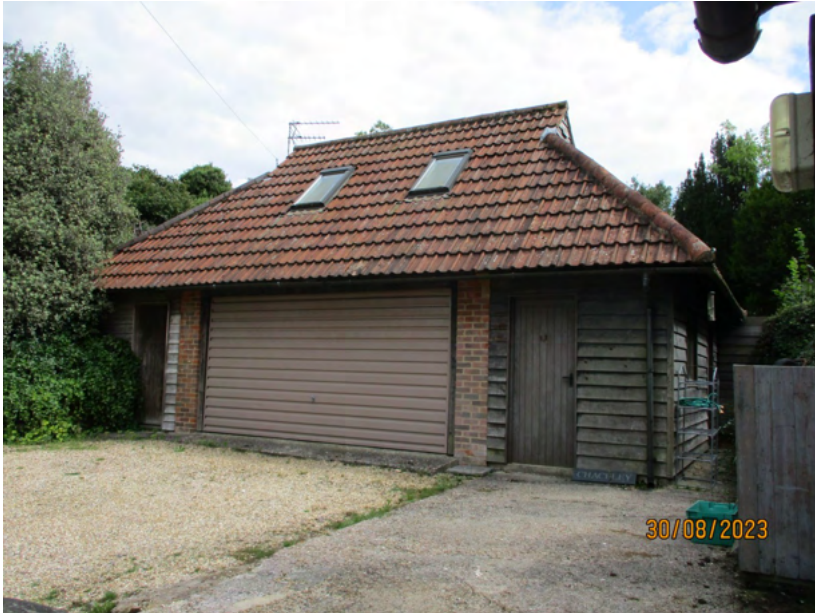
Fig 45:

Garage and ancillary accommodation. A garage building was first constructed between c.1985 and 1992 but to a slightly smaller footprint than the extant footprint. The garage building originally comprised of an asymmetrical structure of central part and south part. The building was extended to the north c.1992 to create the footprint and form that exists today.

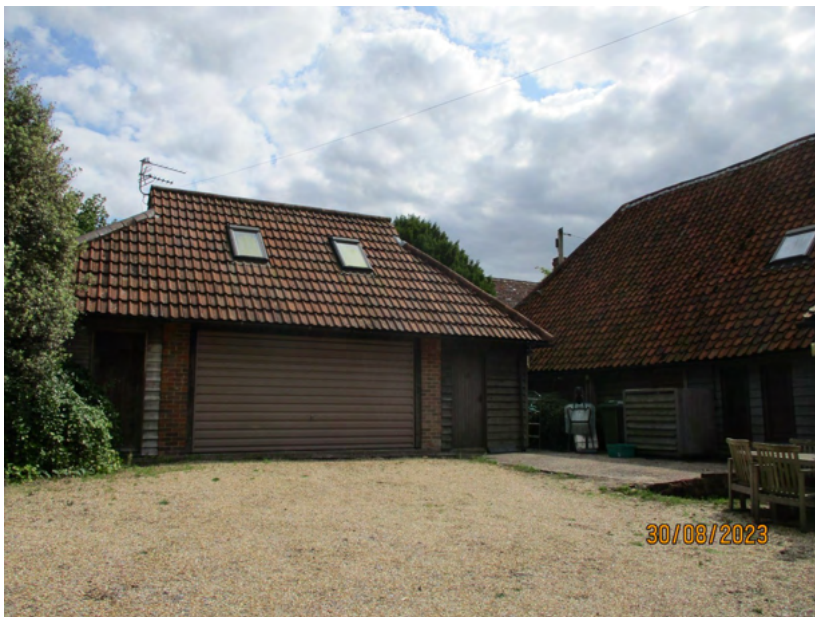
Fig 46:

Garage and ancillary accommodation. A garage building was first constructed between c.1985 and 1992 but to a slightly smaller footprint than the extant footprint. The garage building originally comprised of an asymmetrical structure of central part and south part. The building was extended to the north c.1992 to create the footprint and form that exists today.
