Site:	Cowdray Works Yard
Client:	Metis Homes
Job Number:	784 -A112595
Report Type(s):	Update Bat Emergence Letter Report to discharge Condition 7 of of planning (SDNP/21/04040/FUL)
File Location:	M:\Projects\784-A112595 Cowdry Work Yard\60 Project Output\61 Work in Progress\Update Letter Report 2024

The purpose of this report is to present the results of the update bat emergence survey and provide avoidance and mitigation measures to discharge Condition 7 (SDNP/21/04040/FUL).

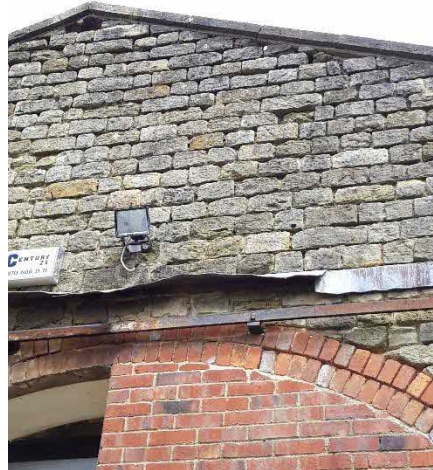
Photograph 1: Stonework Below Roof Apex Southern Aspect of Building B8

The bats recorded emerging and / or returning to building B8 were all noted along the southern aspect of the building from multiple access points within the stonework and from beneath the wooden fascia on the sloping roof section (Photograph 1 and 2).

No additional lighting including security lighting will be located near building B8. Any lighting that is located within the application site must not be direct towards building B8.

Construction activities, including storage of materials must not be carried out within 5m of building B8.

Suitable Haras fencing / hording will be installed to provide an appropriate buffer to building B8.

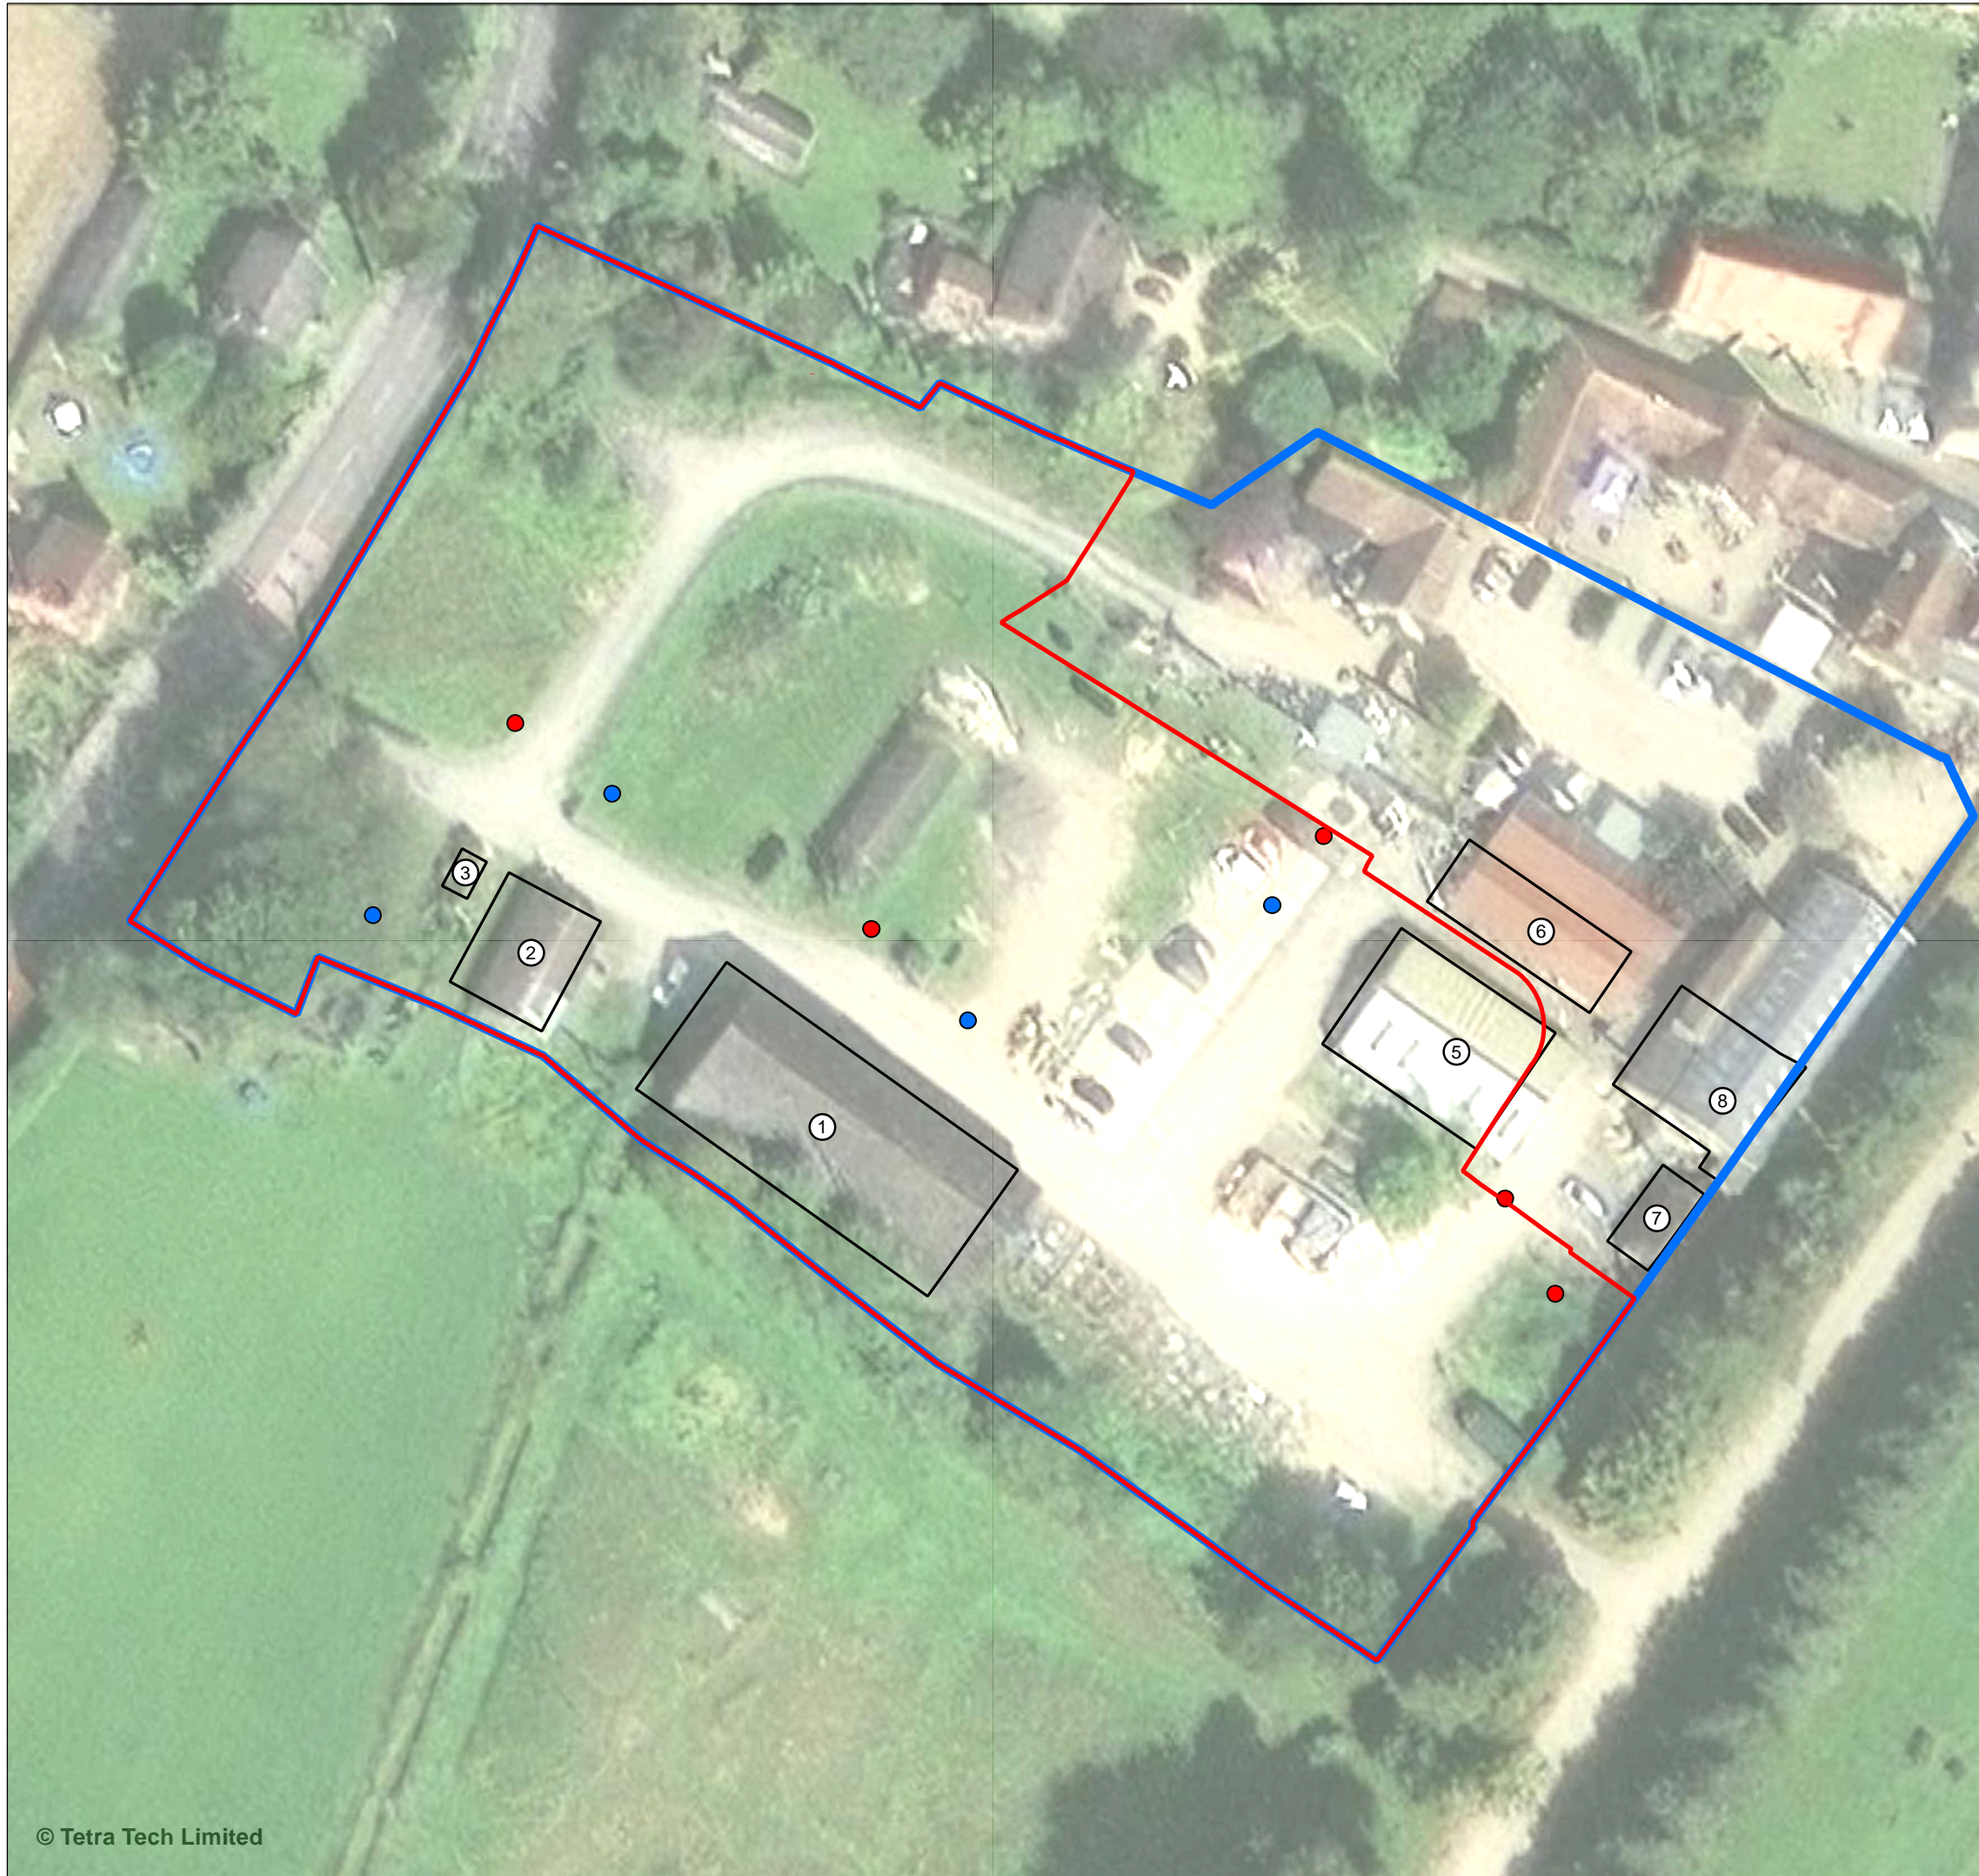
Figure No. 2
 Revision No. B

An updated bat survey was carried out in accordance with the Good Practice Guidelines (Collins, 2023³). A dusk emergence survey on the buildings took place in August 2023, starting half an hour before sunset and continuing for one and a half an hour after. Surveyor positions are shown in Figure 2. Surveyors recorded all bats emerging from and returning to the buildings.

Surveyor Locations

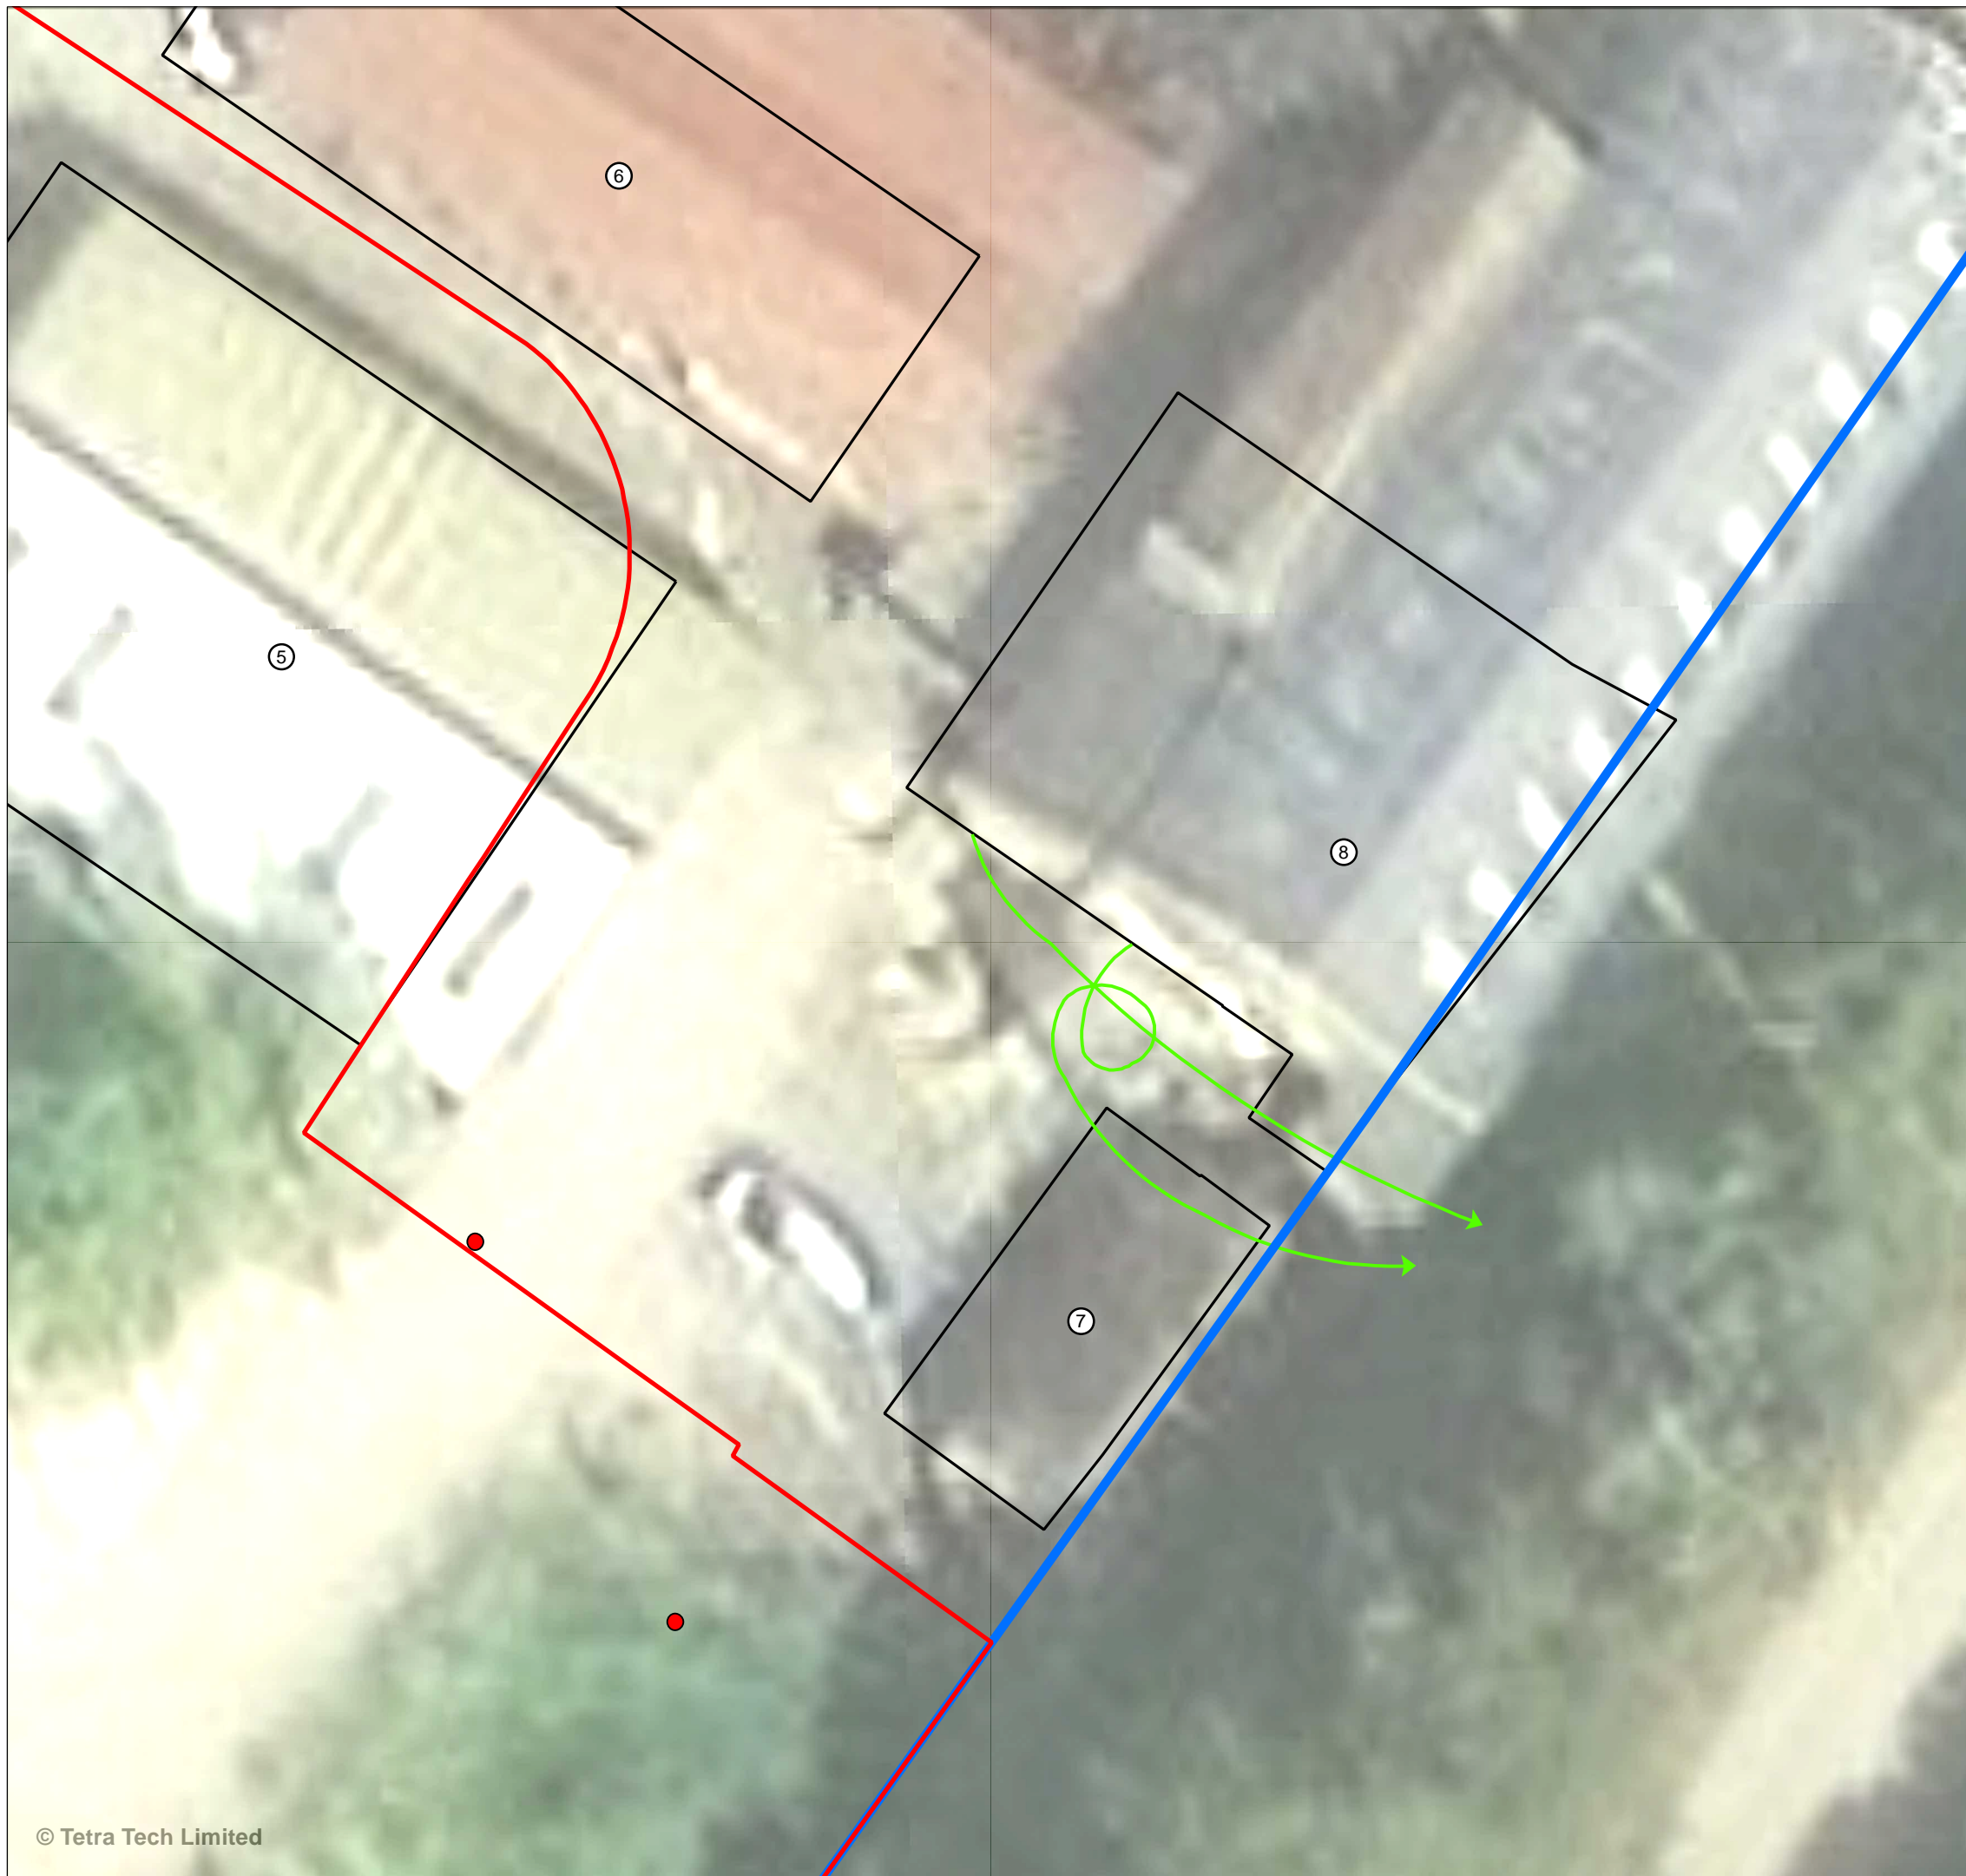
Figure No. 3
 Revision No. B

Two species of bat (common and soprano pipistrelle) were recorded emerging and / or returning to the building on three occasions during surveys conducted in 2019. The update emergence survey conducted in August 2023 recorded a soprano pipistrelle roosting in B8. Table 3 below shows the historical results and update survey results of building B8 from all surveys.

Surveyor Locations and Survey Results B8

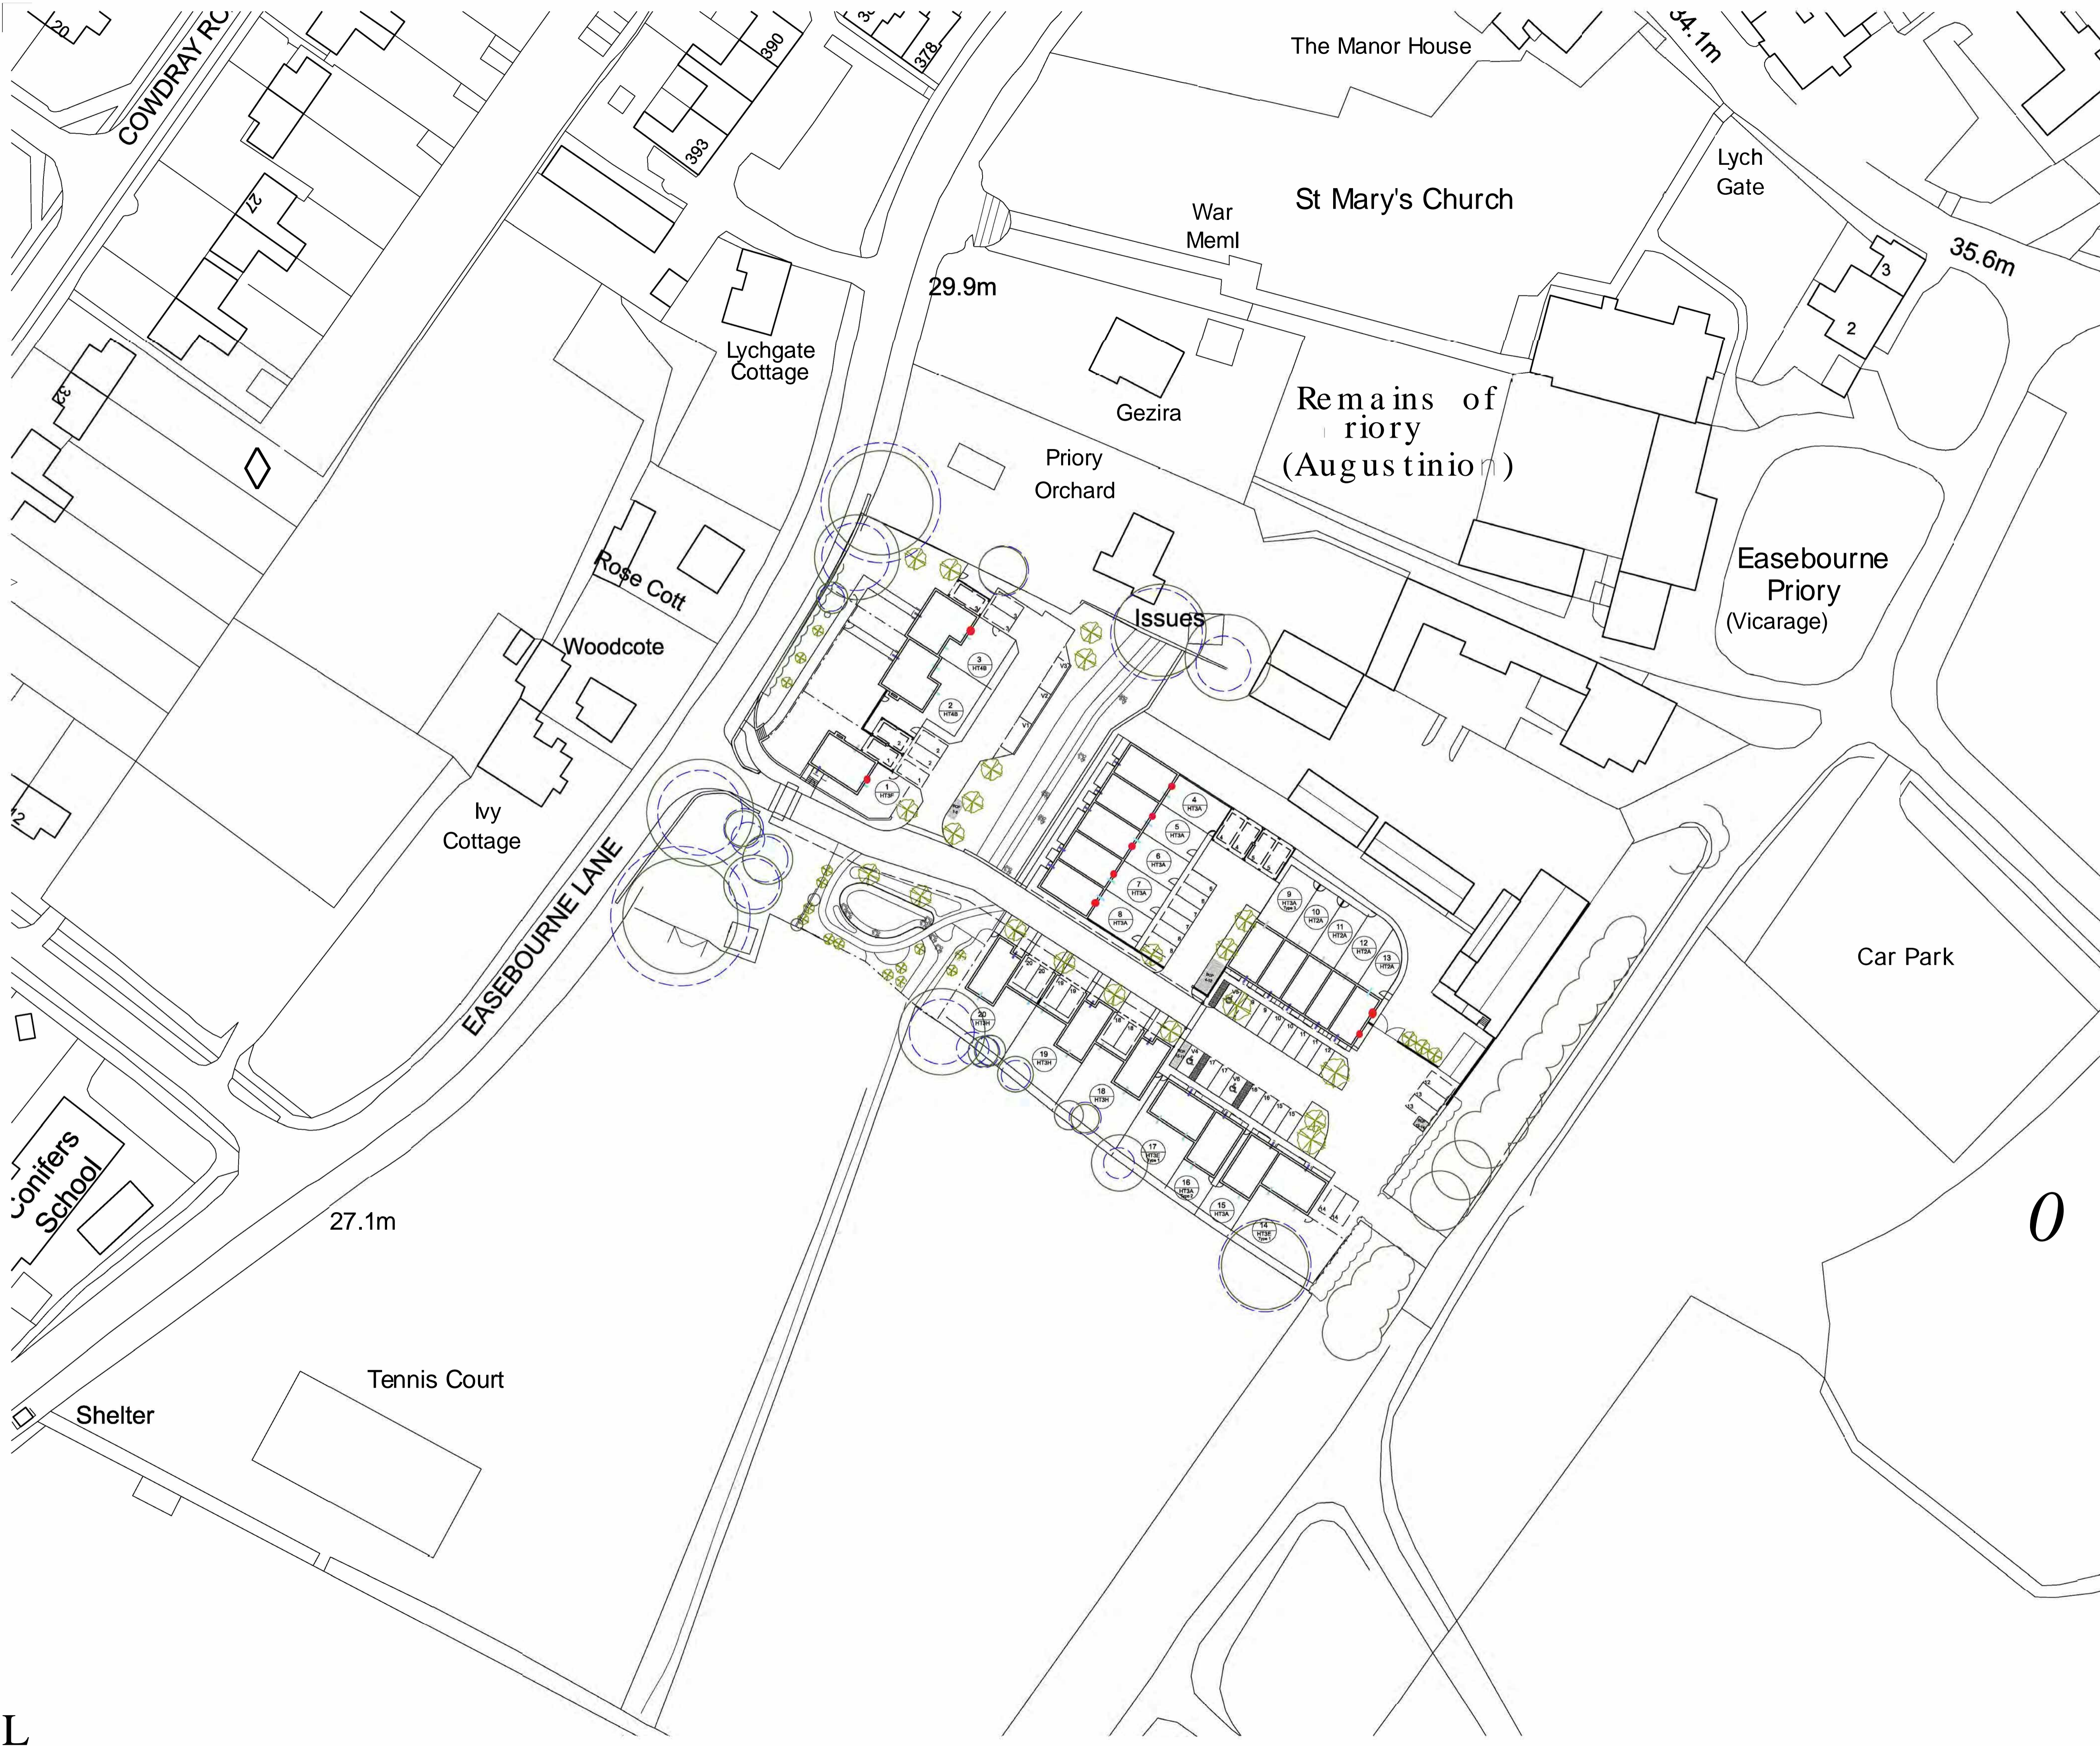
Appendix B – Bat box location plan

Bat tubes will be installed within gable ends of 8 of the new dwellings, see Appendix B.

Key
 ● 2 x bat boxes
