PRELIMINARY BAT ROOST ASSESSMENT

The Boars Head, 14 Lynch Road,
Berkeley, Gloucestershire GL13 9TA

Report
7th December 2022

Report reference:
C3022-1

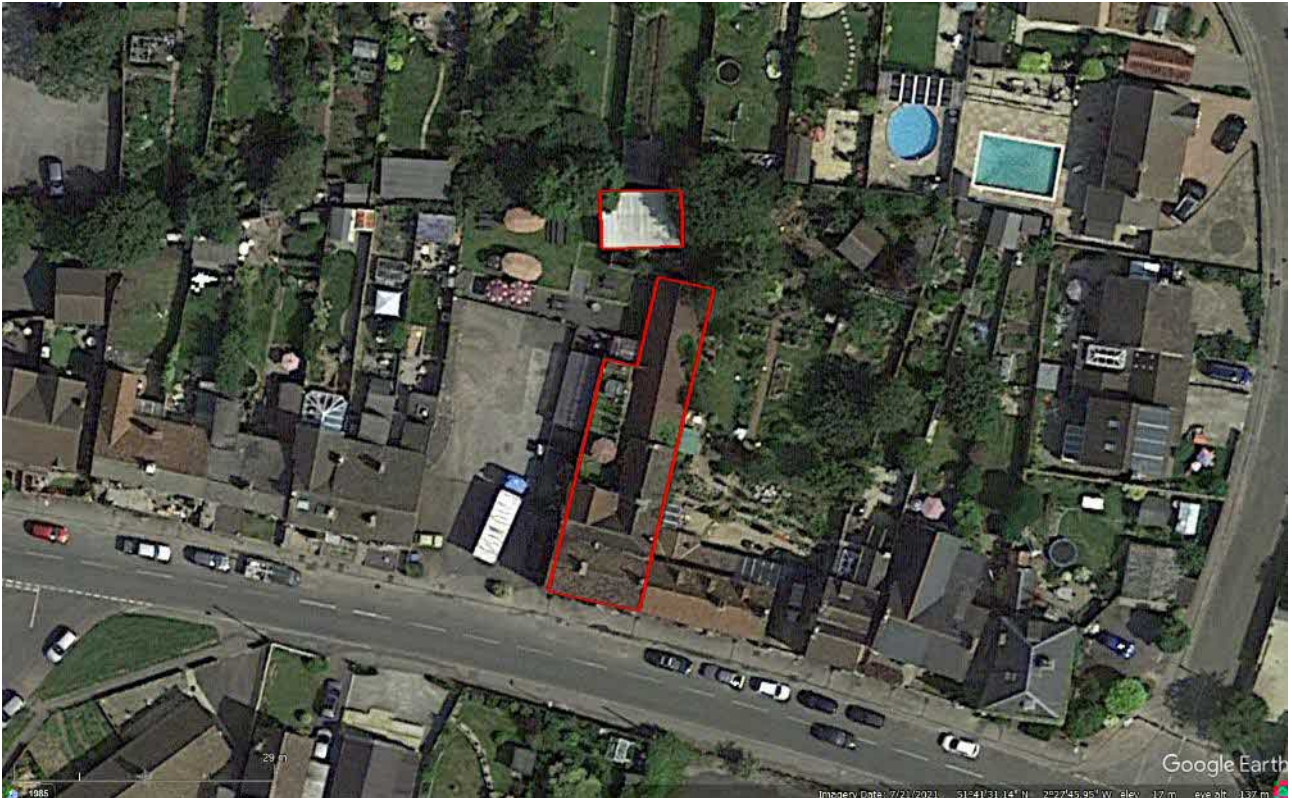
Figure 2: Aerial photo showing surveyed buildings outlined in red.

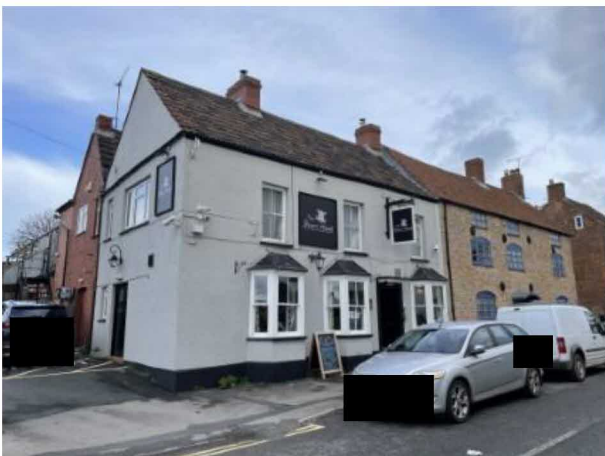
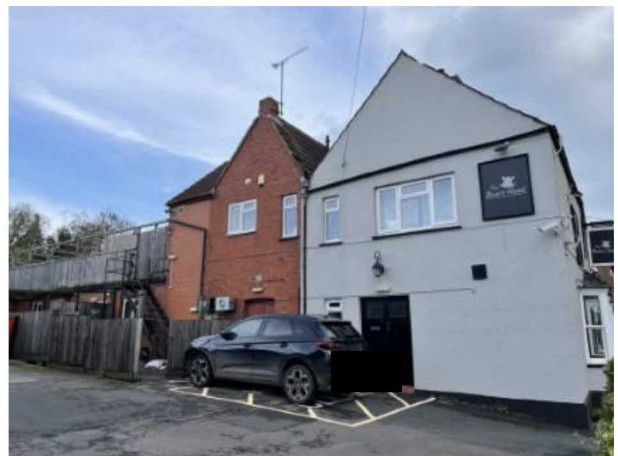
Plates 1 and 2: The Boars Head; showing southern elevation (left) and western gables (right) of structures 1 and 2 (see Figure 3), with pitched, tiled roofs and brick chimneys.

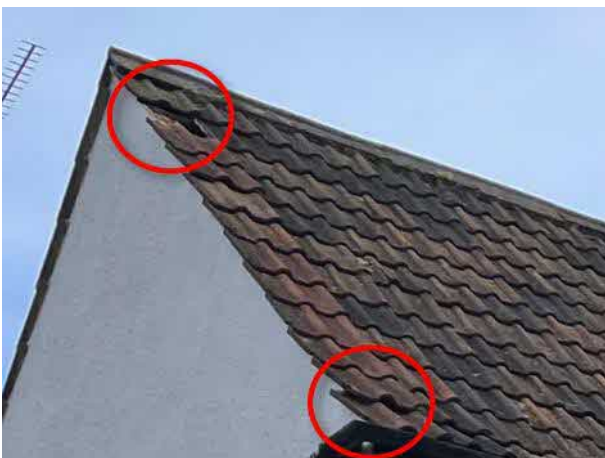
Plate 7: Missing and slipped roof tiles on south Pitch of structure 1.

the tiling. There are also several slipped, broken and missing tiles on some of the roof pitches, including missing and slipped tiles on the south roof pitch of the original building (Plate 7; structure 1, Figure 3); and a missing tile on the south roof pitch of the two-storey extension (Plate 8; structure 2, Figure 3). There are also visible gaps between the concrete ridge tiles and pitch tiles below where the mortar has fallen out, offering access opportunities for bats into the voids or to spaces beneath the ridge tiles.

The apex ridge board has some cobwebs along its length, which is suggestive of no recent bat use. The ridge tiles are visible above the ridge board, with the enclosed cavities below the tiles appearing relatively un-mortared; these cavities are likely to offer suitable access and roosting opportunities for bats. The missing tile on the south roof pitch near the west gable (Plates 7 and 12) would provide easy flying access for bats into the void.

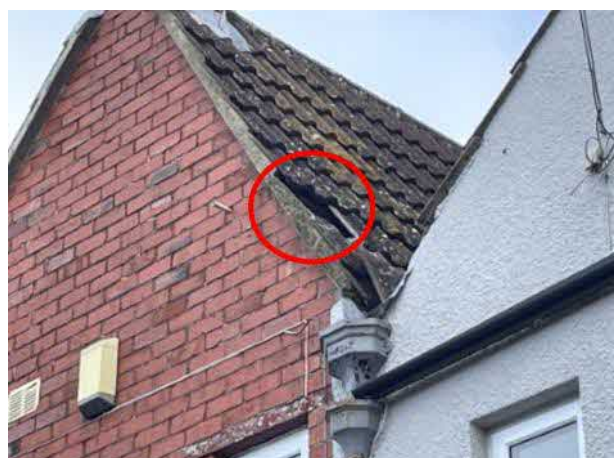
Plate 8: Missing roof tile on south pitch of structure 2

The east-west section of the void is lined with bitumastic felt; there are several large gaps and tears in the lining, with the tiles visible above. The north-south section of the void is unlined. There are missing tiles (Plate 8) as well as many small gaps visible in the tiling that would provide easy access for bats into the void. The ridge boards within the void are mostly heavily cobwebbed, suggesting no recent or extensive bat use, for example by a large number of bats.

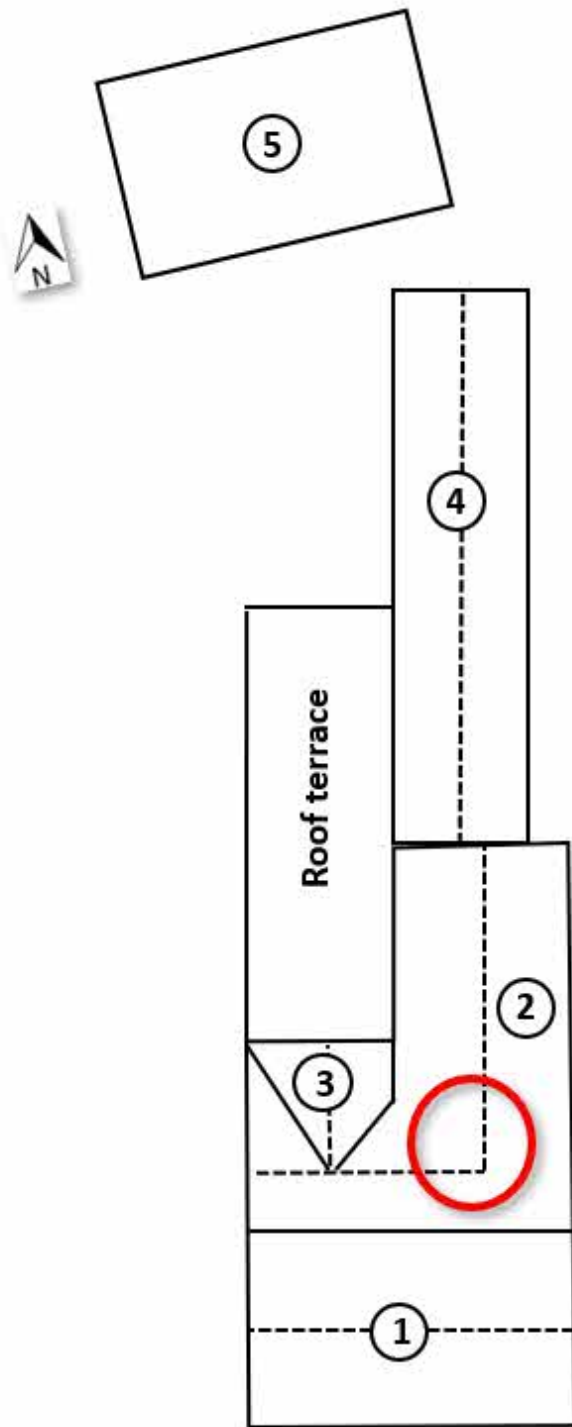
A sample of droppings was collected for DNA analysis, which confirmed the droppings were from whiskered bat (Appendix 4). However, no bats were observed within the void during the site visit.

A small number of bat droppings from whiskered bat were found in the L-shaped void within one of the two-storey rear extensions (structure 2, Figure 4). Considering the relatively low number of droppings present, spanning several years, the roost is likely to represent an occasionally used day or night (feeding) roost for a single bat of this species.

Figure 4: Location of whiskered bat roost (red circle) within the L-shaped two-storey extension.

Currently, the proposals are not believed to affect the roof void (structure 2) where the bat roost is located. However, if any works affecting this void are proposed, including roof repair works or works to tie-in new roof structures, it is recommended that bat activity surveys are undertaken to fully characterise the status of this roost, identify bat access points, and assess the likely impacts on the bat roost.

No works can be carried out to the L-shaped roof void until a protected species licence is obtained, to avoid offences under the Wildlife and Countryside Act 1981 (as amended) and the Conservation of Habitats and Species Regulations 2017 (as amended by The Conservation of Habitats and Species (Amendment) (EU Exit) Regulations 2019). The licence can be applied for only after any necessary Planning Permissions and Listed Building consents are in place and any relevant conditions are discharged.
