Richard Backhouse
111 The Mall, SN1 4JE
rwbackhouse1@gmail.com
07515 888 829

Figure 1 View of 111 The Mall from across the road

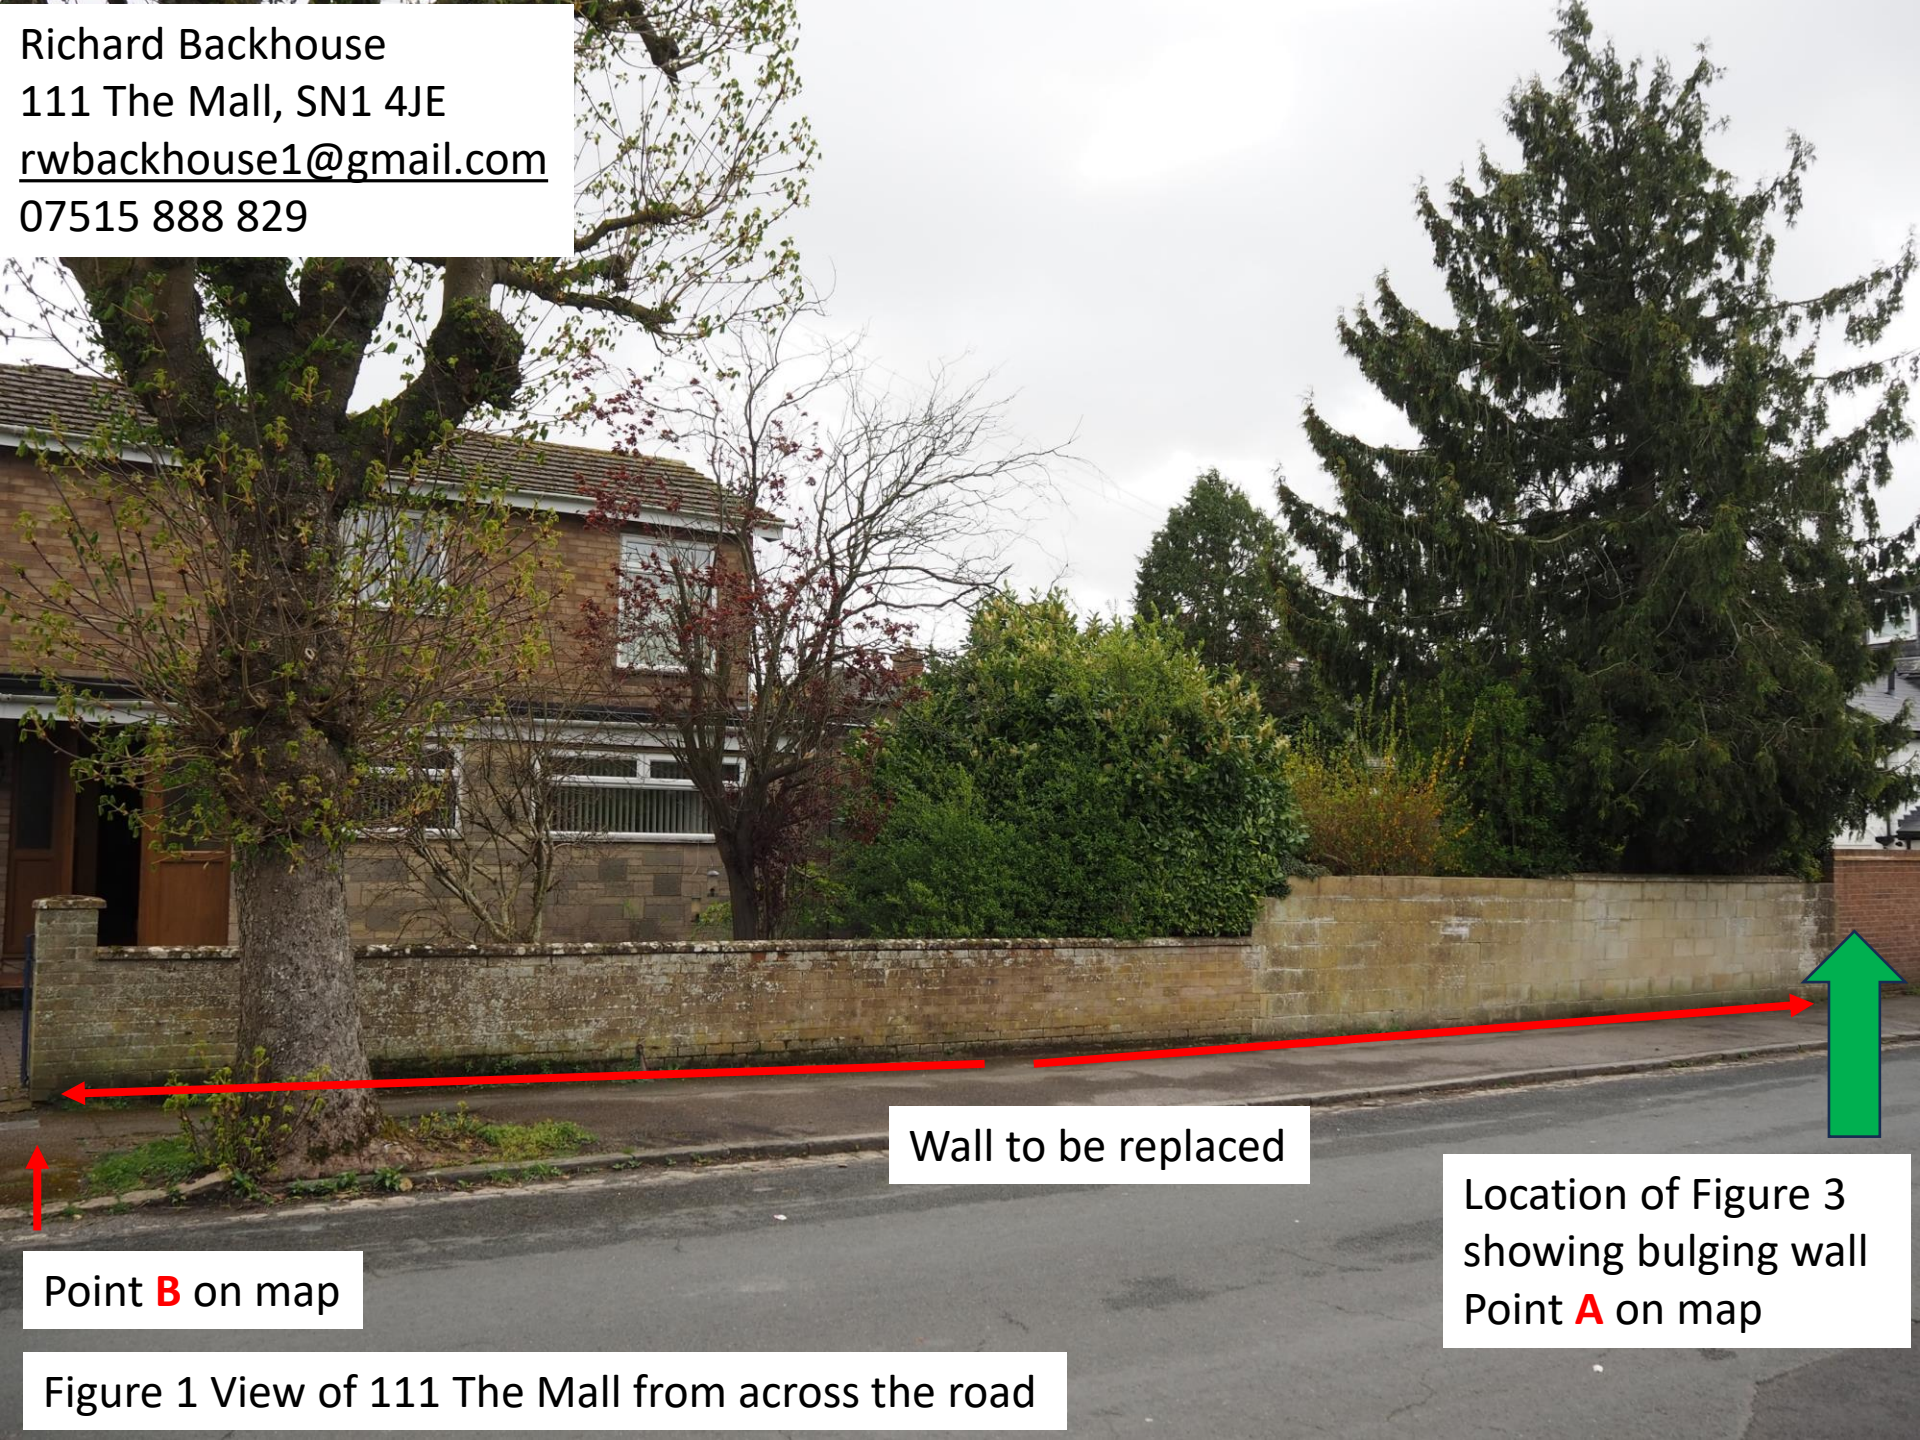
Wall to be replaced

Point **B** on map

Location of Figure 3
showing bulging wall
Point **A** on map

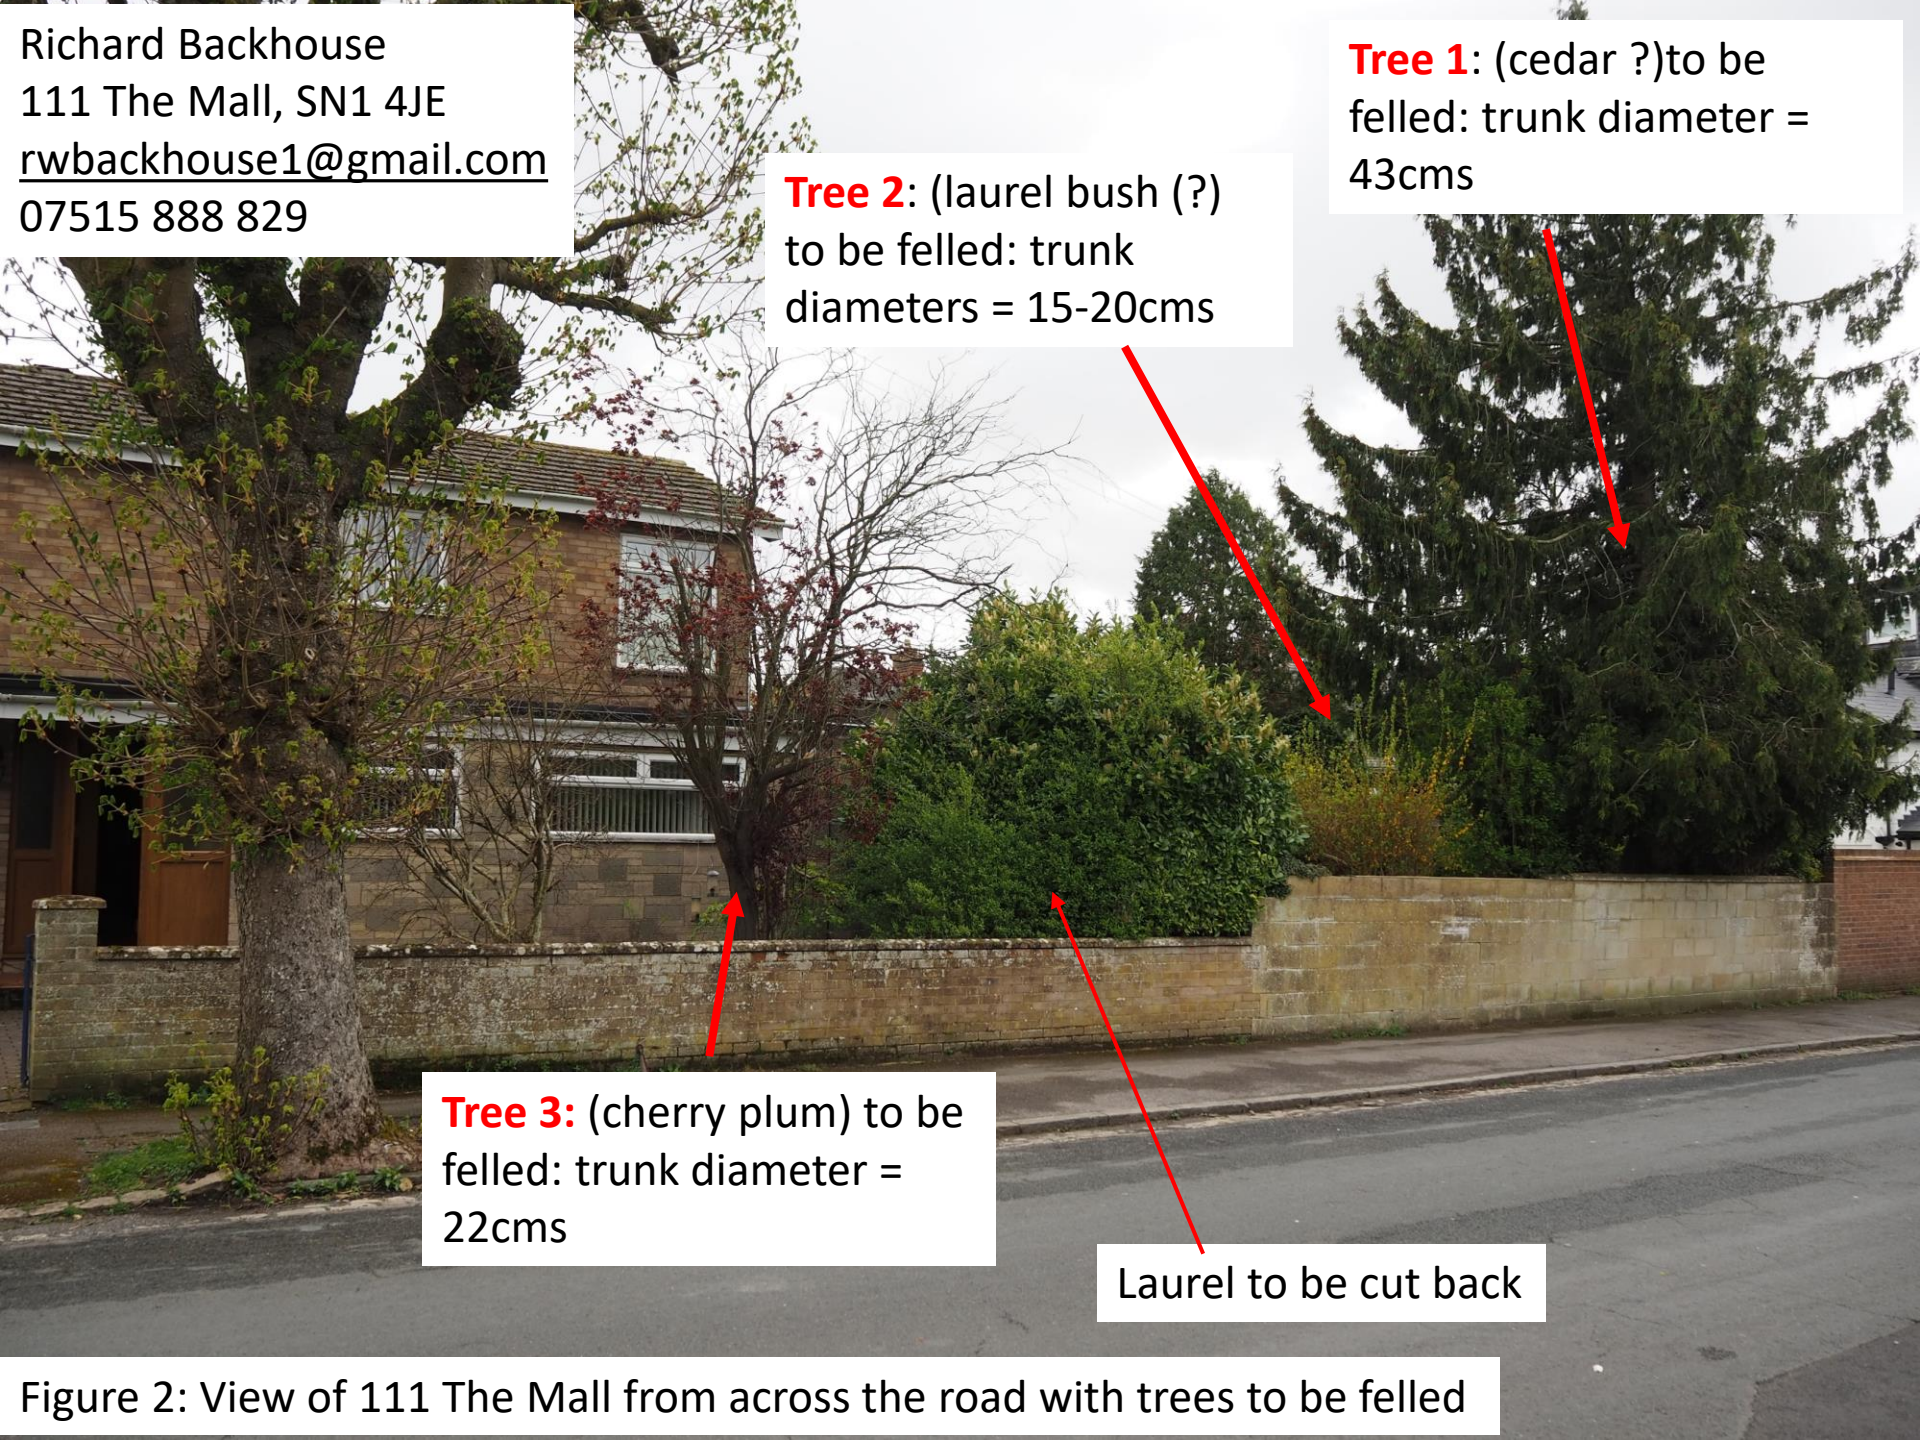
Figure 2: View of 111 The Mall from across the road with trees to be felled

Tree 1: (cedar ?) to be felled: trunk diameter = 43cms

Tree 2: (laurel bush (?)) to be felled: trunk diameters = 15-20cms

Tree 3: (cherry plum) to be felled: trunk diameter = 22cms

Laurel to be cut back

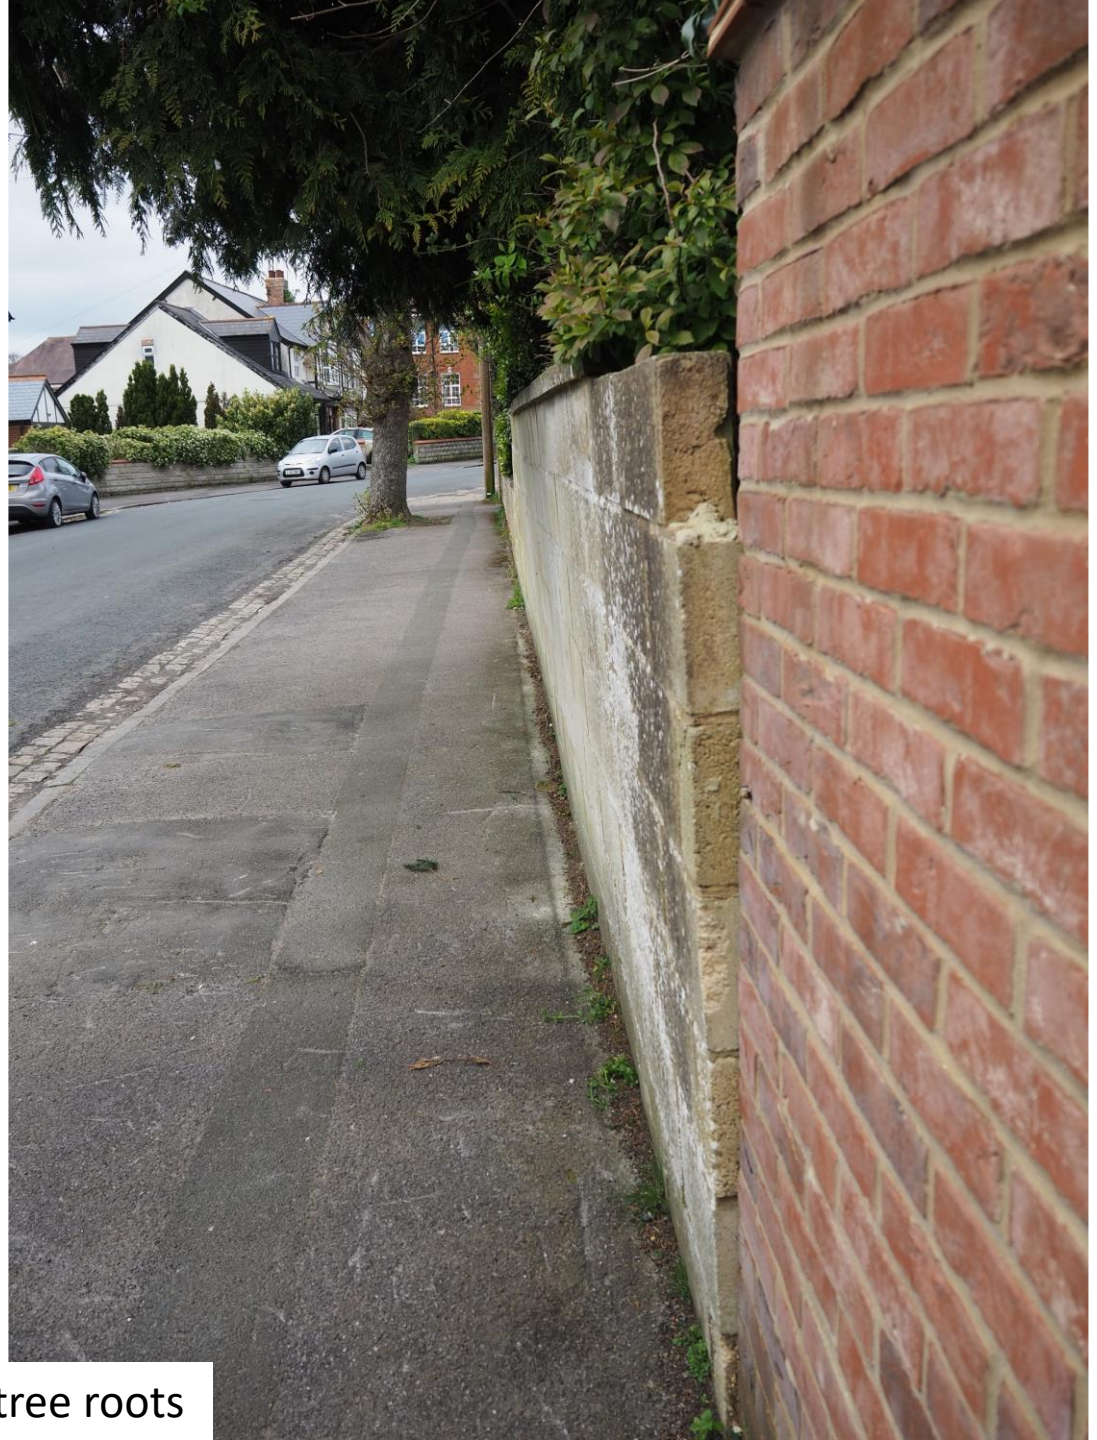
Figure 3 Displacement of wall from tree roots

Bulge in grey sandy wall at right hand side of Figures 1 & 2: note displacement from vertical at top of wall (c. 10cms). This is point **A** on map

Red brick wall in foreground is vertical wall for 66 Westlecot Road

Bulging out of 111 wall aligns with roots of Large Tree 1 (cedar ?) and Tree 2 shown on Figure 2. Note branches overhang the pavement

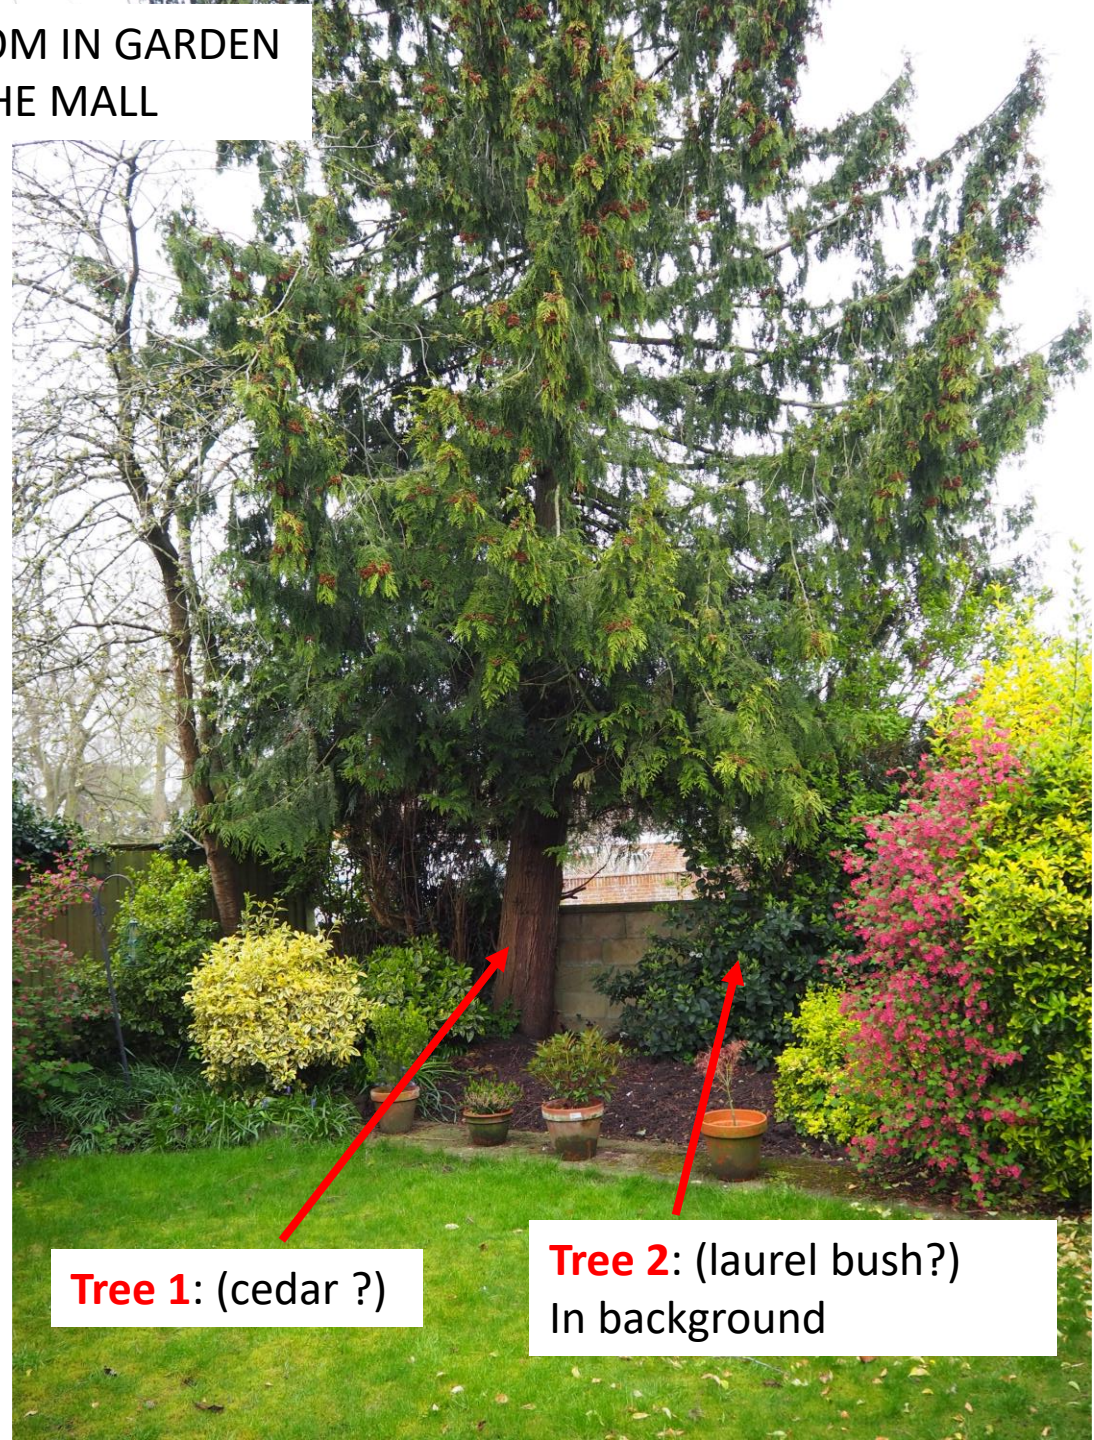
Figure 4 Tree 1 and 2 to be felled

VIEW FROM IN GARDEN
OF 111 THE MALL

Tree 1 is the major tree to be felled
Diameter = 43cms 1.5m above
ground

This is the tree behind the most
prominent bulge in the wall

Tree 1: (cedar ?)

Tree 2: (laurel bush?)
In background

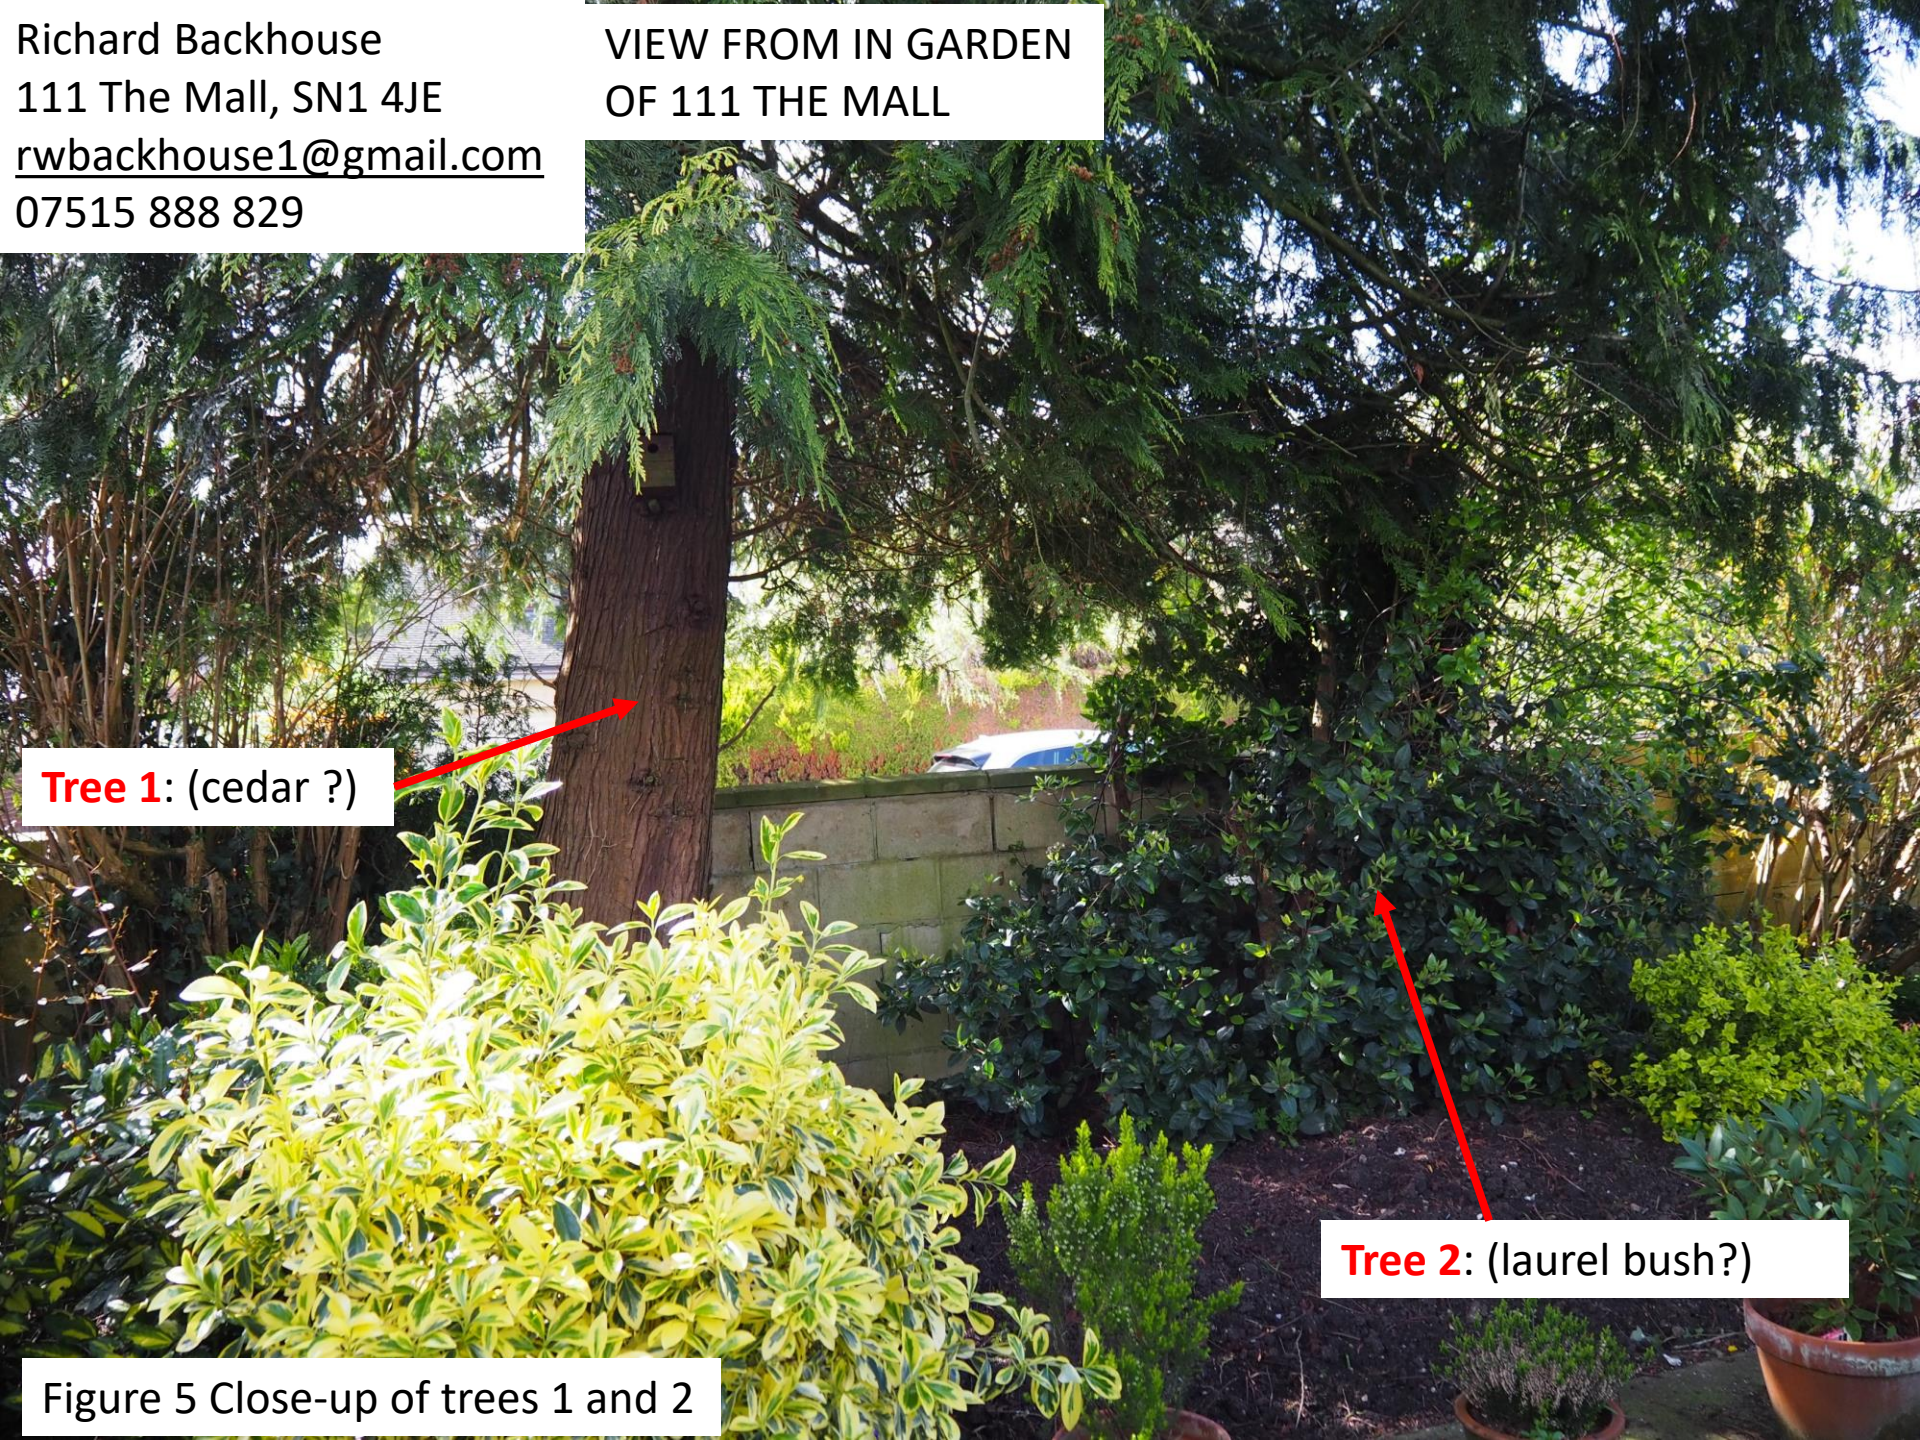
Figure 5 Close-up of trees 1 and 2

VIEW FROM IN GARDEN
OF 111 THE MALL

Tree 1: (cedar ?)

Tree 2: (laurel bush?)

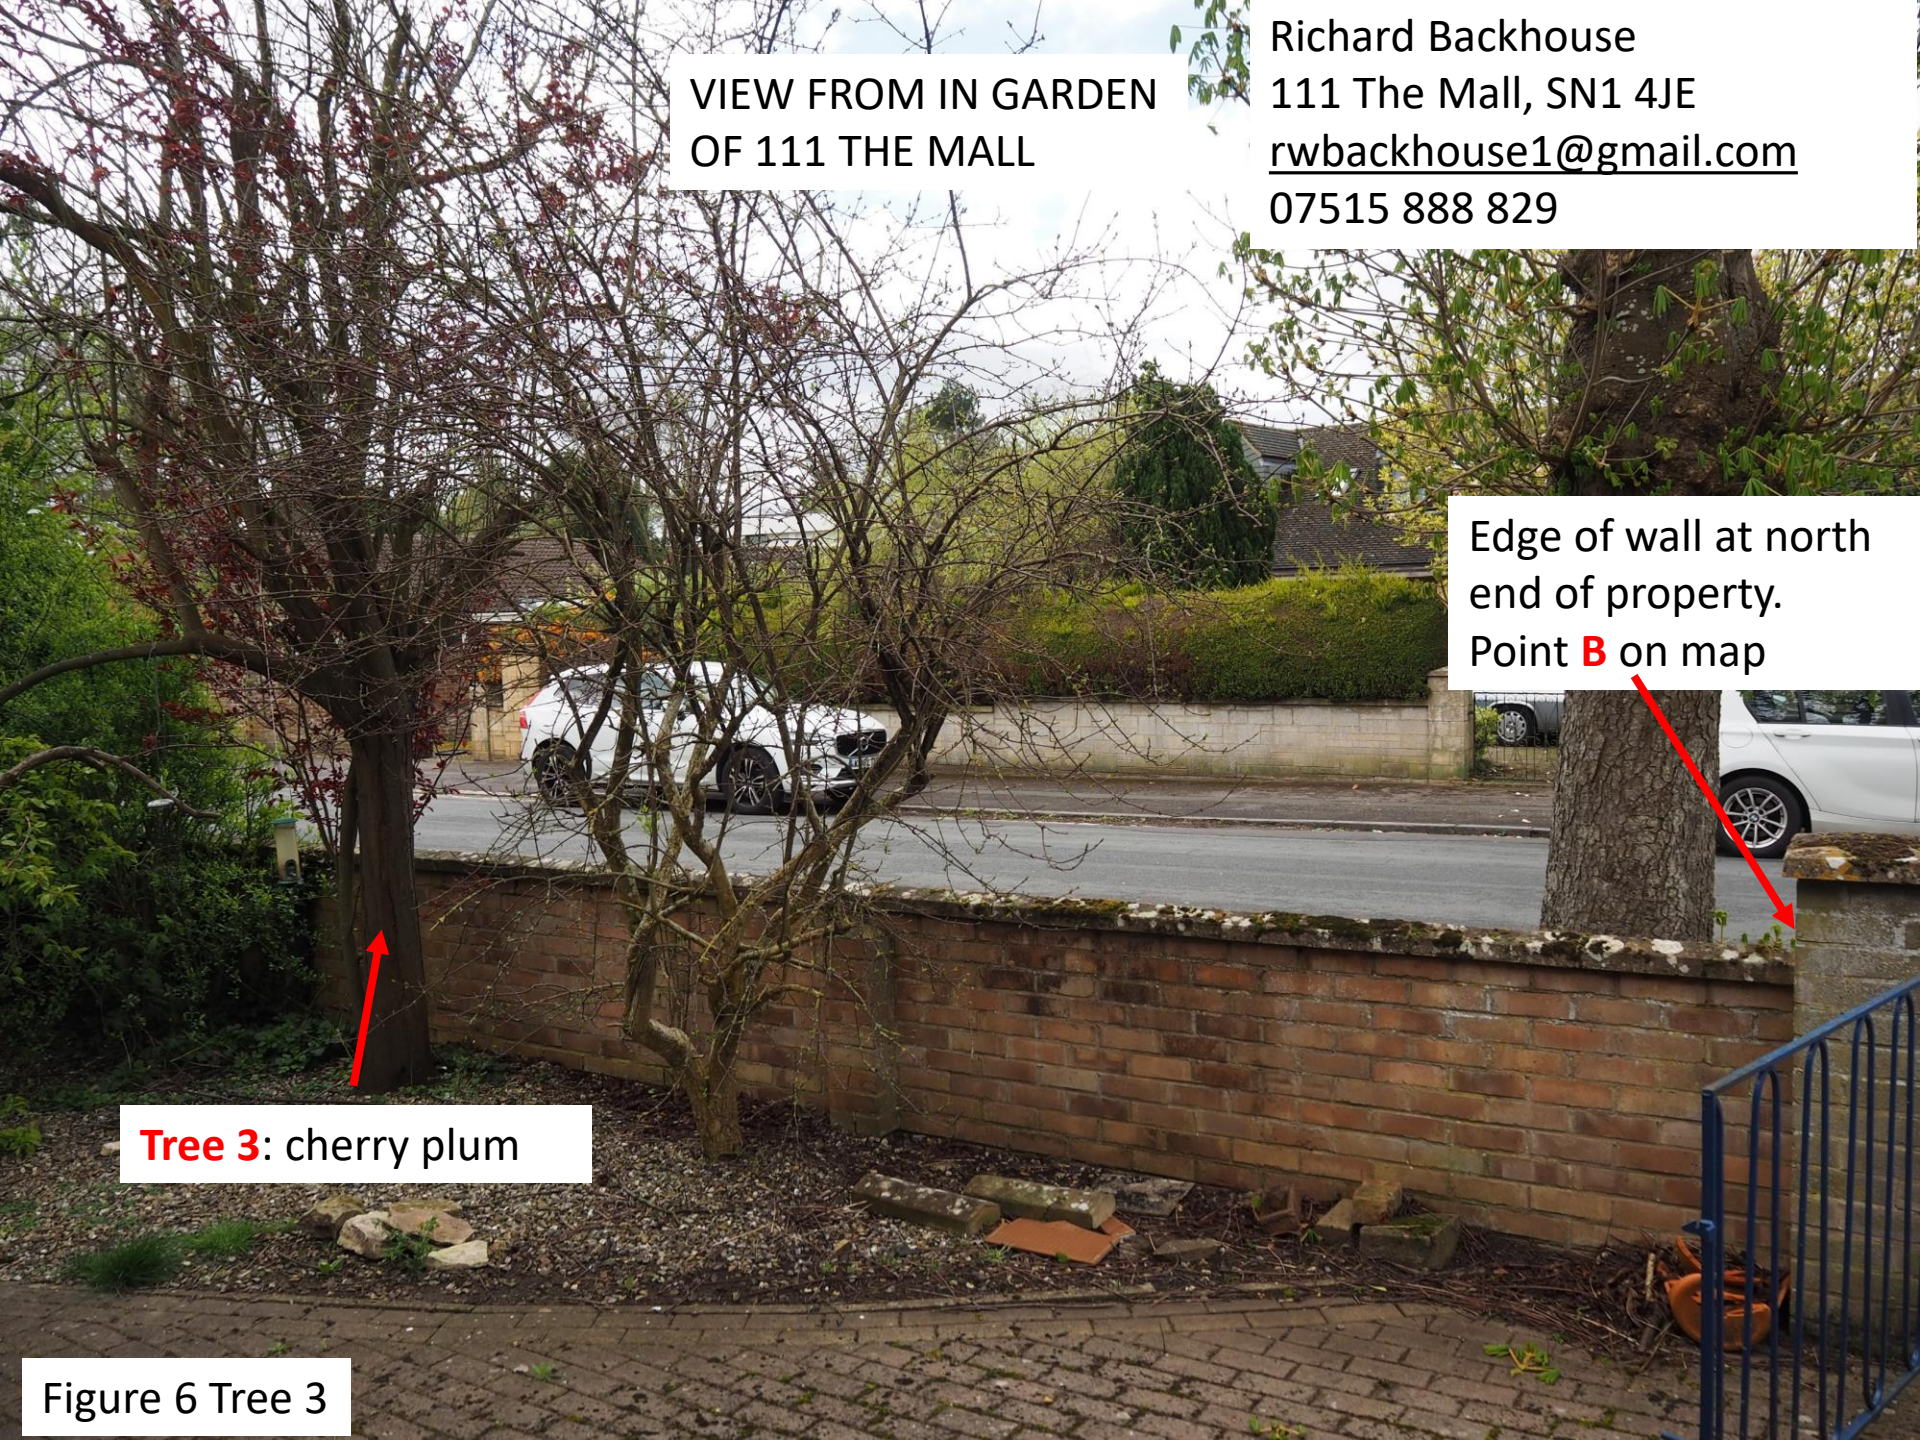
Figure 6 Tree 3

VIEW FROM IN GARDEN
OF 111 THE MALL

Edge of wall at north
end of property.
Point **B** on map

Tree 3: cherry plum
