Whitby Maritime Hub

Geo-Environmental Interpretative Report

WHIT-FHT-XX-XX-RP-C-
00007

PROJECT REFERENCE: 152982

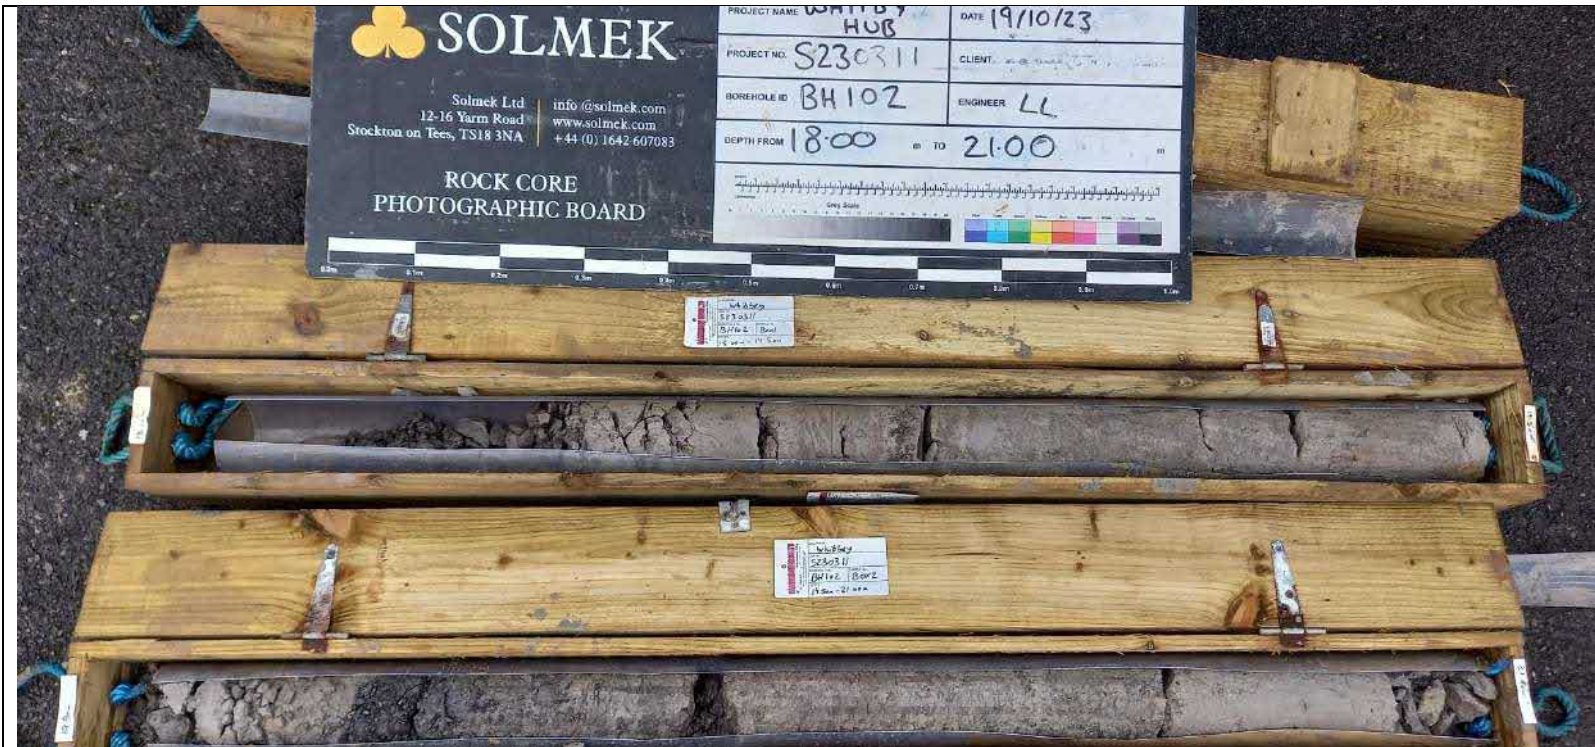
Figure 7: BH102 18.00-21.00m

Title	Rock Core Photographs
Project	Whitby Maritime Hub
Client	Wilmott Dixon Construction
Date	December 2023
Fig No.	Figures 7 & 8
Scale	N/A
Key

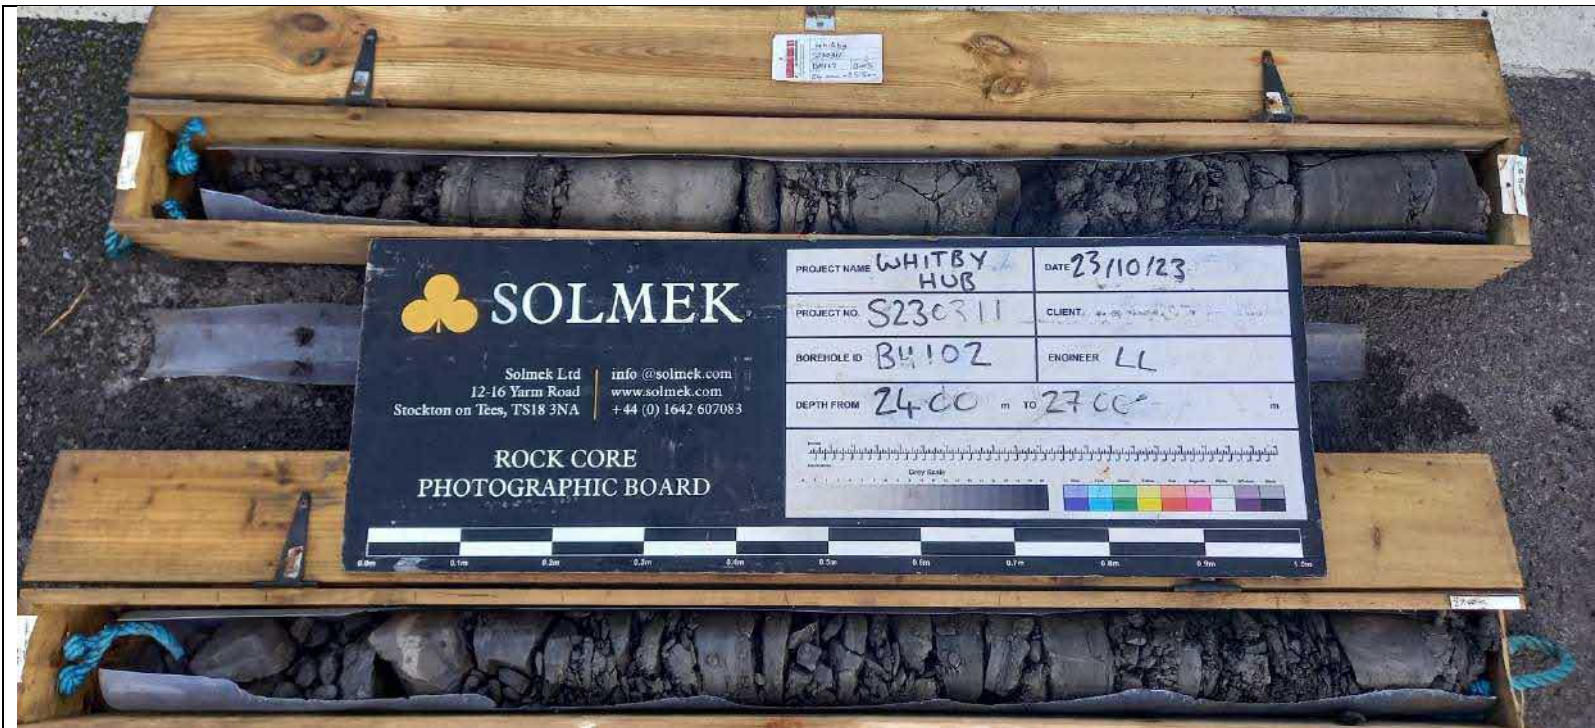
Figure 9: BH102 24.00-27.00m

Title	Rock Core Photographs
Project	Whitby Maritime Hub
Client	Wilmott Dixon Construction
Date	December 2023
Fig No.	Figures 9 & 10
Scale	N/A
Key

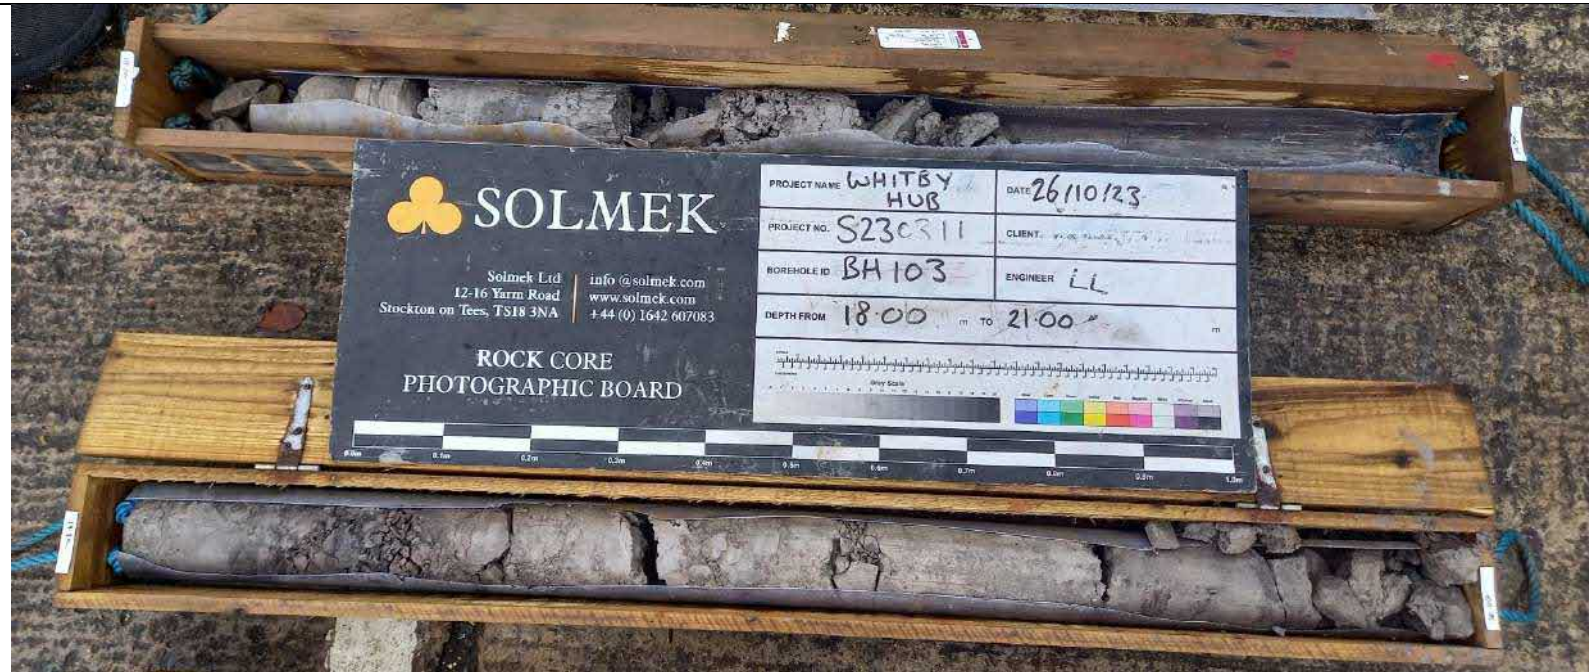
Figure 11: BH103 18.00-21.00m

Title	Rock Core Photographs
Project	Whitby Maritime Hub
Client	Wilmott Dixon Construction
Date	December 2023
Fig No.	Figures 11 & 12
Scale	N/A
Key

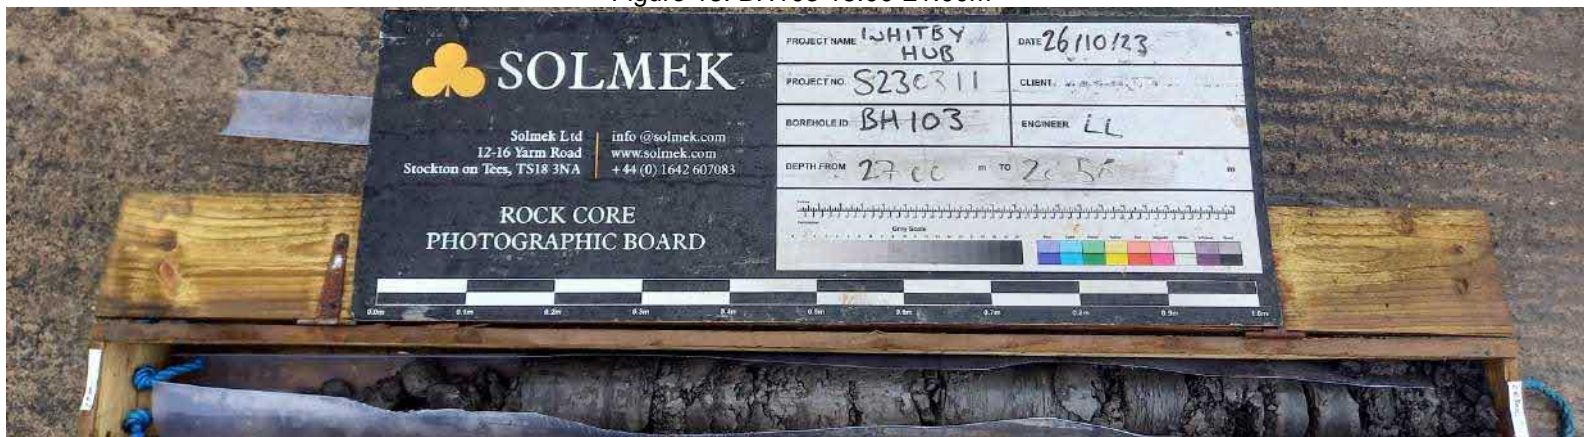
Figure 14: BH103 21.00-24.00m

Title	Rock Core Photographs
Project	Whitby Maritime Hub
Client	Wilmott Dixon Construction
Date	December 2023
Fig No.	Figures 13 & 14
Scale	N/A
Key

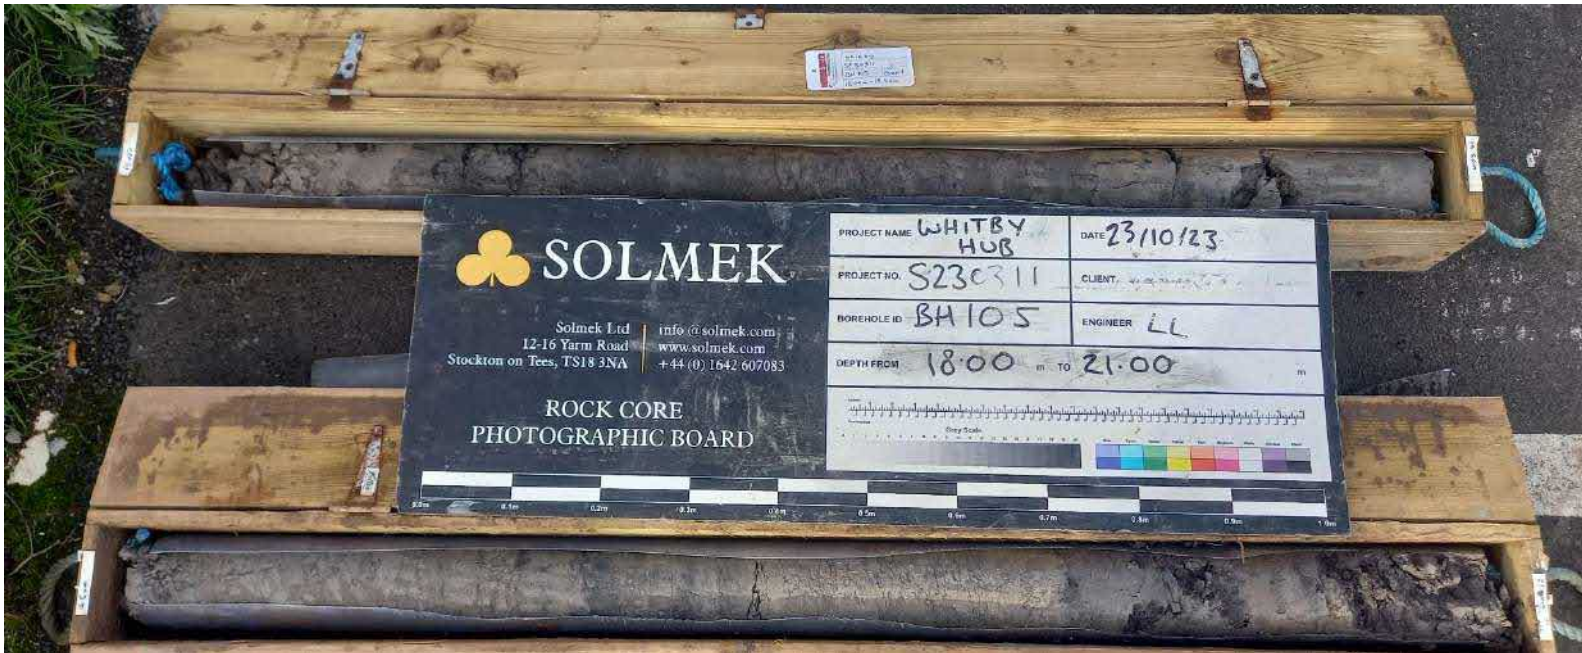
Figure 15: BH105 18.00-21.00m

Title	Rock Core Photographs
Project	Whitby Maritime Hub
Client	Wilmott Dixon Construction
Date	December 2023
Fig No.	Figures 15 & 16
Scale	N/A
Key

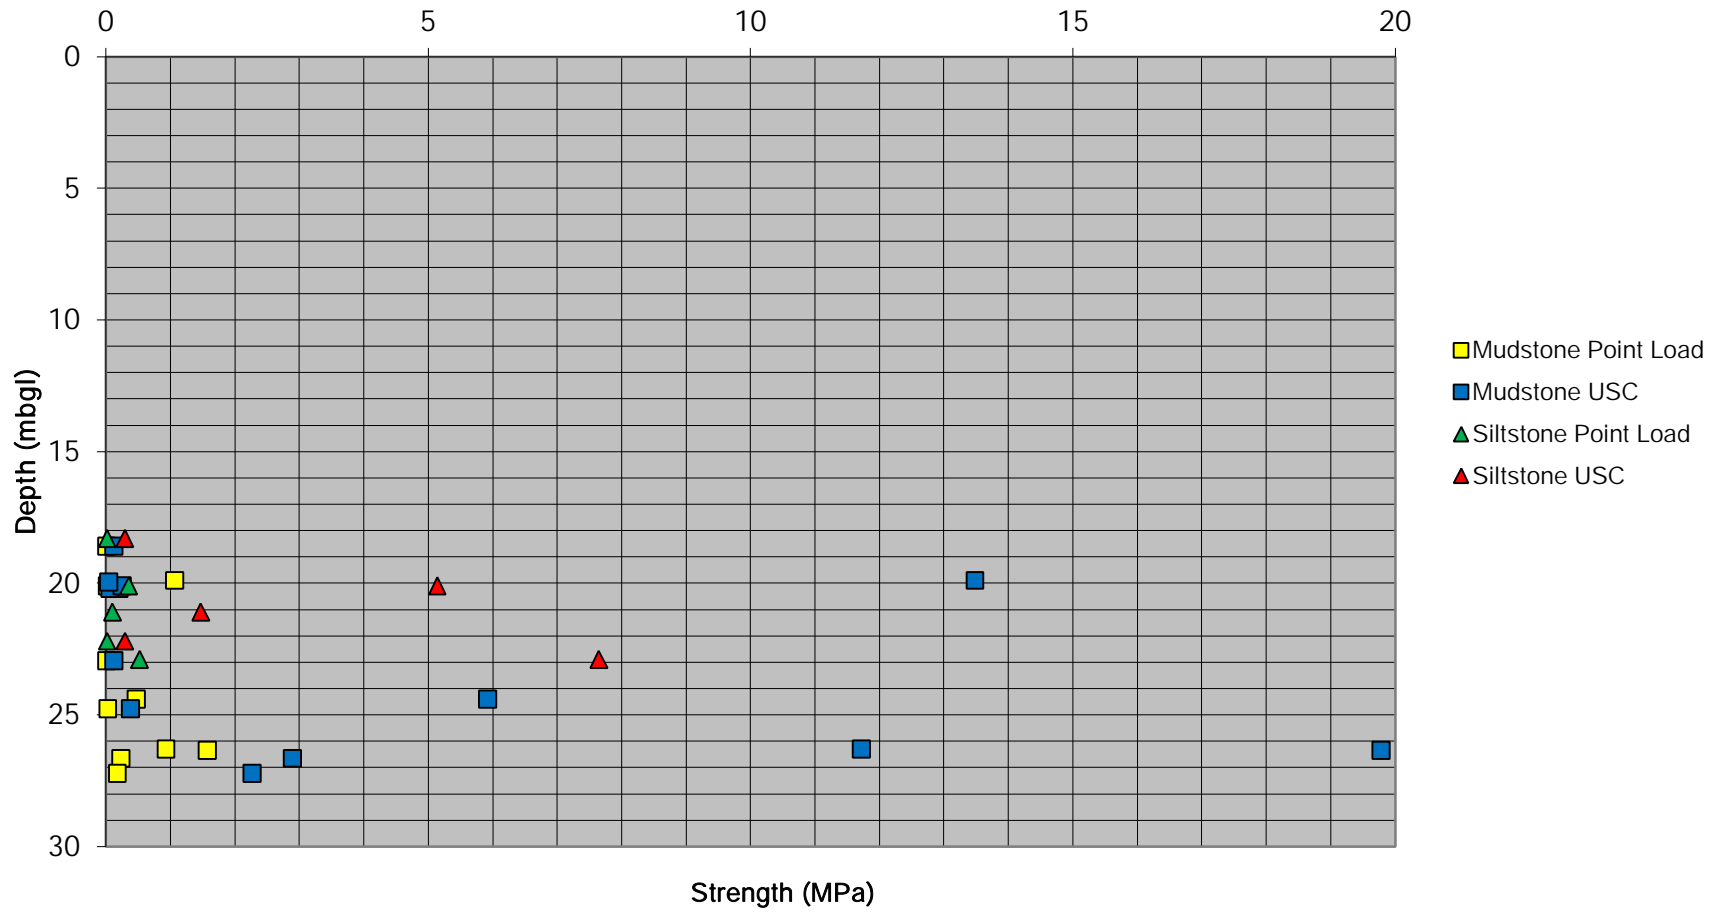
Fig 9 -Strength vs Depth (Mudstone and Siltstone)
Whitby Maritime Training Hub
