**BELLSIDE ROAD, CLELAND
STAGE 2 SITE INVESTIGATION
FOR
TAYLOR HOMES (SCOTLAND) LTD**

Report No.	1748-203	Version:	Revision 1
Author:	AM/WH	Issue Date:	26/7/2023

Name of Site:	North & South Rd, Shawstonfoot, Bellside
Ordnance Survey Grid Reference:	NS 81471 57979
Site Address:	North & South Rd, Shawstonfoot, Bellside
Local Authority:	North Lanarkshire Council
Land Use (Existing):	Field
On site buildings:	No
Proposed Site Use:	Residential Properties with Gardens and Driveway
Area (hectares):	1.05 ha
Type of Investigation:	Stage 2 Ground Investigation – Intrusive Works & Conceptual Site Model

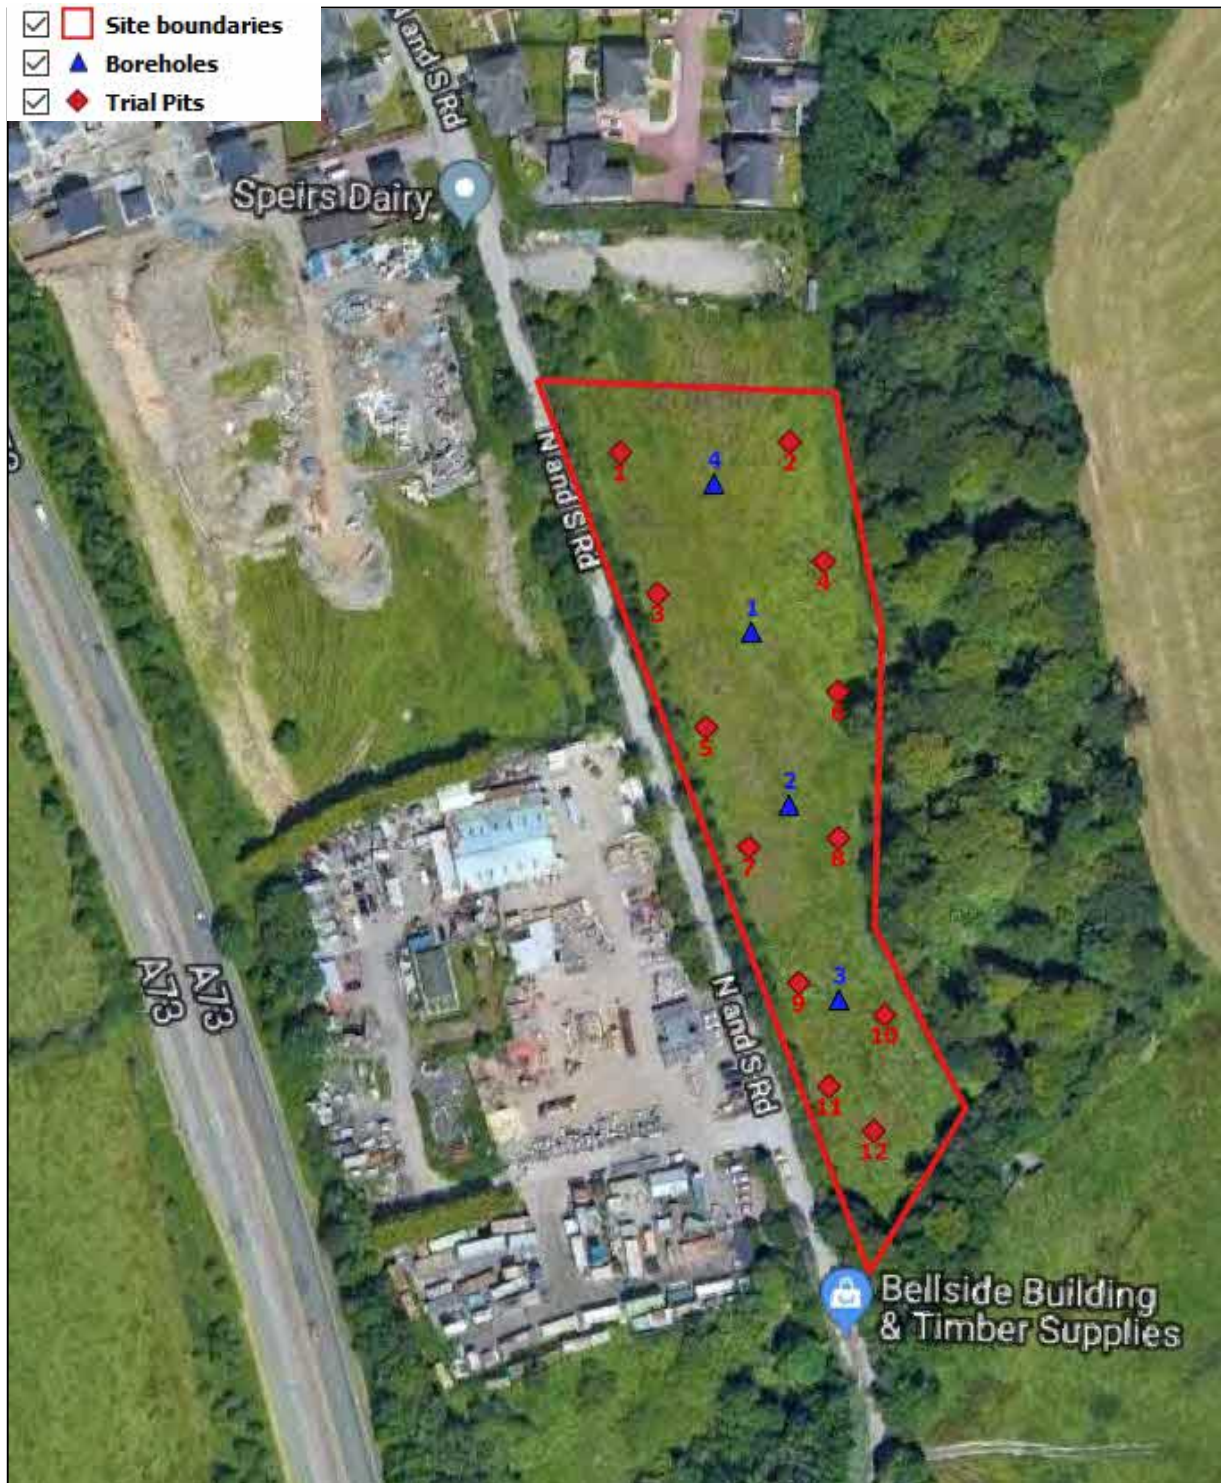
Client: Taylor Homes (Scotland) Ltd	Drawing Title: Site Soil Investigation Locations

International House, Hamilton International Park, Stanley Boulevard, Hamilton, G72 0BN www.terrenus.co.uk
Project: Bellside Rd, Cleland Stage 2	Figure 3	
Date: 28/2/2019		
Grid Ref: NS 81471 57979		
SCALE: N.T.S.		DO NOT SCALE

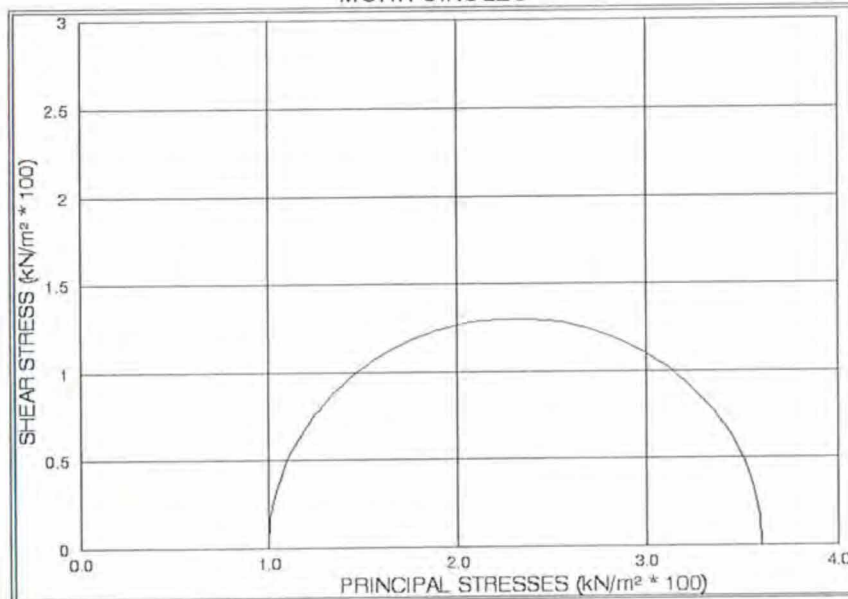
SPEC. / STAGE No : 1 2 3
 WATER CONT. = 14.4 % dry weight
 BULK DENSITY = 2.13 Mg/m³
 DRY DENSITY = 1.86 Mg/m³
 CELL PRESSURES = 100 kN/m²
 SHEAR STRENGTH = 130 kN/m²
 STRAIN at FAILURE = 21 %
 RATE of STRAIN = 2 2 2 %/min.
 MEMBRANE TYPE = Standard Latex - 0.5mm. thick.
 AVERAGE SHEAR STRENGTH = 130 kN/m²
 APPARENT COHESION = kN/m²
 ANGLE of SHR. RESISTANCE = Degrees

READ No	AFEA cm ²	STRAIN %	STRAIN mm	PROVING RING DIAL Divs.	APPLIED LOAD kN	DEVIATOR STRESS kN/m ²
	77.35		0			
1	78.12	1.0	2	9	0.31	40
2	78.91	2.0	4	15	0.55	69
3	79.71	3.0	6	20	0.74	93
4	80.53	3.9	8	25	0.94	116
5	81.37	4.9	10	28	1.06	130
6	82.22	5.9	12	31	1.17	143
7	83.09	6.9	14	35	1.33	160
8	83.98	7.9	16	38	1.45	172
9	84.89	8.9	18	42	1.60	189
10	85.82	9.9	20	44	1.68	196
11	86.77	10.9	22	47	1.80	207
12	87.75	11.8	24	50	1.92	218
13	88.74	12.8	26	53	2.03	229
14	89.76	13.8	28	55	2.11	235
15	90.80	14.8	30	56	2.15	237
16	91.86	15.8	32	58	2.23	243
17	92.95	16.8	34	60	2.31	248
18	94.07	17.8	36	61	2.35	249
19	95.21	18.8	38	64	2.46	256
20	96.38	19.7	40	64	2.46	256
21	97.58	20.7	42	66	2.54	260

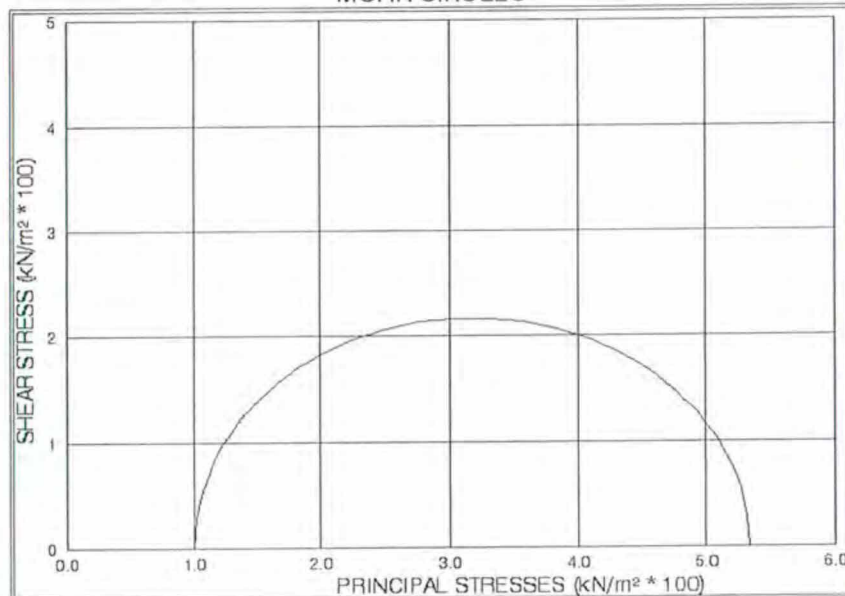
SPEC. / STAGE No : 1 2 3
 WATER CONT. = 12.9 % dry weight
 BULK DENSITY = 2.16 Mg/m³
 DRY DENSITY = 1.91 Mg/m³
 CELL PRESSURES = 100 kN/m²
 SHEAR STRENGTH = 217 kN/m²
 STRAIN at FAILURE = 21 %
 RATE of STRAIN = 2 2 2 %/min.
 MEMBRANE TYPE = Standard Latex - 0.5mm. thick.
 AVERAGE SHEAR STRENGTH = 217 kN/m²
 APPARENT COHESION = kN/m²
 ANGLE of SHR. RESISTANCE = Degrees

READ No	AREA cm ²	STRAIN %	STRAIN mm	PROVING RING DIAL Divs.	APPLIED LOAD kN	DEVIATOR STRESS kN/m ²
	78.52		0			
1	79.31	1.0	2	17	0.63	79
2	80.11	2.0	4	26	0.98	122
3	80.92	3.0	6	32	1.21	150
4	81.76	4.0	8	39	1.49	182
5	82.61	4.9	10	47	1.80	218
6	83.47	5.9	12	52	1.99	239
7	84.36	6.9	14	57	2.19	259
8	85.27	7.9	16	62	2.38	280
9	86.19	8.9	18	66	2.54	295
10	87.14	9.9	20	71	2.74	314
11	88.10	10.9	22	74	2.85	324
12	89.09	11.9	24	78	3.01	338
13	90.10	12.8	26	81	3.13	347
14	91.13	13.8	28	85	3.28	360
15	92.19	14.8	30	89	3.44	373
16	93.27	15.8	32	93	3.60	386
17	94.38	16.8	34	98	3.79	402
18	95.52	17.8	36	101	3.91	409
19	96.68	18.8	38	105	4.07	421
20	97.87	19.8	40	109	4.22	431
21	99.09	20.8	42	111	4.30	434

COMMENTS:
 Prepared by : Vertical Extrusion \ Remoulding
 100mm Diameter Single stage test- (one specimen)

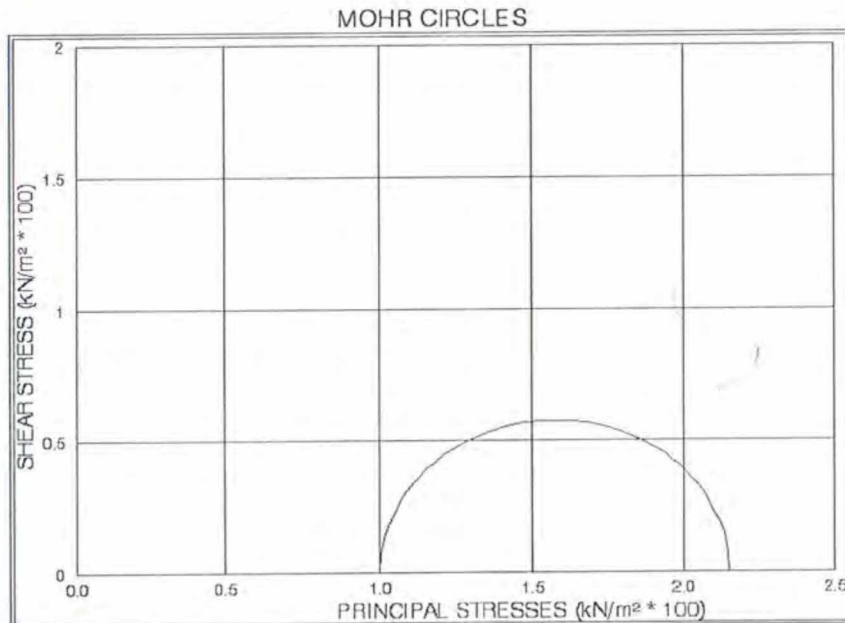
SPEC. / STAGE No : 1 2 3
 WATER CONT. = 17.0 % dry weight
 BULK DENSITY = 2.02 Mg/m³
 DRY DENSITY = 1.73 Mg/m³
 CELL PRESSURES = 100 kN/m²
 SHEAR STRENGTH = 58 kN/m²
 STRAIN at FAILURE = 11 %
 RATE of STRAIN = 2 2 2 %/min.
 MEMBRANE TYPE = Standard Latex - 0.5mm. thick.
 AVERAGE SHEAR STRENGTH = 58 kN/m²
 APPARENT COHESION = kN/m²
 ANGLE of SHR. RESISTANCE = Degrees

READ No	AREA cm ²	STRAIN %	STRAIN mm	PROVING RING DIAL Divs.	APPLIED LOAD kN	DEVIATOR STRESS kN/m ²
	54.22		0			
1	54.78	1.0	2	7	0.23	43
2	55.35	2.0	4	10	0.35	64
3	55.92	3.0	6	12	0.43	77
4	56.52	4.1	8	14	0.51	90
5	57.12	5.1	10	15	0.55	96
6	57.74	6.1	12	16	0.59	102
7	58.37	7.1	14	17	0.63	107
8	59.01	8.1	16	17	0.63	106
9	59.67	9.1	18	18	0.66	111
10	60.34	10.1	20	18	0.66	110
11	61.03	11.2	22	19	0.70	115
12	61.73	12.2	24	19	0.70	114
13	62.45	13.2	26			
14	63.19	14.2	28			
15	63.95	15.2	30			
16	64.72	16.2	32			
17	65.51	17.2	34			
18	66.33	18.2	36			
19	67.16	19.3	38			
20	68.01	20.3	40			
21	68.89	21.3	42

COMMENTS:
 Prepared by : Vertical Extrusion \ Remoulding.
 83mm Diameter Single stage test - (one specimen)

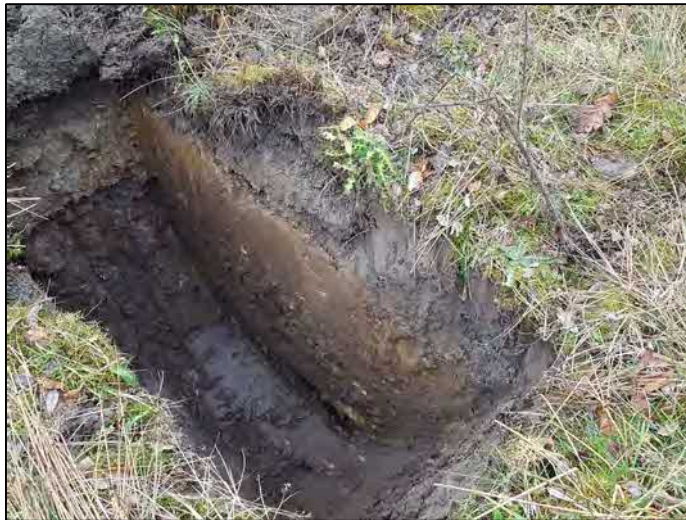
Plate 5 – Trial Pit 4

From this methodology it was found that determinant levels were marginally above the thresholds for lead in the Topsoil of TP4 and TP5. For all other tested inorganic compounds, PAH and TPH hydrocarbons the amounts were found to be below the relevant thresholds.

A potential offsite source for the elevated lead levels within the topsoil of TP4 and TP5 may be the neighbouring builder's yard, which has been known to burn waste material resulting in airborne particulate matter. TP4 and TP5 are situated upwind, on the prevailing wind direction, of this burning area.

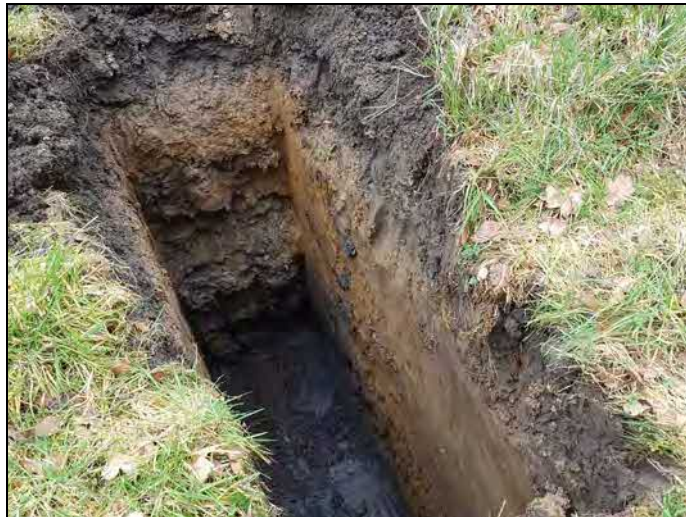
Plate 8 – Trial Pit 10

Situated across the site and found in all site investigation locations. Consists of orange, mottled grey, sandy, gravelly silt/clay and between 0.10 and 1.10m in thickness. This layer is predominantly 0.50m thick with the greatest thickness recorded in TP10 on the eastwards facing slope in the east of the site.

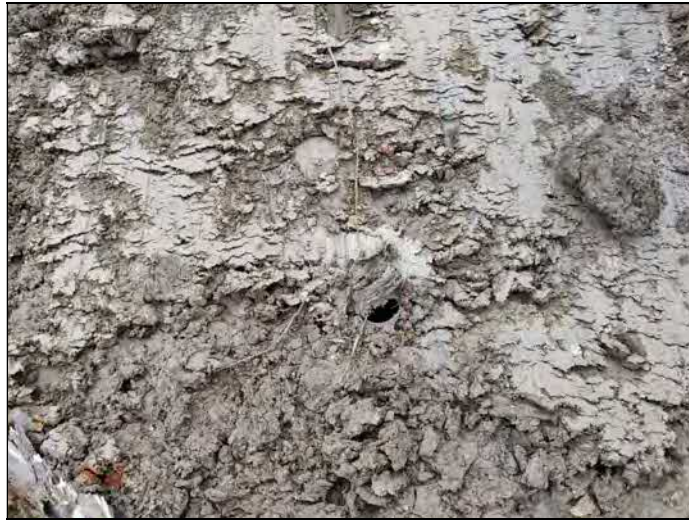
Plate 1 –BHR02 after surface scrape

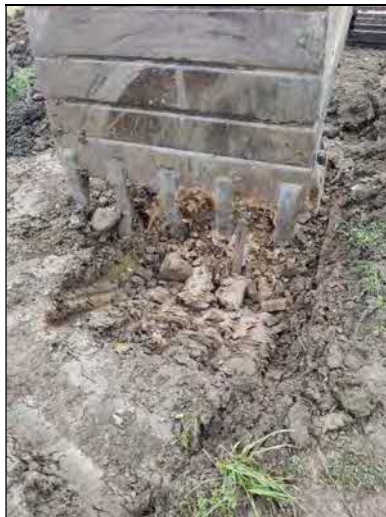
Plate 2 –Excavation of BHR02

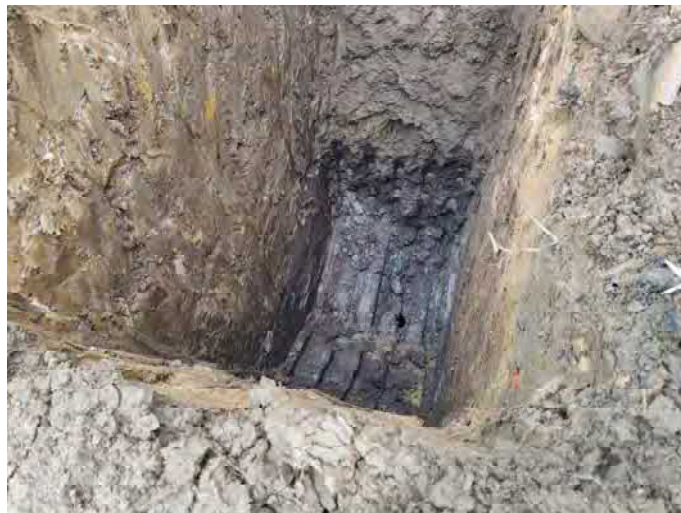
Plate 3 –BHR02 at Rockhead

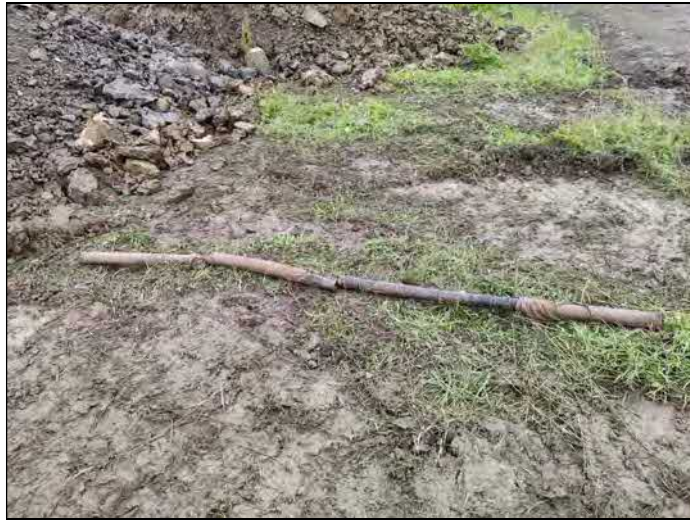
Plate 4 –BHR02 installation

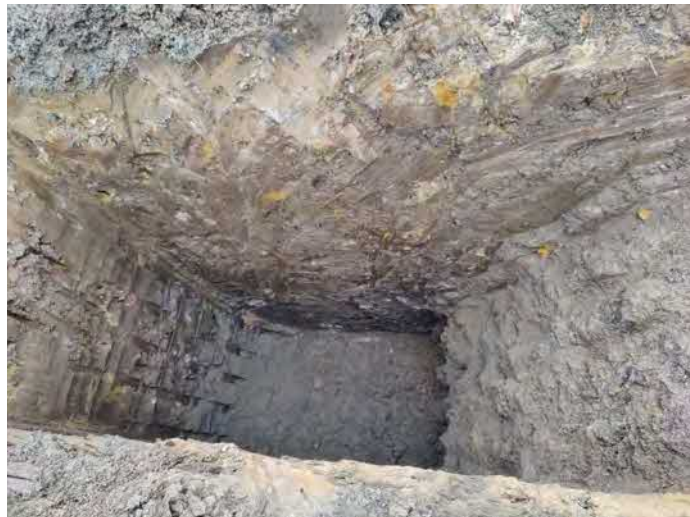
Plate 5 –Cement cap poured into excavation
