## Bat and Barn Owl Assessment

Pheasant Cottage  
Clowance  
Praze  
Cornwall  
TR14 0PT

CEC4674  
4 April 2024

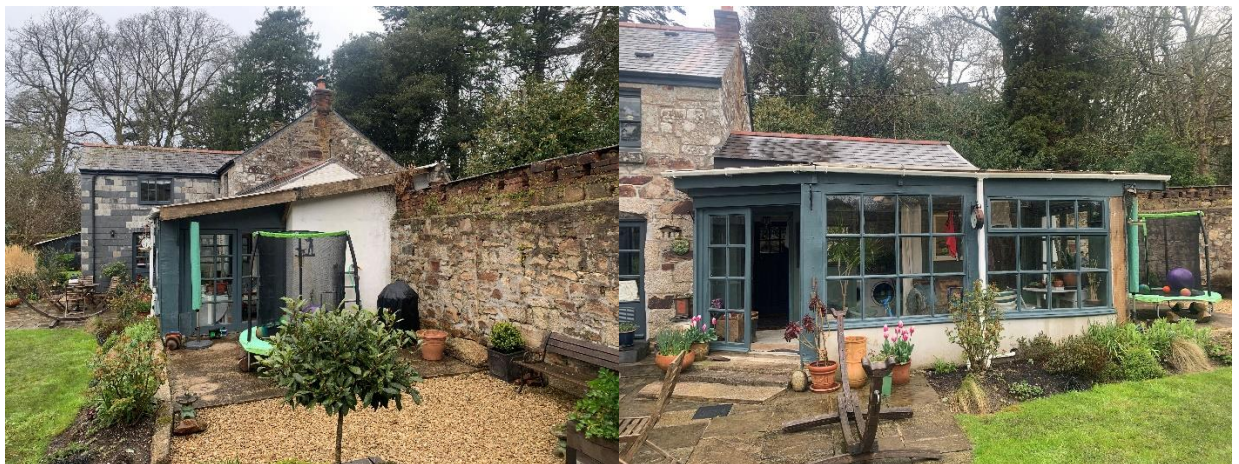
**Figure 3: Extension, eastern elevation (left) Extension, southern elevation (right)**

- 3.2.2. The extension is constructed from stone walls with a pitched composite tile roof. There is a wooden soffit on the northern elevation and a composite slate verge on the southern elevation, the eastern gable end is constructed from UPVC cladding, sealed with insulating tape. There is a lean-to conservatory on the southern elevation of the extension constructed from wooden walls and a clear plastic roof, the plastic roof meets an older section of tiled roof on the eastern elevation.

- 3.2.3. There is no access to the loft space of the extension though the exterior of the building was inspected, including the use of a ladder to closely inspect the gable end and tile verge, as well as the walls, windows and floor around the property. The section where the clear plastic roof meets the tiled section was searched and no signs of bats were visible and no potential access points for bats to the loft of the extension was visible.

- 3.2.5. The extension has well sealed tiles and soffits with no visible access for bats to the loft space leaving the building with negligible potential for bats.

- 3.2.6. Although no current evidence of roosting bats was found it cannot be assumed that bats are not present when works commence. Care should therefore be taken during the work as bats could roost unseen deep within crevices in the structure, particularly under ridge tiles, beneath wall plates, or between or above lintels. If any bats are discovered during the work they must not be handled: works must stop immediately and advice sought from CEC (tel 01872 245510).

- 3.2.7. If you wish to promote wildlife it is possible to provide roosting opportunities for bats within the completed building. Access for bats can be provided into the roof space (or into the space beneath the roofing slates if the development is to have vaulted ceilings) by leaving small gaps 15-20mm wide by at least 50mm long in suitable places. Suitable places would include behind soffits, fascias and barge boards

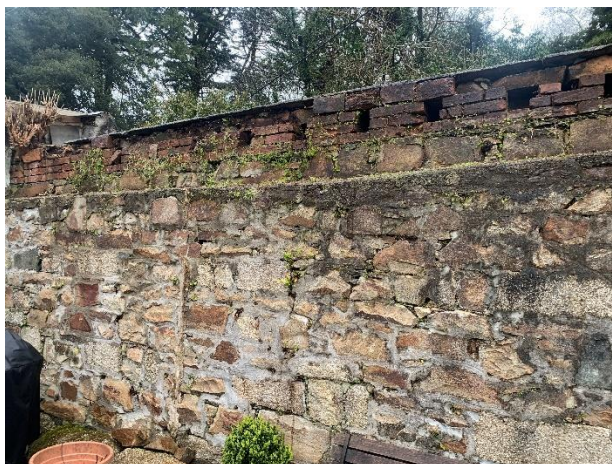
**Figure 4: Section of boundary wall to be affected.**

- 3.2.4. The boundary wall where the extension will be extended is a granite wall with a brick top. There are crevices along the wall in the red brick and the granite wall. The crevices were searched and no signs of bats were found.
