LAND CONTAMINATION SURVEYS

RE: Land off Middle Lane, Nether Broughton – Topsoil Chemical Analysis

1. Introduction

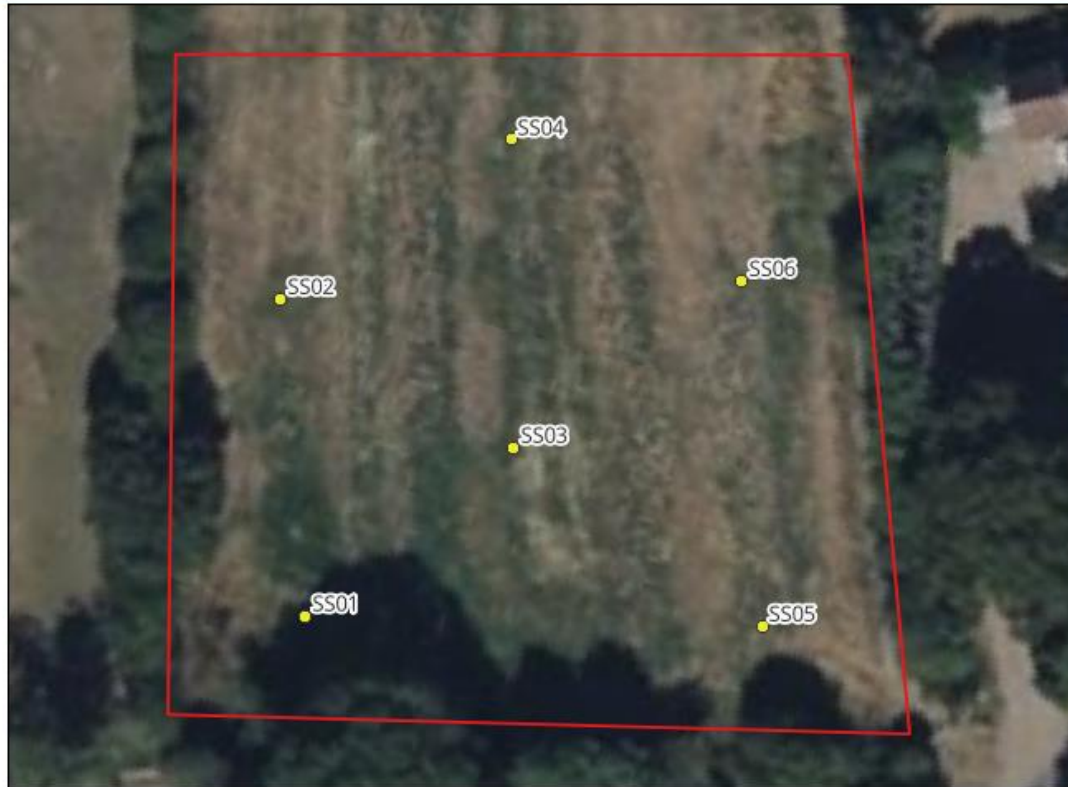
EHLP

Castledine Environmental attended site on the 16th February 2024 in order to undertake six hand-dug exploratory hole locations (designated SS01 to SS06 inclusive) and progressed to depths of between 0.60mbgl and 0.80mbgl. The location of hand-dug pits are presented on the site plan provided in Appendix B.

SS01
● Shallow Sample

Appendix B – Exploratory Hole Location Plan
