#### RE: **MANOR HOUSE CLOSE, EARLS BARTON**

Condition 4 within the Decision notice NW-22-00836-FUL, NW-22-00837-LBC NW-23-00096-FUL & NW-23-00097-LBC states that.

In order to discharge the above condition, the following replacement materials have been suggested.

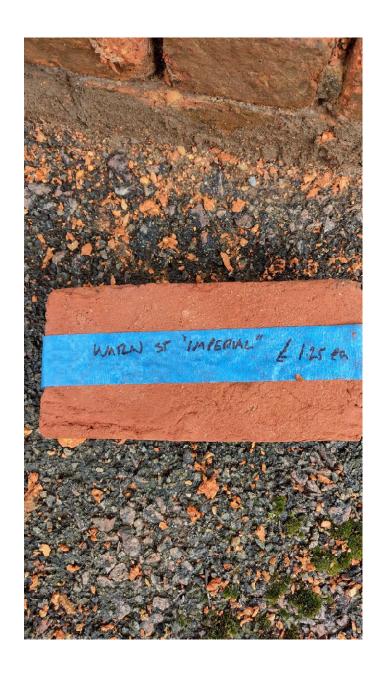
Photograph 1 – Brick Replacement

Bricks which cannot be reclaimed during the remedial works due to their loss of structural integrity are to be replaced by reclaimed soft red imperial bricks. Please refer to photograph 1 for an image of the proposed material.

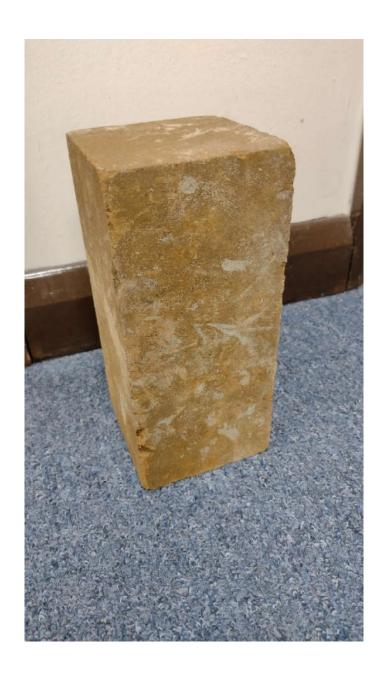
Photograph 2 – Coping Replacement

Along the boundary wall there are multiple concrete copings, we believe these copings have been installed during earlier repairs to the wall and have no historic significance. With the above in mind, we have suggested that all concrete copings are replaced with handmade ironstone copings, the stone for said copings will be sourced from Great Tew Quarry which is located in Oxfordshire. Please refer to photograph 2 for an image of the proposed material.

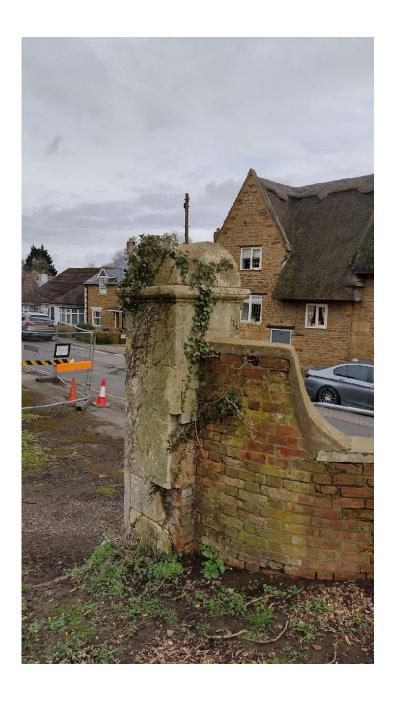
Photograph 3 – Limestone Block Replacement

Both the piers within the boundary wall have multiple defects which include missing sections of stone & crumbling stone renders. It has been proposed that similar limestone blocks are stitched to the existing stone blocks and a new stone render is applied to areas where the existing stone render is crumbling. The above-mentioned materials are to match the existing on a like for like basis. Please refer to photographs 3 & 4 for images of the proposed materials.
