Aldi, Colliery Lane, Hetton-le-Hole
Phase II Geo-environmental
Assessment

For Aldi Stores Limited

Date: 9 February 2023

Doc Ref: P18-474-3E-XX-XX-RP-G-9000

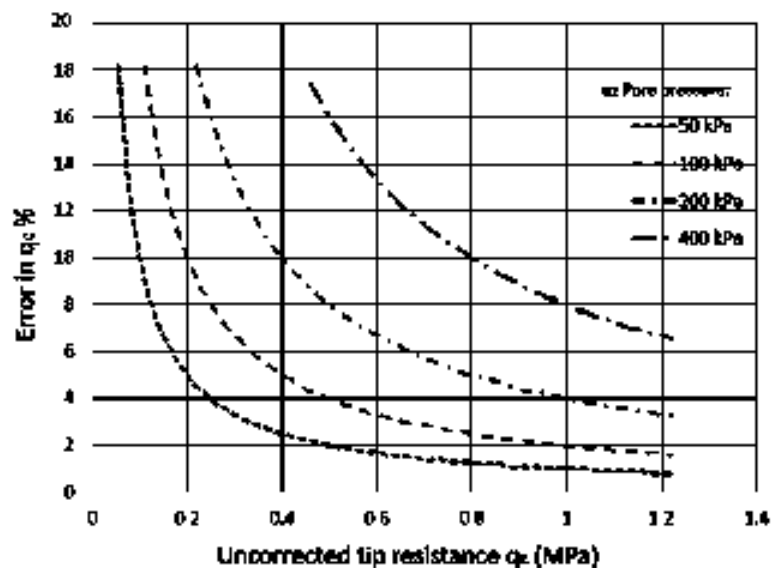
Figure 5-1 Uncorrected tip with measured tip resistance

Where a is the 'area ratio' and $(1 - a)$ is the proportion of cross-sectional area between the cone tip and penetrometer body where pore pressures (positive or negative) can act to add or subtract from the total external axial force on the tip. The difference between measured and corrected values is largest in low strength collapsible soils with large excess pore pressures. The percentage adjustment is described by the curves on the chart below for $a = 0.8$:

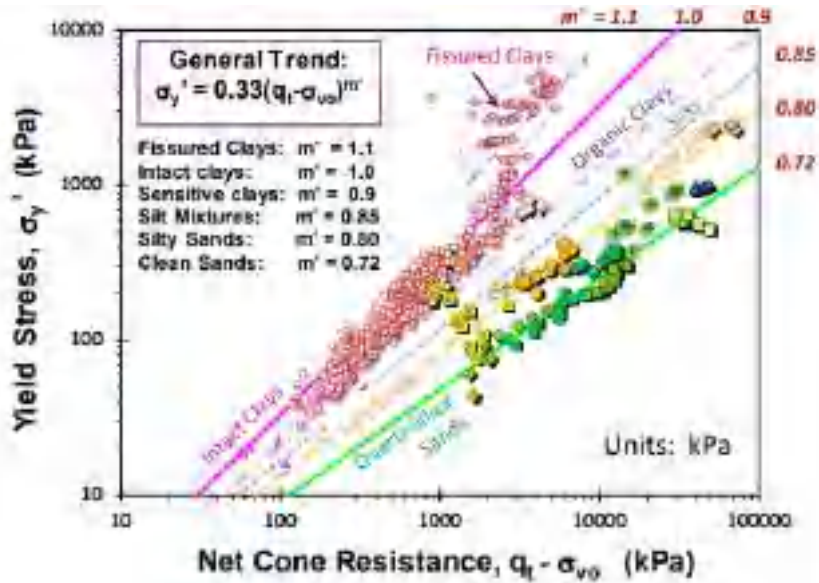
Figure 5-6 Preconsolidation stress with net cone resistance power law, reproduced from Mayne (2014).

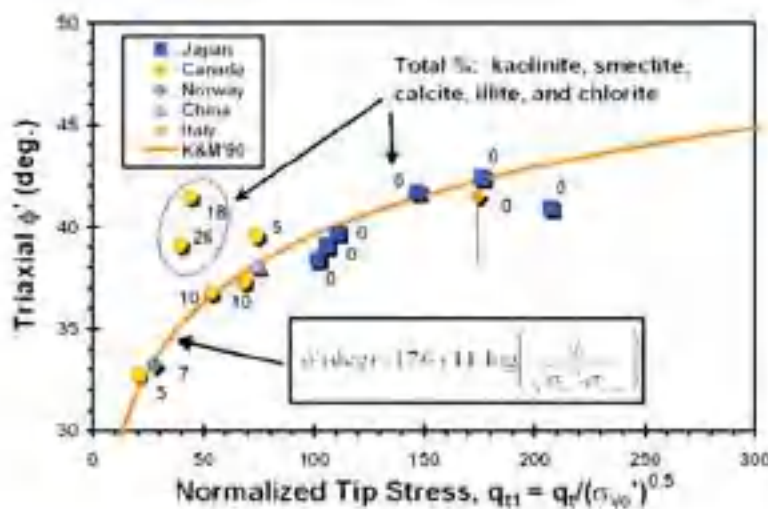
The presence of compressible minerals tends to reduce tip resistance resulting in lower estimate of friction angle, while very coarse (sand) or larger grain size tends to increase tip resistance resulting in higher estimate. Increased penetration resistance due to high k_0 conditions also results in an overestimate of friction angle.

Figure 5-7 Peak triaxial friction angle from undisturbed sands with normalised cone resistance.

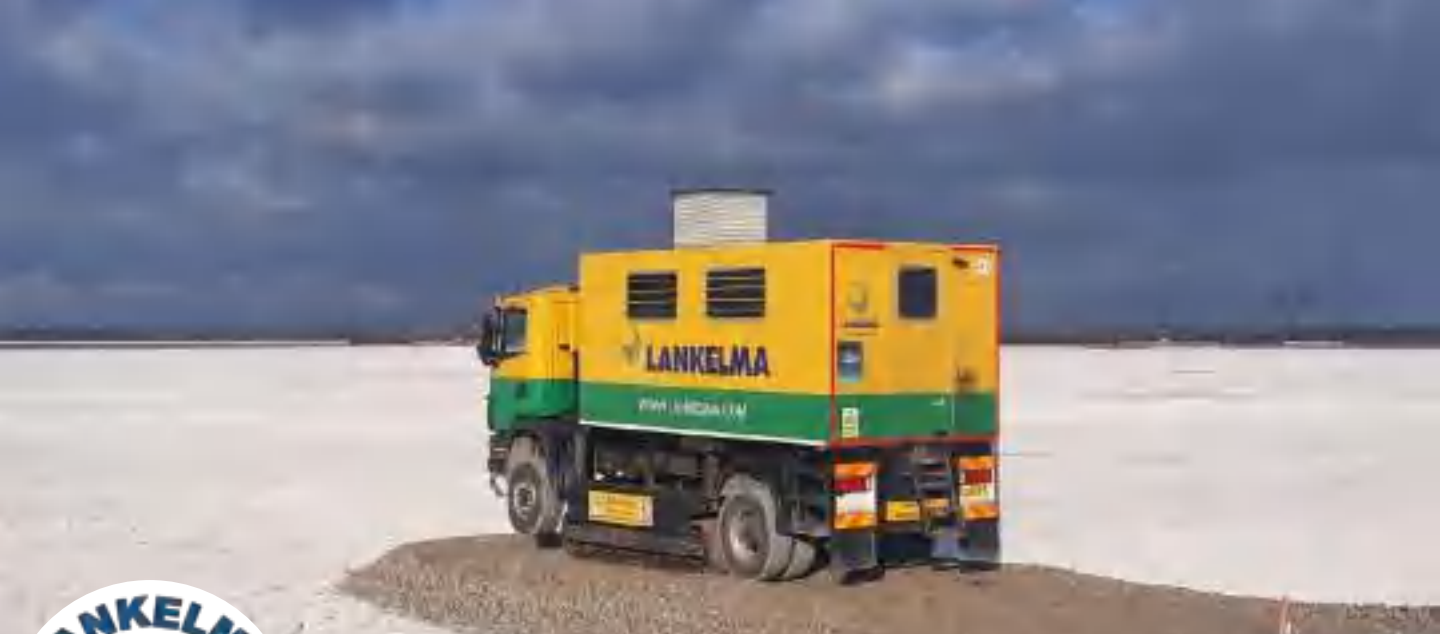
UK3 Track-truck

Rig weight	20.5 T
Max. operating ram capacity	17 T
Max. travelling speed	86 km/h
Track material	Steel
Track length	3300 mm
Track width	650 mm
Jack plate dimensions	Tracks act as jacks
Jack arrangements	1nr. on each side
Max. ground clearance on jacks	210 mm
Max. ground bearing pressure	Tracking/pushing – 47 kPa Pulling – 88 kPa
Max. testing gradient	10 degrees
Max. traversing gradient	20 degrees (operator assessed)
Noise output at 2 m	Testing - 74 dBA Driving – 87 dBA
Clamp arrangement	36/55 push-pull clamp
Ram stroke	1.2 m
Max. casing size	55 mm

An expected 100m+ of standard CPTu testing can be executed in a day (depending on conditions and access).

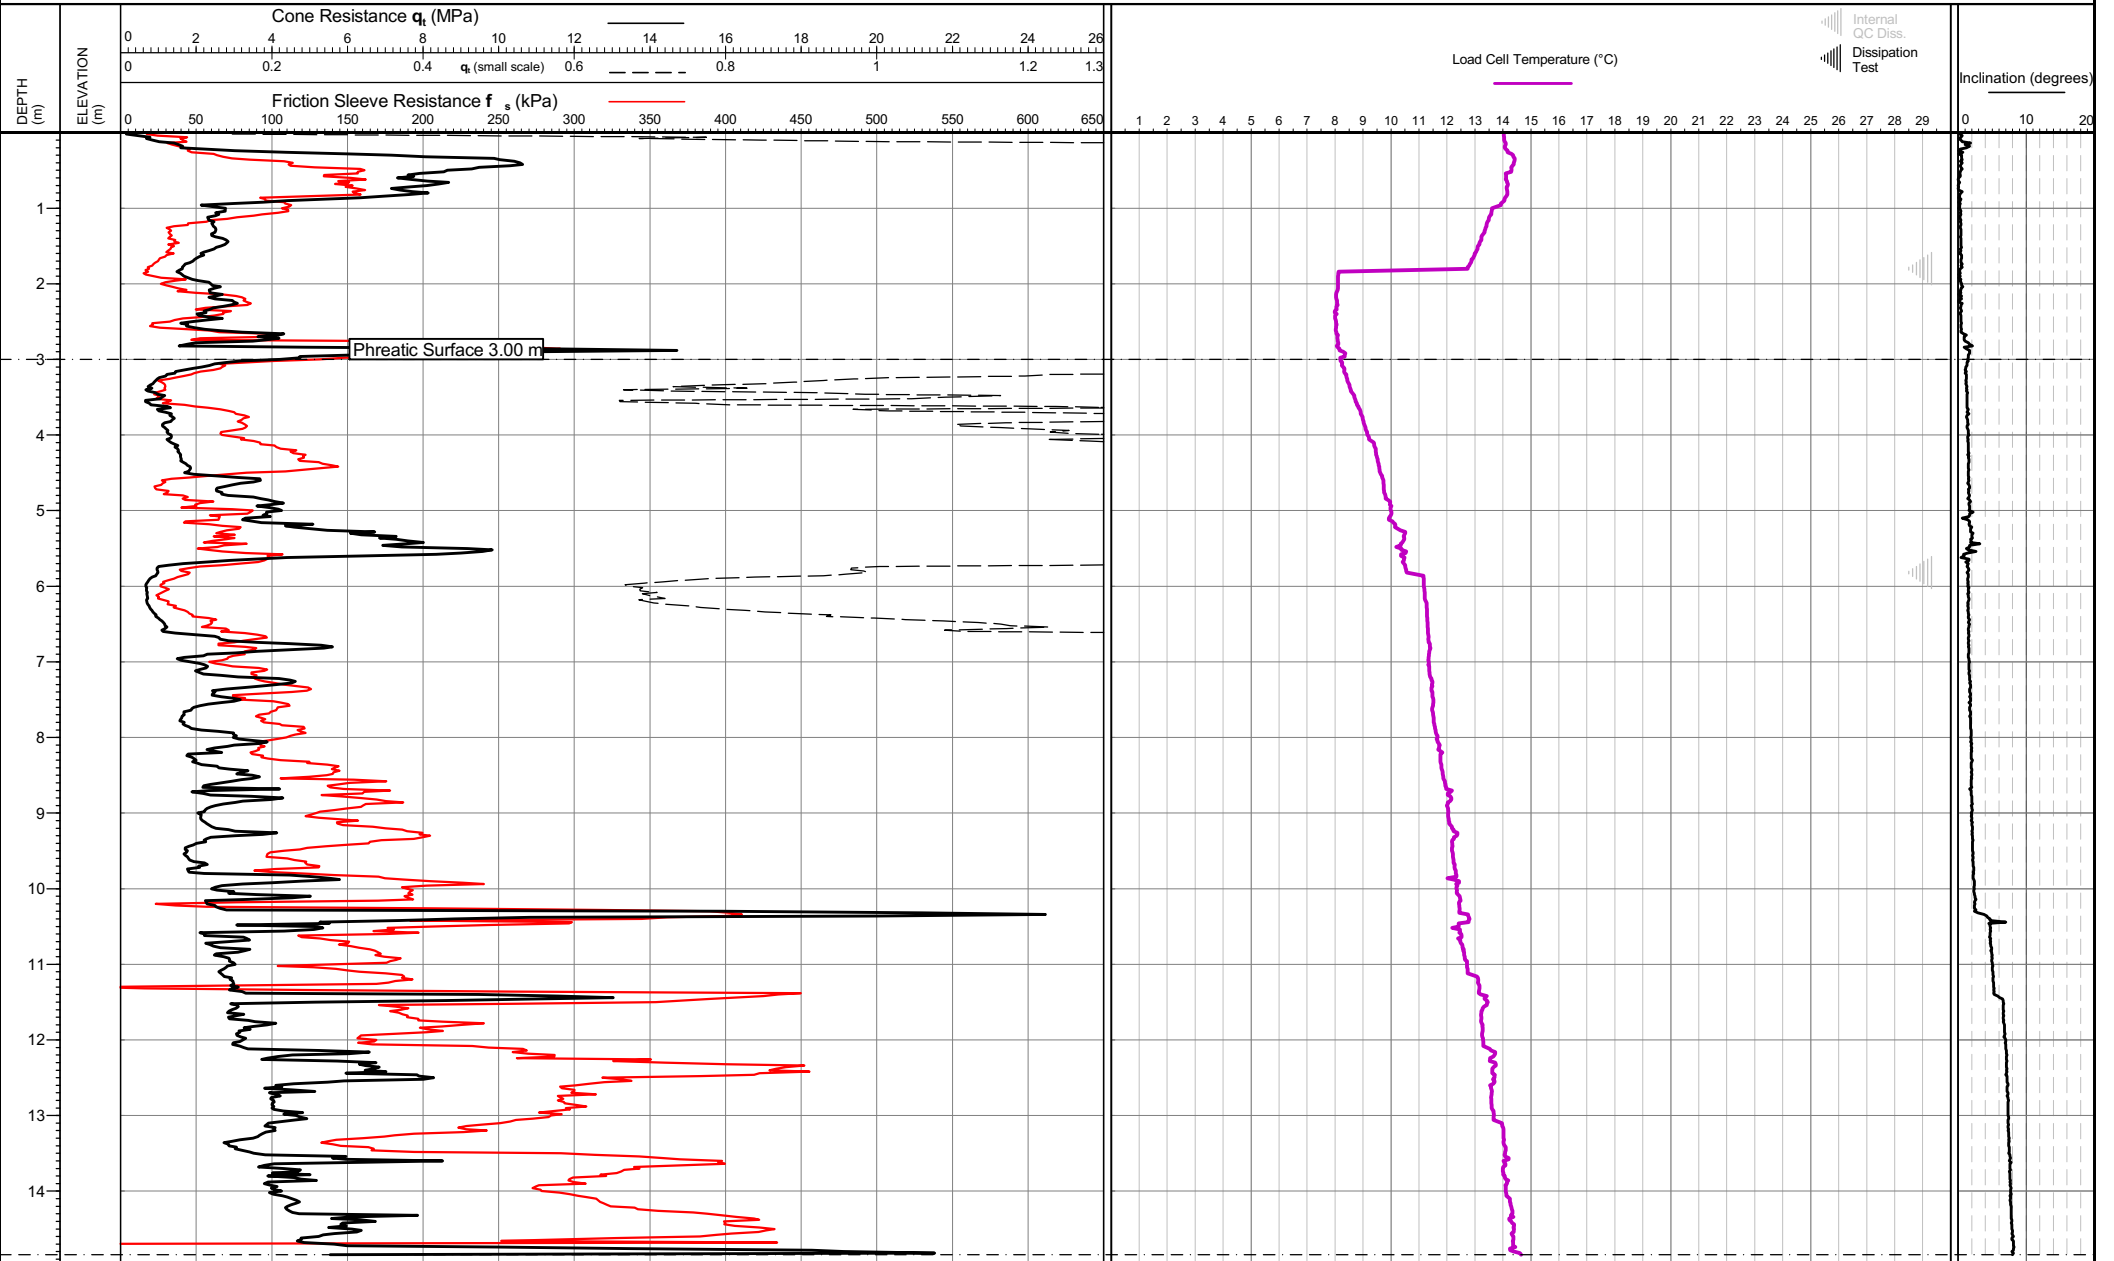
<p>Cone area (mm²): Cone ID: S15-CFIPTT.2117 Operator: Walter Geddes Rig Used: UK3 Date of test: 27/01/2023 12:10:26</p>	<p>Zero drift (Pre/post test) q_c (kPa): -85.0 f_s (kPa): 1.3 ($f_{s, drift} - q_{c, drift}$) u_2 (kPa): -5.2</p>	<p>Location: Tyne & Wear, UK Coordinates: 435775, 546815 Elevation: Coordinate system:</p>	<p>Remarks: *Phreatic surface origin: Arbitrary value Termination Remark: Inclination</p>	<p>Date of plot: 31-01-23 Lankelma Project Ref: P-108244-1 Checked by: Chris Player</p>	<p>TEST ID: CPT06 Page 1 of 2</p>
---	---	--	--	--	---

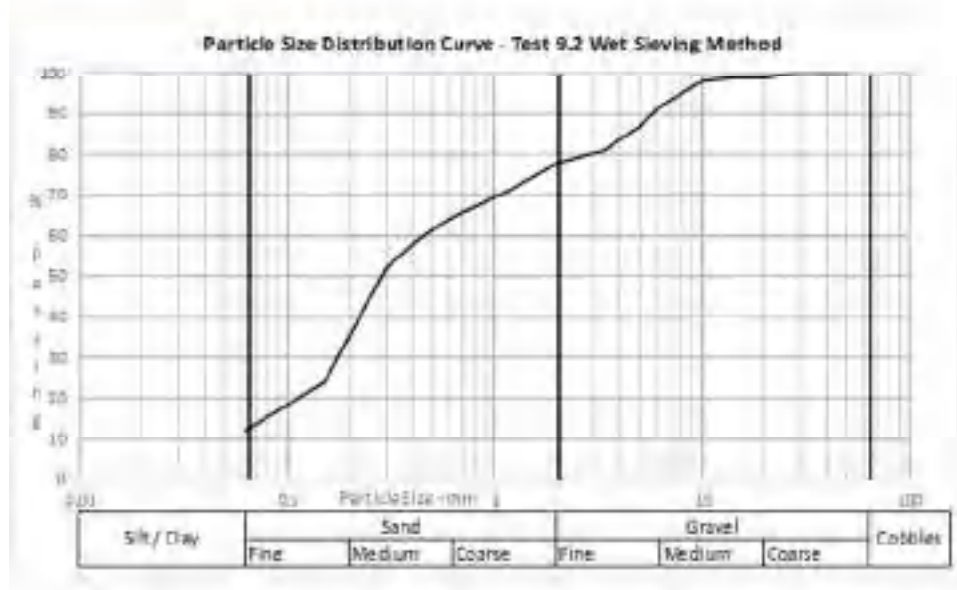
PSD Sieving		PSD Sedimentation	
Size (mm)	% Passing	Size (mm)	% Passing
75	100	No sedimentation test	
63	100		
50	100		
37.5	100		
28	100		
20	99		
14	99		
10	98		
6.3	92		
5	87		
3.35	81		
2	78		
1.18	71		
0.6	64		
0.425	59		
0.300	52		
0.212	38		
0.150	24		
0.063	12

Gravel %	22
Sand %	66
Silt/Clay %	12
