**PROPOSED REPLACEMENT OF BATHROOM WINDOW & PROVISION OF  
EXTRACTOR FAN TO SOUTH EAST ELEVATION  
OF  
PURSLEY FARMHOUSE, SHENLEY WD7 9EN**

**HERITAGE STATEMENT**

*March 2024*

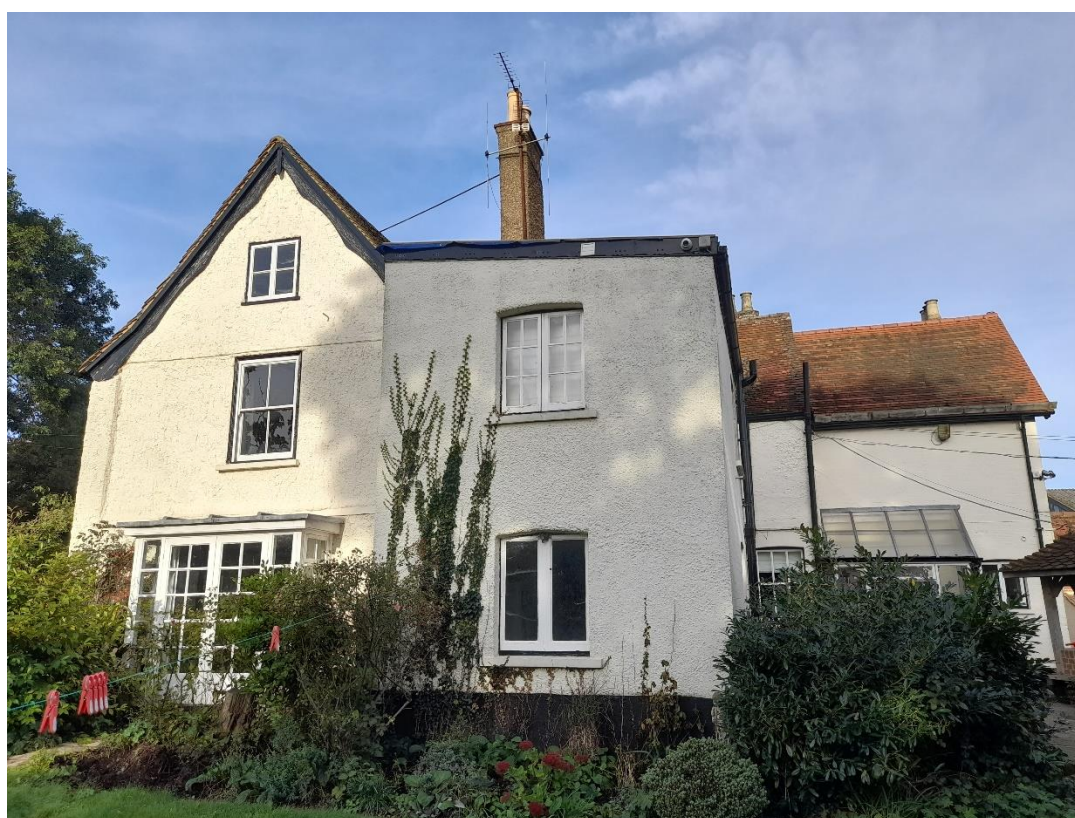
*Image 1*

*South East elevation of Pursley Farmhouse showing window to be replaced to first floor under flat roof*

Photograph 1 on the front cover of this Heritage Statement shows the South East elevation, with the window proposed for replacement on the directly under the flat roof.

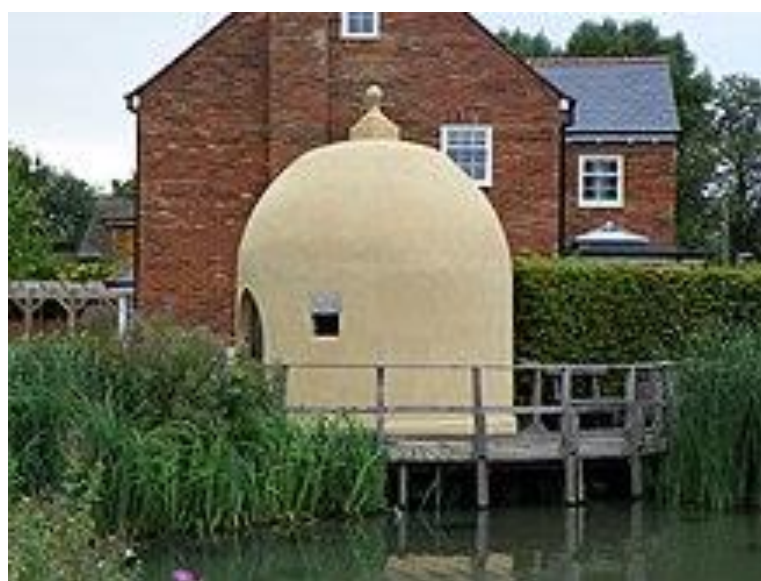
*Image 3*  
*The Cage on the Pond is a village lock-up dating from the 18th century*

The structure is a small, circular building with a domed top, surmounted by a ball finial. A pointed timber plank door has strap hinges and there are two small, iron barred openings with stone tablets above bearing the inscription "DO WELL. AND FEAR NOT." on one and "BE SOBER. BE VIGILANT." on the other. Also inscribed is "1810" which is the date it was repaired after a tree grew through the roof.

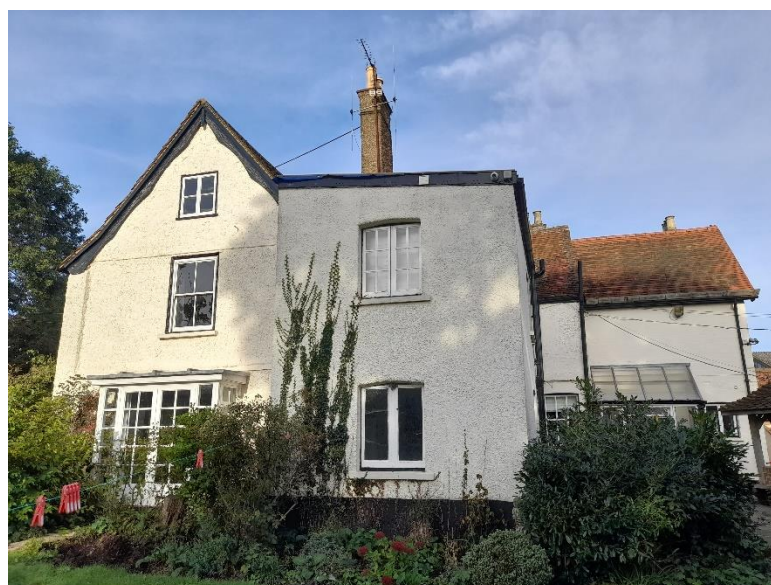
**Image 4**  
*View of South East facing elevation, with Bathroom window proposed for replacement under flat roof*

Image 4 below shows the South East facing elevation of Pursley Farmhouse, with the Bathroom window directly under the flat roof.

A section detail shown in Appendix I details the construction of the proposed window, which will have the following specification:

- Removal of existing window, with ironmongery carefully salvaged for re-use
- Use of FSC certified treated softwood timber to similar profile of existing window.
- Double casement to match existing design, with each casement consisting of six panes of glass.
- Frames to be factory pre-painted in white to match existing.
- Insertion of slimline heritage double glazed units within 14mm glazing bars.
- Replacement of cill to match existing profile, decorated in white to match existing.
- Clean & re-use existing ironmongery, re-fitted using traditional slotted screws

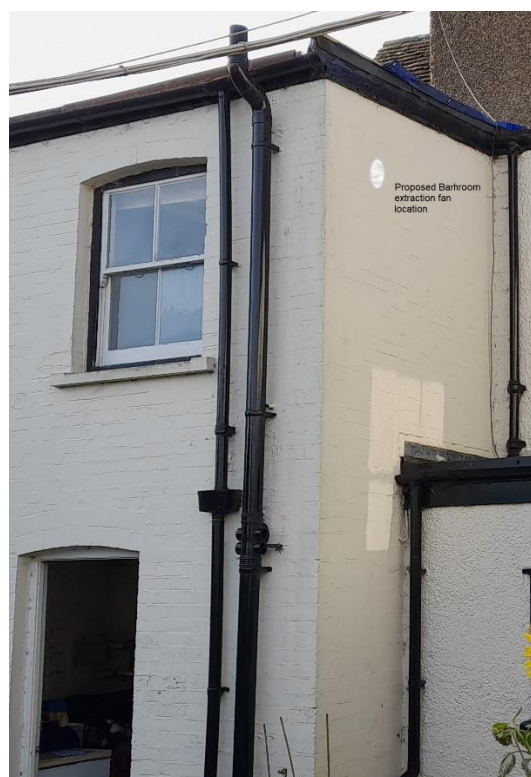
**Image 5**  
*Location of proposed extractor fan ventilation grill*

Image 5 below shows the rear elevation of Pursley Farmhouse, with the proposed location of the extractor fan marked on the North West facing wall.

The elevations attached in Appendix H also show the proposed location of the extractor fan on this wall. The works themselves are very simple and comprise the following:

- Core drilling a 110mm hole directly through the Bathroom wall in the position shown in image 4 above and on the proposed elevations.

- Installation of a 100mm diameter Vent-Axia extract fan with timer & humidity control within the Bathroom, in accordance with Manufacturer's instructions and current IEE Regulations
- Installation of white plastic cover grill to external wall face.

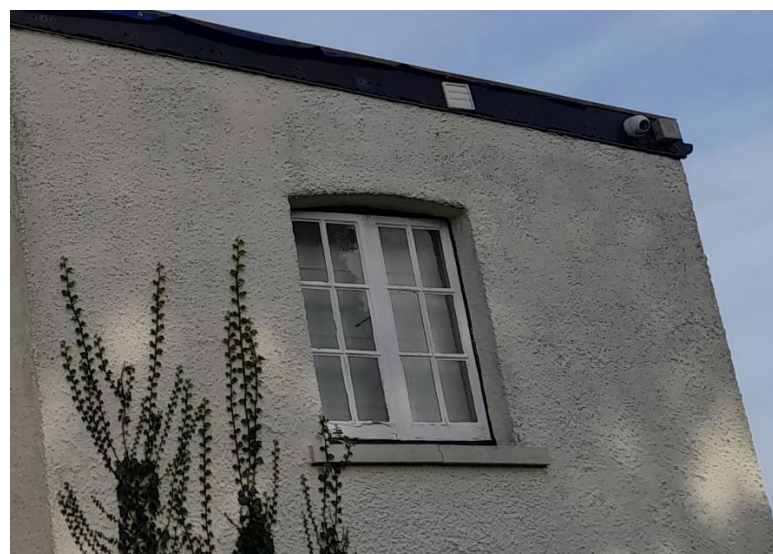
*Image 6*  
External close up of existing Bathroom window

The existing twin casement Bathroom window to the first floor South East facing wall can be seen from image 6 below.

The condition of the window is difficult to see from this image, although the peeling paint and some rot is evident when enlarged. Image 7 below however, taken internally when the window was forced open, shows black mould to the surfaces caused by lack of proper ventilation over a lengthy period.

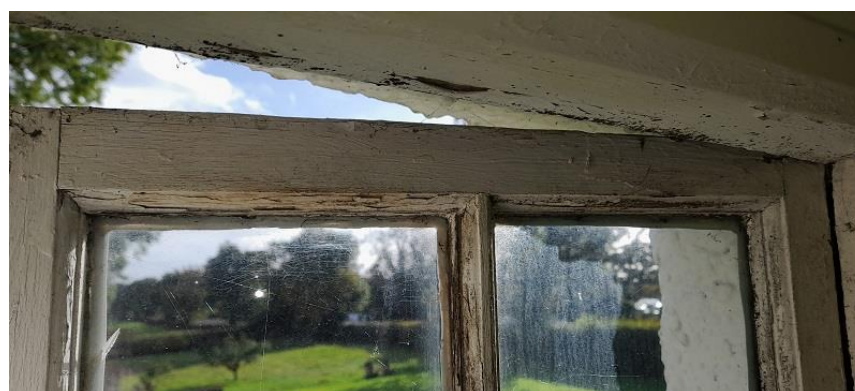
*Image 7*  
Swollen frame has made window very difficult to open, with subsequent hazardous black mould around entire frame & glazing bars

The lack of maintenance has inevitably caused the timber to swell, with subsequent rot owing to the high moisture content. Images 8 – 9 below also show the condition of the window, to such a degree that it is now considered a hazard to health.

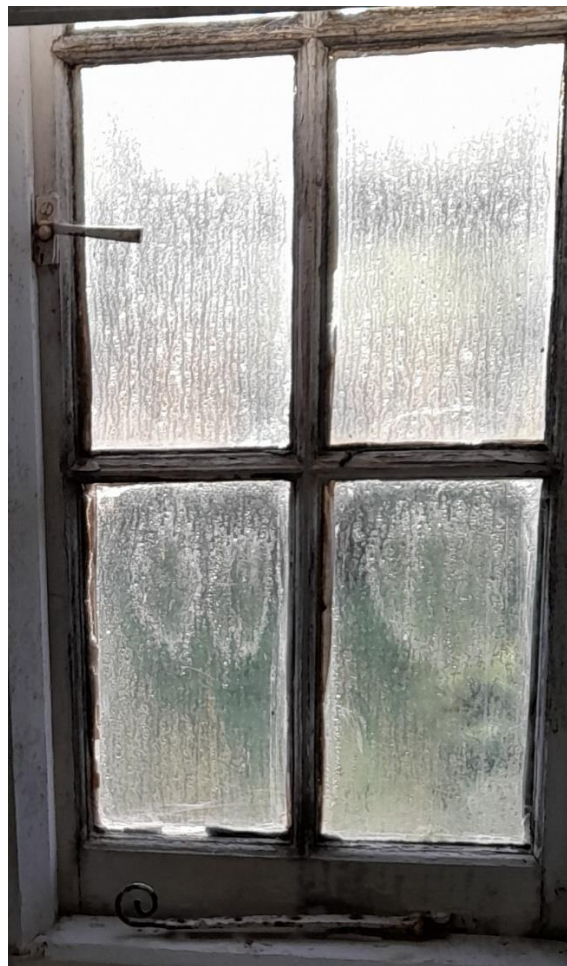
*Image 9*  
*Ironmongery will be retained for replacement window*

The rat tail ironmongery will be removed and reinstated to the replacement window, which will be also be in timber with narrow glazing bars incorporating slim line heritage double glazed units which will improve the thermal performance to ensure sustainability - as advocated in Section 5.2 of BS 7913.

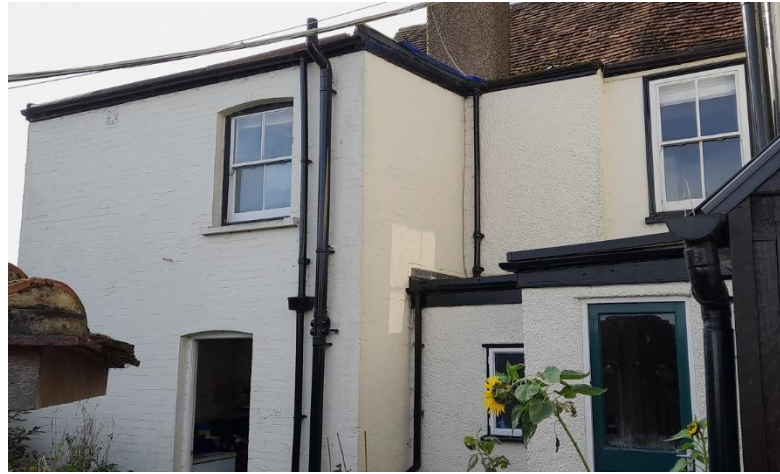
**Image 10**  
*Left side of rear elevation to Pursley Farmhouse, highlighting minimal significance of extension*

The left side of the rear elevation of Pursley Farmhouse can be seen in image 10 below - the proposed location of the extractor fan is marked from image 5 and has been chosen as it will be on the least obtrusive wall.

This image also highlights the minimal significance of this element of the building, with the twentieth century flat roofs and additional storey to the Victorian Scullery removing any aesthetic quality that it might have once had.

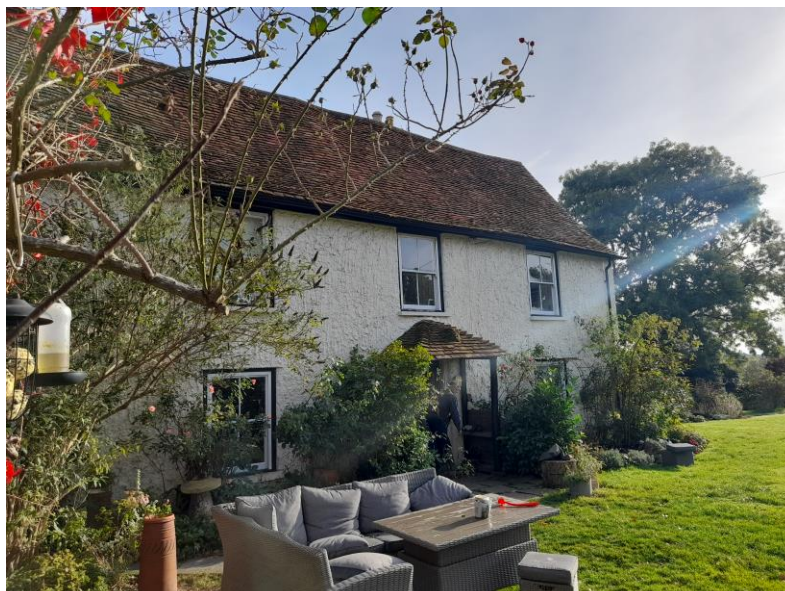
**Image 13**  
*View towards Pursley Farmhouse from closest element of Barn, highlighting that there will be no impact from the proposed works on its setting*

This photograph shows the close proximity of the neighbouring Farmhouse, and the potential impact of any works to the front elevation; but as the roof works are being undertaken to the South East side and the rear they are not visible in any way, as they are entirely screened from view.

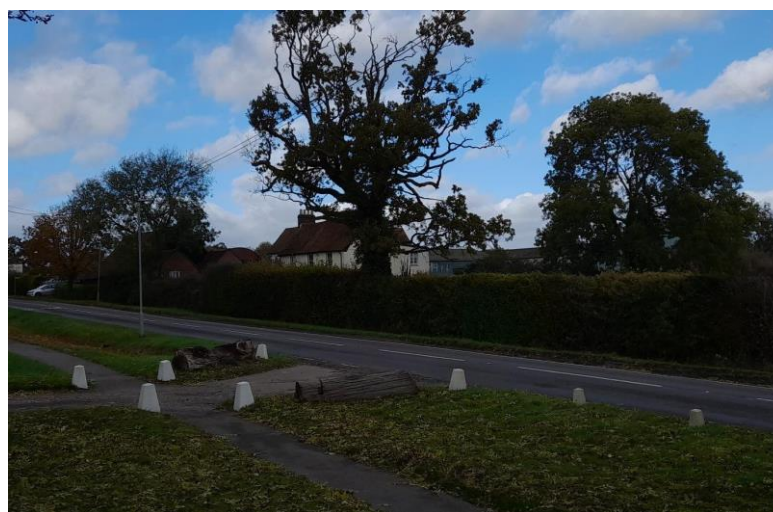
**Image 16**  
*View of Pursley Farmhouse from Tomten*

This photograph shows that the Bathroom window to the South East wall is barely visible - and only then in the Winter when the leaves have fallen off the trees - but as the design for the new window will be the same at this distance there will be no visible difference, so again the setting will remain unaffected by the proposed works.
